# CORROSION OF A193 GRADE B7 BOLT MATERIAL IN BWR SODIUM PENTABORATE SOLUTIONS

STP-NU-068

Date of Issuance: March 14, 2014

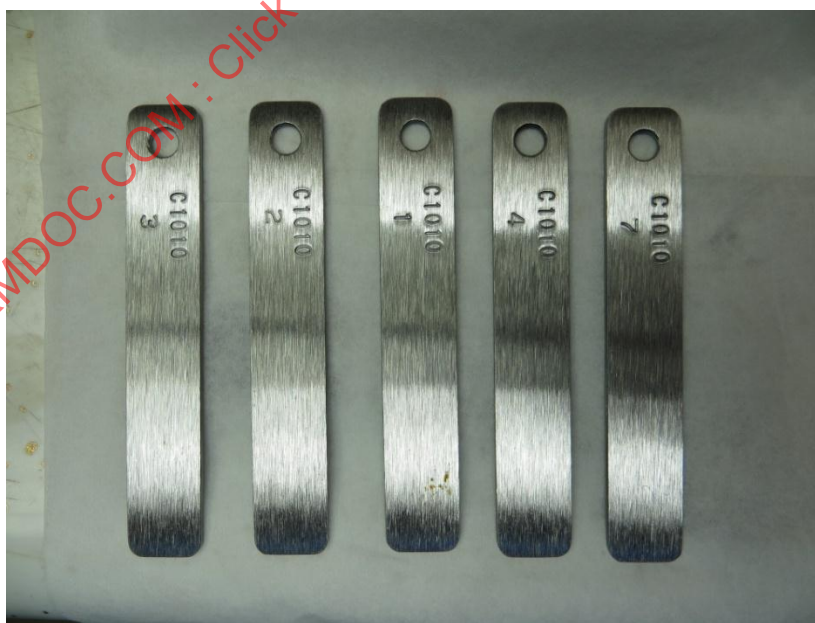
**Figure 3-1: C1010 Test Coupons 1, 2, 3 and 4  
After 20 Days of Exposure and Un-Exposed Coupon 7**

The condition of the C1010 test coupons (Numbers 1 to 4) is compared to that of an un-exposed C1010 coupon (Number 7) in Figure 3-1. Very limited indications of localized corrosion are present near the bottom of Coupon 1. Condition of the C4140 test coupons (Numbers 7 to 10) is compared to that of an un-exposed C4140 coupon (Number 11) in Figure 3-2 Figure 3-3. The only visually observable corrosion of the C4140 material was on Coupons 8 and 10. Coupon 10 exhibited small localized regions of oxide formation on the front side of the coupon. Coupon 8 exhibited more limited localized corrosion on the lower end of the back side of the coupon.

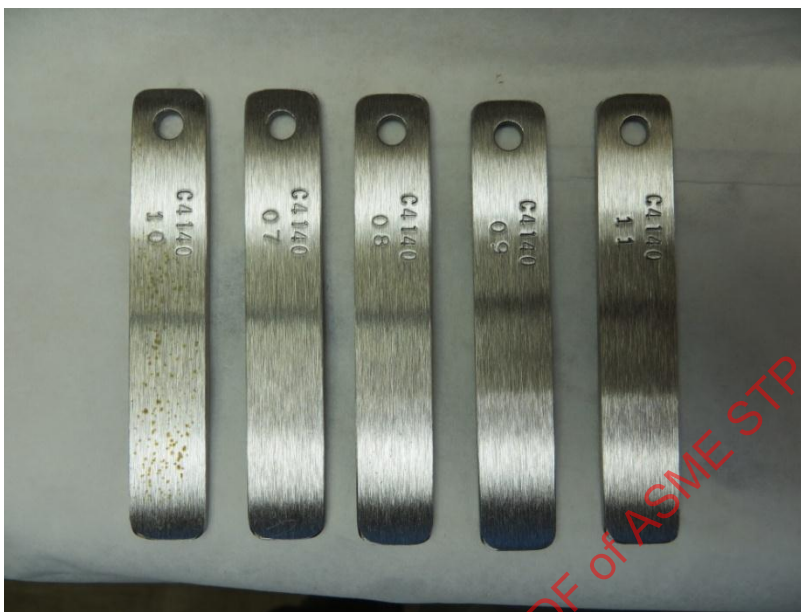
**Figure 3-2: C4140 Test Coupons 7, 8, 9 and 10 (Front Face)  
After 20 Days of Exposure and**

| Coupon Series | Coupon No. | 20 Day Exposure | | 2 Month Exposure | |
|---|---|---|---|---|---|
| C4140 | 7 | N/A | No visible corrosion | C4140 Back | Limited number of oxide nodules on bottom of back side |

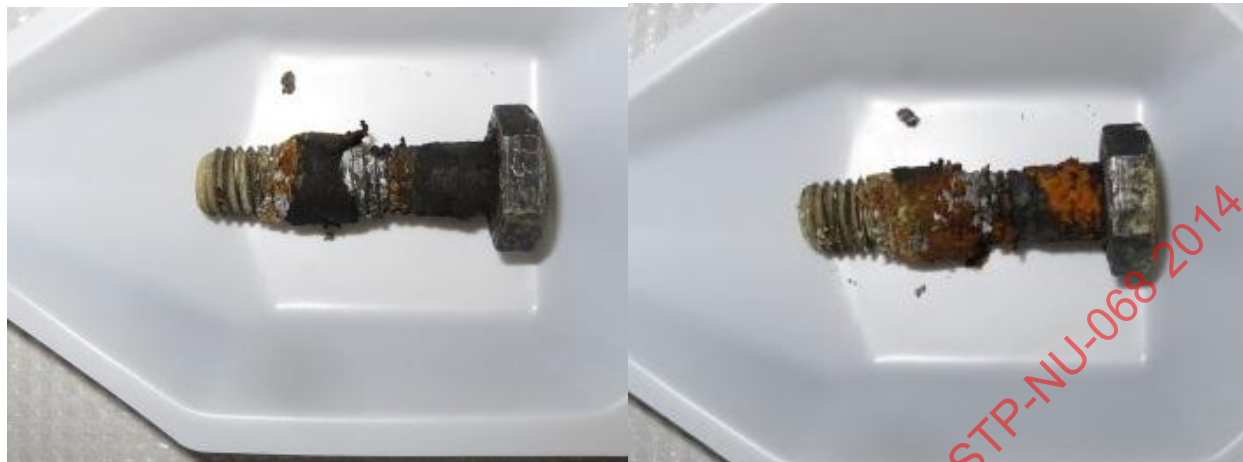
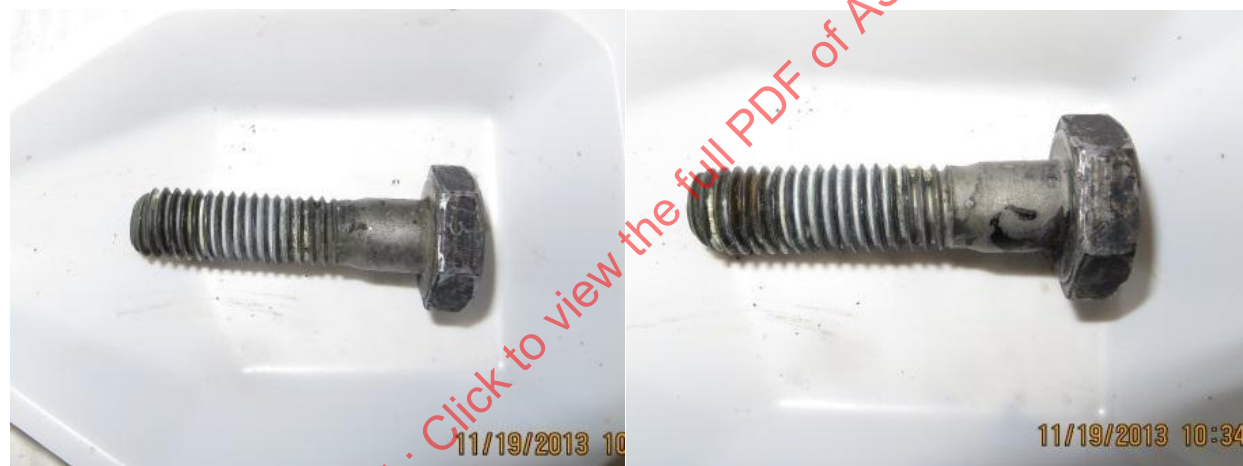
**Figure 4-12: Bolt 13 before and after Initial Deposit Removal**

Pictures of the bolts before and after attempts to remove the deposits by rinsing and chasing the threads are presented in Figure 4-12 to Figure 4-15. As shown, white deposits were still observed between the threads on all four bolts. Bolts were then scrubbed with a wire brush under flowing hot tap water, soaked in demineralized water and placed in an ultrasonic bath for five minutes. This process effectively removed the deposits, and there was no visual indication of residual deposits or metal oxide. The bolts were then dried and reweighed.

- The weight losses from Bolts 13, 14 and 16 correspond to average metal loss and corrosion rates of 2.14, 0.85 and 1.51 g/dm<sup>2</sup>-mo, respectively, based on an estimated area of 0.27 dm<sup>2</sup> for the bolt shank and total threaded length.

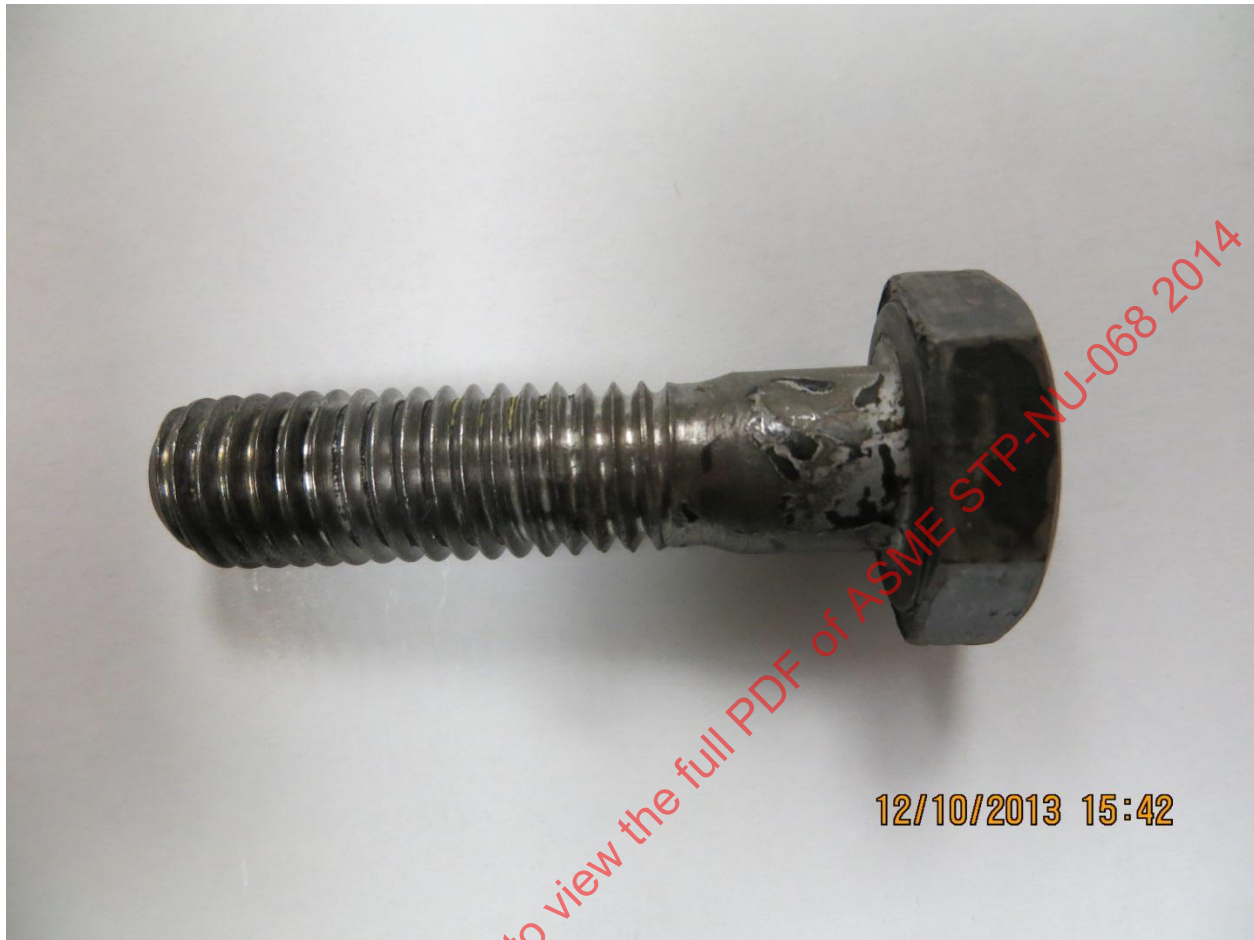
**Figure 4-16: Bolt 13 after Final Cleaning**

- Bolt 13 – Limited amounts of crystal deposits were present in the deepest grooves between some threads. There were no visible signs of pitting or other localized corrosion. Some local loss of material due to corrosion was present on the bolt shank (Figure 4-16).
- Bolt 14 – Limited crystal deposits were observed between some threads. Oxidation was observed at the bottom of the threads. Portions of a black outer layer were flaked off the shank of the bolt.
- Bolt 15 – Oxidation was apparent at a few locations, but corrosion appeared minimal.
- Bolt 16 – Limited amounts of white crystals were present in the thread grooves. Some local loss of material due to corrosion was present on the bolt shank (Figure 4-17).

Since there was evidence of localized corrosion in the shank region of Bolts 13 and 16, and the metal loss indicated that there should be a measurable decrease in the shank diameter of these bolts if corrosion was primarily in the shank region and threaded region above the nut, measurements of the shank diameter for all of the flange bolts including three new bolts were made at two locations around the bolt circumference (offset by 90°). Results are given in Table 4-3. As shown, there was a decrease of 0.004 to 0.005 inches in the shank diameter of Bolt 13 at the location of the simulated leak. This bolt had the largest weight loss (1.038 grams) during the test at 203°F. The observed diameter decrease is in reasonable agreement with the values of 0.004 to 0.007 inches estimated from the weight loss data. The diameter decrease for Bolt 16 also is in reasonable agreement with the estimated corrosion rates. No quantifiable decrease in shank diameter was observed for any of the bolts exposed at 95°F which is consistent with the weight loss observations.

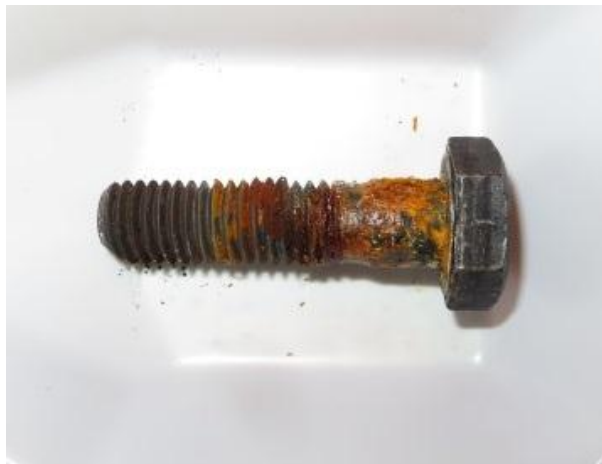
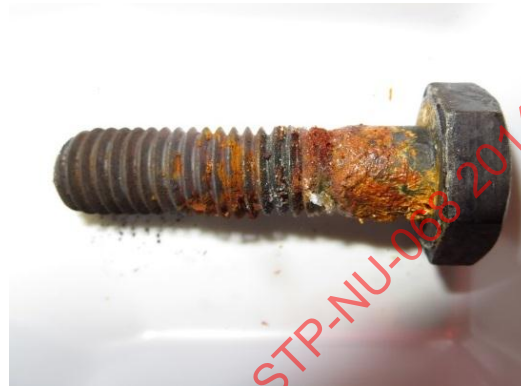
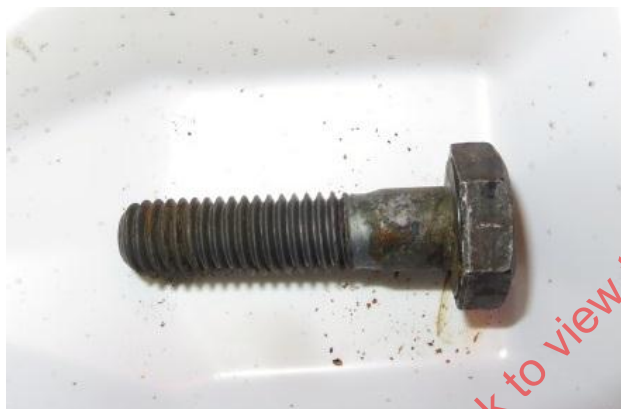
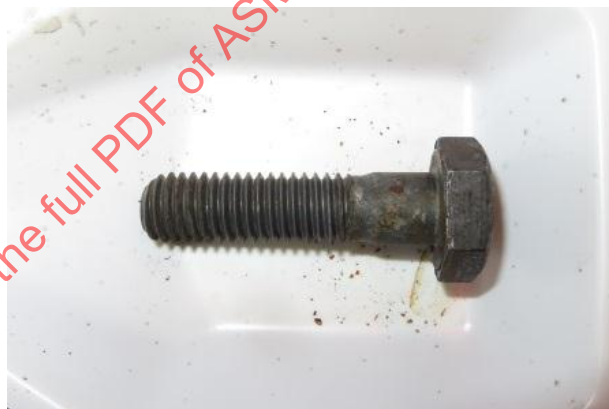
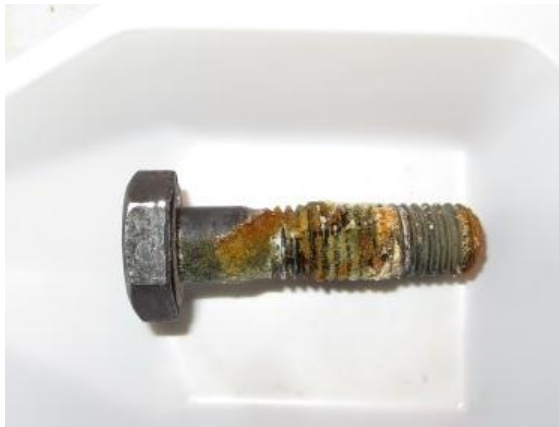
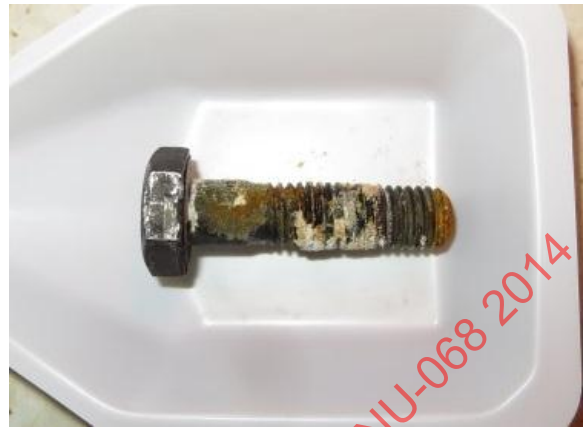
## APPENDIX B: Low Temperature Test Photographs

Pictures of the bolts before and after removal of deposits are given in Appendix B. Although a rust colored deposit was generally observed on all bolts following removal, there was no visual indication of local corrosion attack on any of the bolts after they were soaked in 2.5% NaPB solution at room temperature to dissolve readily soluble salts, dried, rinsed, brushed with a soft bristle brush, and dried before final reweighing.
