SAE AIR1707

Patterns of O-ring Failures

The information presented herein describes the commonly observed patterns of O-ring failure by means of both text and illustration. Possible causes and corrective actions are indicated for alleviating the problem.

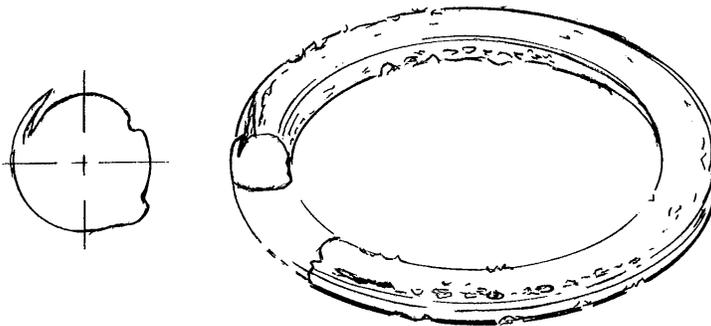
3.2.2 Appearance: Exhibits many small nibbles removed from the O-ring adjacent to the downstream clearance area, or a small section of the O-ring may be extruded. Typical of high pressure systems, this process sometimes erodes half of the O-ring cross-section before major leakage occurs.

3.2.3 Cause: Clearance is too large, pressure is too high, O-ring is too soft, O-ring is softened and swelled by fluid, clearance increases under pressure, eccentricity causes irregular gap, and corners of O-ring gland are too sharp.

FIGURE 1 - Extrusion and Nibbling

3.2.4 Corrective Action: Closer metal fits, use of backup rings or other antiextrusion devices such as cap strips, harder O-ring material, use of O-ring more compatible with system fluid, more rigid or concentric metal components, and break edges of gland to a radius of about 0.001 - 0.002 in. (0.025 - 0.050 mm). T-seals that fit into the same gland may also be substituted.

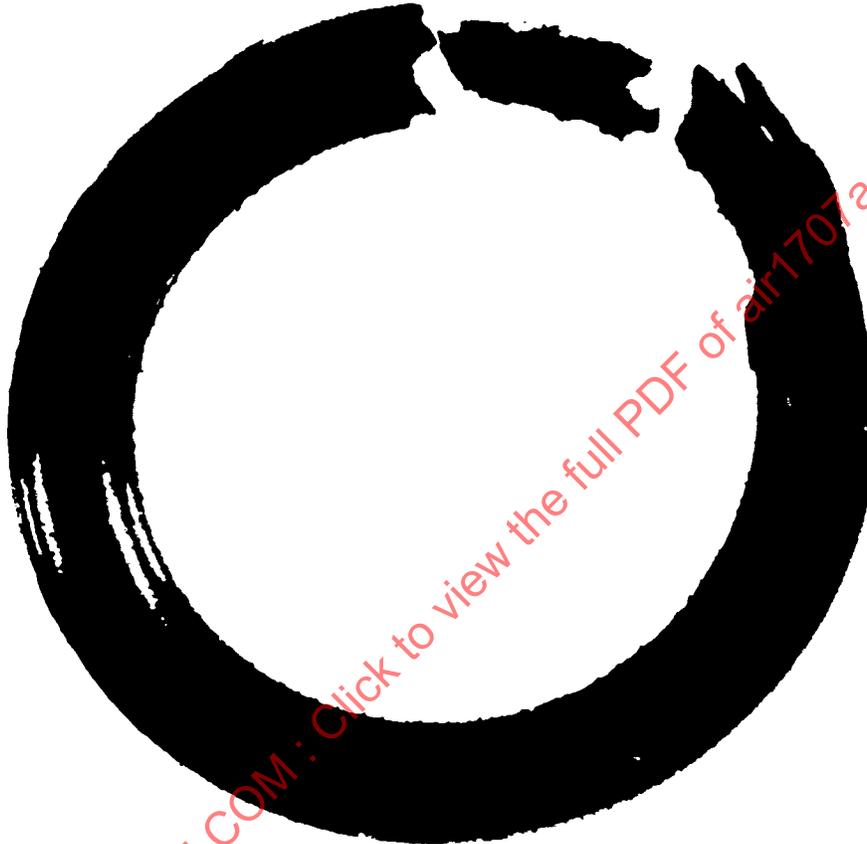
FIGURE 2 - Extrusion and Nibbling

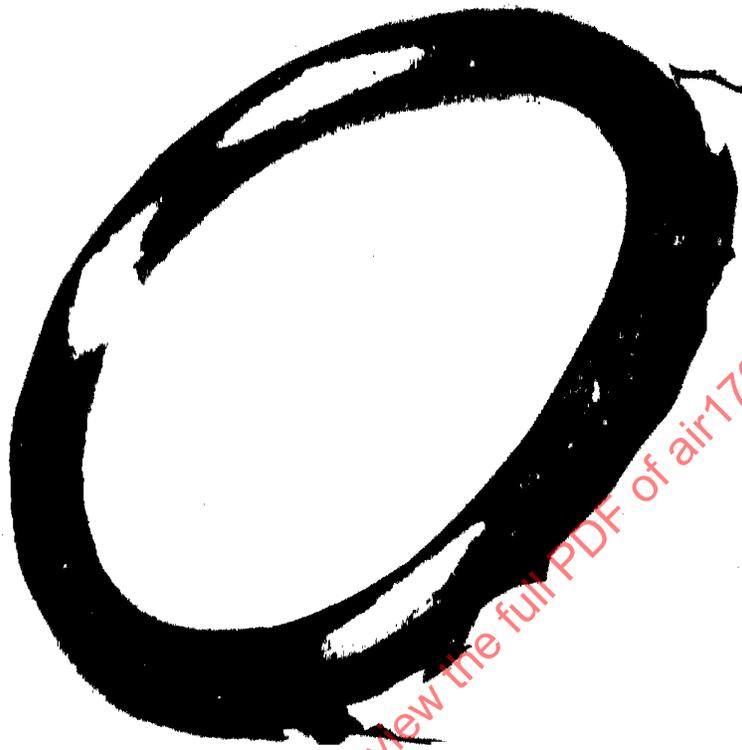
FIGURE 3 - Nibbling and Skiving

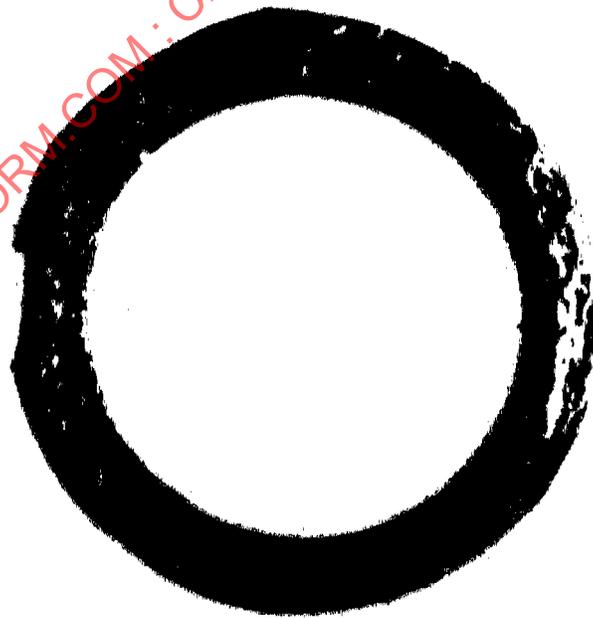
FIGURE 4 - Nibbling and Abrading

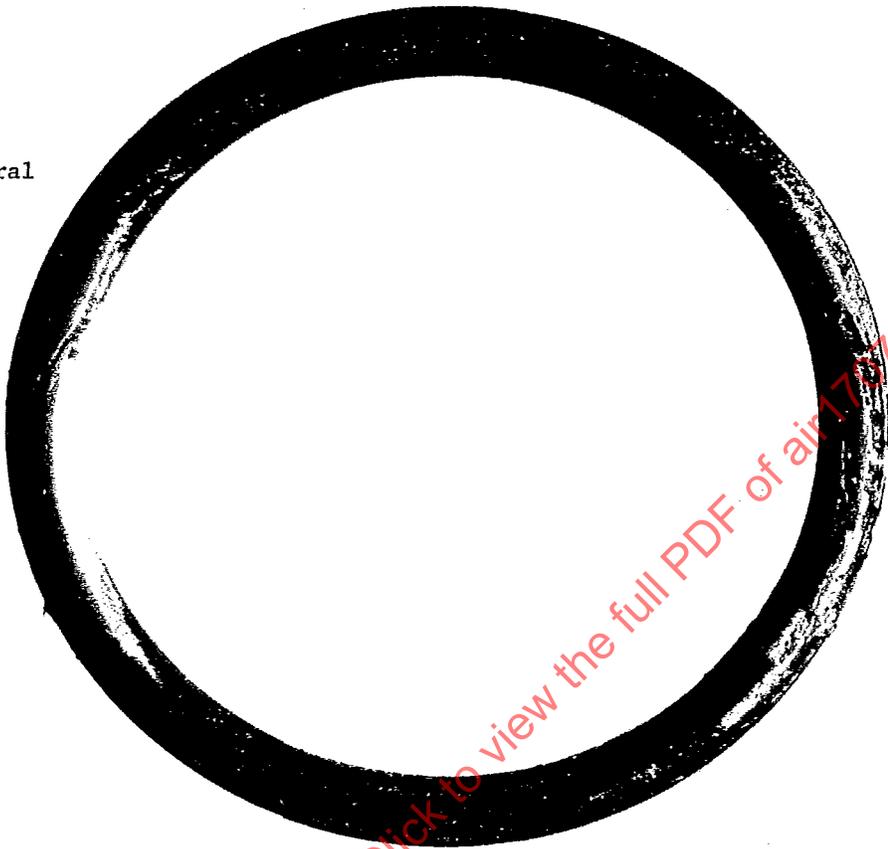
FIGURE 5 - Nibbling and Extrusion

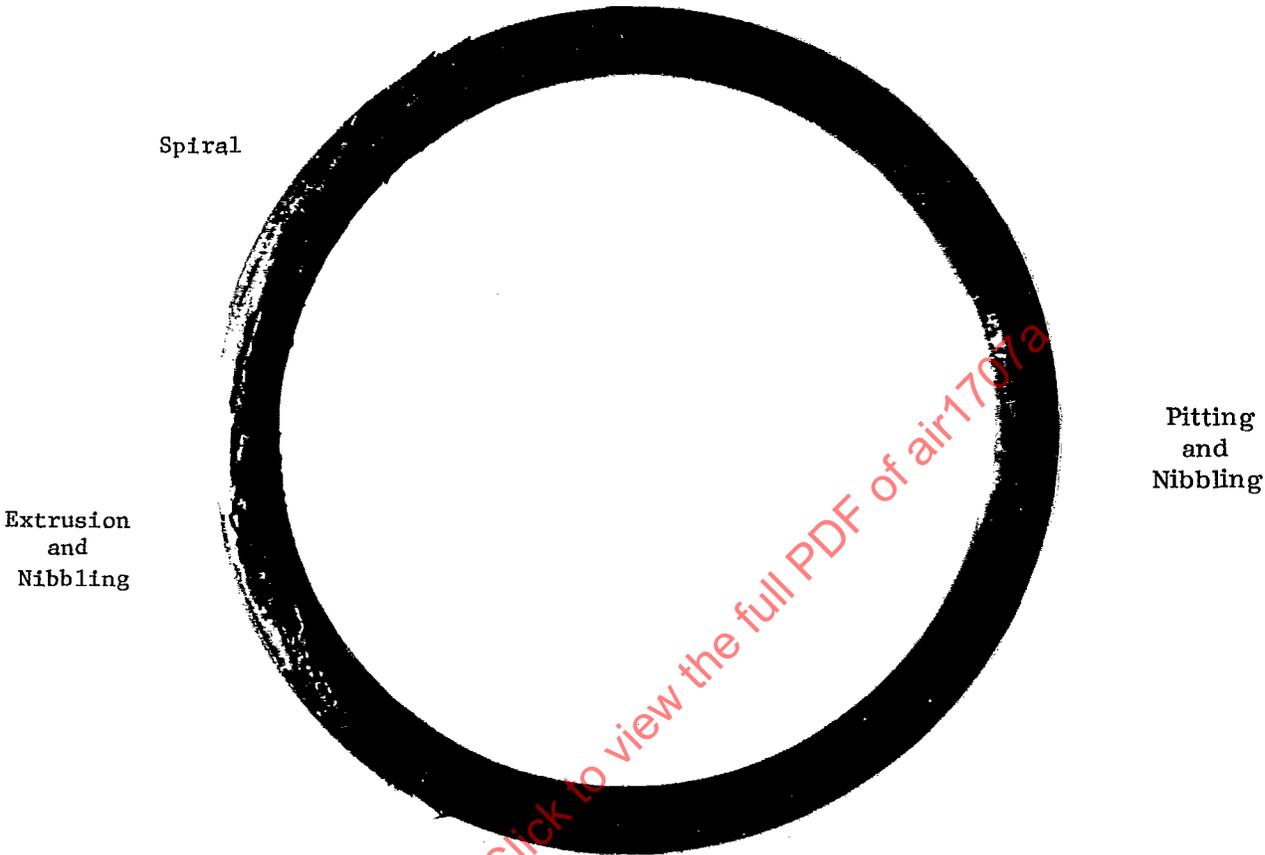
FIGURE 6 - Nibbling, Extrusion, Pitting, and Spiral Failure

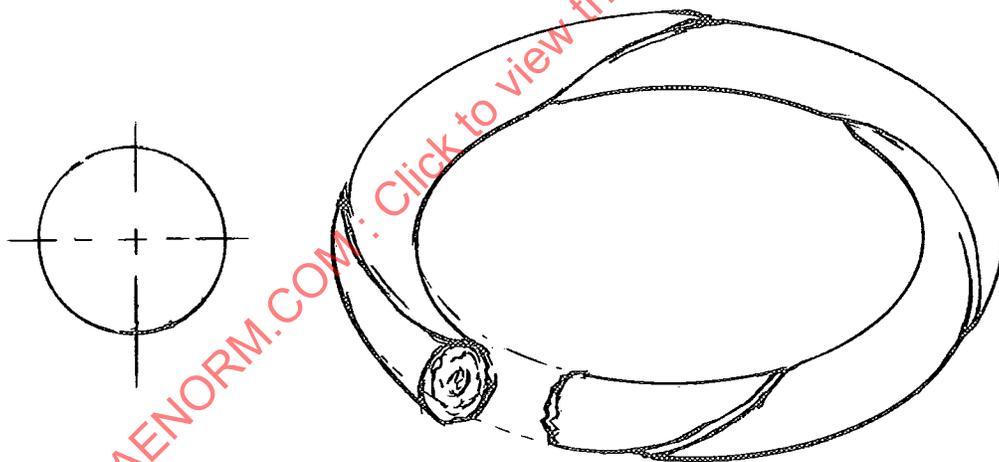
3.3.2 Appearance: Exhibits a deep spiral cut (usually at about 45°) into the O-ring cross-section.

3.3.3 Cause: Conditions which cause segments of the O-ring to slide and others to roll, simultaneously. The O-ring generally gets pinched or "hung up" at one point of its periphery. Side loads causing the O-ring to get caught in an eccentric component, uneven surface finishes, poor or uneven dispersion of lubricant and stroke speeds contribute.

FIGURE 7 - Spiral Failure

3.3.4 Corrective Action: Improve metal surface finish to the 10 - 20 $\mu\text{in.}$ (0.25 - 0.50 μm) range, improve lubrication, use backups or other antiextrusion devices if possible, reduce gap, and consider seals other than O-rings such as T-seals.

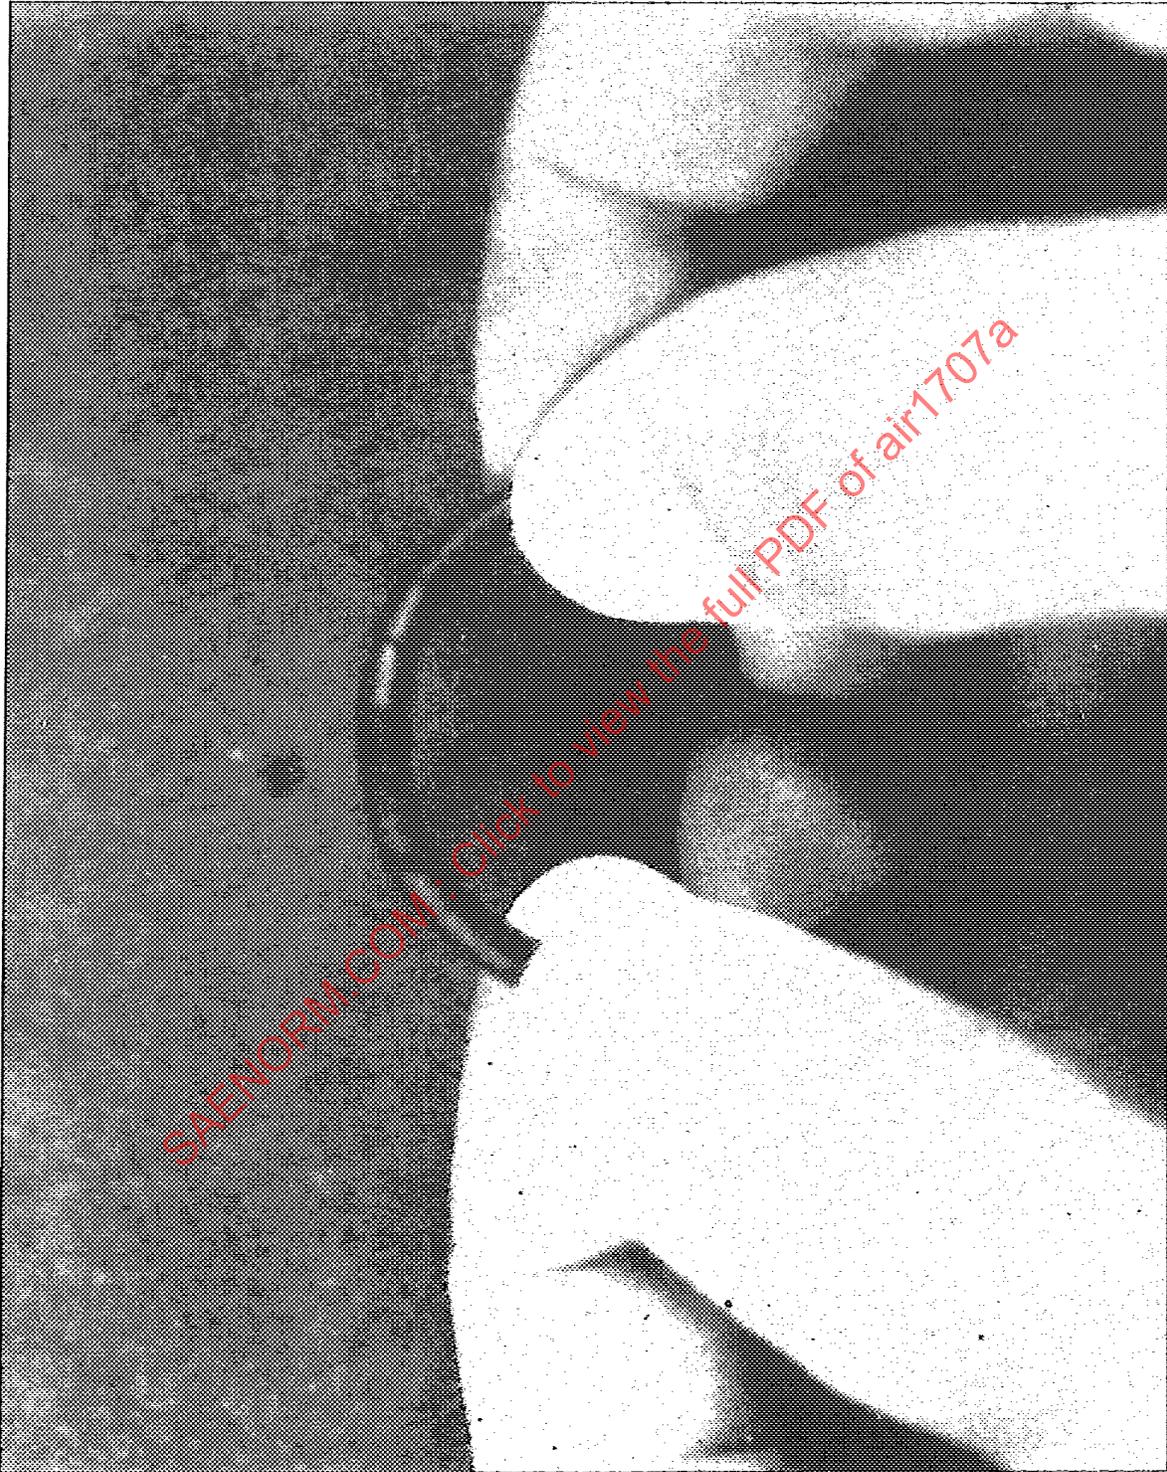
FIGURE 8 - Spiral Failure

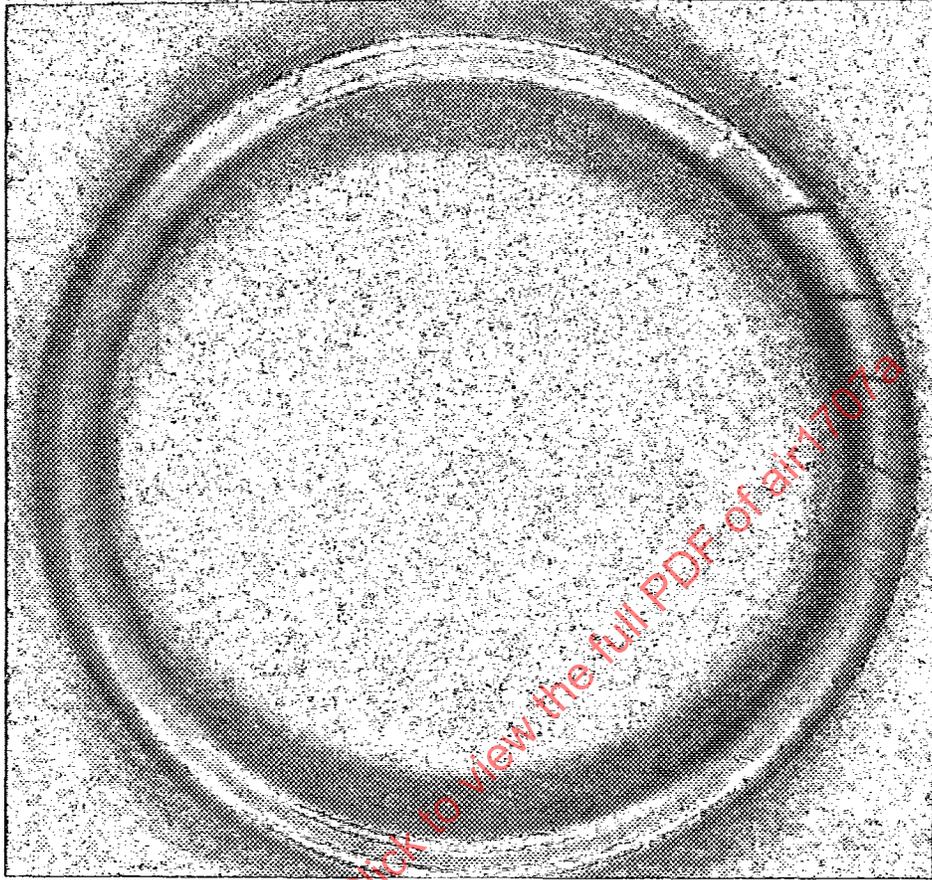
FIGURE 9 - Spiral Failure

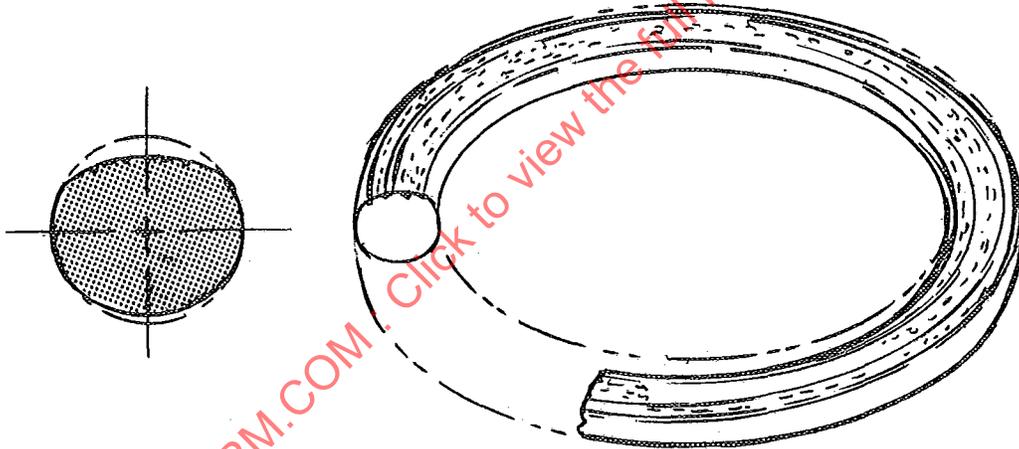
3.4.2 Appearance: Flat area on one side of cross-section of O-ring where moving contact is made with metal component. Frequently shows wear lines on the cross-section parallel to motion of the seal.

3.4.3 Cause: Too rough or too smooth metal surfaces, poor lubrication, high temperatures, or fluid contamination.

FIGURE 10 - Abrasion

3.4.4 Corrective Action: Use recommended metal finishes, provide adequate lubrication, use O-ring material compatible with service temperature, and eliminate fluid contamination. Rapid wear can be expected with finishes below 5 $\mu\text{in.}$ (0.13 μm).

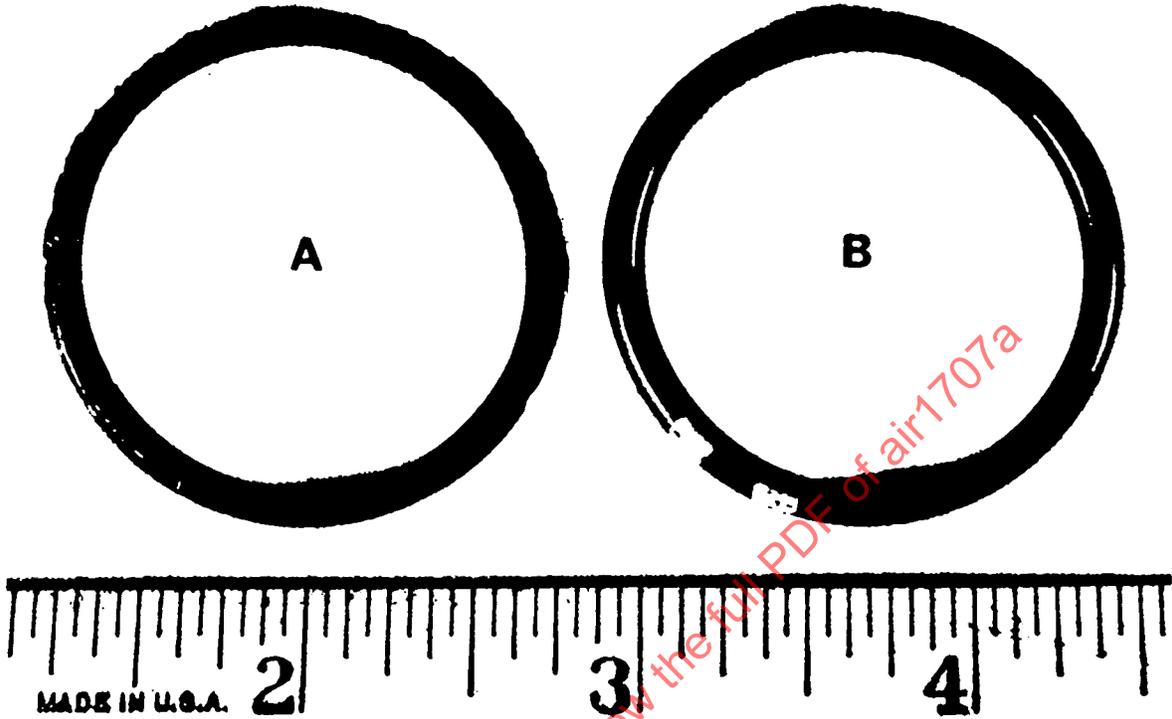
A = Severely abraded and nibbled
B = Normal condition after same period of service
Scale as shown

FIGURE 11 - Abrasion

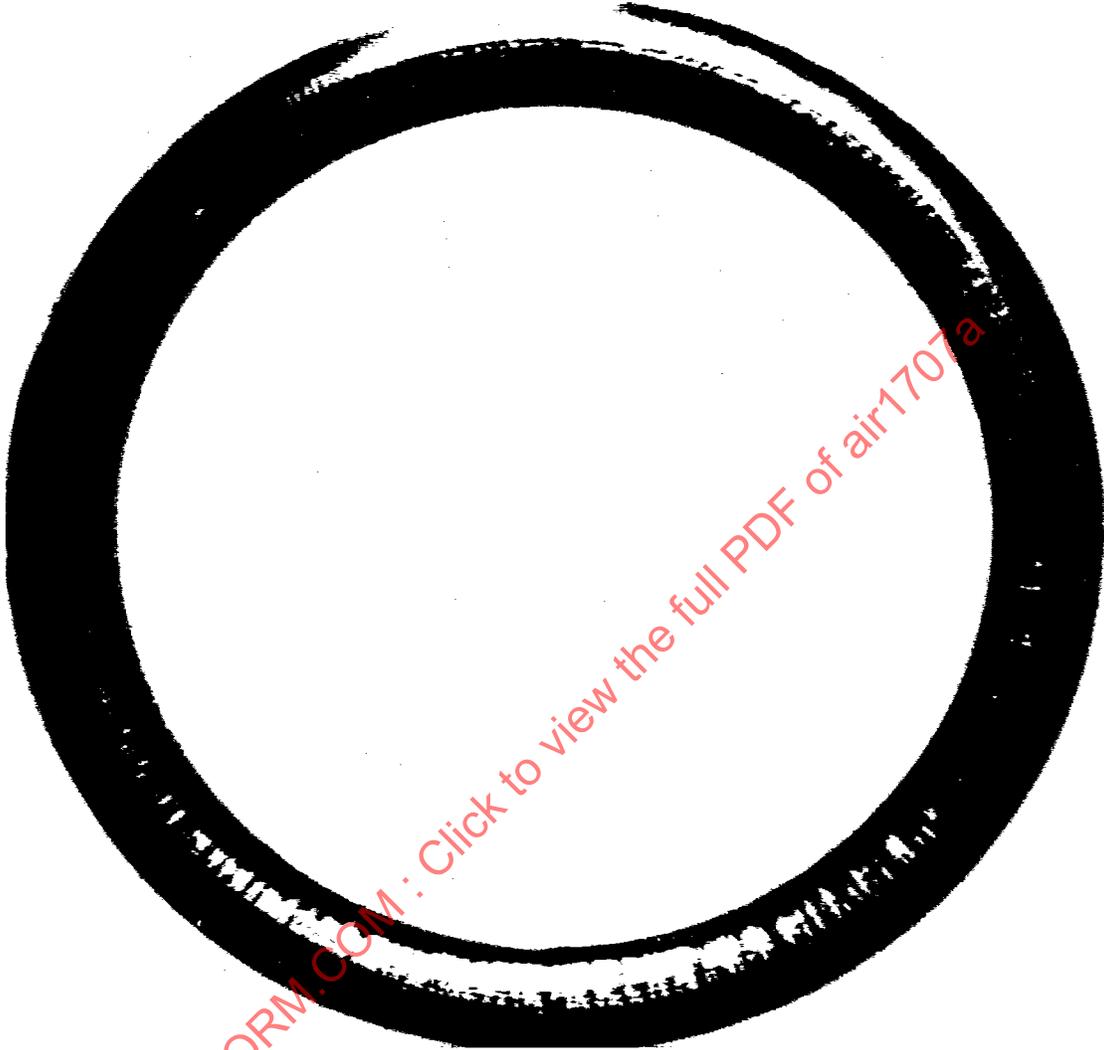
FIGURE 12 - Abrasion

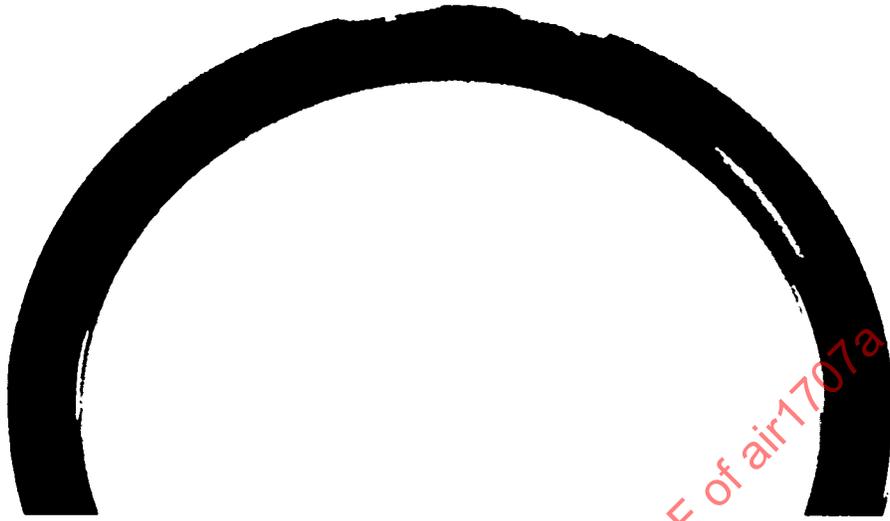
FIGURE 13 - Abrasion at Color Code

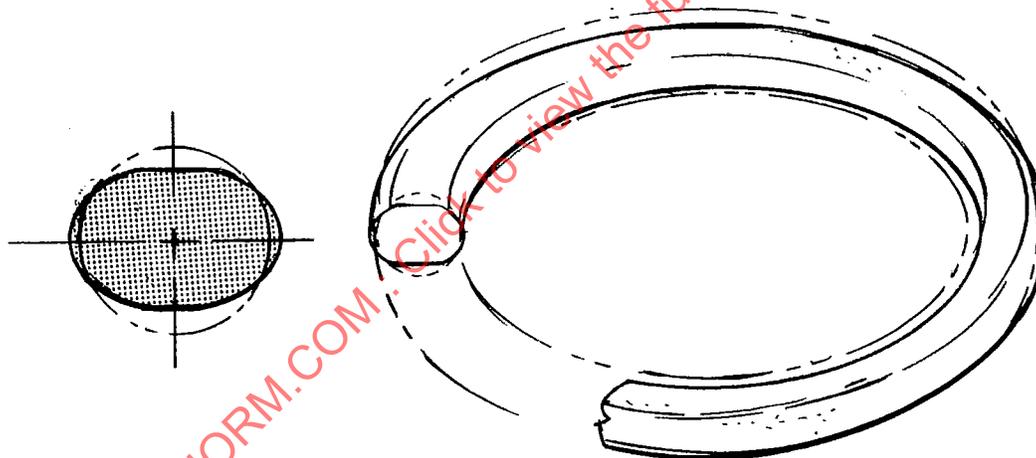
3.5.2 Appearance: Flat area on both sides of O-ring cross-section in the area being squeezed.

3.5.3 Cause: Temperature too high (either environmental or frictional) causing hardening, excessive volume increase from fluid causing overfill, excessive squeeze to achieve seal, O-rings not completely vulcanized, or use of compound with poor set properties.

FIGURE 14 - Compression Set

3.5.4 Corrective Action: Use O-ring material compatible with fluid and temperature service, minimize conditions which increase service temperature, review squeeze to be sure it is proper, and use an improved, low-set compound if available. A good quality, well-inspected O-ring is important.

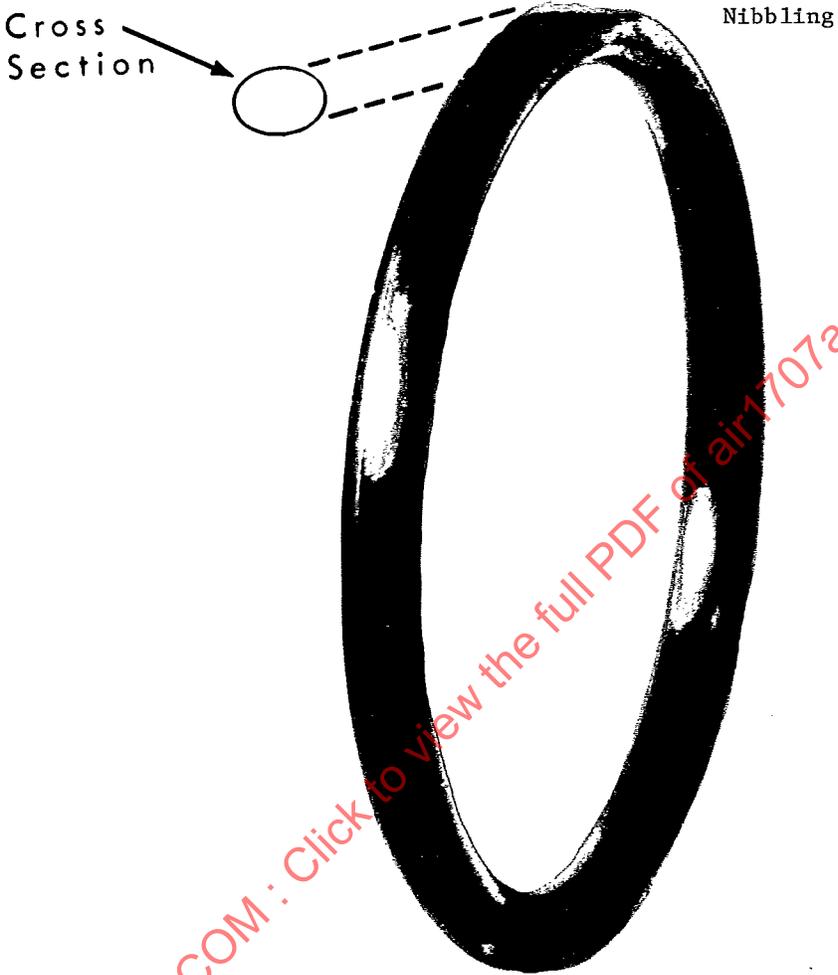
FIGURE 15 - Compression Set

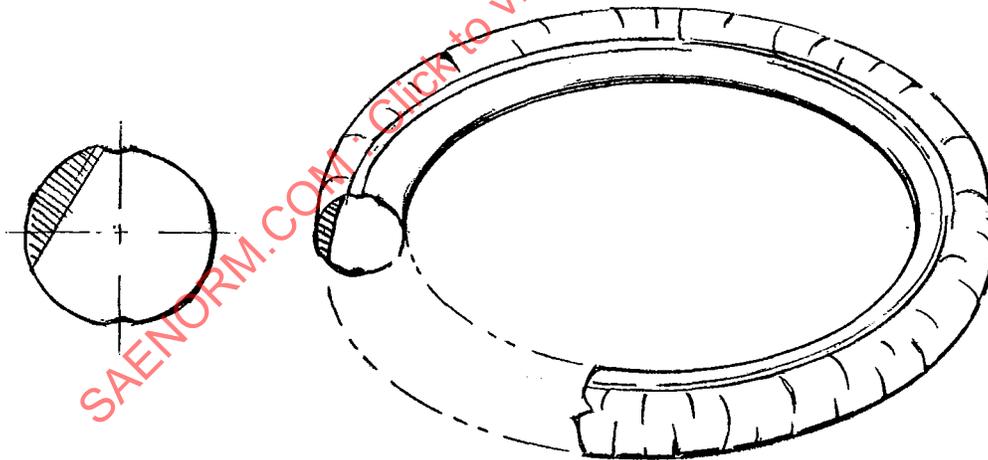
- 3.6.1 Occurrence: Dynamic or static seals under stress and exposed to atmosphere containing ozone and air pollutants.
- 3.6.2 Appearance: Many small cracks perpendicular to the direction of stress may be small enough to be unseen with unaided eye or large enough to progress entirely through the cross-section (also see 3.8.3). Cracking of the outside surface of the O-ring is the most common.

- 3.6.3 Cause: Ozone attacks unsaturated or double bond points in polymer chain of some polymers causing chain scission. Usually, the outside surface, that area exposed to the atmosphere, is where the damage is seen.

FIGURE 16 - Weather or Ozone Cracking

- 3.6.4 Corrective Action: If conditions of service cannot be remedied, the rubber material must be changed. Use rubber materials that are saturated and inherently resistant to ozone attack. Change storage conditions to reduce exposure time to detrimental environment. Sufficient improvement can, at times, be obtained by using rubber compounds with antiozonant additives.

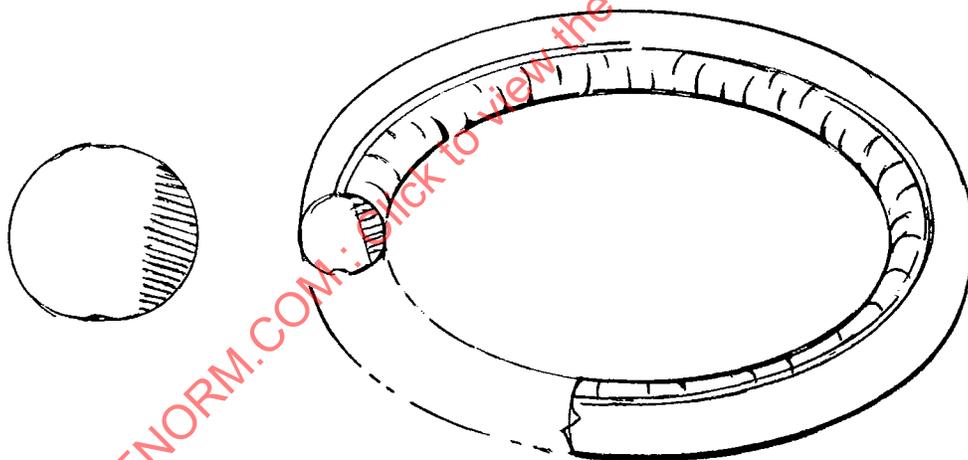
- 3.7.1 Occurrence: Dynamic or static seals subjected to elevated temperatures and atmosphere. Common in pneumatic or air service.
- 3.7.2 Appearance: Hardening of the rubber, which begins at the surface and progresses through the entire O-ring cross-section. Accompanied by high compression set if O-ring is under compression.
- 3.7.3 Cause: Environmental temperature is too high for rubber material, causing hardening due to additional cross-linking in the rubber, evaporation of rubber plasticizer, or oxidation. It may be a combination of these.
- 3.7.4 Corrective Action: Decrease service temperature, use oxidation resistant material with better high-temperature characteristics, or protect surface from oxygen exposure (as wiper seals).
- 3.7.5 Examples:

FIGURE 17 - Hardening and Oxidation

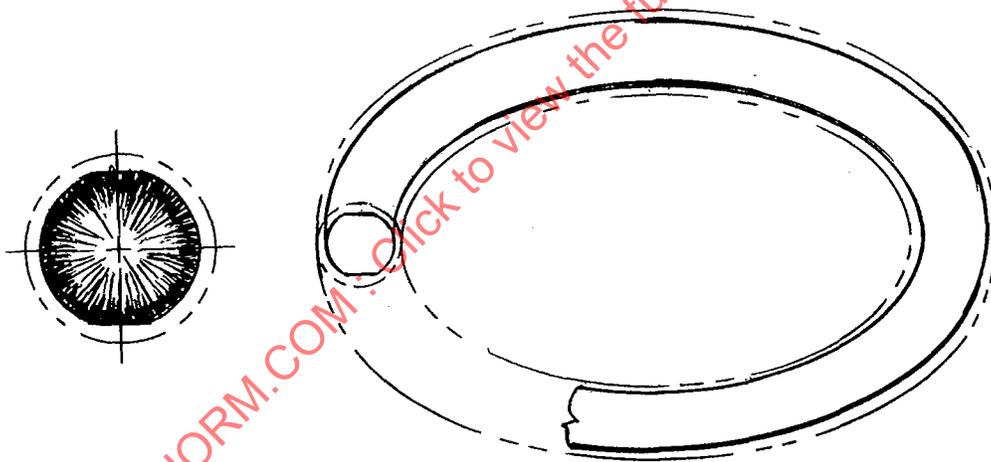
- 3.8.1 Occurrence: Dynamic and static seals usually in fuel systems subject to dry-out periods, but occasionally in other systems.
- 3.8.2 Appearance: Small cracks in stressed area of O-ring cross-section, accompanied by loss in volume.
- 3.8.3 Cause: Extraction of plasticizer by service fluid followed by evaporation of service fluid during dry-out period. Results are hardening of the rubber material and decrease in elongation to the extent that cracks appear where stressed. This condition is accelerated in the presence of ozone.
- 3.8.4 Corrective Action: Assuming service conditions cannot be improved, change to a compatible rubber material with low or no extractable plasticizer content.
- 3.8.5 Examples:

FIGURE 20 - Plasticizer Extraction
