<b>AEROSPACE INFORMATION REPORT</b>	<b>AIR1707</b>	<b>REV. B</b>
	Issued 1981-10 Revised 2014-09	
Superseding AIR1707A		
Patterns of O-ring Failures

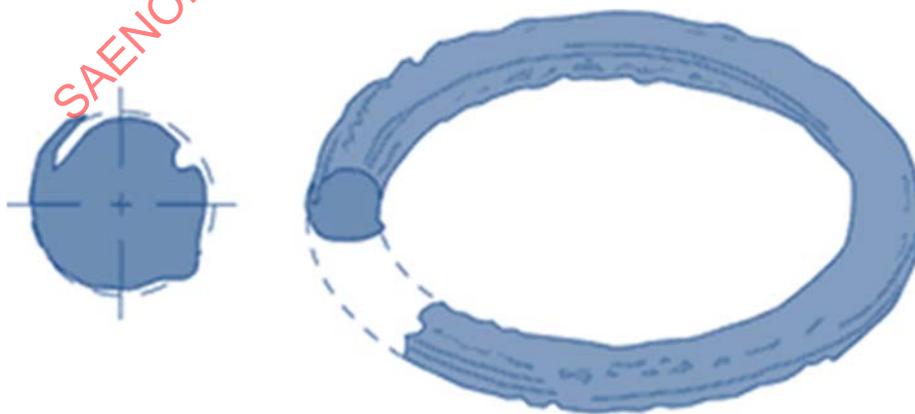
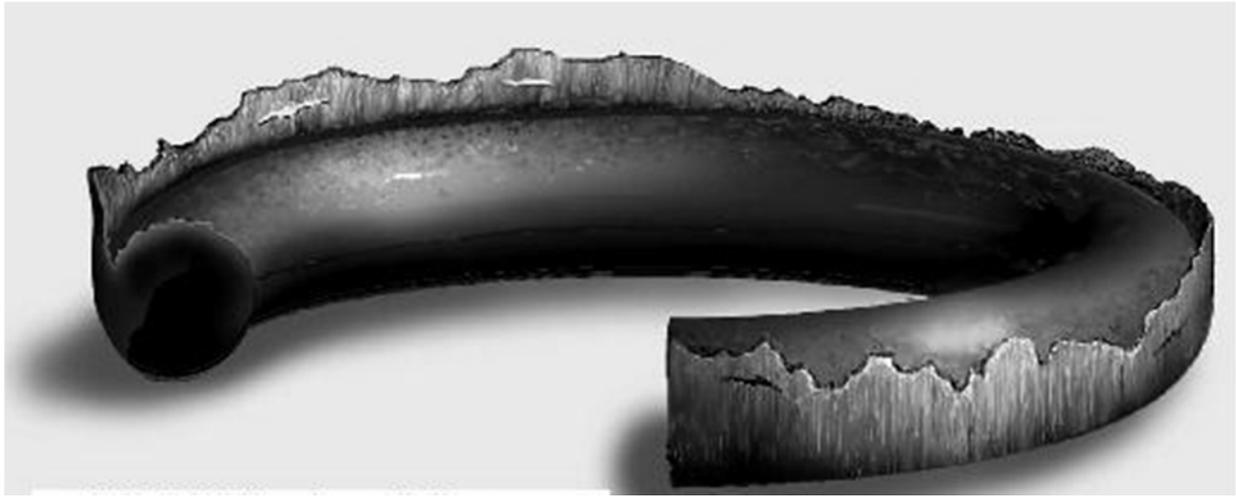
Exhibits many small nibbles removed from the O-ring adjacent to the downstream clearance area, or a small section of the O-ring may be extruded. Typical of high pressure systems, this process sometimes erodes half of the O-ring cross-section before major leakage occurs.

Clearance is too large, pressure is too high, O-ring is too soft, O-ring is softened and swelled by fluid, clearance increases under pressure, eccentricity causes irregular gap, and corners of O-ring gland are too sharp.

FIGURE 1 - EXTRUSION AND NIBBLING

FIGURE 2 - EXTRUSION AND NIBBLING (USED WITH PERMISSION FROM R.L. HUDSON)

Closer metal fits (reduce diametral clearance or reduce plate gap,) use of backup rings or other antiextrusion devices such as cap strips, harder O-ring material, use of O-ring more compatible with system fluid, more rigid or concentric metal components, and break edges of gland to a radius of about 0.001 to 0.002 inch (0.025 to 0.050 mm). T-seals that fit into the same gland may also be substituted.

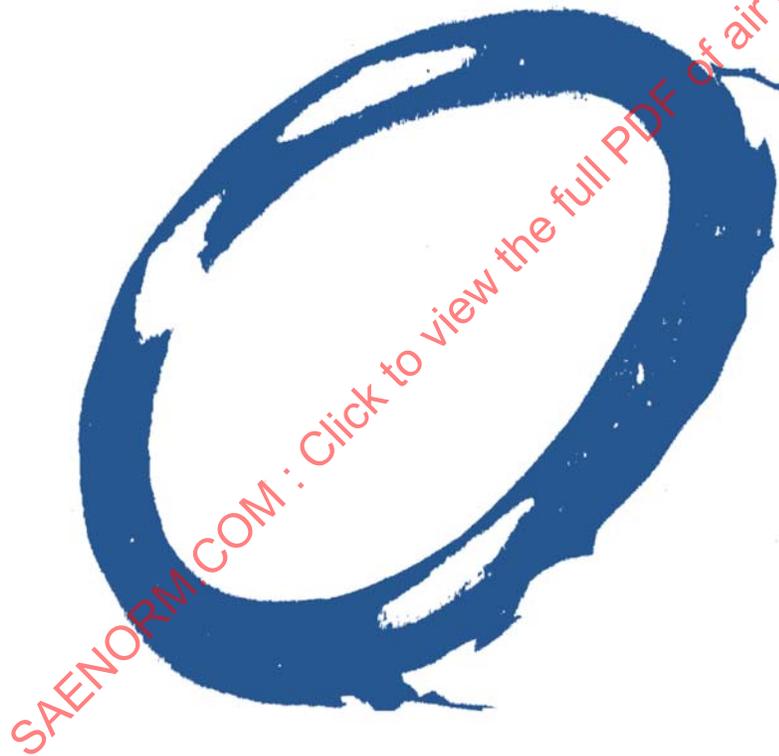
FIGURE 3 - NIBBLING AND SKIVING

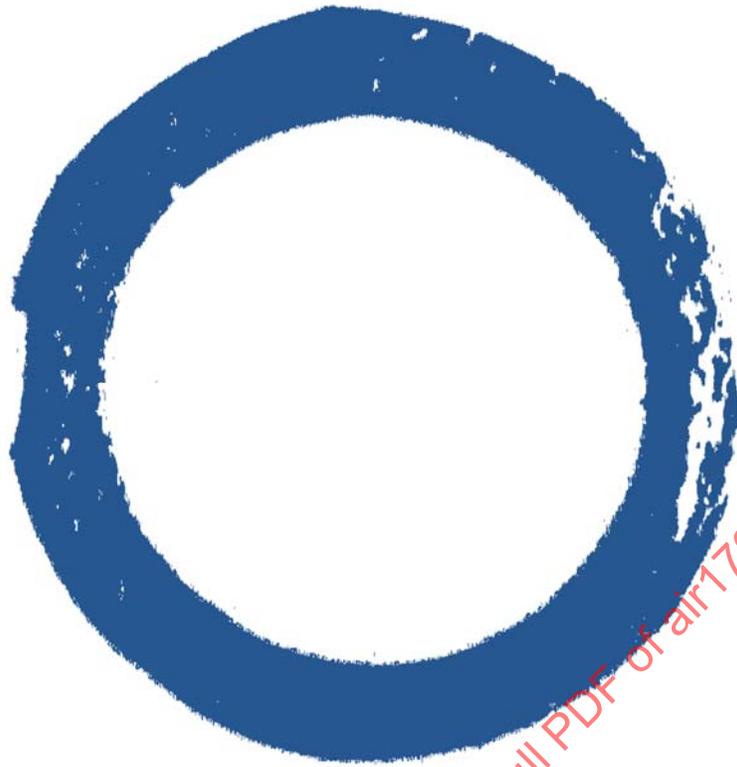
FIGURE 4 - NIBBLING AND ABRADING

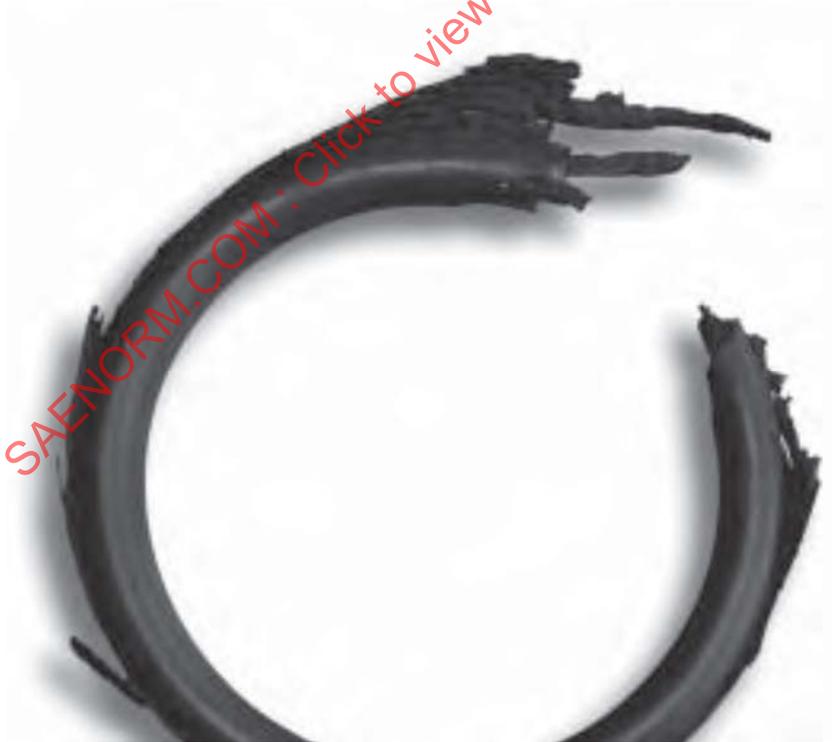
FIGURE 5 - NIBBLING AND EXTRUSION

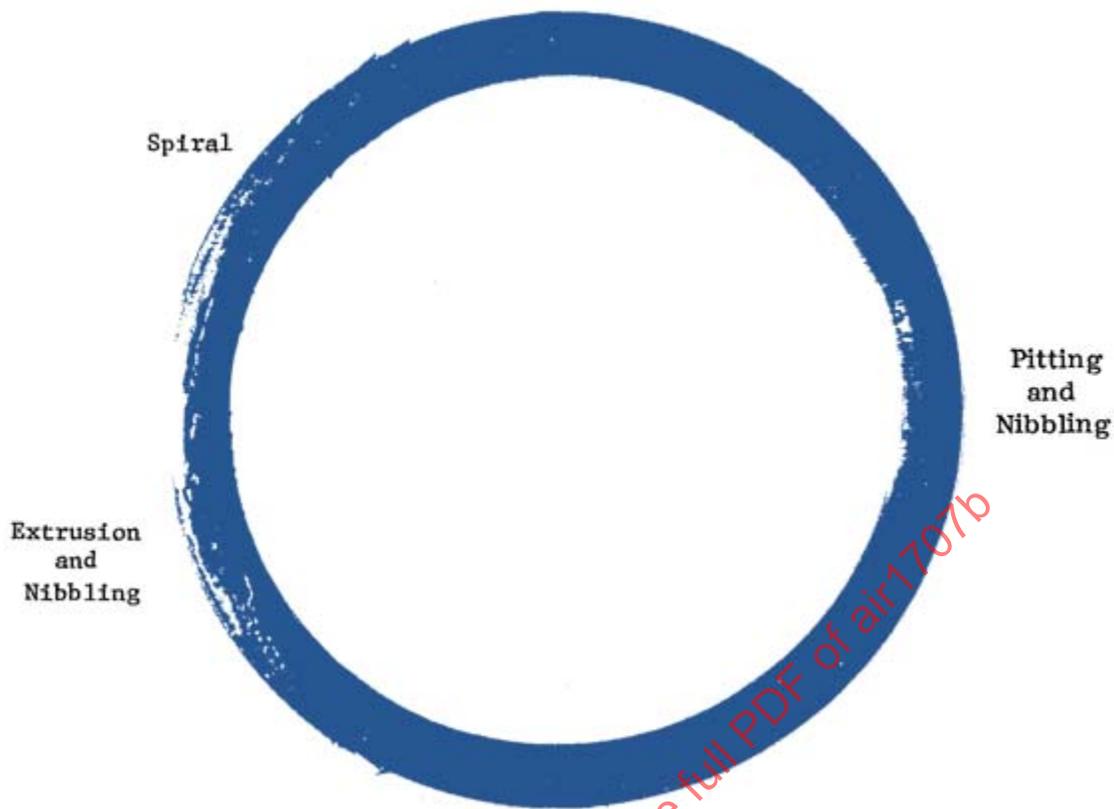
FIGURE 6 - NIBBLING, EXTRUSION, PITTING, AND SPIRAL FAILURE

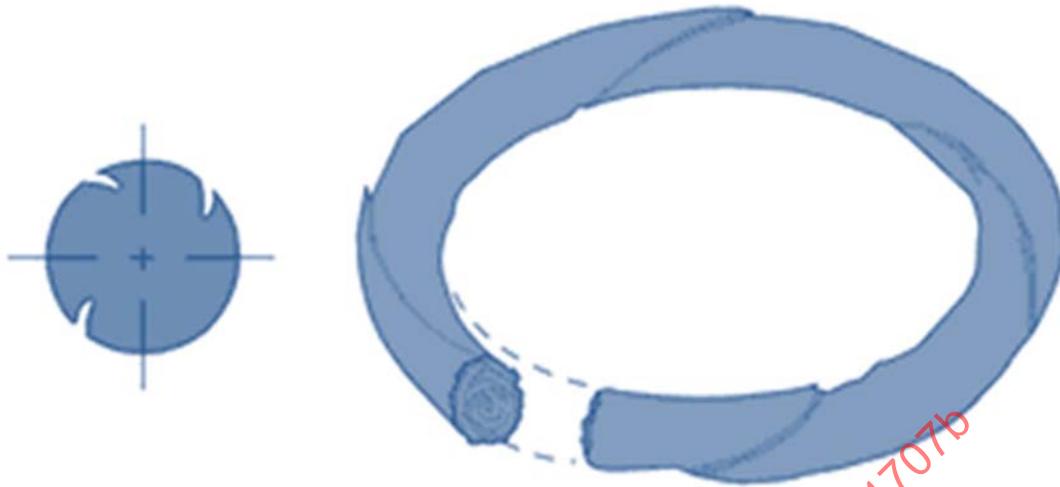
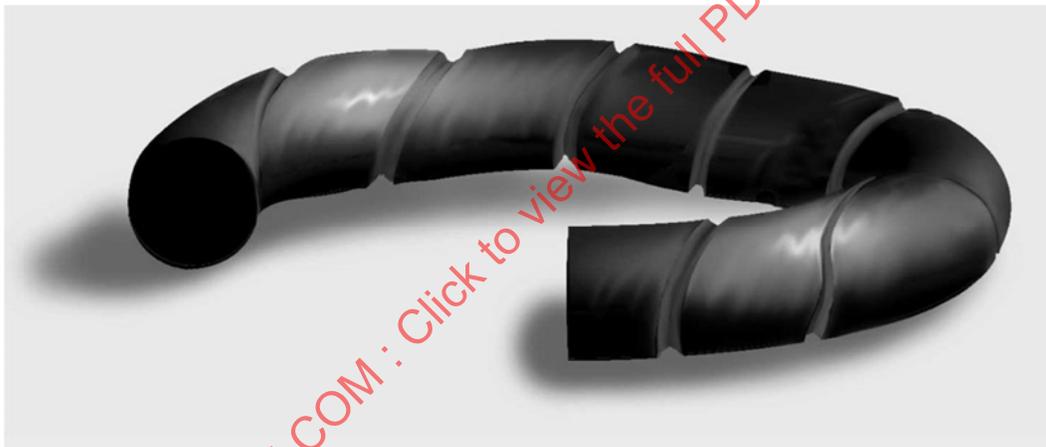
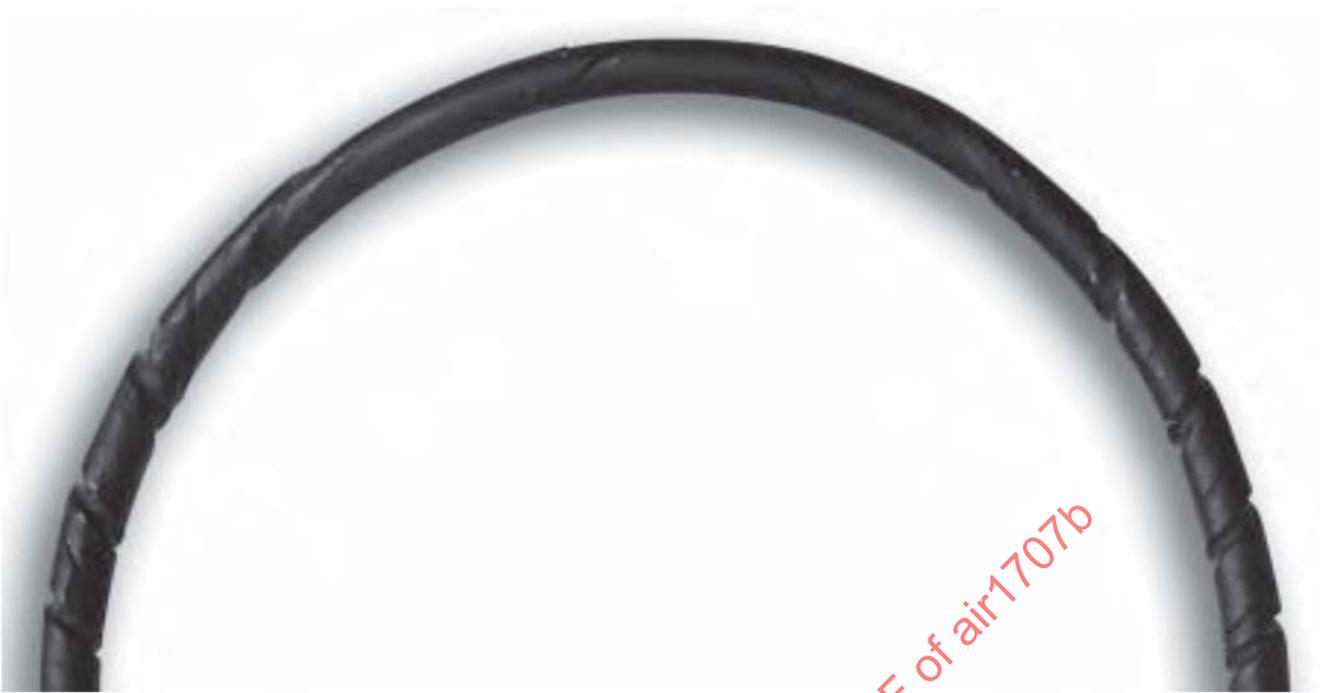
Exhibits a deep spiral cut (usually at about 45 degree) into the O-ring cross-section.

Conditions which cause segments of the O-ring to slide and others to roll, simultaneously. The O-ring generally gets pinched or "hung up" at one point of its periphery. Side loads causing the O-ring to get caught in an eccentric component, uneven surface finishes, poor or uneven dispersion of lubricant and stroke speeds contribute.

FIGURE 7 - SPIRAL FAILURE

FIGURE 8 - SPIRAL FAILURE (USED WITH PERMISSION FROM R.L. HUDSON)

FIGURE 9 - SPIRAL FAILURE (PHOTO COURTESY OF PARKER HANNIFIN)

Improve metal surface finish to the 10 to 20 microinches (0.25 to 0.50  $\mu\text{m}$ ) range, improve lubrication, use backups or other antiextrusion devices if possible, reduce gap, and consider seals other than O-rings such as T-seals.

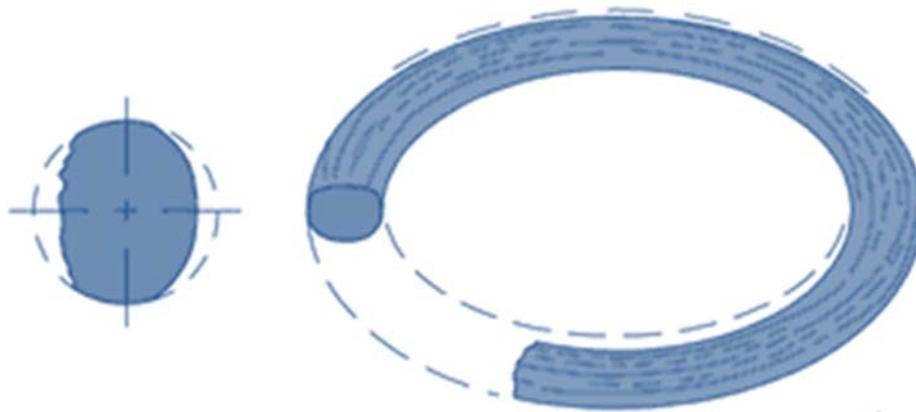
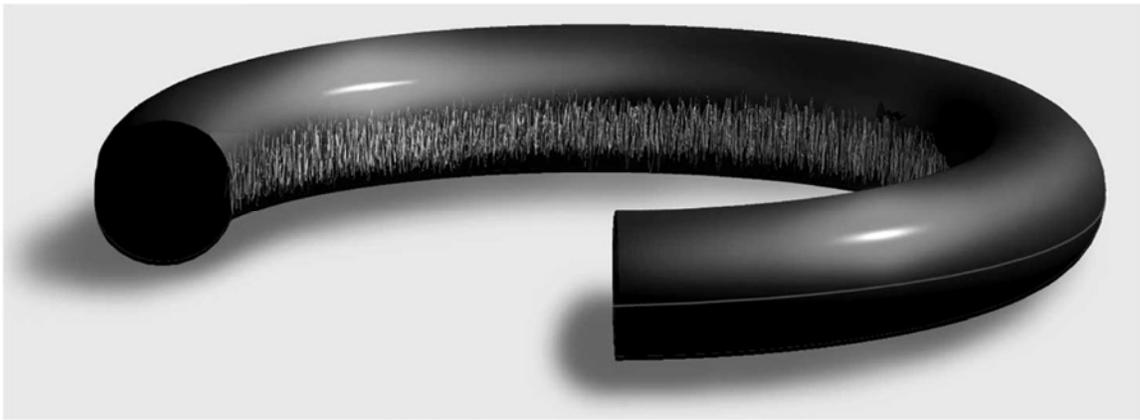
Flat area on one side of cross-section of O-ring where moving contact is made with metal component. Frequently shows wear lines on the cross-section parallel to motion of the seal.

Too rough or too smooth metal surfaces, poor lubrication, high temperatures, or fluid contamination.

FIGURE 10 - ABRASION

FIGURE 12 - ABRASION (USED WITH PERMISSION FROM R.L. HUDSON)

Use recommended metal finishes, provide adequate lubrication, use O-ring material compatible with service temperature, and eliminate fluid contamination. Rapid wear can be expected with finishes below 5 microinches (0.13  $\mu\text{m}$ ).

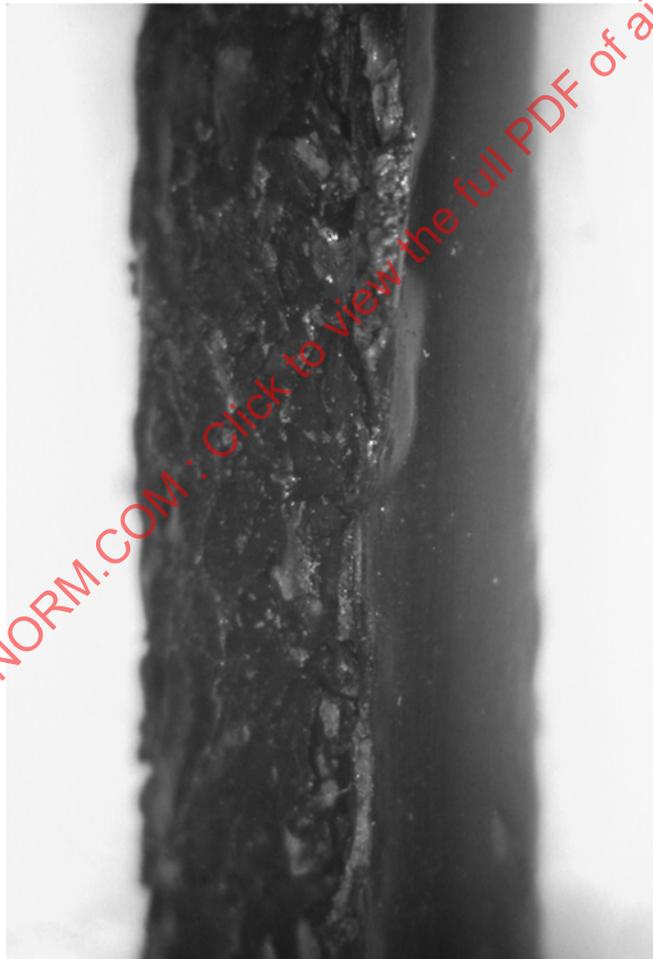
FIGURE 11 - ABRASION ON ONE SIDE

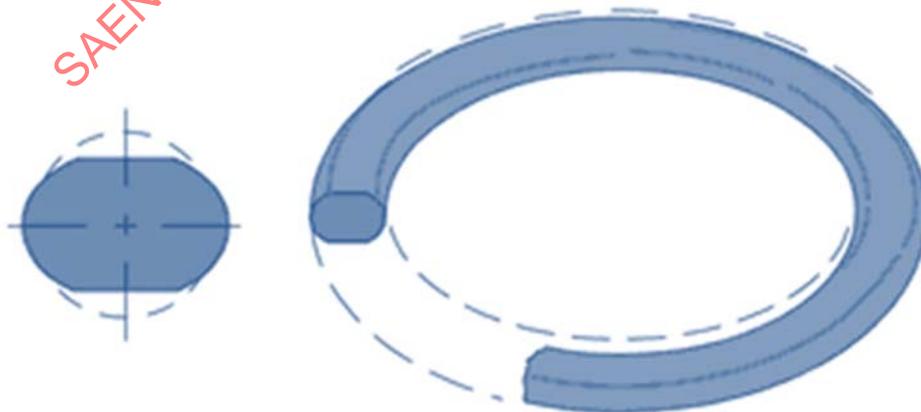
Flat area on both sides of O-ring cross-section in the area being squeezed.

Temperature too high (either environmental or frictional) causing hardening, excessive volume increase from fluid causing overfill, excessive squeeze to achieve seal, O-rings not completely vulcanized, or use of compound with poor set properties. In extremely rare cases, this can also be caused if a ring is over-cured (reversion.)

FIGURE 13 - COMPRESSION SET

Use O-ring material compatible with fluid and temperature service, minimize conditions which increase service temperature, review squeeze to be sure it is proper, and use an improved, low-set compound if available. A good quality, well-inspected O-ring is important.

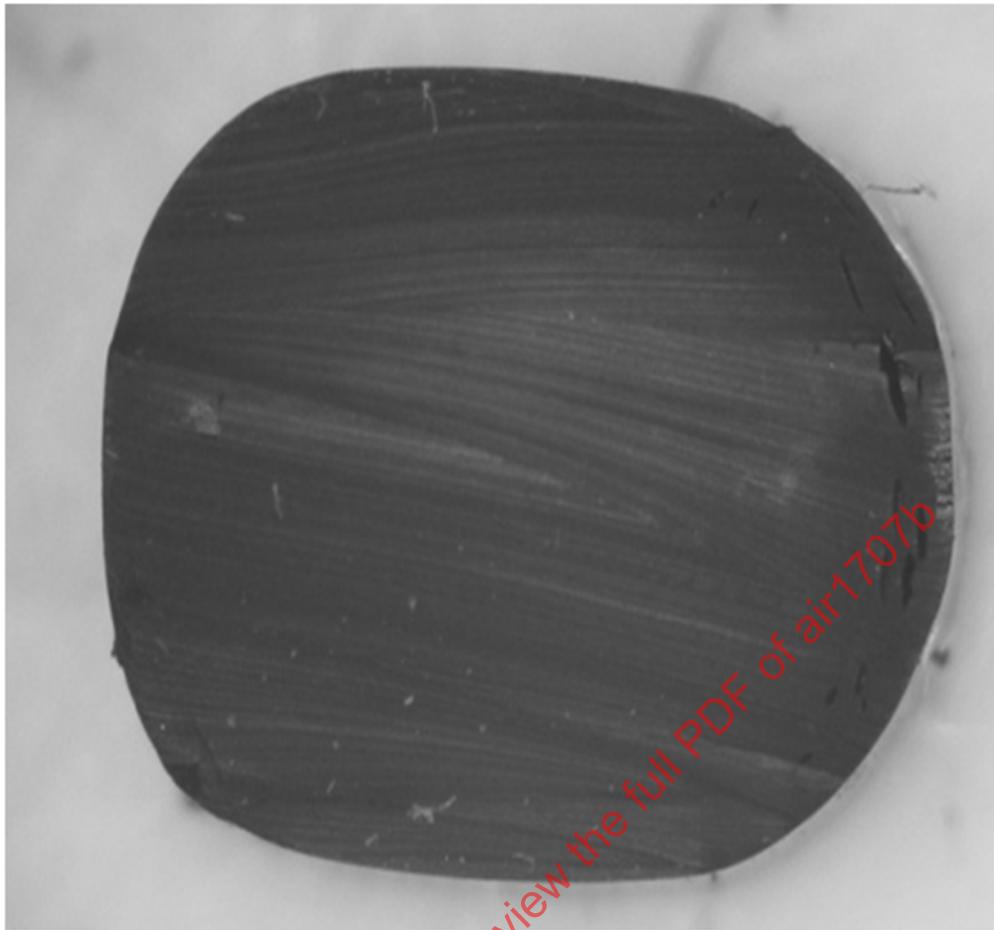
FIGURE 14 - COMPRESSION SET ON THREE SIDES (CROSS-SECTION)

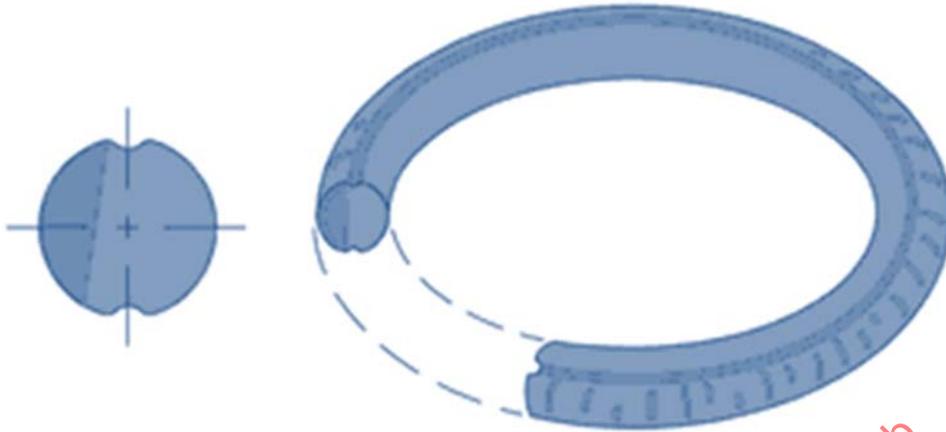
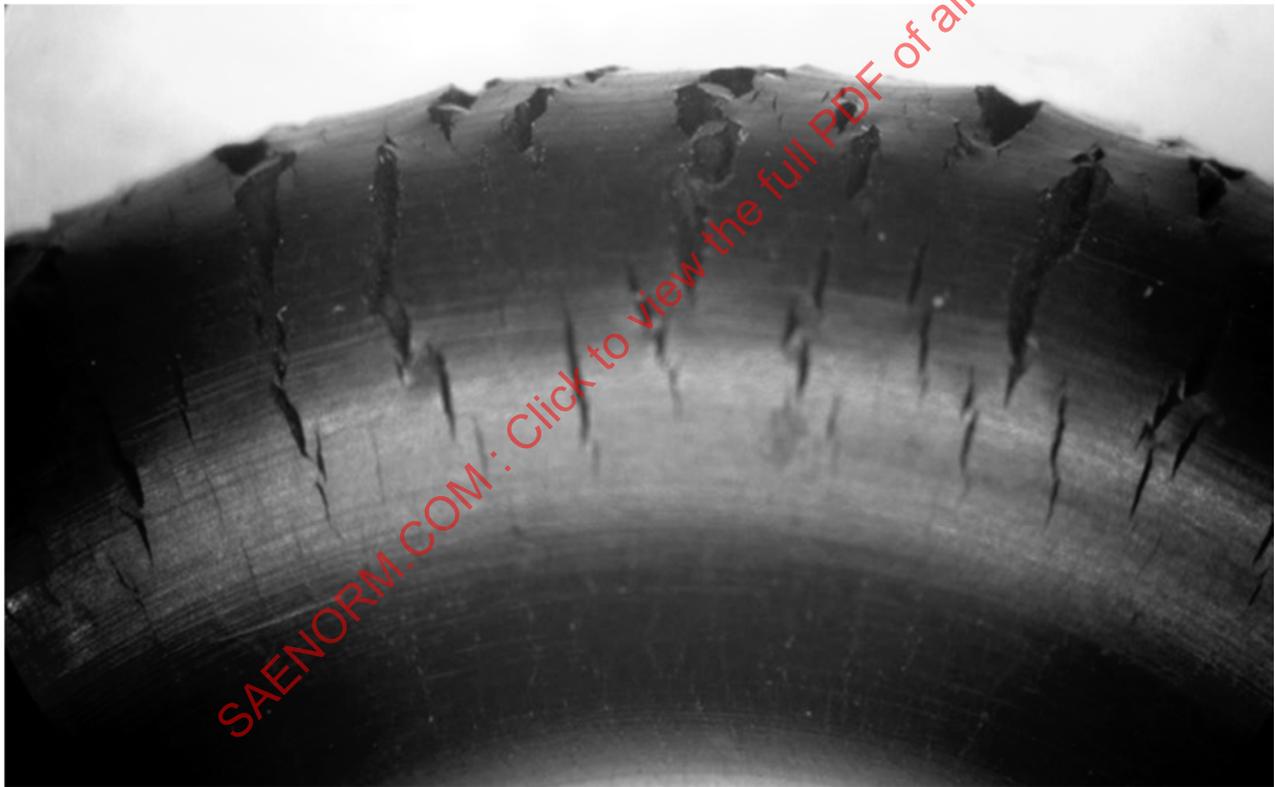
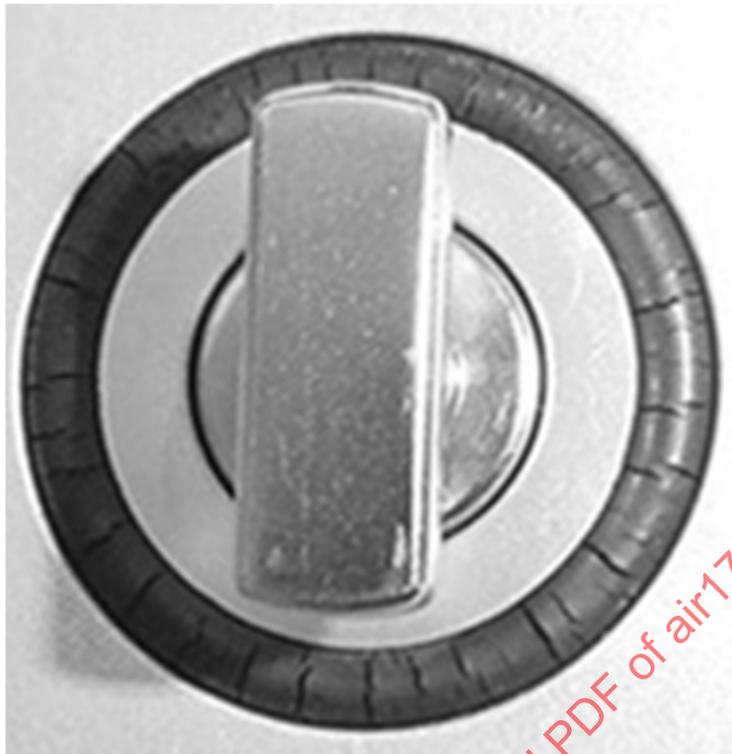
Many small cracks perpendicular to the direction of stress may be small enough to be unseen with unaided eye or large enough to progress entirely through the cross-section (also see 4.8.3). Cracking of the outside surface of the O-ring is the most common.

Ozone attacks unsaturated or double bond points in polymer chain of some polymers causing chain scission. The damage is usually seen on the outside surface, exposed to the atmosphere.

FIGURE 15 - WEATHER OR OZONE CRACKING

FIGURE 16 - CRACKING FROM OZONE

FIGURE 17 - CRACKING FROM OZONE

If conditions of service cannot be remedied, the rubber material must be changed. Use rubber materials that are saturated and inherently resistant to ozone attack. Change storage conditions to reduce exposure time to detrimental environment. Sufficient improvement can, at times, be obtained by using rubber compounds with antiozonant additives.

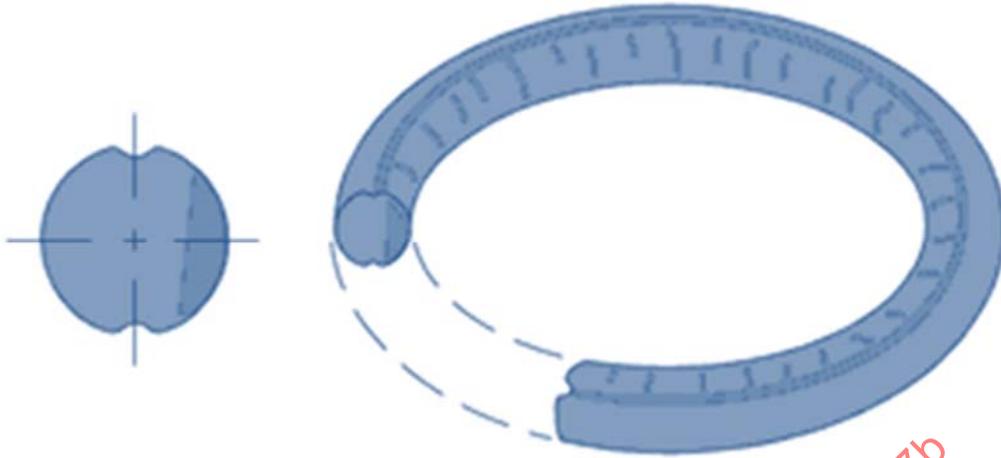
Hardening of the rubber begins at the surface and progresses through the entire O-ring cross-section. Hardening is accompanied by high compression set if O-ring is under compression.

Environmental temperature and oxygen exposure are too high for the selected rubber material, causing hardening due to additional cross-linking in the rubber, evaporation of rubber plasticizer, or oxidation. It may be a combination of these.

FIGURE 18 - HARDENING AND OXIDATION

Decrease service temperature, select a rubber material with better resistance to high-temperature and/or oxygen exposure, or protect surface from oxygen exposure (as wiper seals).

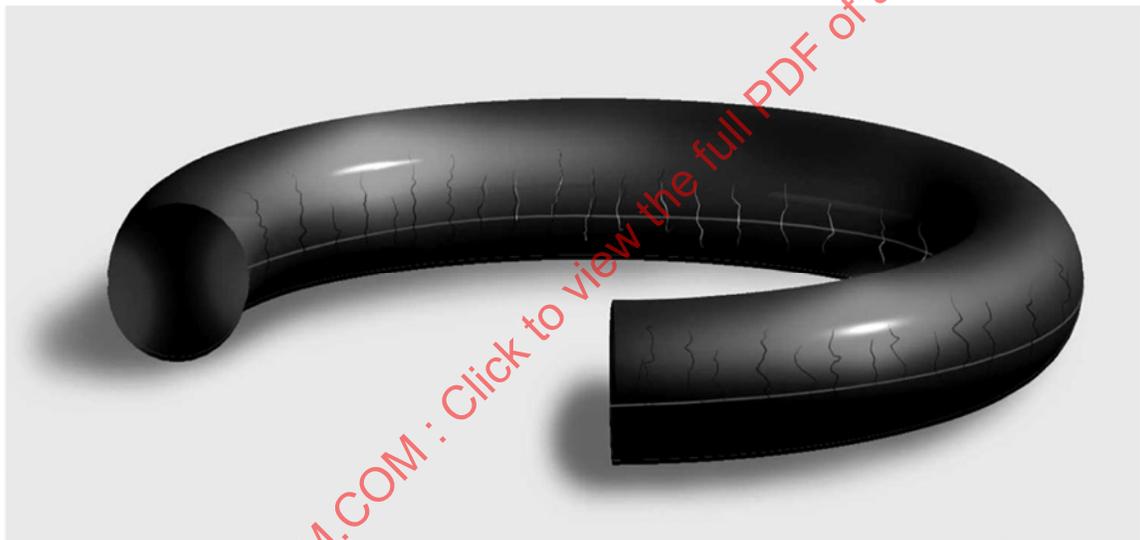
FIGURE 19 - WEATHER CRACKING (USED WITH PERMISSION FROM R.L. HUDSON)

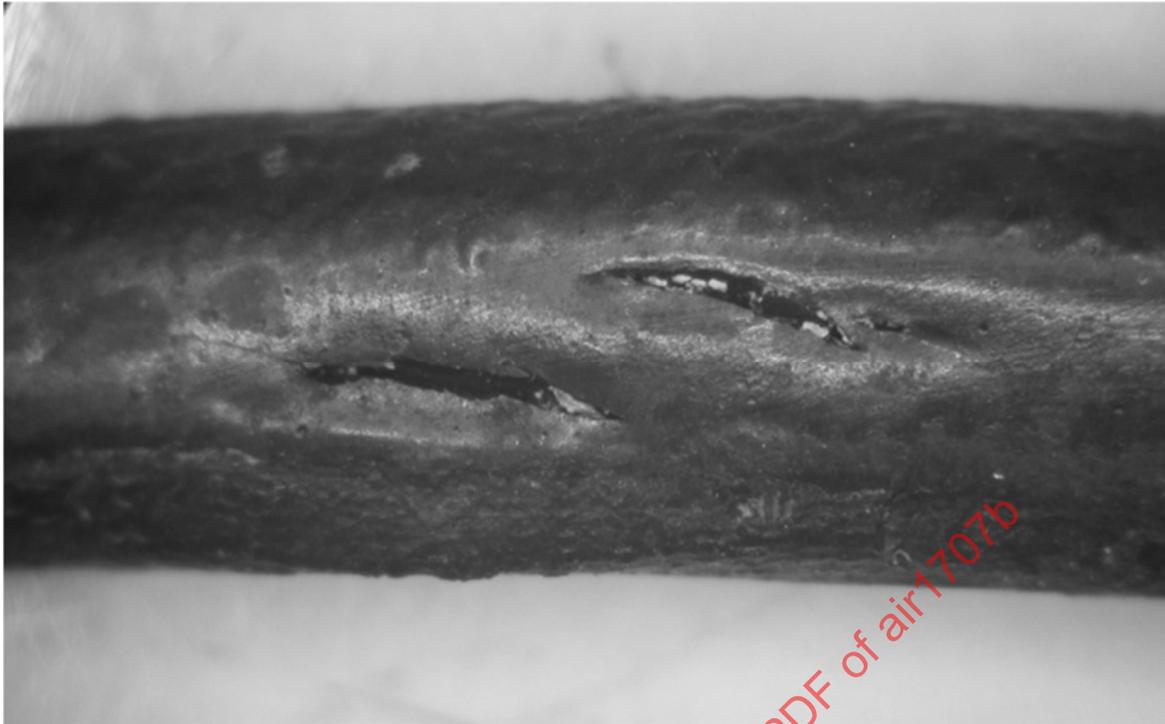
FIGURE 20 - HARDENING AND PITTING

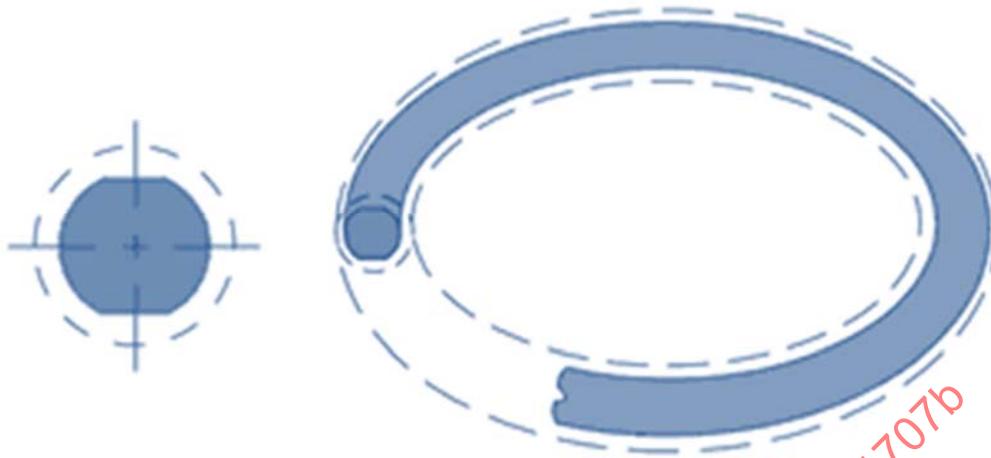
Small cracks in stressed area of O-ring cross-section, accompanied by loss in volume. This is often difficult to detect with a visual inspection.

Extraction of plasticizer by service fluid followed by evaporation of service fluid during dry-out period. Results are hardening of the rubber material and decrease in elongation to the extent that cracks appear where stressed. This condition is accelerated in the presence of ozone.

FIGURE 21 - PLASTICIZER EXTRACTION

Assuming service conditions cannot be improved, change to a compatible rubber material with low or no extractable plasticizer content.

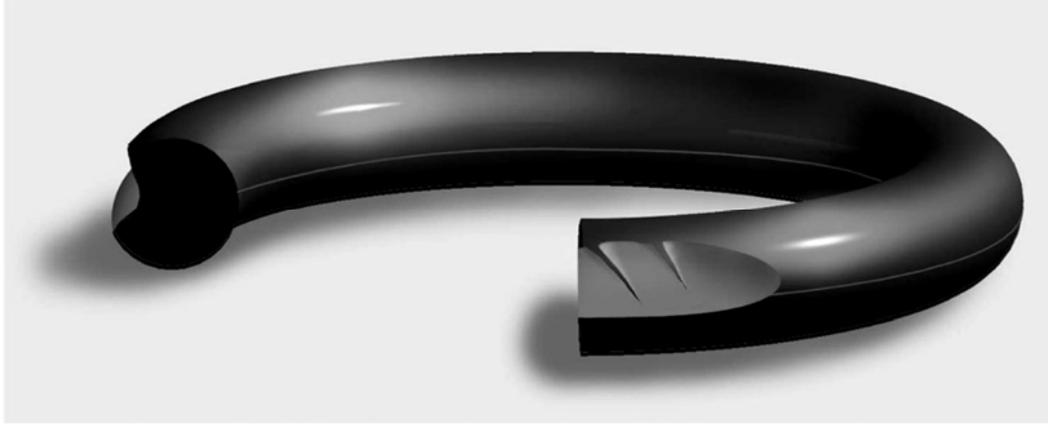
Short cuts or notches or a "shinned" surface or a "skived" cut that can extend at a uniform thickness clear around the periphery of the O-ring and can continue through the cross-section as if it were being peeled. May also present as spiraling or twisting in certain applications.

Sharp corners on mating metal parts, threads, or insufficient lead-in chamfer; inside diameter of O-ring too small on rod seal or too large on piston seal installation. Blind grooves in multiple port valves are especially troublesome.

FIGURE 22 - INSTALLATION DAMAGE (USED WITH PERMISSION FROM R.L. HUDSON)

Adjust dimensions of metal components and O-rings to eliminate cutting or pinching of seals when possible. Lead-in chamfers should be 20 degrees maximum and "break" sharp corners of chamfer and groove edges. Use tubular installation tools to cover threads and sharp corners during O-ring installation. If feasible in the application, use an elastomer that is more resistant to mechanical damage (e.g., EPDM instead of silicone).

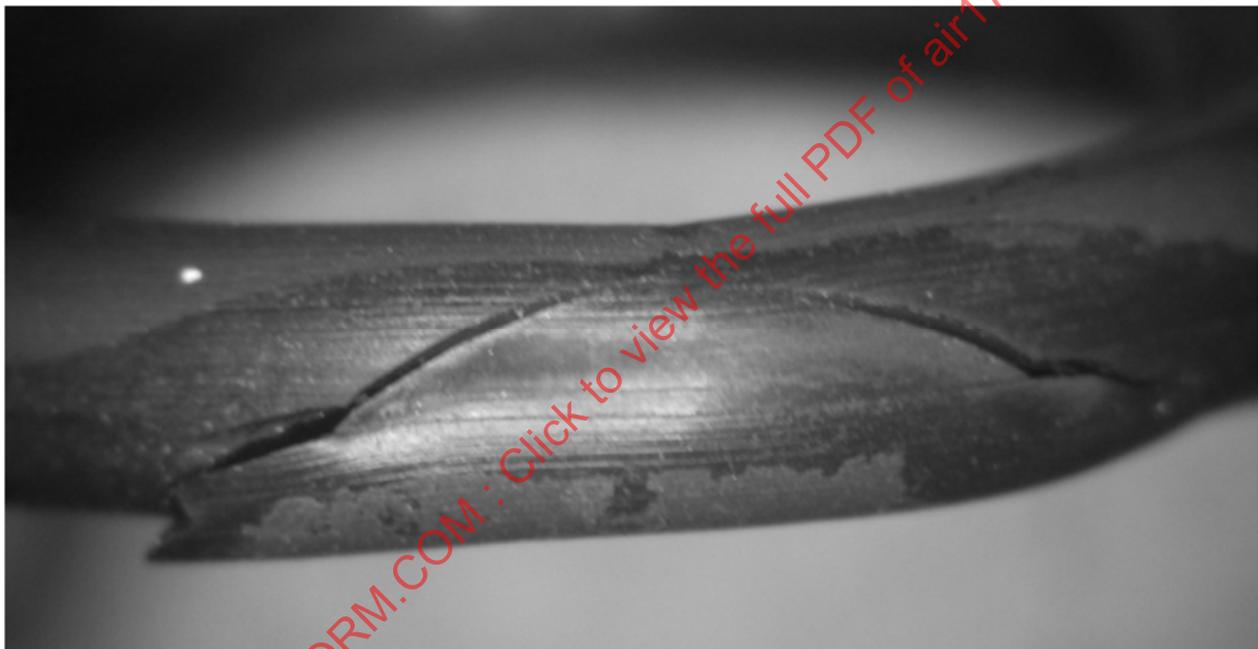
FIGURE 23 - TWISTED AND PUNCTURED INSTALLATION DAMAGE

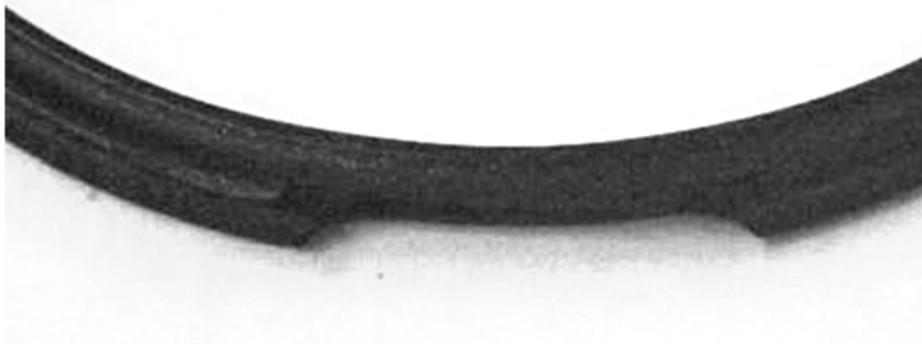
FIGURE 24 - SKIVED INSTALLATION DAMAGE
