AIR4092

## INVESTIGATION OF PTFE "MELT" PHENOMENON FOR HIGH PRESSURE HOSES

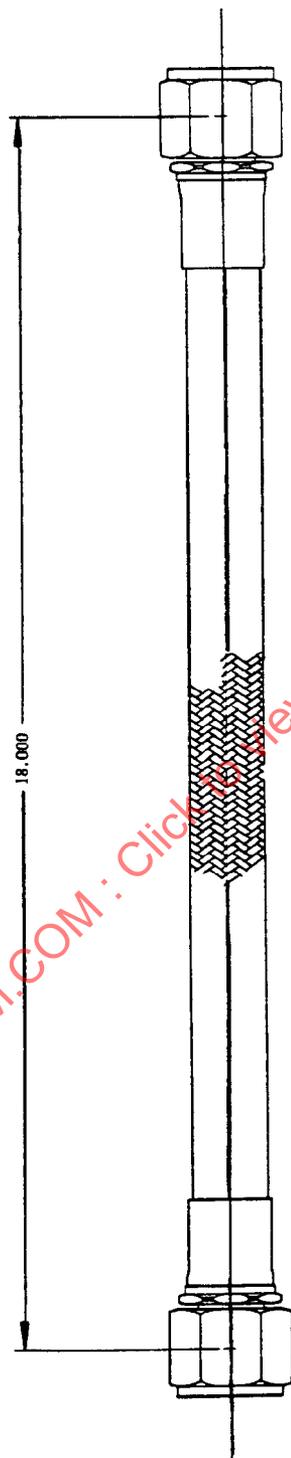
FIGURE 1

1. 18 in long, "230" Series, -8 size assemblies using straight to straight flared fittings. This is the lightweight, high pressure hose (see Fig. 1). Conforms to AS1339 and AS115 (bare hose) and MIL-H-38360.
2. 18 in long assembly is identical to sample 1, except it has an integral silicone firesleeve (see Fig. 2). Conforms to AS1339 and AS115 (integral firesleeve) 15 min and MIL-H-38360.
3. 18 in long assembly, "660" Series, -8 size assemblies using straight to straight flared fitting. This is the heavy duty spiral-wrapped, high pressure hose (see Fig. 3). Conforms to AS 604 and AS 621 (bare hose) and MIL-H-38360.

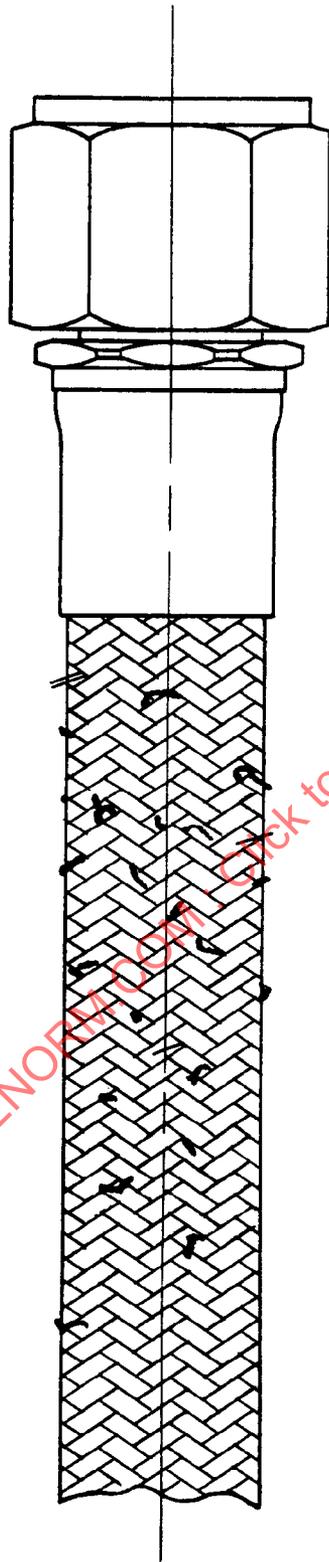
FIGURE 5

1. Bare "230" series, lightweight hose assembly showed heavy Teflon extrusion of PTFE through the braid and some broken braid externally and major deterioration of the innercore internally (see Figs. 5 and 6).
2. The "230" series, lightweight hose with integral firesleeve showed light extrusion of PTFE through the braid and some broken braid externally and major deterioration of the innercore internally (see Figs. 7 and 8).
3. The "660" series showed no extrusion of PTFE through the braid but did have broken wires externally, and it showed deformation of the innercore but no heat deterioration of the PTFE internally (see Figs. 9 and 10).

230-8  
21.3 Hz 16 g  
FAILURE 20 MIN

For hose assembly applications where the hose can be subjected to applied or induced vibration with high displacements along the axis of the hose, use the heavy duty spiral-wrapped type of hose. One typically critical application is the pump discharge hose for main and auxiliary pumps on aircraft. When the application requires an integral firesleeve to meet fire resistance of TSO or AS specifications, consideration can be given to the use of the lightweight hose and firesleeve combination as the most cost effective solution, provided the axial component of the vibration to be experienced does not exceed 0.200 double amplitude for an 18-in length of hose.
