AEROSPACE HYDRAULICS AND ACTUATION LESSONS LEARNED

SAE AIR4543

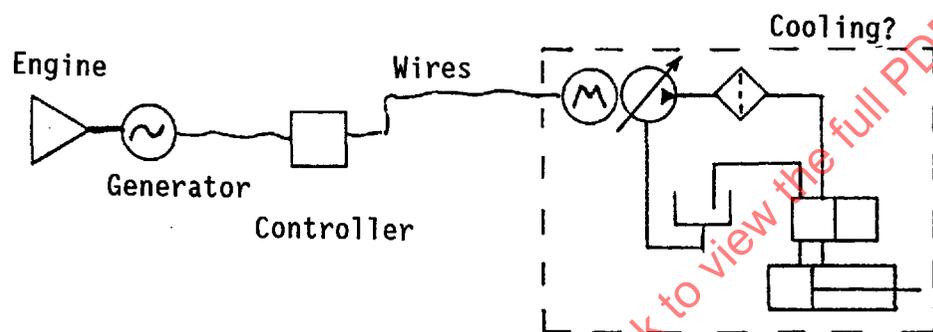
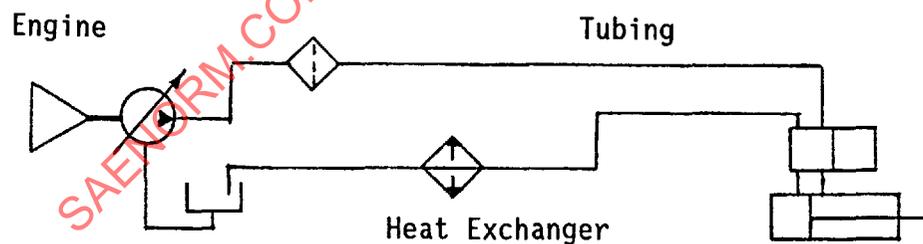
FIGURE 3.1.2 - Biased Trade Studies

ISSUE: Trade studies often fail to assess all influences on the air vehicle.

Frequently in such trade studies the following issues are not compared:

Cooling
Power transmission
Power conversion

SOLUTION: Conduct the trade study from the point of original power generation (usually the engine) to the point of final utilization.

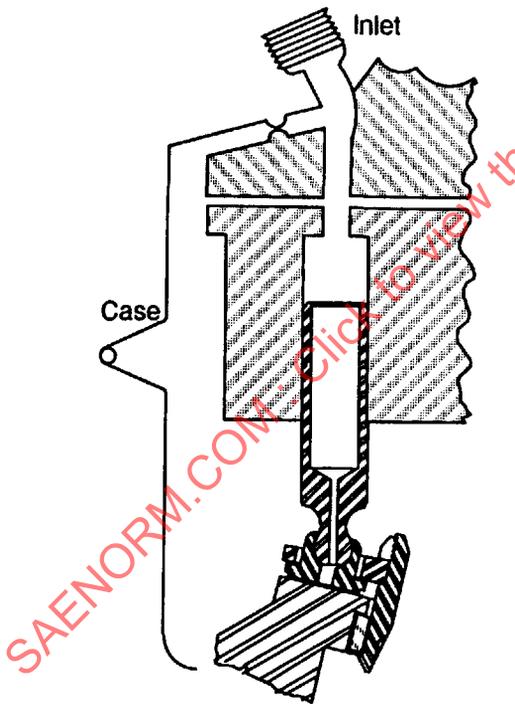
FIGURE 3.1.3 - Pump Overheat and Rapid Wear

PROBLEM: PUMP OVERHEAT AND RAPID WEAR

- ISSUE:**
1. Pump case drain line too small
 2. Creates high back pressure (case)
 3. Creates high discharge pressure (flow)
 4. Overheat (pump)
 5. Excessive pump shoe wear

- SOLUTION:**
1. Increase line size (case drain)
 2. Use bypass type filters
 3. Reroute line to reduce pressure drop
 4. Internally drain (to inlet) if minimum system demand available

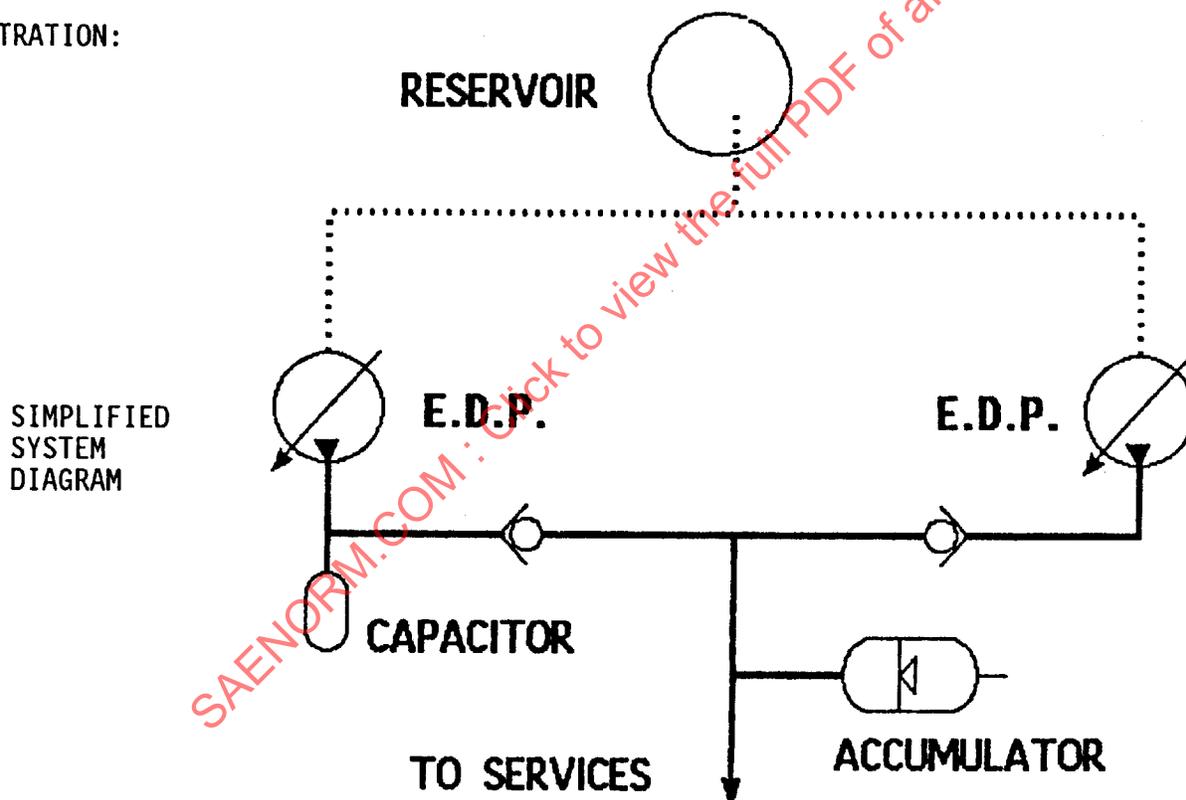
FIGURE 3.1.8 - Hydraulic System Noise

PROBLEM: HYDRAULIC SYSTEM NOISE

- ISSUE:
1. With a twin engine driven pump (E.D.P.) hydraulic system, there were complaints of noise, although not encountered with:
 - a. Earlier production aircraft;
 - b. When system is pressurized by ground rigs.
 2. Resonance condition occurred in the shortest line downstream of E.D.P. due to the reduced volume of the high pressure part of the hydraulic system.

- SOLUTION:
1. Initially increase the accumulator size to that previously fitted.
 2. Finally, revert to a smaller accumulator and add a "capacitor" (a small pressure vessel (22 in³) to the system).

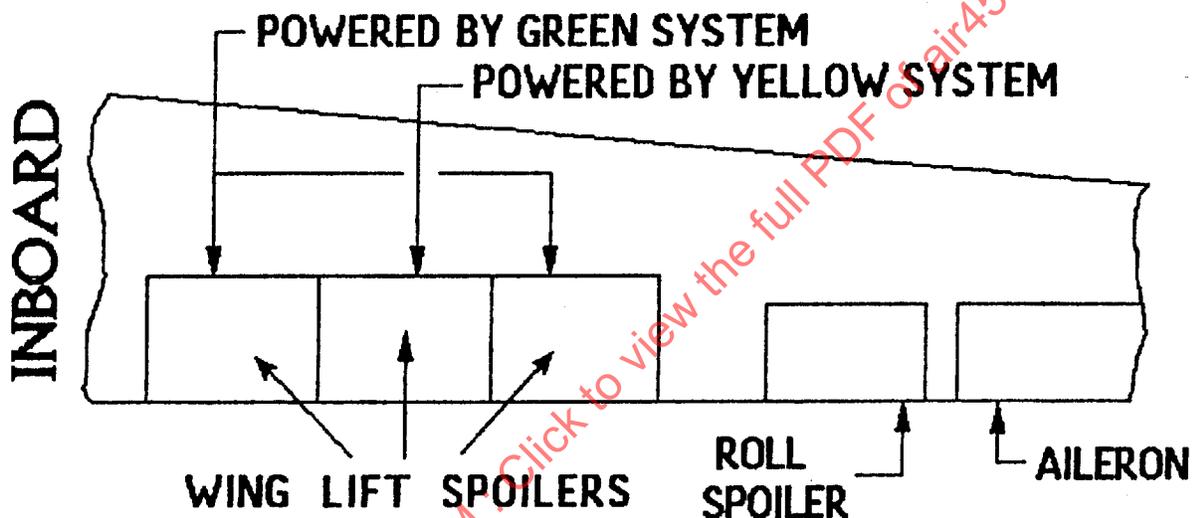
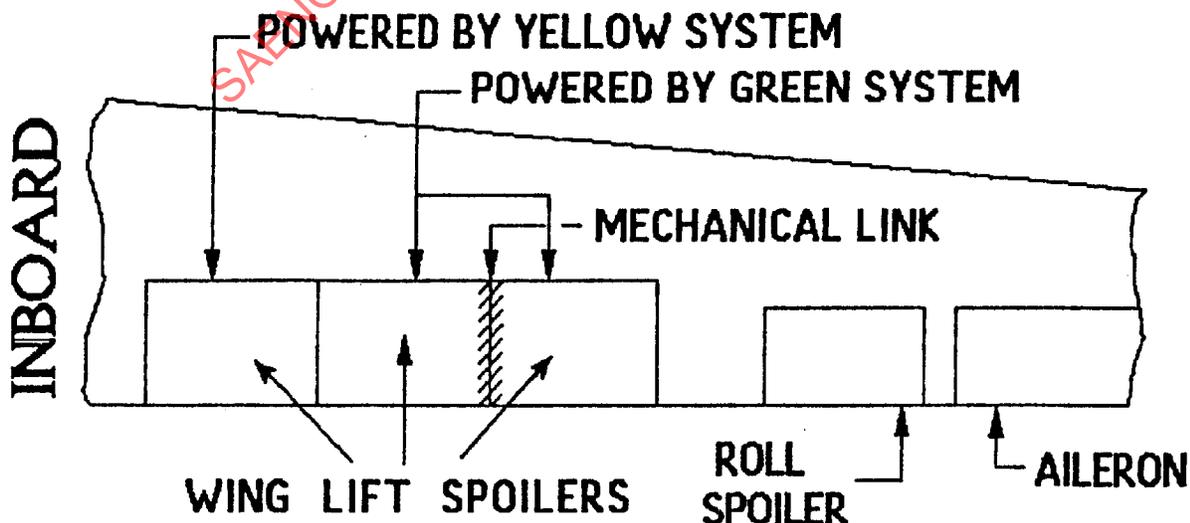
FIGURE 3.1.9 - Effect of JAR/FAR Requirement on Flight Control Surface Operation

- ISSUE:**
1. Noncompliance with JAR/FAR 25.671:
 2. A single failure of a flight control surface attachment point could cause a catastrophic event.
 3. The center or outboard ground lift spoiler panel could deploy following the failure of the eye end attachment point, for example, such that an inadvertent rolling moment could not be controlled.

- SOLUTION:**
1. Reroute hydraulic supplies to the lift spoilers and link the center and outboard panels.

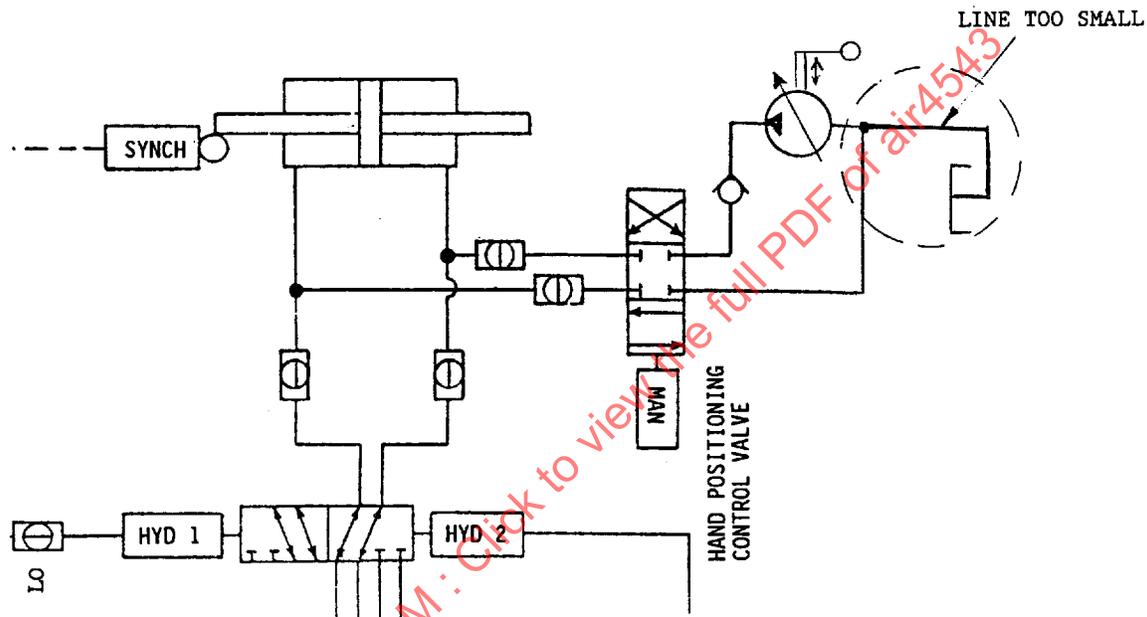
FIGURE 3.1.13 - Inadequately Sized Hand Pump Suction Line

PROBLEM: INADEQUATELY SIZED HAND PUMP SUCTION LINE

SOLUTION: The variable displacement hand pump discharges fluid as the pump handle is stroked in each direction. However, analysis indicated that the pump takes suction only when the pump is stroked in one direction. As a result, considerable flow is required from the unpressurized reservoir during the suction stroke even though the cylinder is balanced (equal volume for each direction of travel). The diameter of the make-up line from the reservoir to the pump suction had been sized for minimal flow and had to be increased to obtain rated pump capacity.

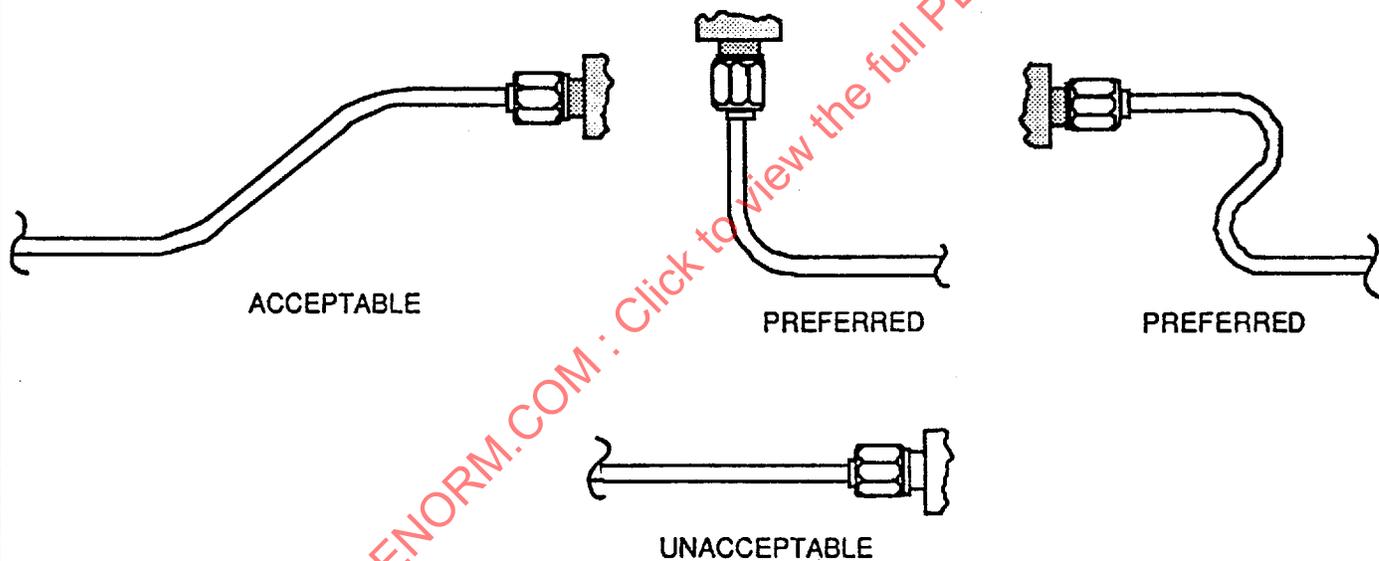
FIGURE 3.1.14 - Hydraulic Component Installation/Tubing Tolerances

- ISSUE:**
1. During initial installations, tubes without flexibility cannot be sufficiently extended for fit.
 2. Tubes without flexibility sustain damage from pressure surges and vibration.

SOLUTION: Incorporate bend(s) in the hydraulic tubing to increase the tolerances and dissipate surges.

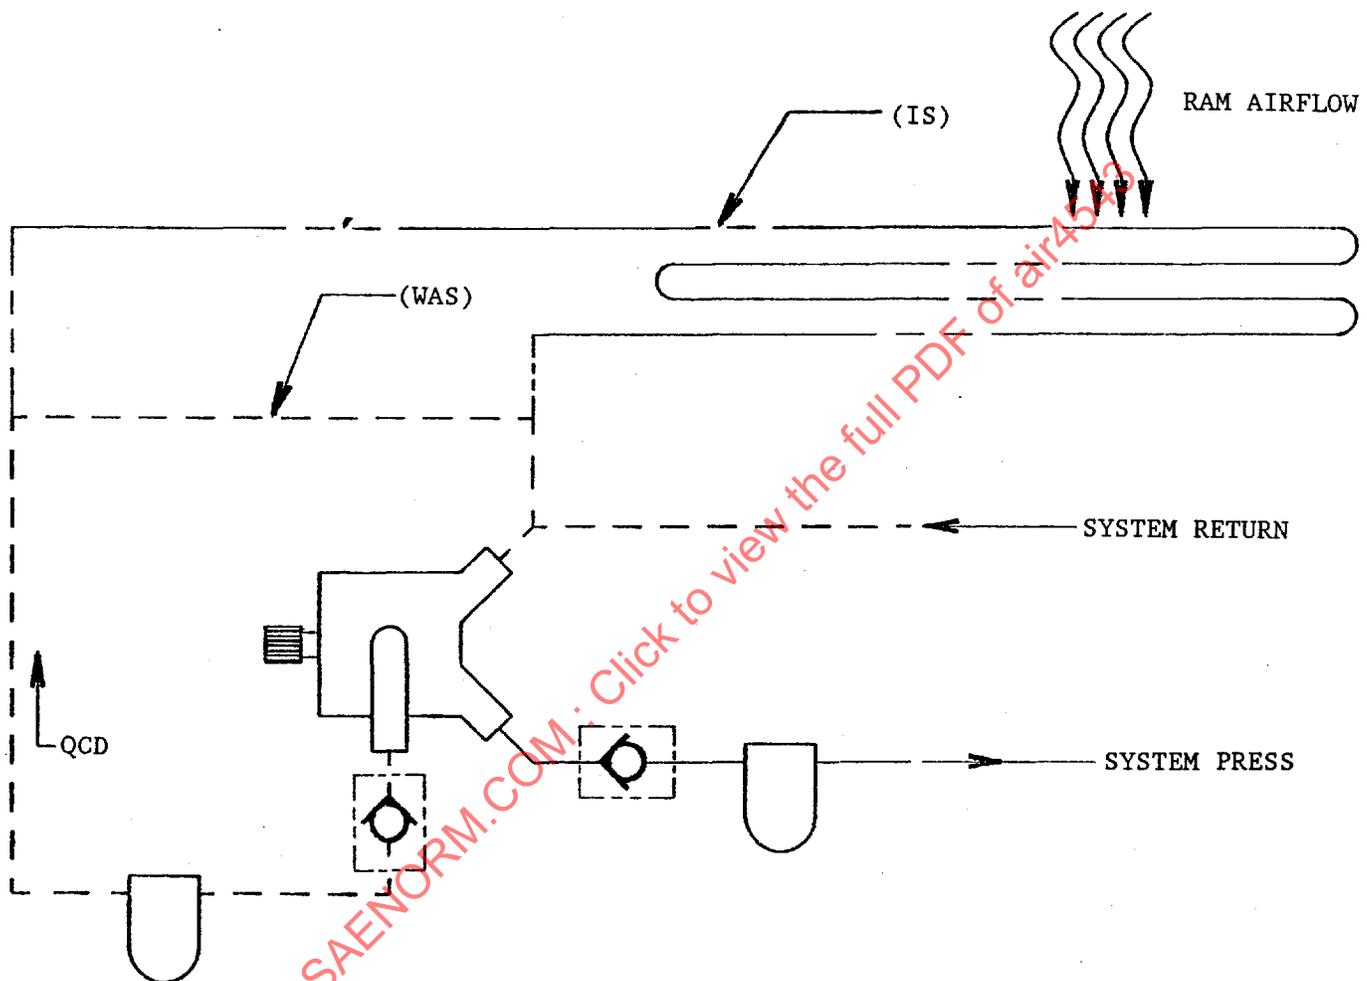
FIGURE 3.1.16 - System Overheat Caused by Inefficient Pump and Lack of Heat Exchanger

PROBLEM: SYSTEM OVERHEAT CAUSED BY INEFFICIENT PUMP AND LACK OF HEAT EXCHANGER

- SOLUTION:**
1. Revise the specifications to buy the pump with guaranteed efficiency and case drain flow over the life of the pump.
 2. Increase the case drain line diameter and the filter housing size.
 3. Reroute the case drain line to increase surface area and also expose to area with ram air.

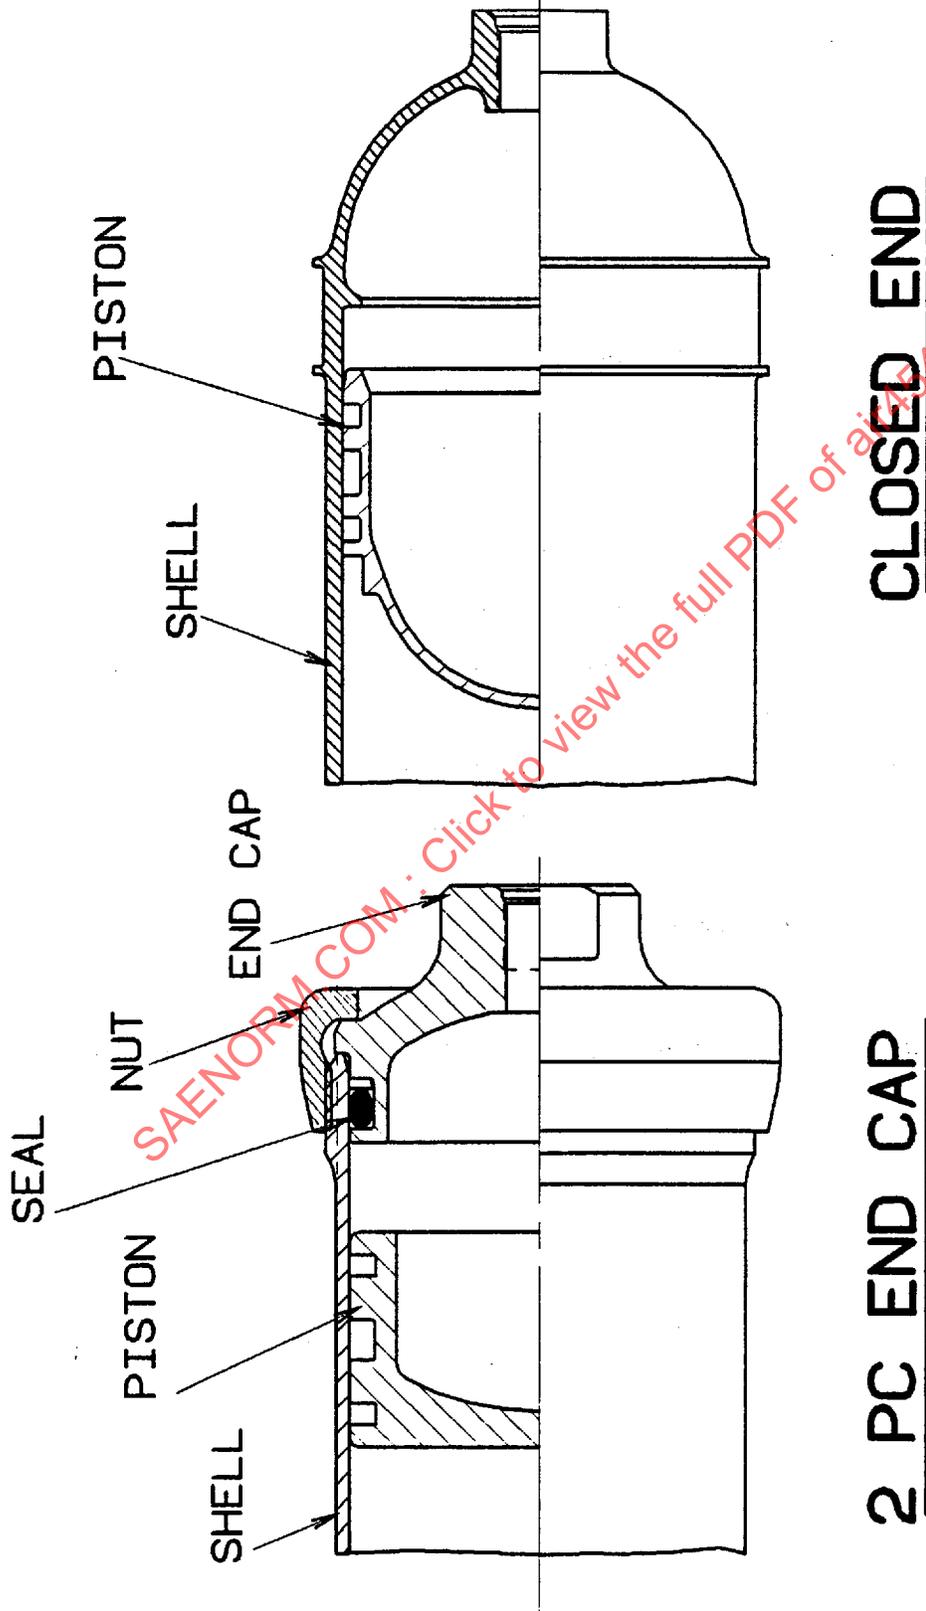
FIGURE 3.2.1.1 (Continued)

PROBLEM: EXCESSIVE OR PREMATURE LEAKAGE ACROSS ACCUMULATOR SEALS

ISSUE: Gas leaking into the system can cause a loss of aircraft or system.

1. Ensure that the chrome plate is controlled to minimize cracking (cracks inherent in chrome plating process).
2. Ensure that the seal compound meets all temperature, pressure, and pressure discharge requirements. Minimize the compression set and explosive decompression.
3. Use the closed end cap on gas side (eliminate static seal).
4. Improve the seal concept to improve sealing capability (multiple seals, metal bellows, etc.).

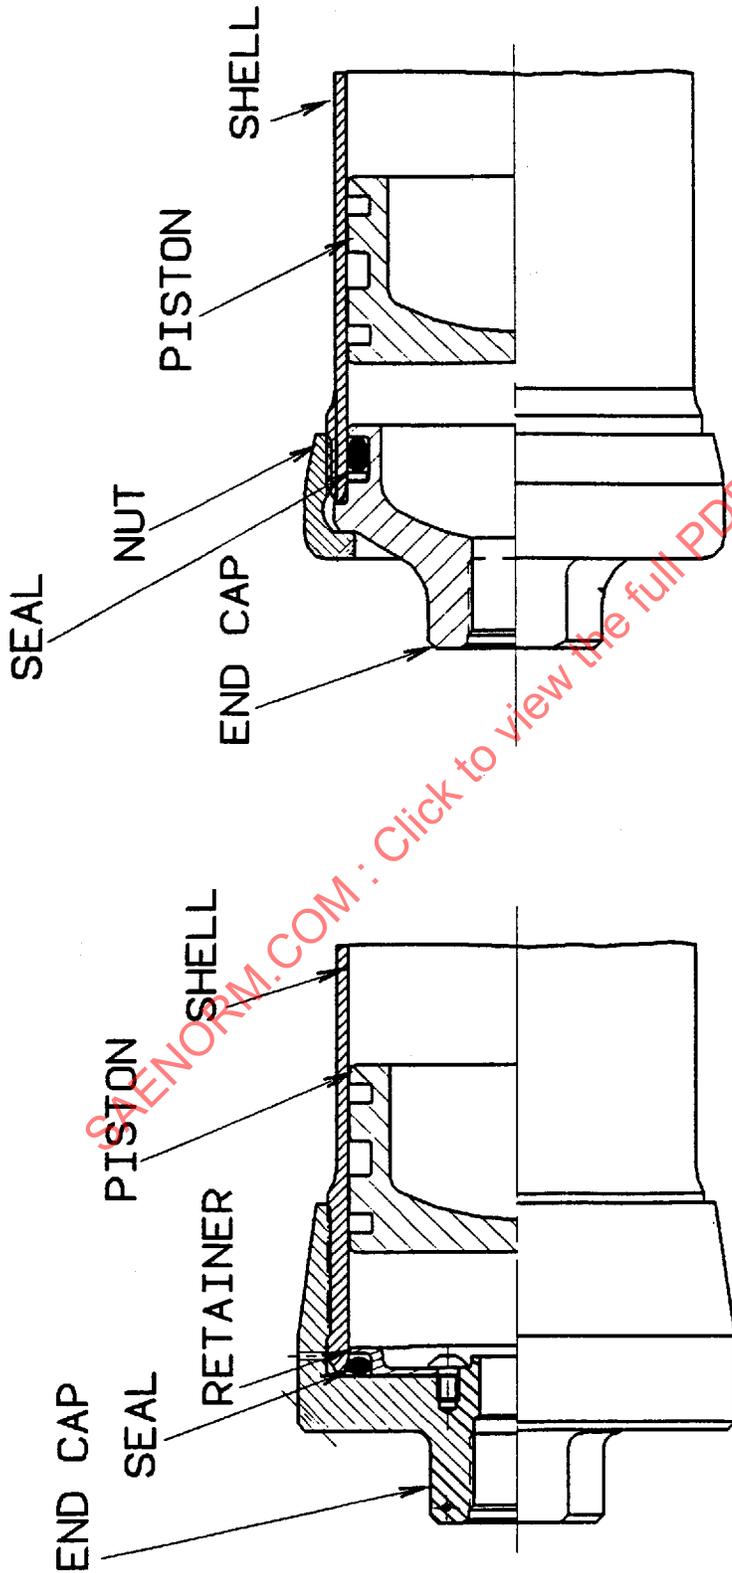
FIGURE 3.2.1.2 (Continued)

PROBLEM: PREMATURE FAILURE OF ACCUMULATOR END CAPS

ISSUE: Failed accumulators are an extreme hazard to aircraft.

- SOLUTION:**
1. Replace aluminum with steel or equivalent.
 2. Ensure that equipment is used at design pressure.
 3. Use two piece end cap design to distribute stresses (steel nut and aluminum gland).
 4. Use the closed end cap on gas side.
 5. Use materials with good fracture toughness - slow crack propagation.
 6. Provide adequate corrosion protection.

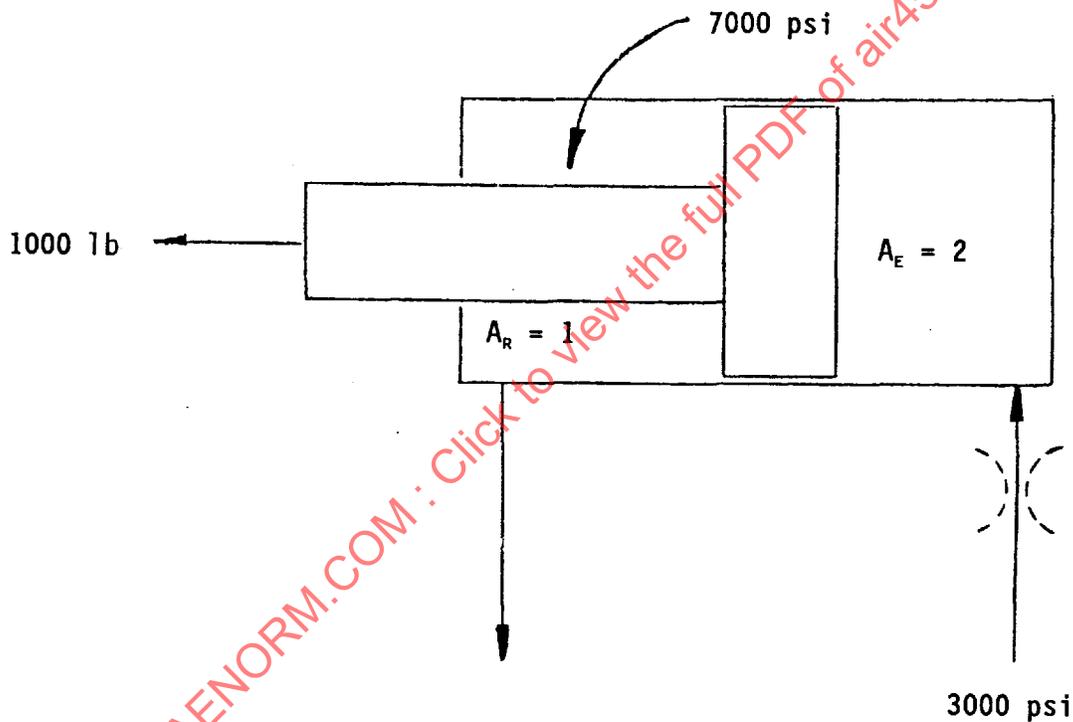
FIGURE 3.2.2.1 - Pressure Intensification in Extending Cylinder

ISSUE: There have been many cases where designers failed to recognize the high pressure that can occur on the retract side of a cylinder due to pressure intensification and/or an aiding load.

SOLUTION: Include a restrictor in the extend line so that the extend pressure is reduced to an acceptable level.

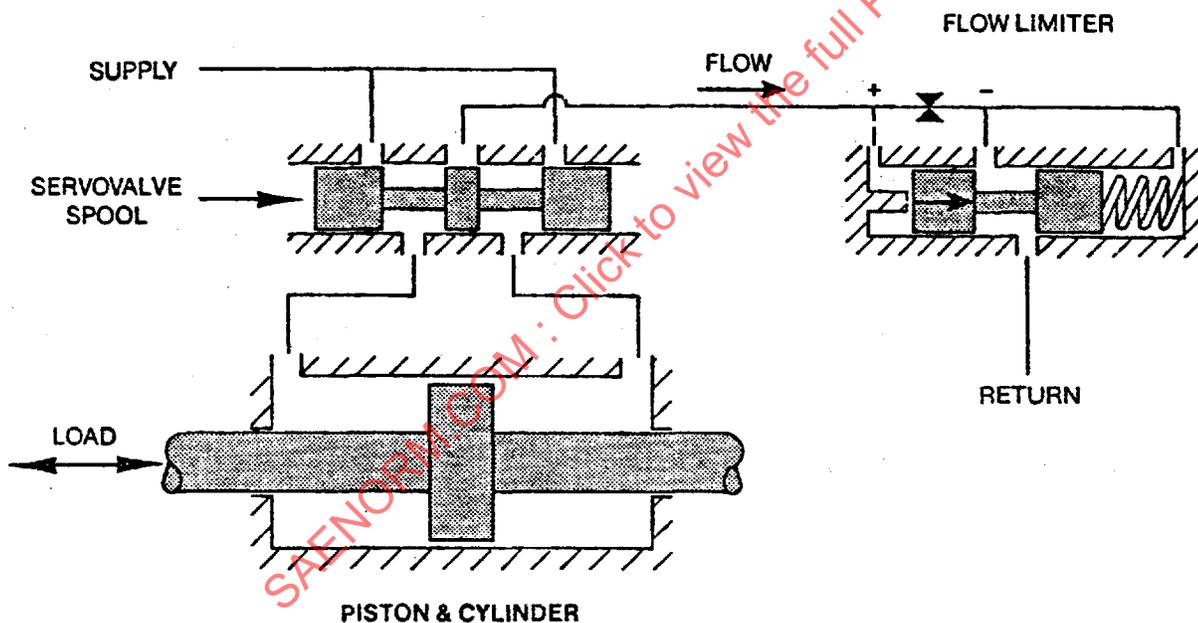
FIGURE 3.2.2.2 - Servovalve Separation From the Manifold Due to Servoactuator Velocity Limiting

- ISSUE:**
1. During the countdown for the initial launch of the Gemini two-man space vehicle, the primary servovalve of the dual redundant TVC actuator blew off the manifold.
 2. The actuator flow limiter used to restrict excessive TVC rate caused high back pressure during engine start transient.
 3. The high impulse loads can create transient back pressure on the servovalve. Alternate configurations for limiting actuator velocity should be considered if impulse loads cannot be suppressed.

- SOLUTION:**
1. A quick fix was to beef-up the servovalve body and mounting.
 2. A long-term solution has been to add cylinder bypass (pressure relief) valves to dissipate energy of hard engine/rocket motor starts.

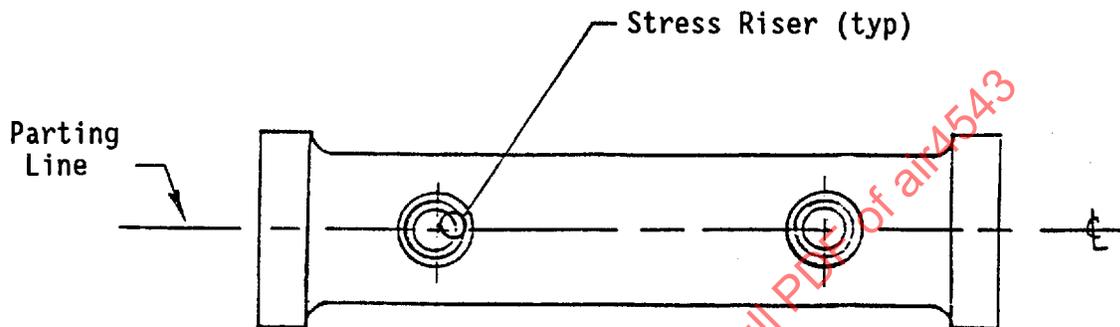
ILLUSTRATION 1

PROBLEM: FATIGUE FAILURES IN CYLINDERS WITH PARTING LINE THROUGH PORTS

ISSUE: The parting line placement on the cylinder centerline for "shallow draw" forging creates stress risers at the ports and at the thinnest section of the cylinder. This can result in fatigue failures or shortened life (see Illustration 1).

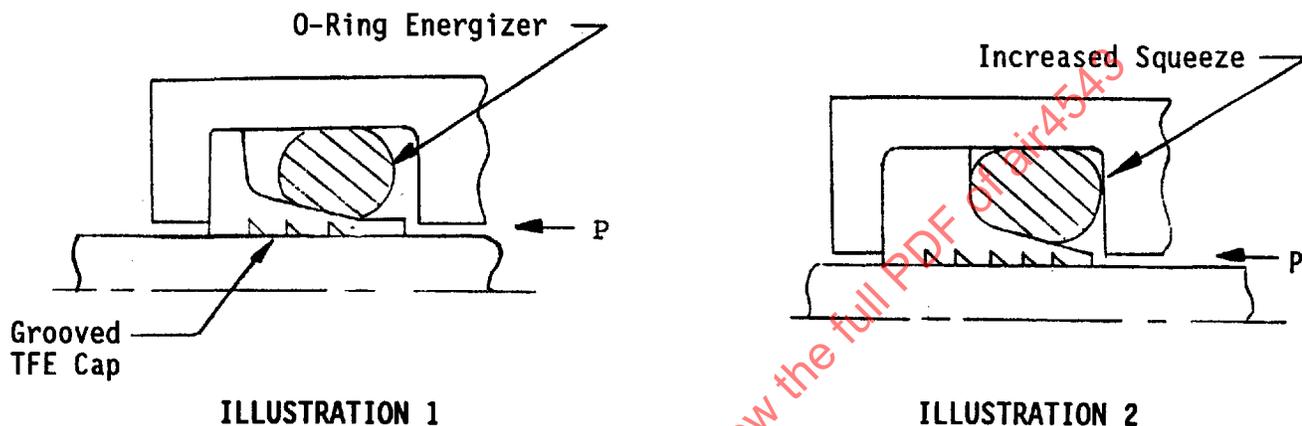
FIGURE 3.2.2.5 - Rejection of Low Friction Actuators for Dynamic Leakage

PROBLEM: REJECTION OF LOW FRICTION ACTUATORS FOR DYNAMIC LEAKAGE

ISSUE: Actuators designed and qualified for low friction (manual reversion) applications sometimes fail leakage tests for no apparent reason. TFE capped rod seals, such as shown in Illustration 1, are usually employed to meet low friction.

- SOLUTION:**
1. Low friction simultaneously with low leakage is a contradiction and a challenge. Analyses and development tests in concert with seal supplier(s) is required early to arrive at optimum seal configuration. (Reference Table 1.)
 2. Strive to qualify at least one alternate seal to preclude production and delivery problems later.
 3. Roughening the surface of the seal with a mild abrasive prior to assembly can improve leakage. However, improvement is only temporary and uncontrolled process is undesirable.
 4. Typical Example: An actuator with nine capped seals suddenly experienced a 50% rejection rate after several years of production. Rejections were eliminated by increasing squeeze (fill) from 51% to 91% and increasing the number of grooves (see Illustration 2). The friction penalty was doubled, but the total friction was still well within the 104# limit.

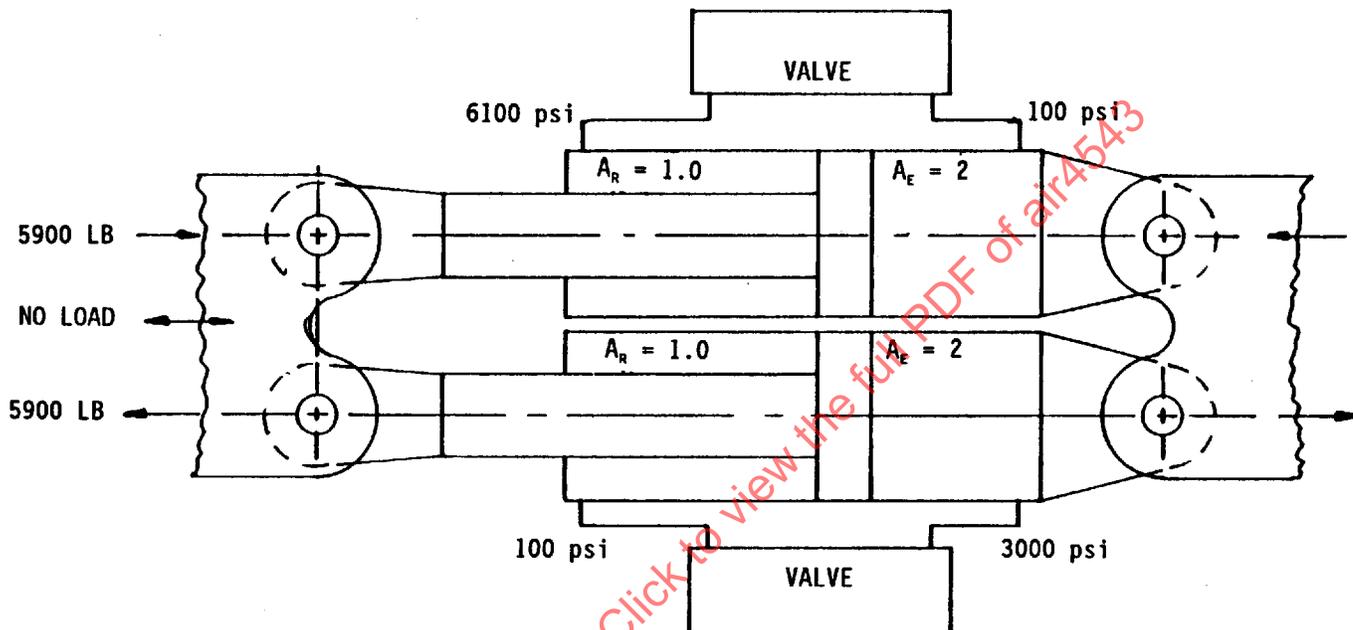
FIGURE 3.2.2.6 - Fatigue Damage to Loaded Structure and Cylinders

PROBLEM: FATIGUE DAMAGE TO LOADED STRUCTURE AND CYLINDERS

- SOLUTION:**
1. Use a single tandem valve for control pressure matching.
 2. Mechanically couple separate valves for control pressure matching.
 3. Use pressure transducers and electronic equalization to match control pressures.
 4. Use underlapped separate servovalves to match control pressures at null (may still have a dynamic force fight problem).

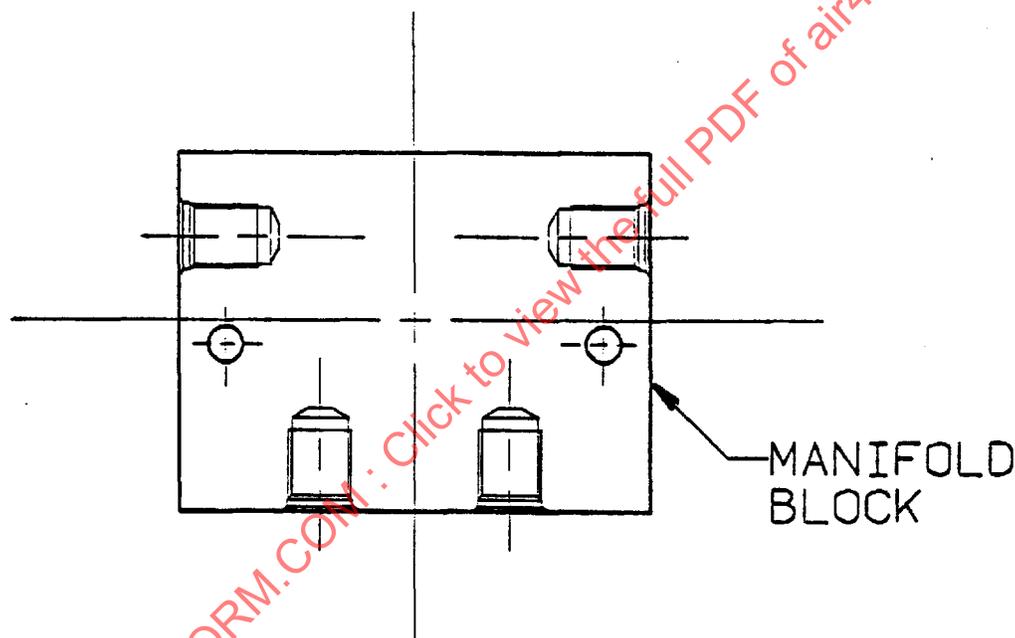
FIGURE 3.2.2.9 - Aileron Failed to Operate

PROBLEM: AILERON FAILED TO OPERATE

ISSUE: No hydraulic oil was being delivered to the L/H aileron actuator. After extensive troubleshooting, it was found that a manifold block passage had not been drilled.

SOLUTION: Although the manifold had passed inspection it was decided to replace it. Afterwards the aileron worked.

Never take for granted that any part is per the drawing.

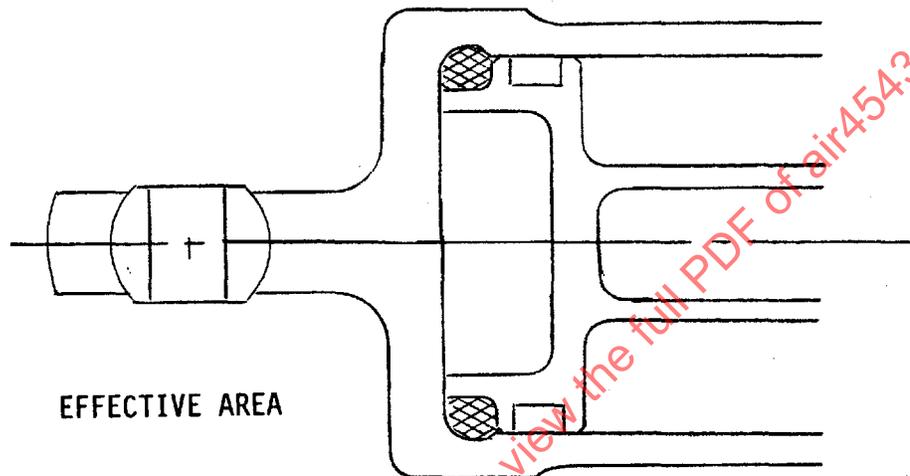
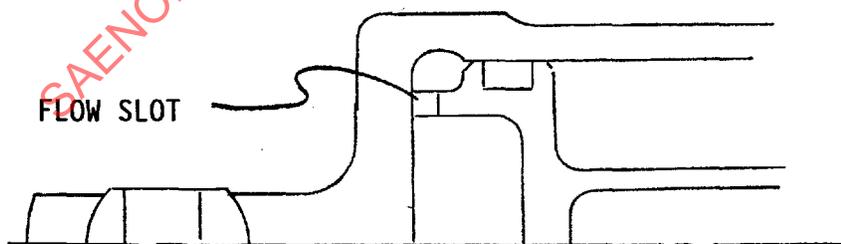
FIGURE 3.2.2.10 - Fully Retracted Actuator Fails to Extend Against Load

PROBLEM: FULLY RETRACTED ACTUATOR FAILS TO EXTEND AGAINST LOAD

SOLUTION: Add flow slot in retract stop ring to assure that full head area is pressurized.

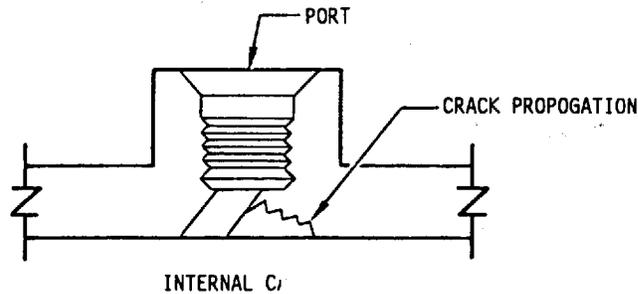
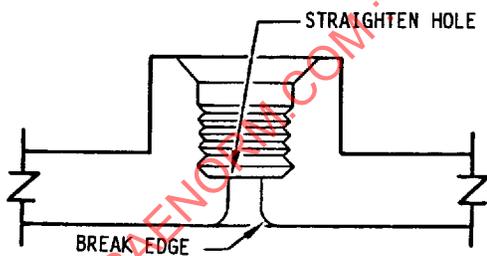
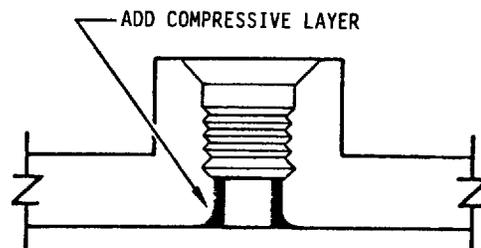
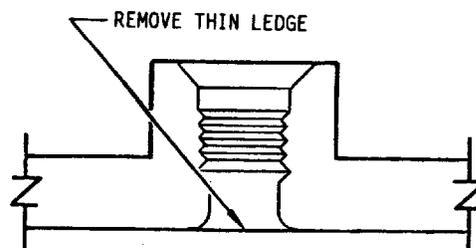
FIGURE 3.2.2.13 - Aluminum Manifold Fatigue

ISSUE: Early fatigue failures due to notch effect of hole intersections.

- SOLUTION:**
1. Keep hole intersection angles as near 90° as possible (Illustration 1)
 2. Break edges at hole intersections (Illustration 1)
 3. Add a localized compressive stress layer if feasible (various methods) (Illustration 2)
 4. Design to avoid - remove discontinuities where possible (Illustration 3)

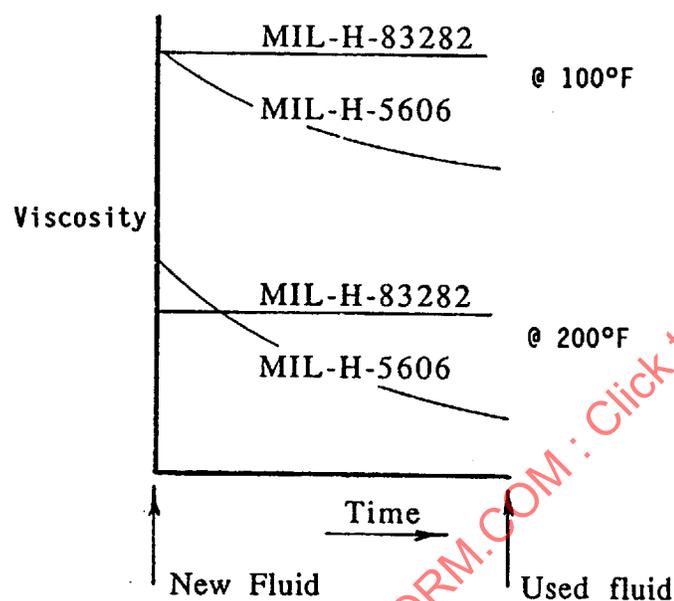
A low leakage requirement may test acceptably with a high viscosity, new, fluid and unacceptably with a low viscosity, used, fluid.

SOLUTION: Specify that test benches be operated for 8 h through orifices to shear fluid prior to conducting critical leakage acceptance tests.

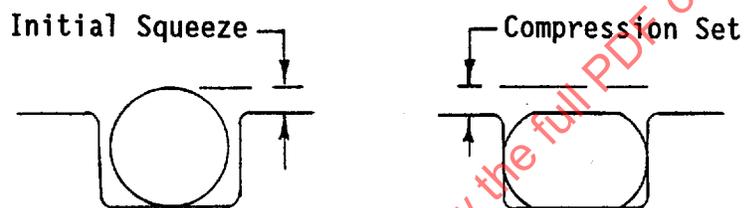
ILLUSTRATION 1

ISSUE: Small cross-section static seals, typically 0.070 in diameter, per MS28775 or MIL-P-83461 (nitrile) are prone to leakage failures. A contributing factor may be local "necking down" caused by uneven installation stretch forces for large sizes. However, the primary problem is due to compression set of the elastomer, which is critical for small cross-sections. High temperature operation for a few hours results in a permanent loss of squeeze with leakage pronounced at normal as well as colder temperatures and low pressures (see Illustration 1).

- SOLUTION:**
1. Where external seepage would result, avoid small cross-section seals, especially for sizes above a 2 in diameter. Where they must be used, the elastomer compound should be changed:
 - a. Fluorocarbon per MIL-R-83485 has been successful in solving problems where the temporary loss of squeeze below -40°F due to the coefficient of shrinkage can be accepted, i.e., slight seepage at low temperature.
 - b. Phosphonitrilic fluoroelastomer (PNF) per MIL-P-87175 has been successful solving problems where squeeze must be maintained down to -65°F .
 - c. Fluorosilicone per MIL-R-25988 may prove to be an acceptable lower cost alternate to PNF in certain applications such as face seals.

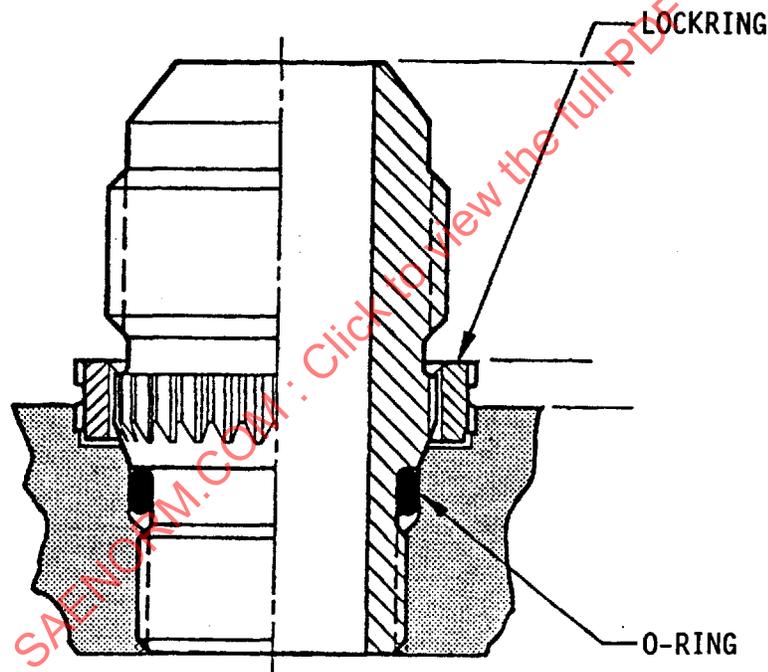
FIGURE 3.2.7.4 - Damaged Ports

PROBLEM: DAMAGED PORTS

SOLUTION: Removable boss fittings should be employed whenever possible.
