AEROSPACE INFORMATION REPORT

SAE AIR4543

Issued 1992-01
 Revised 2000-06

Aerospace Hydraulics and Actuation Lessons Learned

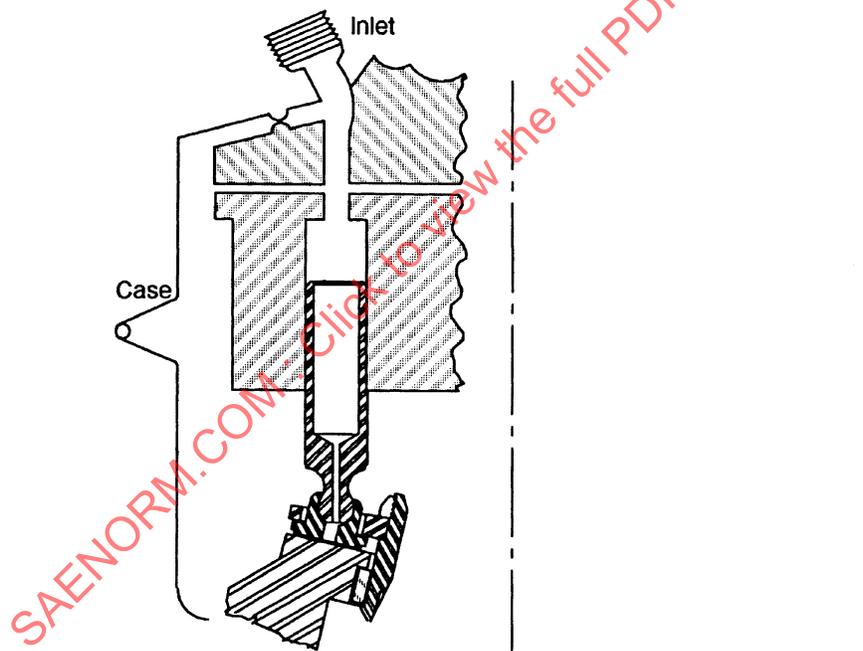
FIGURE 3.1.3 - Pump Overheat and Rapid Wear

- ISSUE:
1. Pump case drain line too small
 2. Creates high back pressure (case)
 3. Creates high discharge pressure (flow)
 4. Overheat (pump)
 5. Excessive pump shoe wear

- SOLUTION:
1. Increase line size (case drain)
 2. Use bypass type filters
 3. Reroute line to reduce pressure drop
 4. Internally drain (to inlet) if minimum system demand available

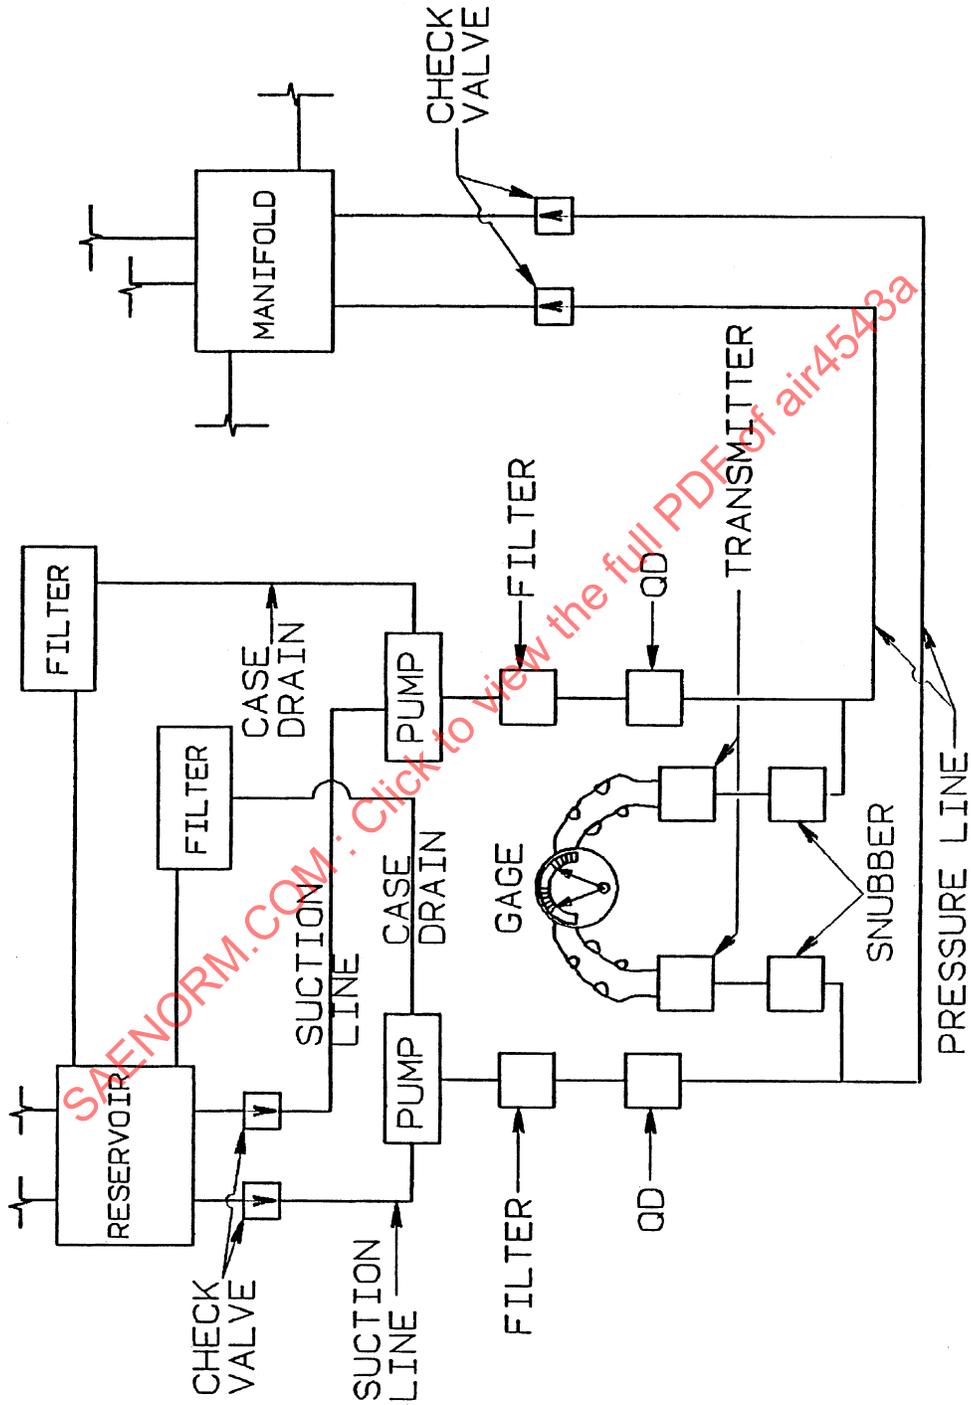
FIGURE 3.1.7 - Pump Suction Line Bursting

- ISSUE:**
1. On the initial engine run of a twin engine aircraft the R/H pump suction line burst.
 2. The line was replaced and the R/H engine started - no problem.
 3. The L/H engine was started and the R/H suction line burst.
 4. The line was replaced and the L/H engine started - no problem.
 5. The R/H engine was then started and the R/H suction line burst.

- SOLUTION:**
1. The R/H pump compensator was found to have a slightly lower pressure setting than required.
 2. A failed pump outlet check valve created a reverse pumping situation on the R/H side.
 3. Pump and check valve were replaced.

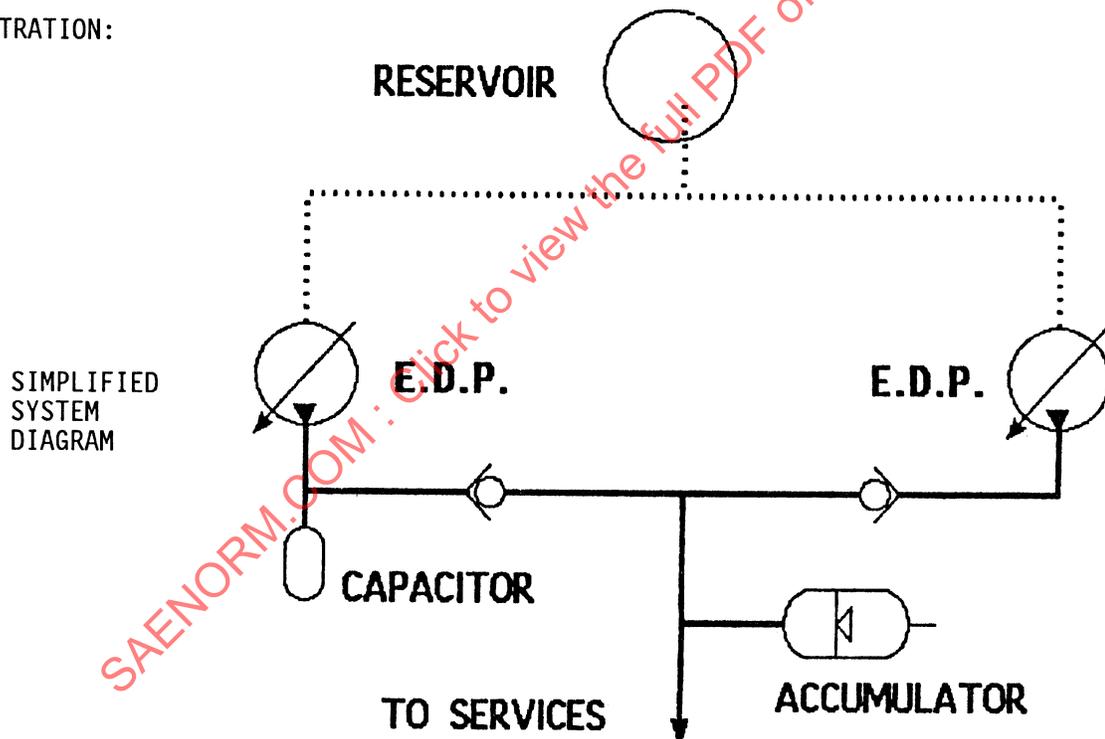
FIGURE 3.1.8 - Hydraulic System Noise

- ISSUE:
1. With a twin engine driven pump (E.D.P.) hydraulic system, there were complaints of noise, although not encountered with:
 - a. Earlier production aircraft;
 - b. When system is pressurized by ground rigs.
 2. Resonance condition occurred in the shortest line downstream of E.D.P. due to the reduced volume of the high pressure part of the hydraulic system.

- SOLUTION:
1. Initially increase the accumulator size to that previously fitted.
 2. Finally, revert to a smaller accumulator and add a "capacitor" (a small pressure vessel (22 in³) to the system).

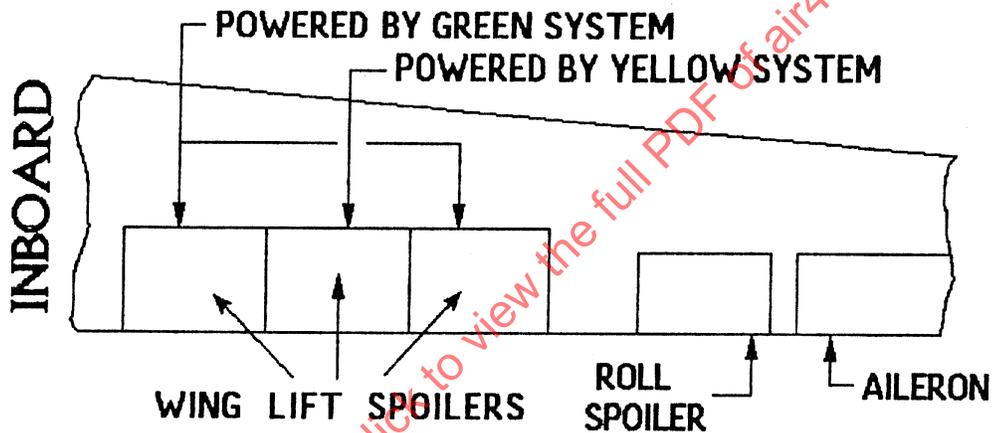
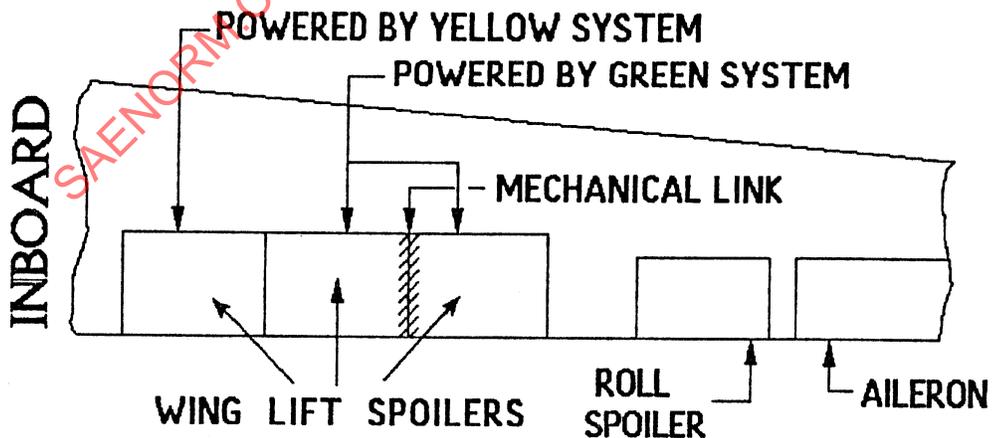
FIGURE 3.1.9 - Effect of JAR/FAR Requirement on Flight Control Surface Operation

- ISSUE:
1. Noncompliance with JAR/FAR 25.671:
 2. A single failure of a flight control surface attachment point could cause a catastrophic event.
 3. The center or outboard ground lift spoiler panel could deploy following the failure of the eye end attachment point, for example, such that an inadvertent rolling moment could not be controlled.

- SOLUTION: 1. Reroute hydraulic supplies to the lift spoilers and link the center and outboard panels.

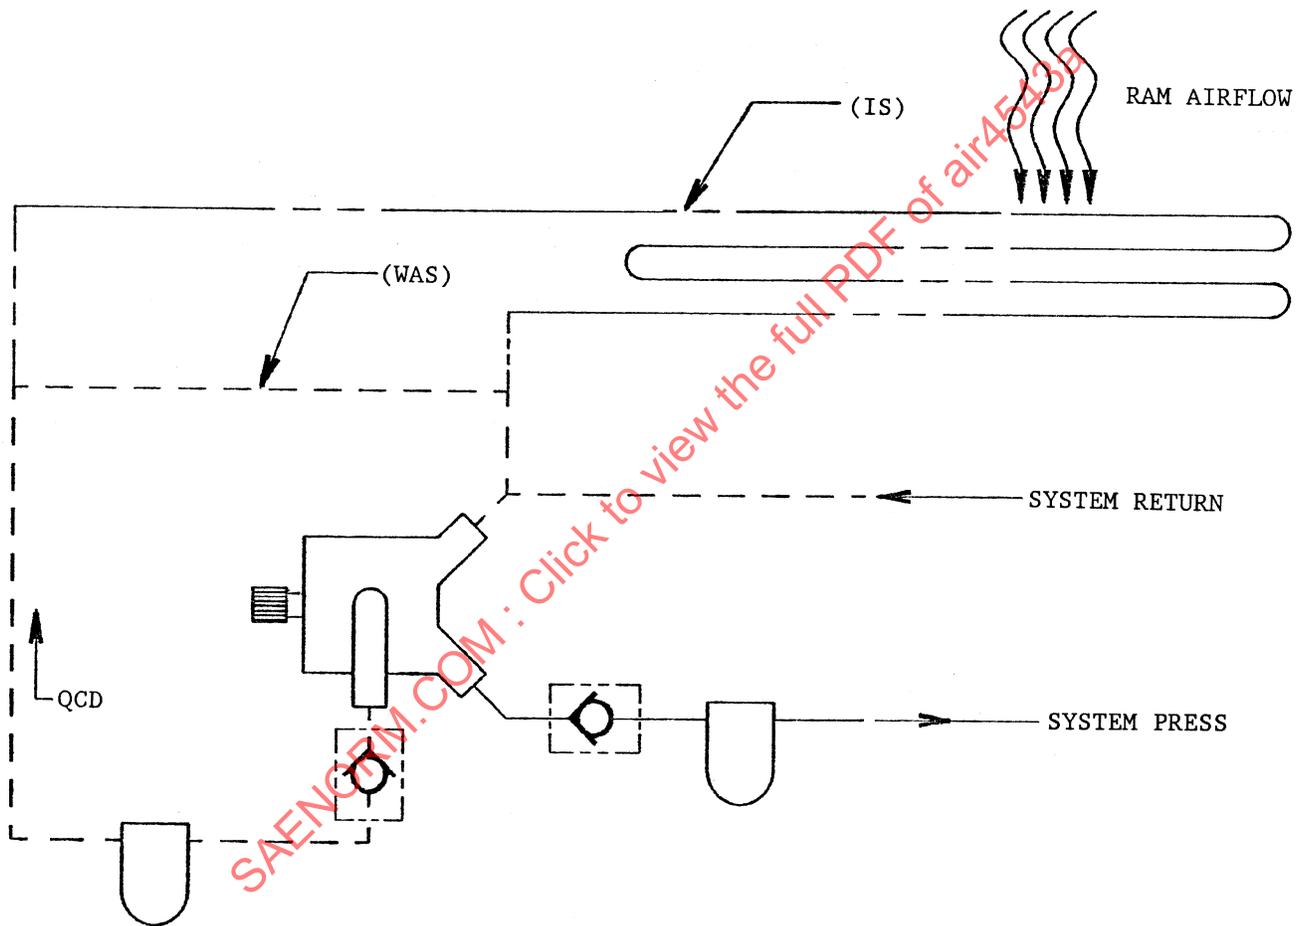
FIGURE 3.1.16 - System Overheat Caused by Inefficient Pump and Lack of Heat Exchanger

PROBLEM: SYSTEM OVERHEAT CAUSED BY INEFFICIENT PUMP AND LACK OF HEAT EXCHANGER

- SOLUTION:
1. Revise the specifications to buy the pump with guaranteed efficiency and case drain flow over the life of the pump.
 2. Increase the case drain line diameter and the filter housing size.
 3. Reroute the case drain line to increase surface area and also expose to area with ram air.

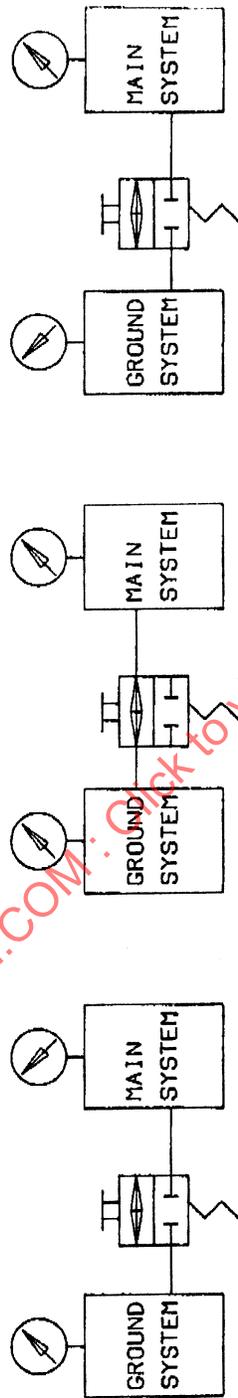
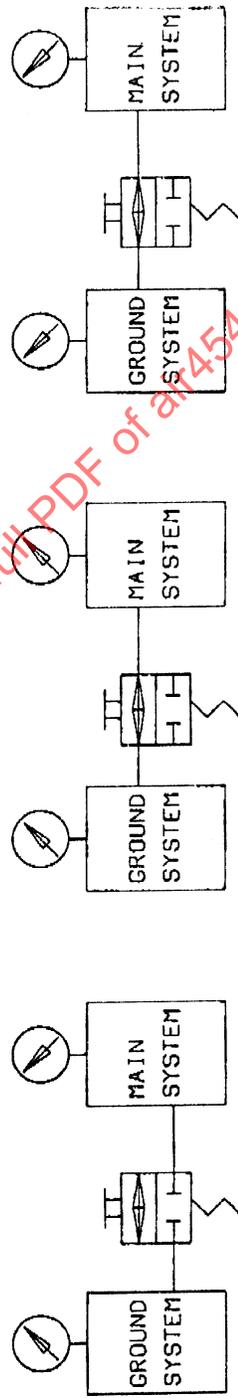
FIGURE 3.1.23 - Intrasystem Fluid Transfer

Issue: Ground/utility checkout transfers "compression" fluid to main system

SOLUTION: Decompress main system as final checkout action.

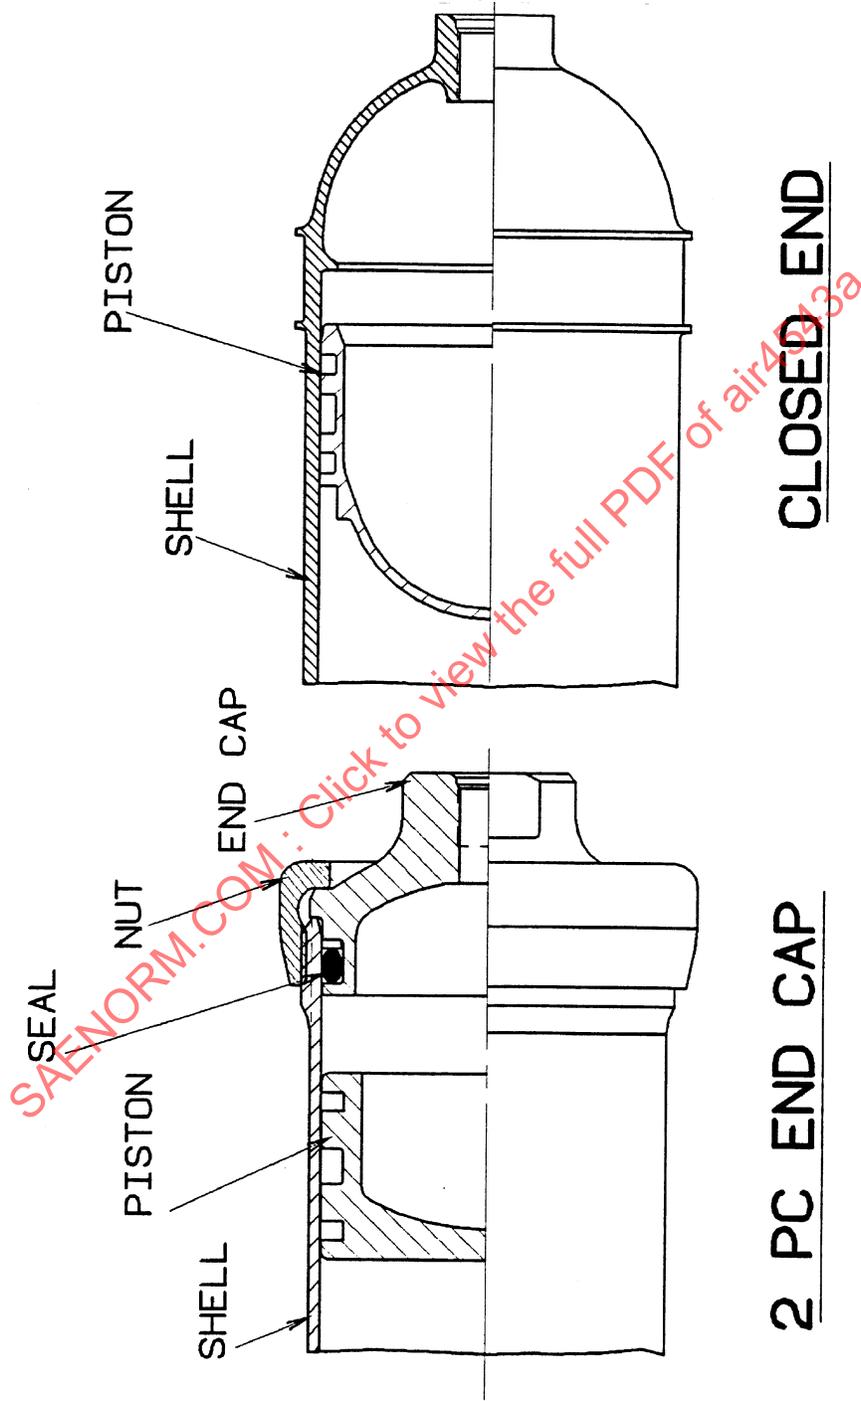
FIGURE 3.2.1.1 - Excessive or Premature Leakage Across Accumulator Seals

PROBLEM: EXCESSIVE OR PREMATURE LEAKAGE ACROSS ACCUMULATOR SEALS

ISSUE: Gas leaking into the system can cause a loss of aircraft or system.

- SOLUTION:**
1. Ensure that the chrome plate is controlled to minimize cracking (cracks inherent in chrome plating process).
 2. Ensure that the seal compound meets all temperature, pressure, and pressure discharge requirements. Minimize the compression set and explosive decompression.
 3. Use the closed end cap on gas side (eliminate static seal).
 4. Improve the seal concept to improve sealing capability (multiple seals, metal bellows, etc.).

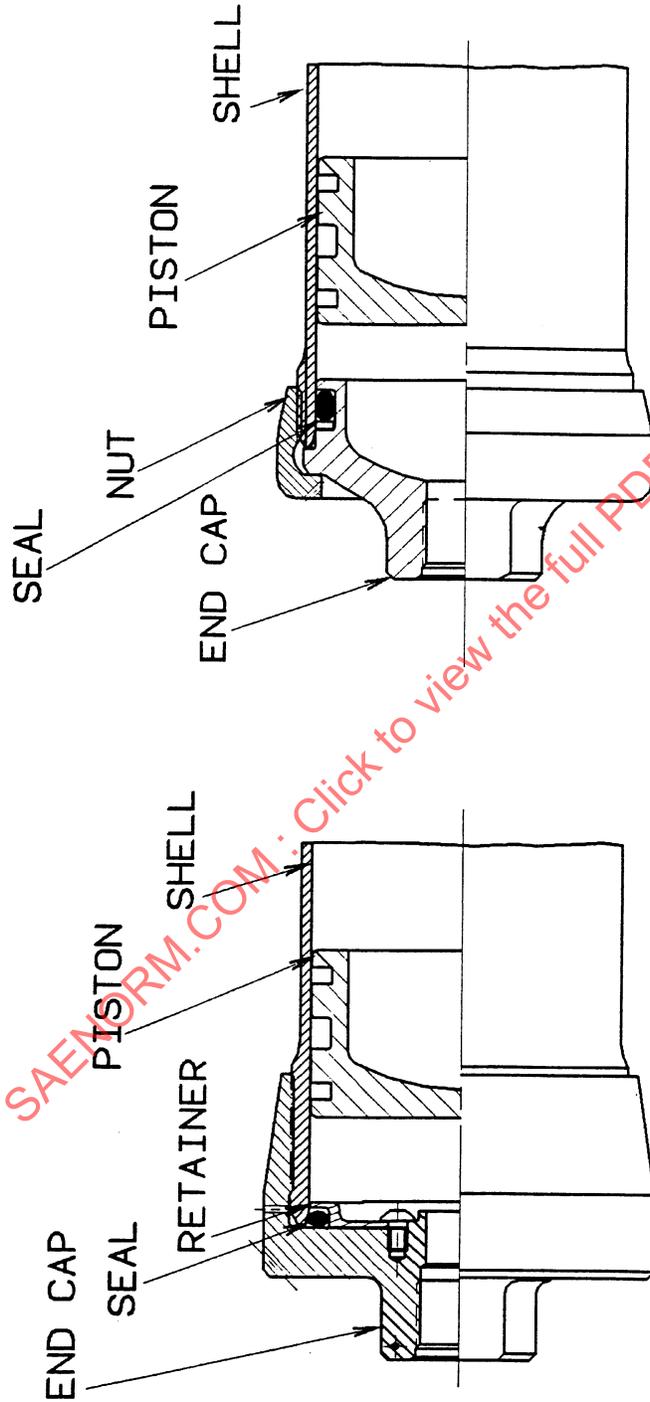
FIGURE 3.2.1.2 - Premature Failure of Accumulator End Caps

PROBLEM: PREMATURE FAILURE OF ACCUMULATOR END CAPS

ISSUE: Failed accumulators are an extreme hazard to aircraft.

- SOLUTION:**
1. Replace aluminum with steel or equivalent.
 2. Ensure that equipment is used at design pressure.
 3. Use two piece end cap design to distribute stresses (steel nut and aluminum gland).
 4. Use the closed end cap on gas side.
 5. Use materials with good fracture toughness - slow crack propagation.
 6. Provide adequate corrosion protection.

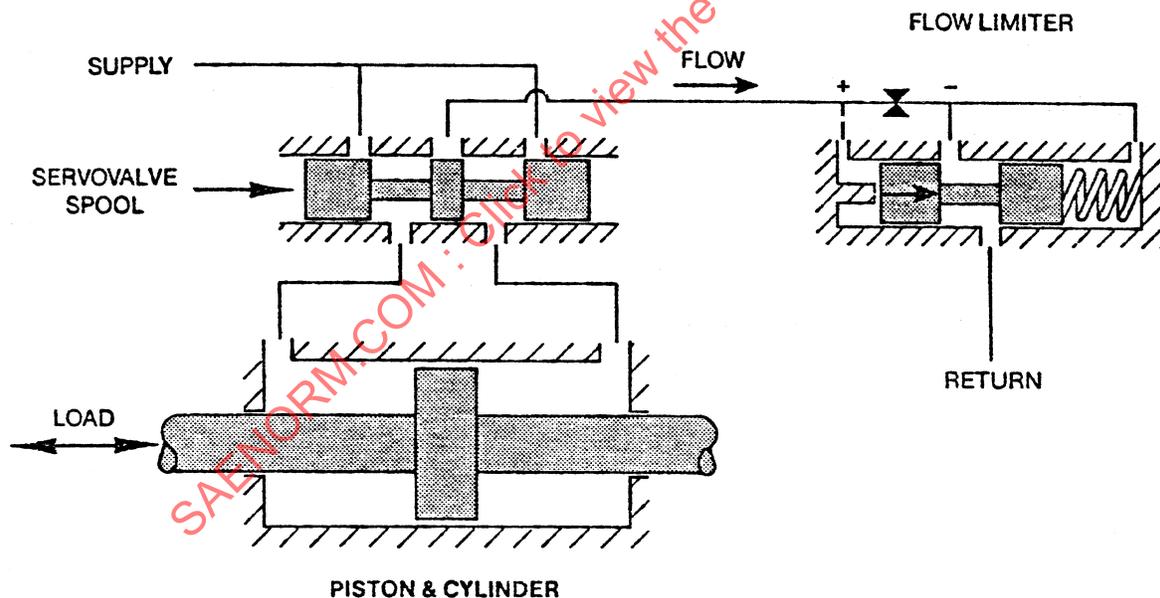
- ISSUE:**
1. During the countdown for the initial launch of the Gemini two-man space vehicle, the primary servovalve of the dual redundant thrust vector control actuator blew off the manifold.
 2. The actuator flow limiter used to restrict excessive thrust vector control rate caused high back pressure during engine start transient.
 3. The high impulse loads can create transient back pressure on the servovalve. Alternate configurations for limiting actuator velocity should be considered if impulse loads cannot be suppressed.

- SOLUTION:**
1. A quick fix was to beef-up the servovalve body and mounting.
 2. A long-term solution has been to add cylinder bypass (pressure relief) valves to dissipate energy of hard engine/rocket motor starts.

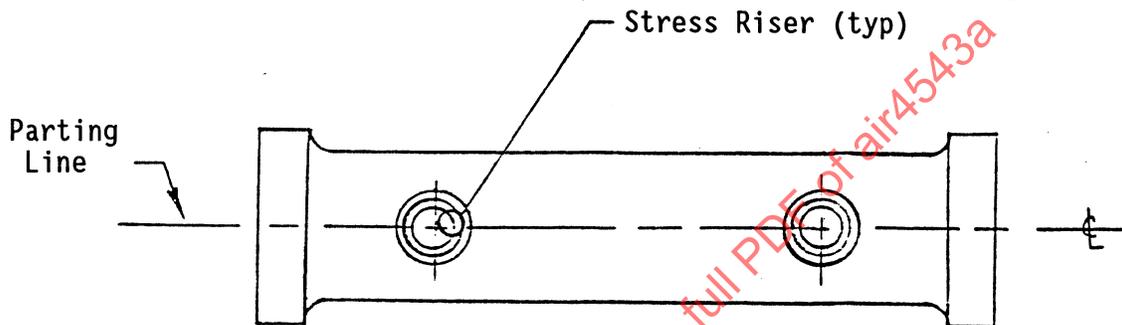
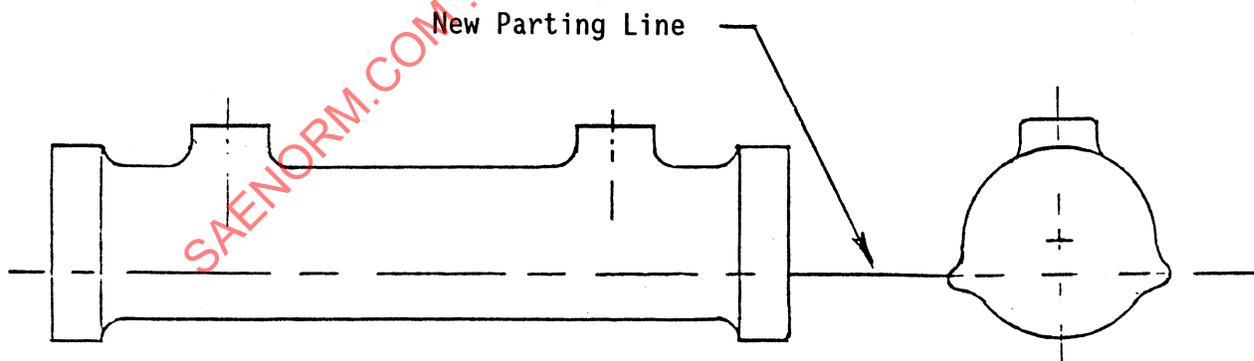
ISSUE: The parting line placement on the cylinder centerline for "shallow draw" forging creates stress risers at the ports and at the thinnest section of the cylinder. This can result in fatigue failures or shortened life (see Illustration 1).

SOLUTION: Relocate the parting line off the cylinder centerline and completely off the ports (see Illustration 2).

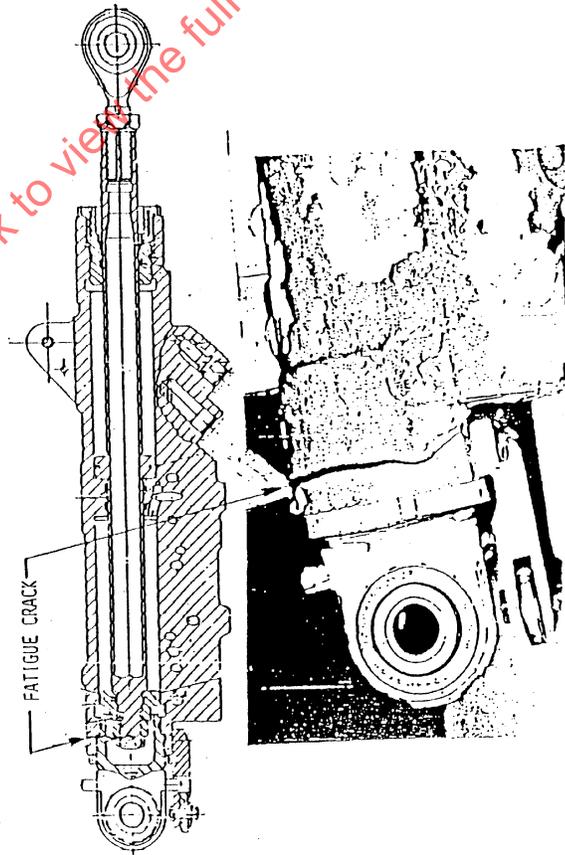
FIGURE 3.2.2.15 - Internal Threads in Aluminum Actuators and Components

Thread root cross section of Actuator #1
Mag = 200x. Actuator S/N 380

Thread root cross section of Actuator #2, note crack at root radius. Mag = 200x. ACTUATOR S/N 278

SOLUTION: Specify minimum root radii when designing aluminum components with internal cut threads.

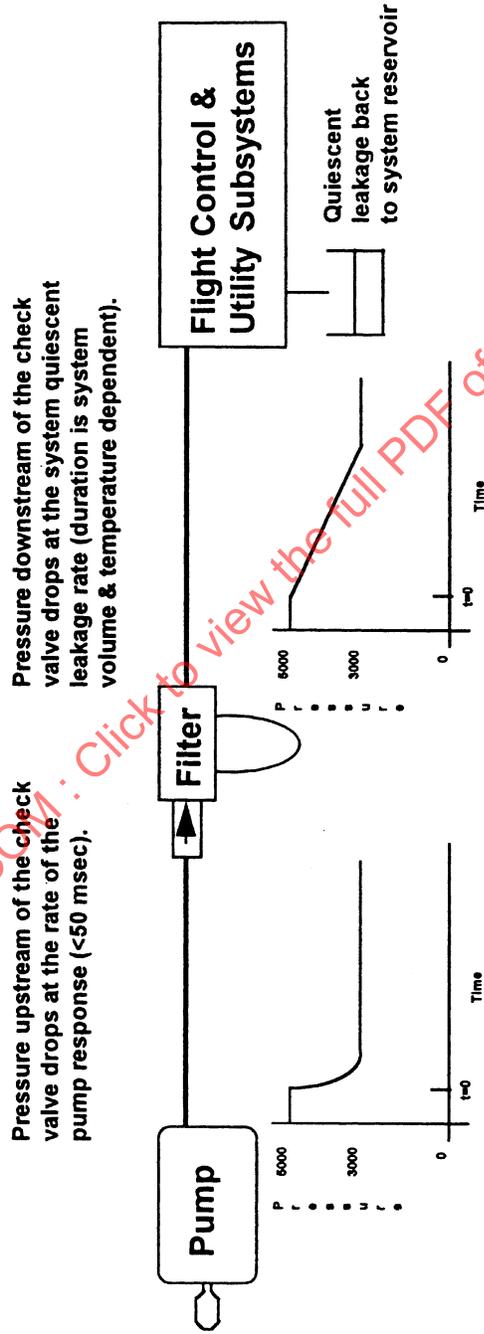
FIGURE 3.2.5.7 - Dual Pressure Pump Instability

PROBLEM: DUAL PRESSURE PUMP UNSTABLE WHEN SWITCHING PRESSURE
ISSUE: Switching from high pressure to low pressure causes the high pressure filter check valve to close resulting in inadequate system volume downstream of the dual pressure pump to maintain stability.

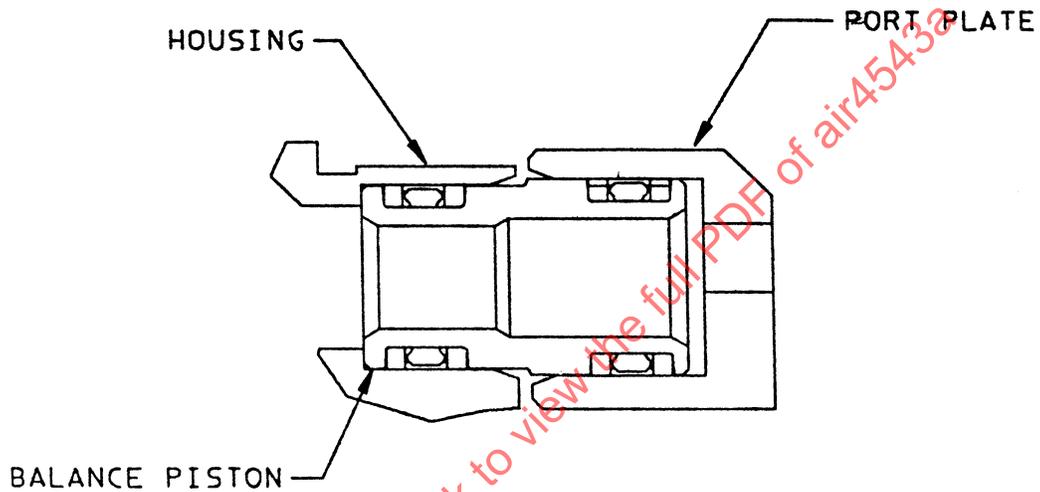
ISSUE: Cyclic/reversing pressures on floating port plate type units causes dithering wear on seals at high frequency. Can cause leakage and contamination debris.

SOLUTION: Unbalancing of transfer tube causes greater force in one direction and prevents dithering motion, thus reducing seal wear and leakage.
