(R) Aerospace Hydraulics and Actuation Lessons Learned

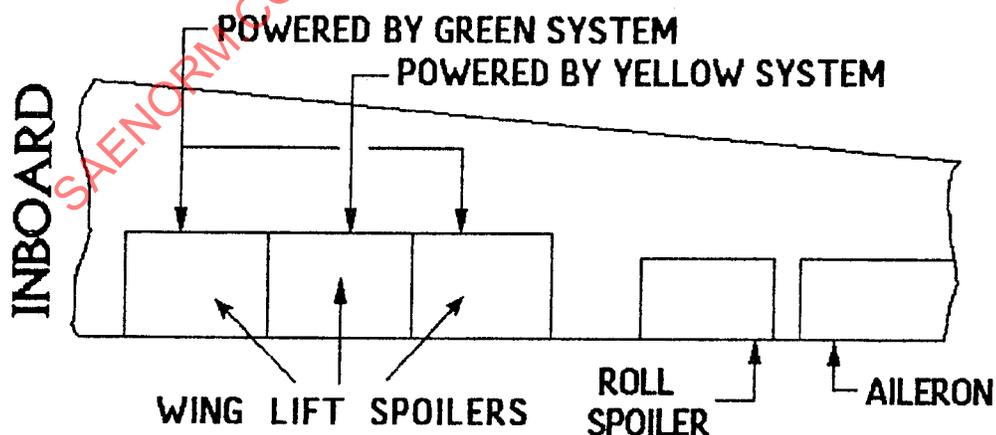
- b. A single failure of a flight control surface attachment point could cause a catastrophic event.
- c. The center or outboard ground lift spoiler panel could deploy, following the failure of the eye end attachment point for example, such that an inadvertent rolling moment could not be controlled.

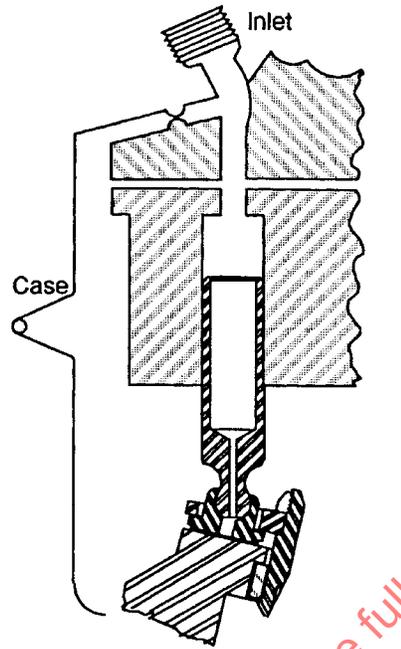
PROBLEM: Pump overheat and rapid wear installed in aircraft system.

- Pump case drain line too small
- Creates high back pressure (case)
- Creates high discharge pressure (flow)
- Overheat (pump)
- Excessive pump shoe wear

- a. Increase line size (case drain)
- b. Use bypass type filters
- c. Reroute line to reduce pressure drop
- d. Internally drain (to inlet) if minimum system demand available

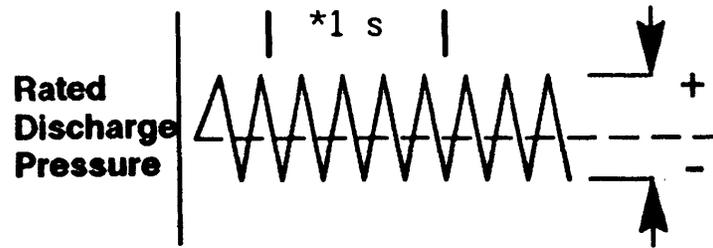
PROBLEM: Hydraulic system life and noise degraded by excessive pump pressure ripple.

- a. Line fatigue
- b. Excessive wear (moving parts)
- c. Vibration/noise

NOTE: Ripple amplitude: Acceptable +/- 10%, Desirable +/- 5 %, Achievable +/- 2%

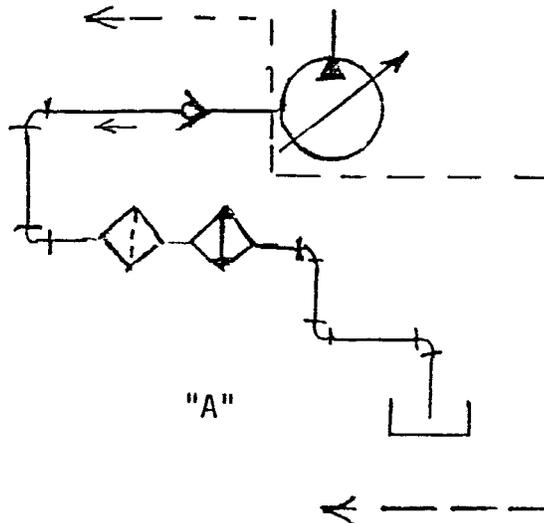
ISSUE: Restrictions in the hydraulic pump/motor case drain plumbing can cause high pressure and subsequent failure of the pump/motor case. Restrictions can be caused by too small diameter tubing, long tubing lengths, or improper component installations. The restrictions can result in high line pressure drop, resulting in high pressures in the pump or motor case. Pump and motor cases are generally designed to a 500 lbf/in² (3450 kPa) proof pressure or less.

- a. Analyze the installation and determine the pressure drop of the pump or motor case drain plumbing from the case to the reservoir. The analysis should include evaluations considering delta pressure of all possible case drain flow and fluid temperature combinations, case drain filter variables, transient flows, and component installation.

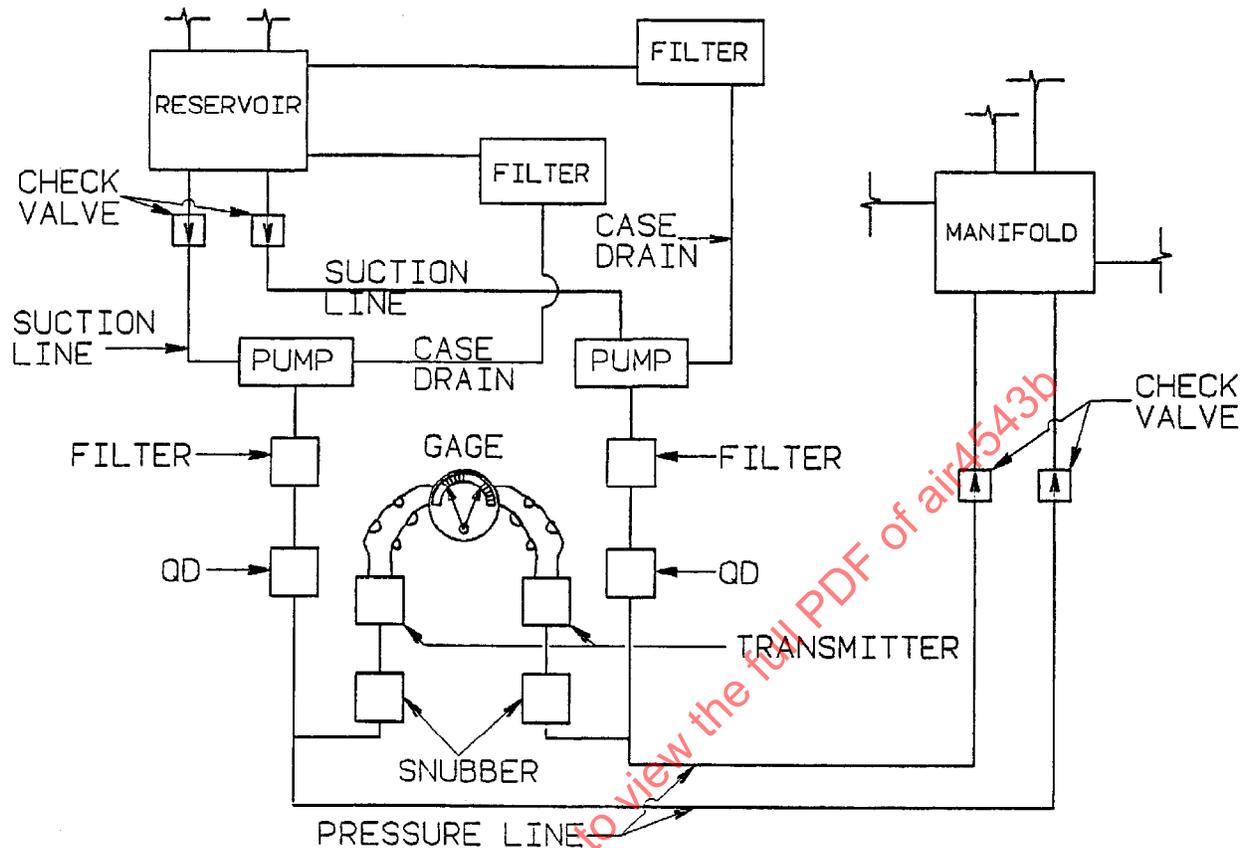
- a. On the initial engine run of a twin engine aircraft the R/H pump suction line burst.
- b. The line was replaced and the R/H engine started - no problem.
- c. The L/H engine was started and the R/H suction line burst.
- d. The line was replaced and the L/H engine started - no problem.
- e. The R/H engine was then started and the R/H suction line burst.

- The R/H pump compensator was found to have a slightly lower pressure setting than required.
- A failed pump outlet check valve created a reverse pumping situation on the R/H side.
- Pump and check valve were replaced.

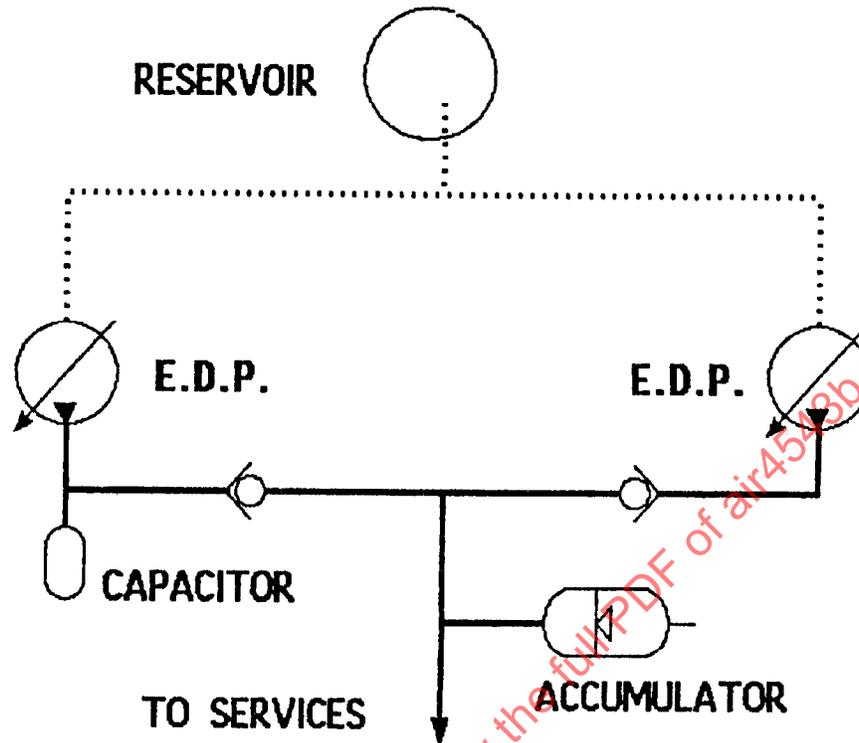
- With a twin engine driven pump (E.D.P.) hydraulic system, there were complaints of noise, although not encountered with:
 - Earlier production aircraft;
 - When system is pressurized by ground rigs.
- Resonance condition occurred in the shortest line downstream of E.D.P. due to the reduced volume of the high pressure part of the hydraulic system.

- Initially increase the accumulator size to that previously fitted.
- Finally, revert to a smaller accumulator and add a "capacitor" (a small pressure vessel (22 in³) (360 cm³) to the system).

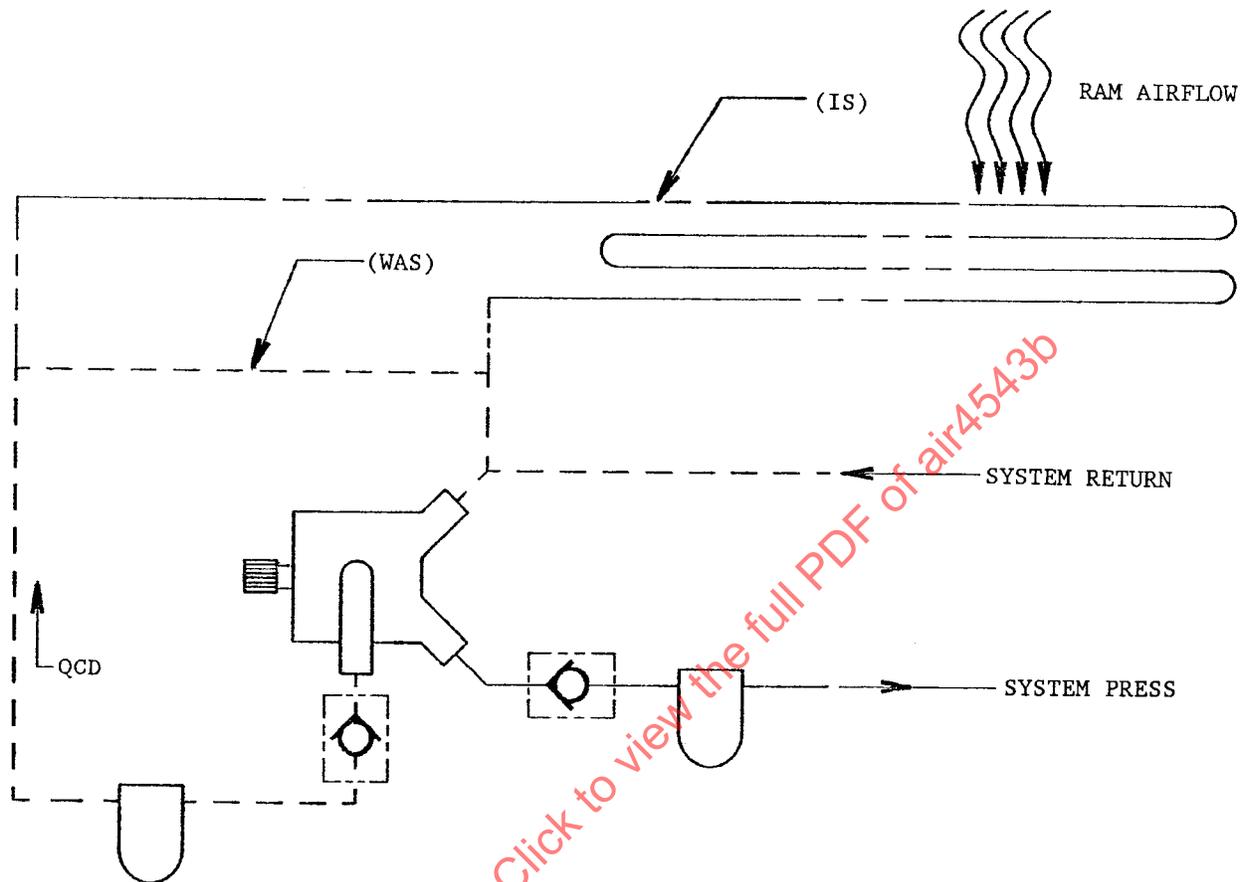
PROBLEM: System overheat caused by inefficient pump and lack of heat exchanger.

- Revise the specifications to buy the pump with guaranteed efficiency and case drain flow over the life of the pump.
- Increase the case drain line diameter and the filter housing size.
- Reroute the case drain line to increase surface area and also expose to area with ram air.

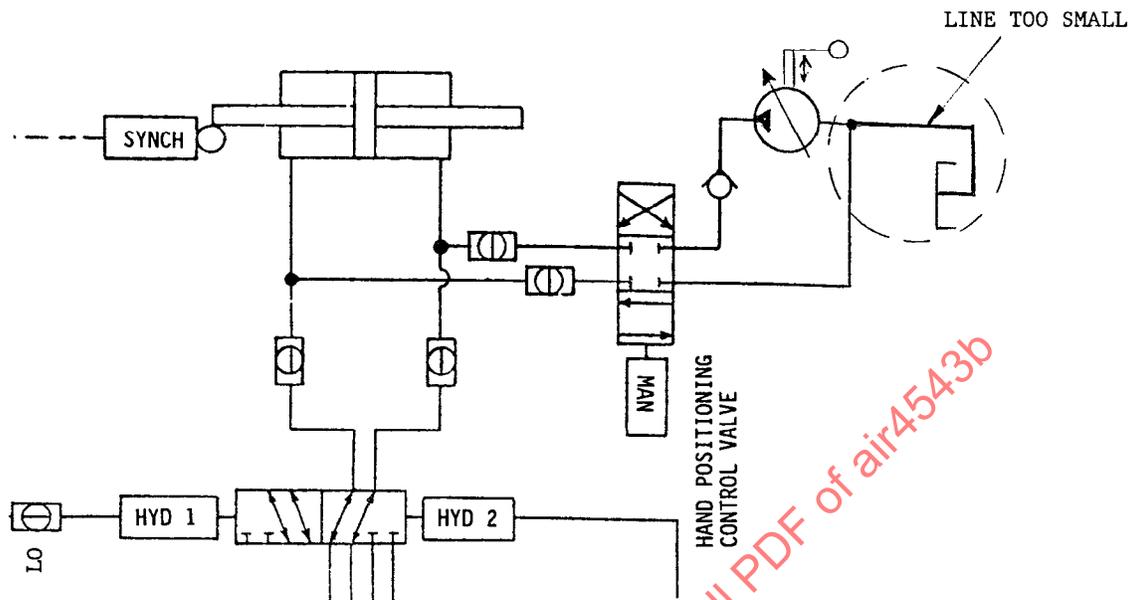
PROBLEM: Inadequately sized hand pump suction line causes unacceptable performance.

SOLUTION: The variable displacement hand pump discharges fluid as the pump handle is stroked in each direction. However, analysis indicated that the pump takes suction only when the pump is stroked in one direction. As a result, considerable flow is required from the unpressurized reservoir during the suction stroke even though the cylinder is balanced (equal volume for each direction of travel). The diameter of the make-up line from the reservoir to the pump suction had been sized for minimal flow and had to be increased to obtain rated pump capacity.

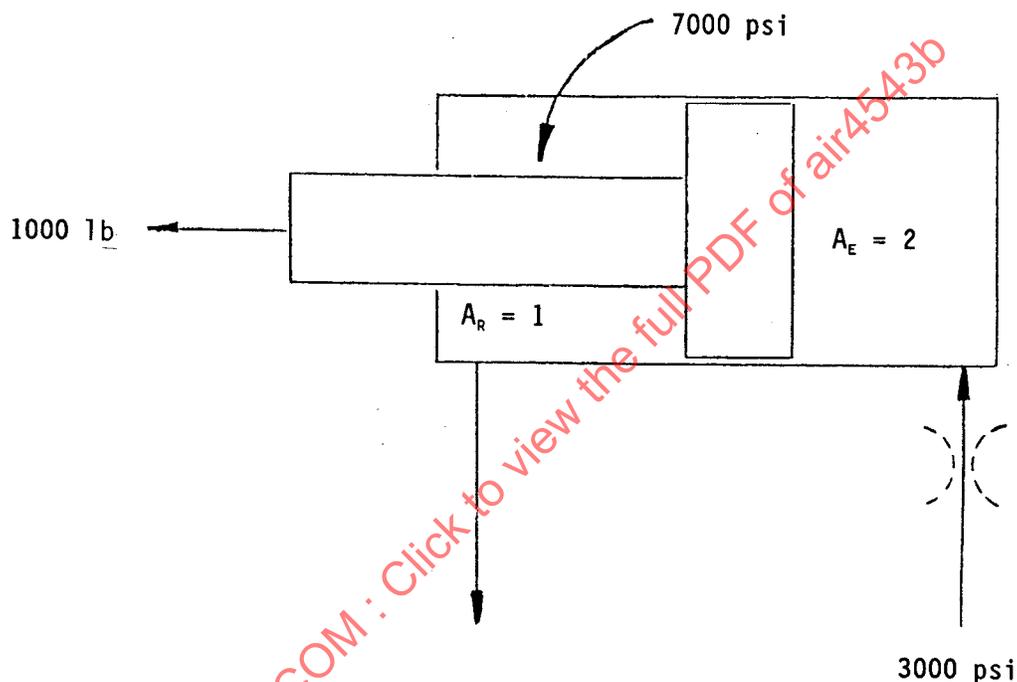
ISSUE: There have been many cases where designers failed to recognize the high pressure that can occur on the retract side of a cylinder due to pressure intensification and/or an aiding load.

SOLUTION: Include restrictor in the extend line so that the extend pressure is reduced to an acceptable level.

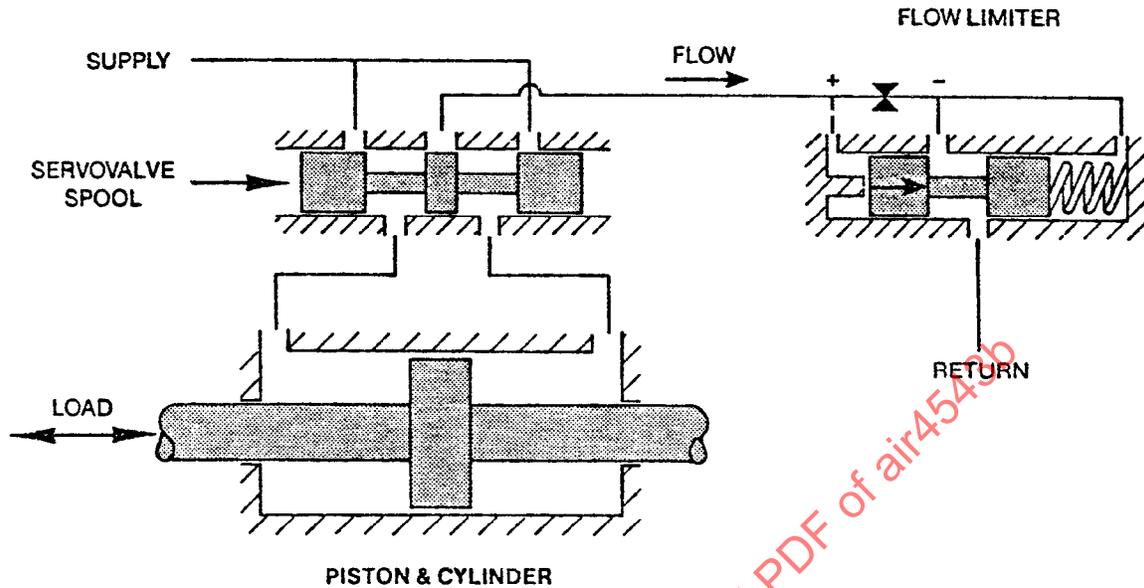
- During the countdown for the initial launch of the Gemini two-man space vehicle, the primary servo valve of the dual redundant thrust vector control actuator blew off the manifold.
- The actuator flow limiter used to restrict excessive thrust vector control rate caused high back pressure during engine start transient.
- The high impulse loads can create transient back pressure on the servo valve. Alternate configurations for limiting actuator velocity should be considered if impulse loads cannot be suppressed.

- A quick fix was to beef-up the servo valve body and mounting.
- A long-term solution has been to add cylinder bypass (pressure relief) valves to dissipate energy of hard engine/rocket motor starts.

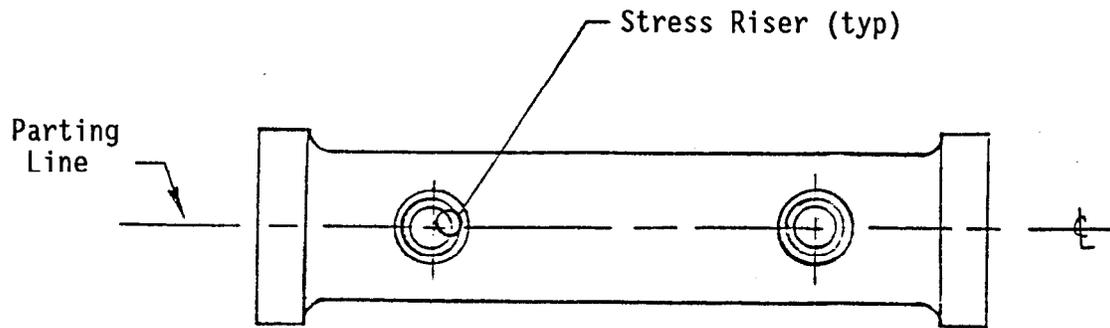
ILLUSTRATION: - 1

PROBLEM: Fatigue failures in cylinders with parting plane through ports.

ISSUE: The parting line placement on the cylinder centerline for "shallow draw" forging creates stress risers at the ports and at the thinnest section of the cylinder. This can result in fatigue failures or shortened life (see Illustration 1).

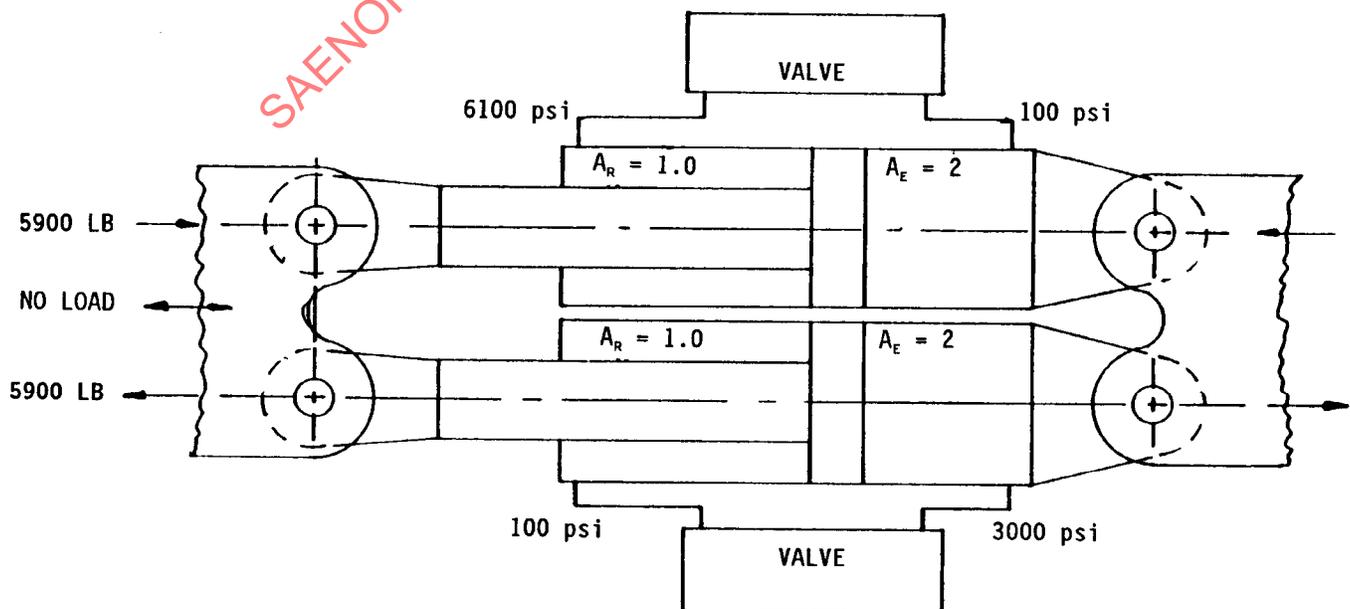
PROBLEM: Fatigue damage to loaded structure and cylinders of side-by-side cylinders.

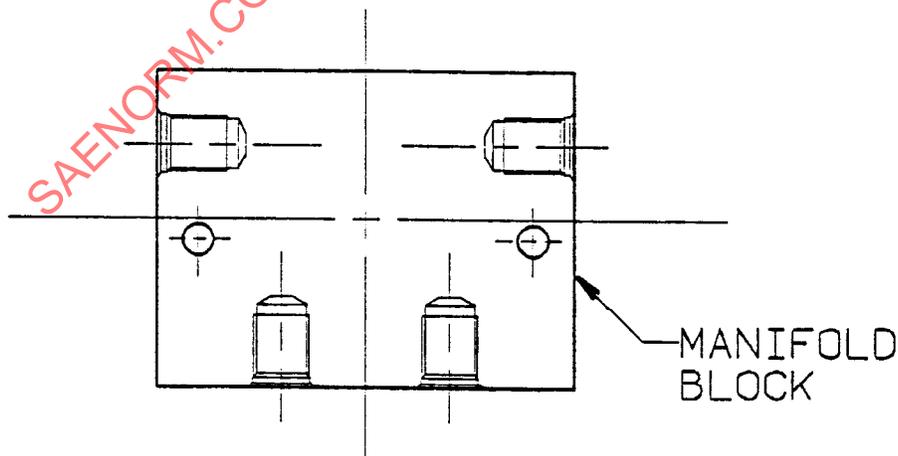
PROBLEM: Installed aileron actuator failed to operate.

ISSUE: No hydraulic oil was being delivered to the L/H aileron actuator. After extensive troubleshooting, it was found that a manifold block passage had not been drilled.

SOLUTION: Although the manifold had passed inspection it was decided to replace it. Afterwards the aileron worked.

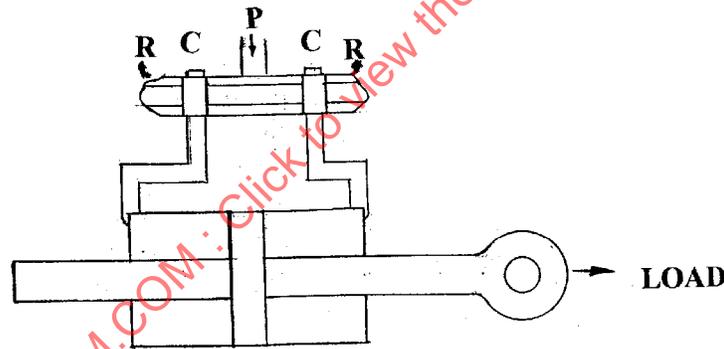
PROBLEM: Early pressure fatigue failures of fly by wire actuators.

ISSUE: Fly by wire servoactuator barrel and end closure pressure fatigue failures occurred in a very short period of use due to a combination of servovalve overlap conditions and continuous small movement command which kept the valve within the overlap region.

To meet low leakage requirements, the supplier provided valves with overlap - long overlap cylinder to return lands and shorter overlap pressure to cylinder lands, tending toward high "no load" null pressures. Combined with an aiding air load, the resisting cylinder pressure may reach a very high pressure value. For example: A constant 1500 lbf/in² (10 300 kPa) extend force pressure load could require the resisting cylinder chamber pressure to approach 4500 lbf/in² (31 000 kPa) in a 3000 lbf/in² (20 700 kPa) system when the valve is in the overlap region and the actuator is extending, depending on the ratio of the overlap lengths.

Combining this condition with small amplitude, low frequency computer generated commands while the aircraft is flying straight and level results in cylinder chamber pressure cycles in the resisting cylinder chamber approaching a 3000 lbf/in² (20 700 kPa) to 4500 lbf/in² (31 000 kPa) range while retracting and extending respectively. If the commands are continuous, even at low frequencies, a substantial number of high pressure cycles may be experienced in a short time even if there is virtually no load change.

- Minimize overlaps but specify overlap balance conditions if a low leakage is required.
- Insure, via very slow cycle looped cylinder pressure monitoring, that there is a good balance of pressure and return land overlaps if overlaps are substantial, i.e., that the cylinder pressure remains within an approximate $(P + R)/2 \pm 500$ lbf/in² (± 3500 kPa) range in the entire overlap region.
- It is important to know what the FCC is requiring the actuator to do.
- Minimize the frequency of small movement commands (system).

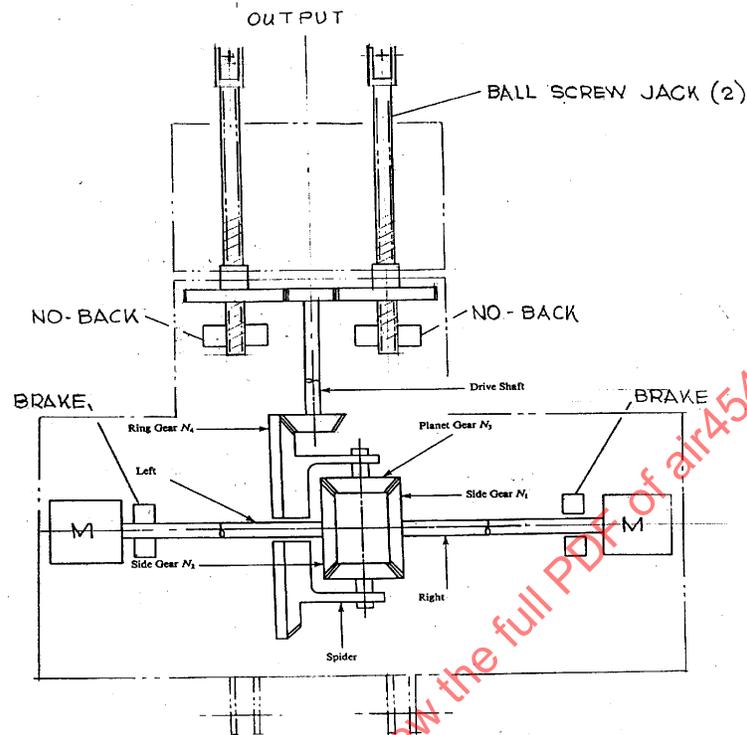
PROBLEM: Latent failures in the design of flight control components.

SOLUTION: Carefully examine the component or system for latent failures. If found, the best solution is simply to alter the design and eliminate the latent failure mode. The next best approach is to properly take into account the exposure of the latent failure mode in determining the actual system failure rate. Hopefully the resultant net failure rate is acceptable for the application being considered. If not, a redesign is in order. Alternately, a reduction in the exposure time of the latent mode may be an option.

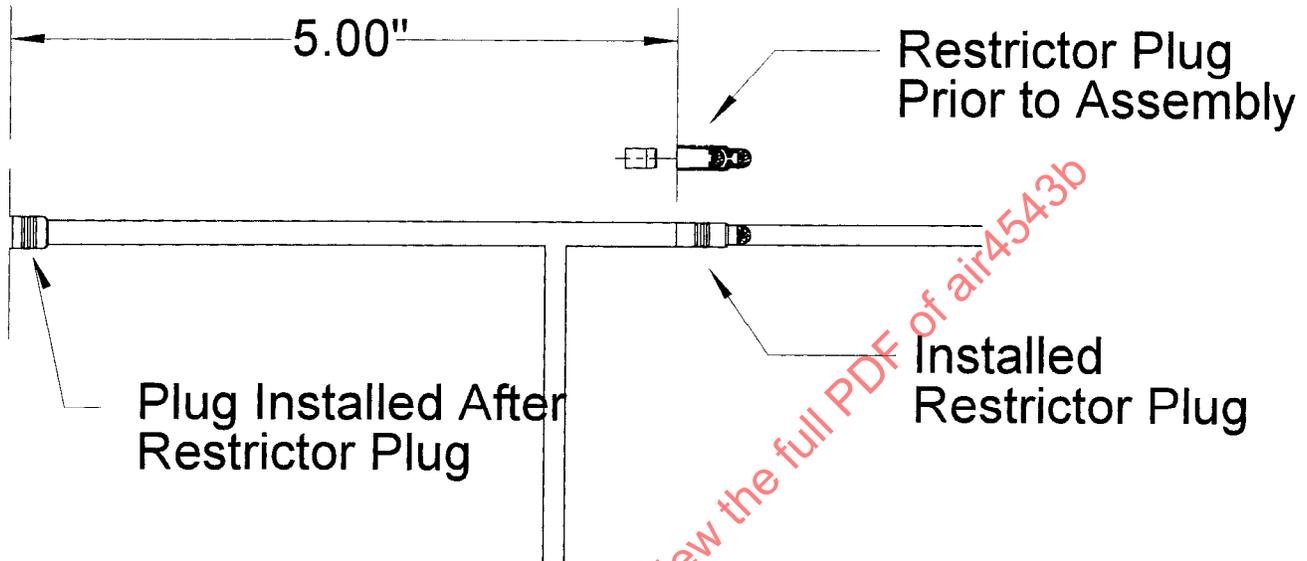
Small Diameter Orifices That Are Deeply Recessed Are Extremely Difficult To Remove

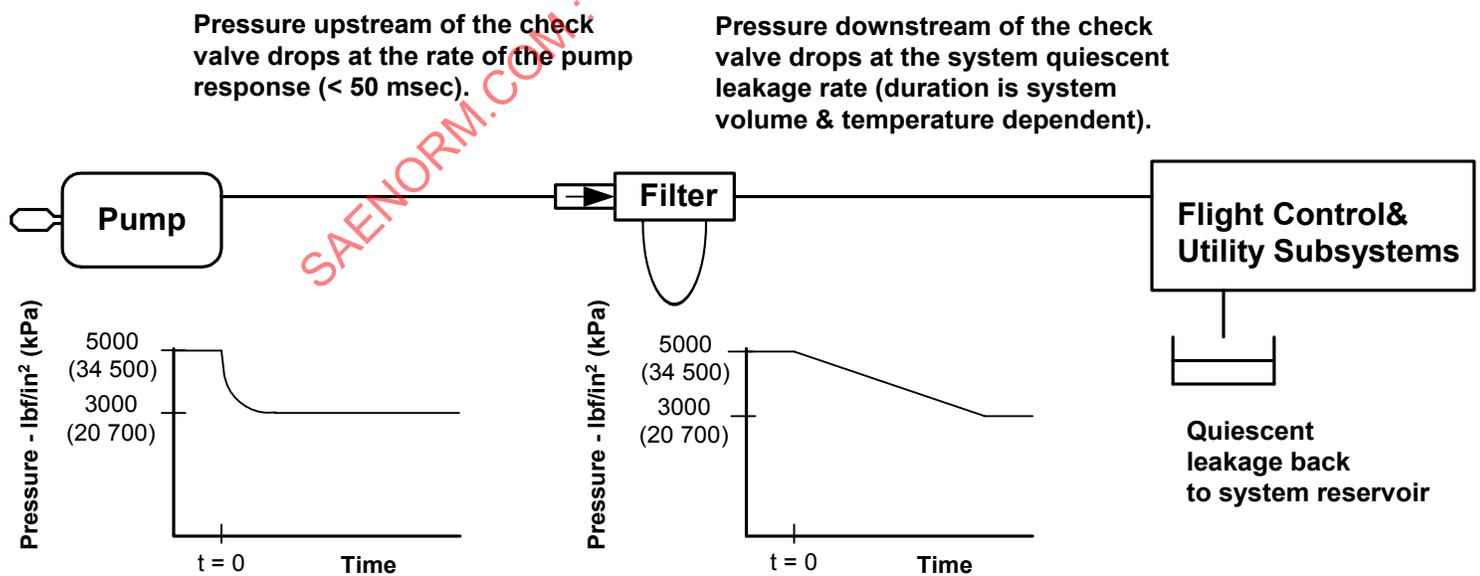
PROBLEM: Dual pressure pump unstable when switching pressure.

SOLUTION: Specify a dual pressure pump response rate, from high pressure to low pressure, which is slower than the system quiescent leakage rate.
