**Rolling bearings — Damage and failures — Terms, characteristics and causes**

# Rolling bearings — Damage and failures — Terms, characteristics and causes

This document classifies different modes of failure occurring in service for rolling bearings made of standard bearing steels. For each failure mode, it defines and describes the characteristics, appearance and possible root causes of failure. It will assist in the identification of failure modes based on appearance.

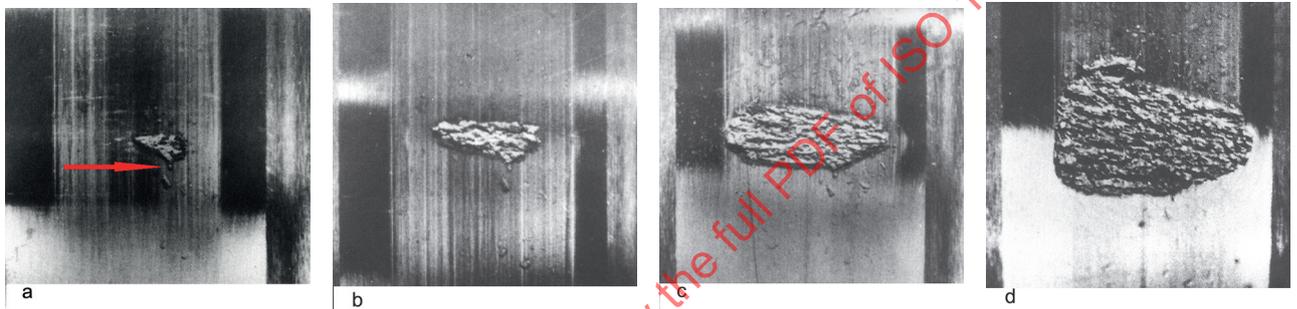
**Figure 1 — Progression of bearing damage**

**NOTE** The spall started just behind the dent in the raceway [a)]. Over a period of time, the spalling becomes more severe [b) and c)]. If not stopped in time, the proof of the root cause disappears [d)].

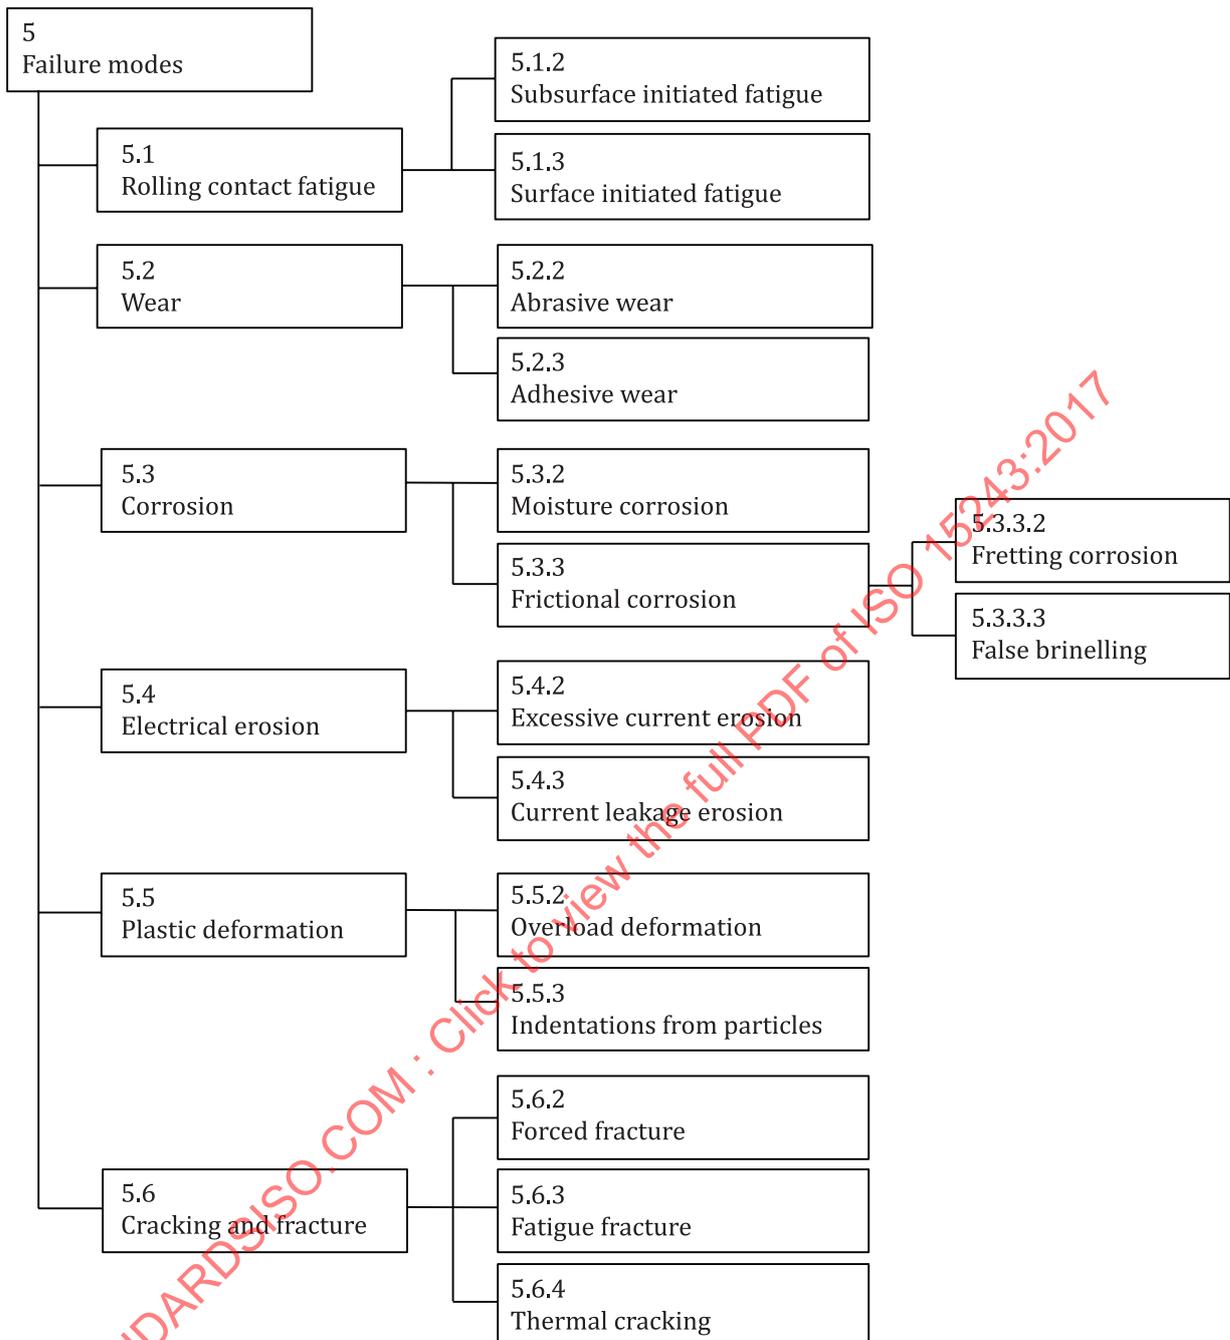
Figure 2 — Classification of failure modes

Preferably, one would classify rolling bearing damage and failures according to the root cause. However, it is often not easy to distinguish between causes and characteristics (symptoms) or, in other words, between failure mechanisms and failure modes. The large number of articles and books written on the subject confirms this (see Bibliography). Therefore, in this document, failure modes are classified in six main groups and various sub-groups (see [Figure 2](#)), based on their visible distinctive characteristic appearance in service.

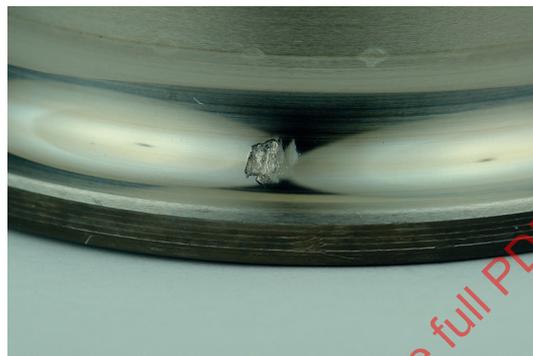
Figure 3 — Initial subsurface spalling in a deep groove ball bearing — Rotating inner ring

The changes might appear at metallurgical investigation (see [A.3](#)). These cracks propagate and when they come to the surface, spalling occurs (see [Figures 3](#) and [4](#)).

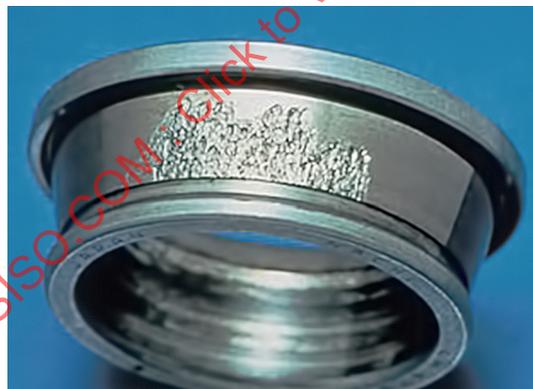
Figure 4 — Advanced subsurface spalling in a tapered roller bearing — Stationary inner ring

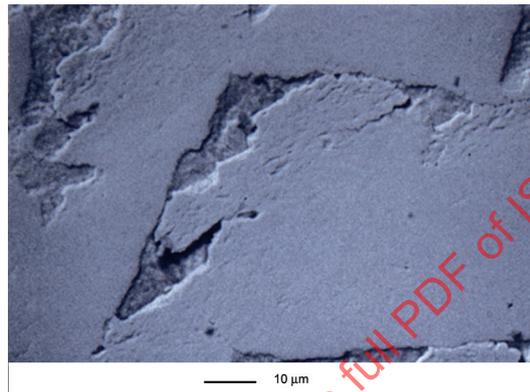
Figure 5 — Asperity microcracks and microspalls on a raceway

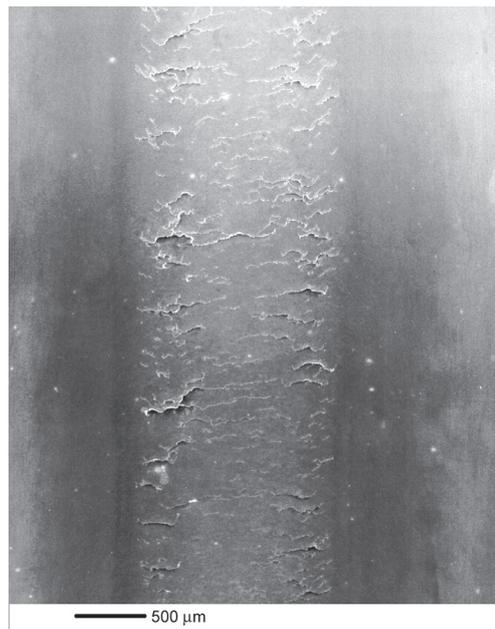
Figure 7 — Microspalled areas on a raceway

— microspalled areas (grey stained) (see [Figure 7](#)).

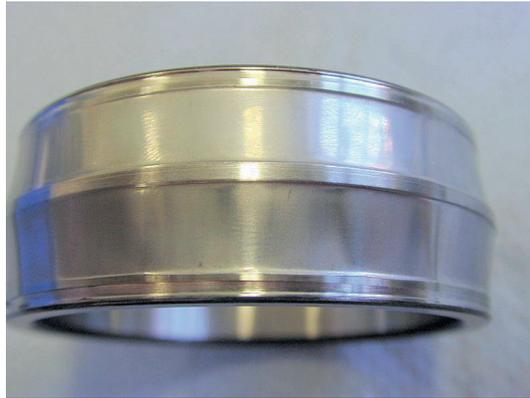
Figure 8 — Abrasive wear on the inner ring of a spherical roller bearing

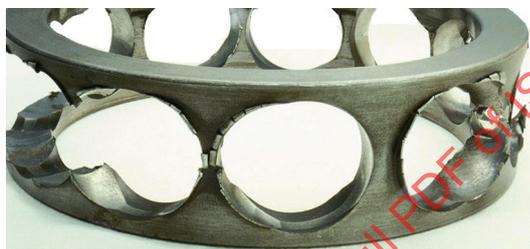
Figure 9 — Advanced abrasive wear on the cage pockets of a solid metal cage

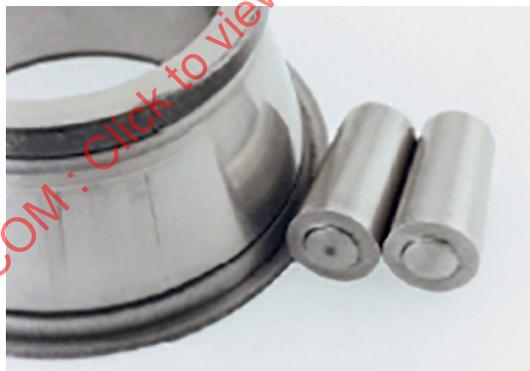
Figure 10 — Abrasive wear on the raceway of the large rib surface of the inner ring and on the large end face of rollers in a tapered roller bearing

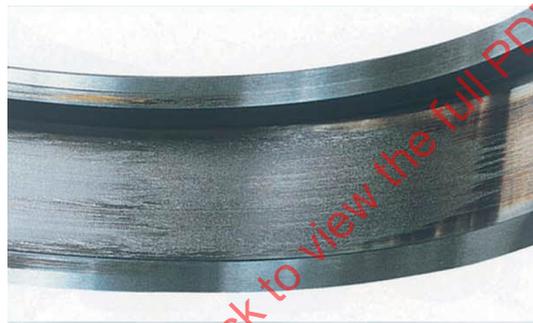
Figure 11 — Smearing on the outer ring raceway of a cylindrical roller bearing

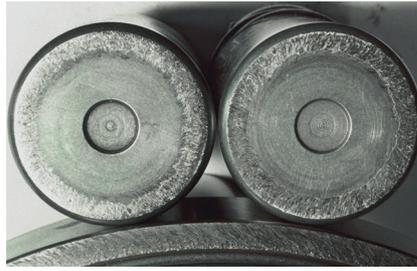
Figure 13 — Smearing on the side face of rollers of a cylindrical roller bearing

Smearing can also occur on the rib faces and on the ends of the rollers due to inadequate lubrication (see [Figure 13](#)). In full complement (cageless) bearings, smearing can also occur in the contacts between rolling elements, depending on lubrication and rotation conditions.

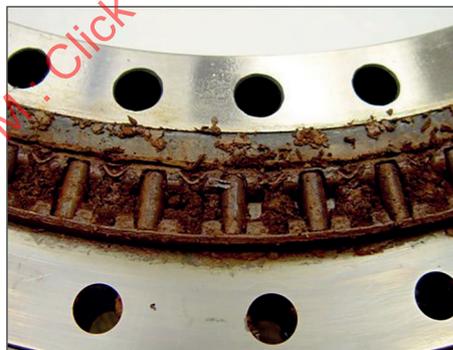
Figure 14 — Moisture corrosion on the cage and rollers of a needle roller thrust bearing

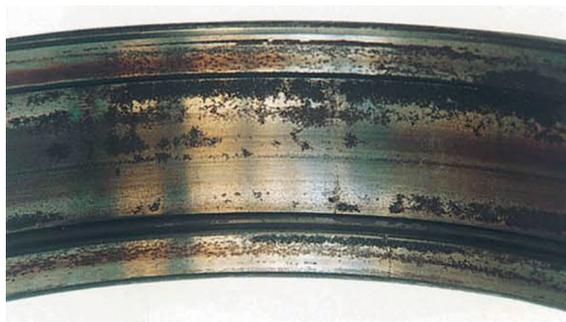
Figure 15 — Moisture corrosion on the outer ring raceway of a cylindrical roller bearing

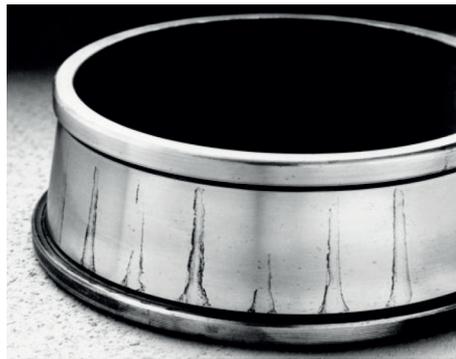
Figure 16 — Contact corrosion at roller pitch on the inner ring raceway of a tapered roller bearing

A specific form of moisture corrosion can be observed in the contact areas between rolling elements and bearing rings where the water content in the lubricant or the degraded lubricant reacts with the surfaces of the adjacent bearing elements. During static periods, the advanced stage will result in dark discolouration of the contact areas at intervals corresponding to the ball/roller pitch (see [Figure 16](#)); eventually producing corrosion pits.

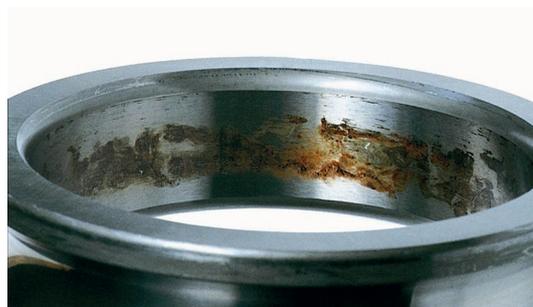
Figure 17 — Fretting corrosion in the inner ring bore of a deep groove ball bearing

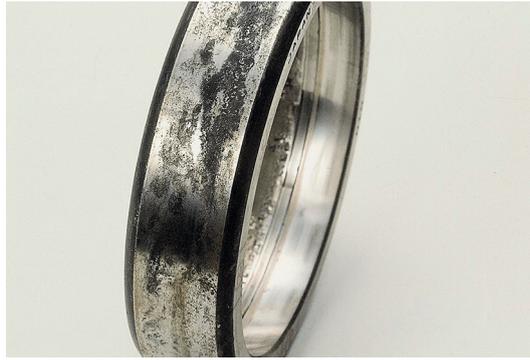
**Figure 18 — Fretting corrosion on the outer diameter of a roller bearing**

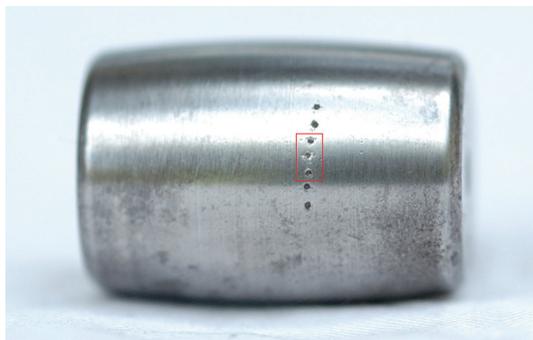
Figure 21 — Roller of a spherical roller bearing — Craters formed by the passage of excessive electric current

This damage (electrical pitting) may appear as a series of craters with diameters of up to 500  $\mu\text{m}$  (see [Figures 21](#) and [22](#)). The craters are duplicated on the rolling element and raceway contact surfaces, typically in bead-like procession in the rolling direction (see [Figure 21](#)).

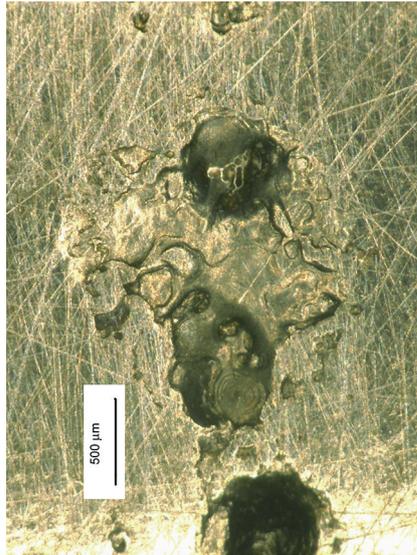
Figure 22 — Enlargement of [Figure 21](#) showing craters and molten material

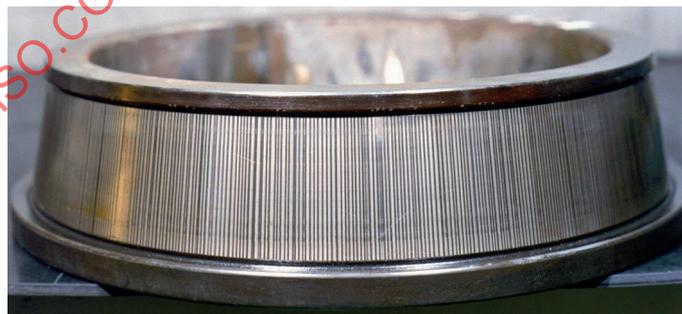
Figure 23 — Fluting (washboarding) as a result of current leakage on the inner ring raceway of a tapered roller bearing

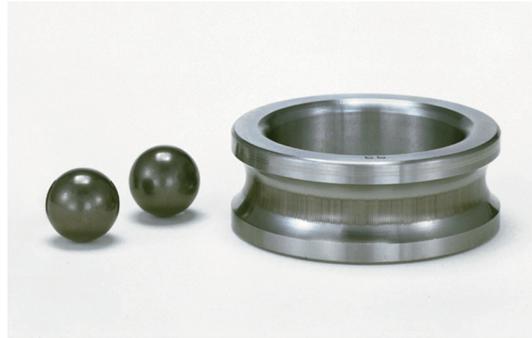
Figure 24 — Fluting on the inner ring raceway and matt dark grey coloured balls of a deep groove ball bearing

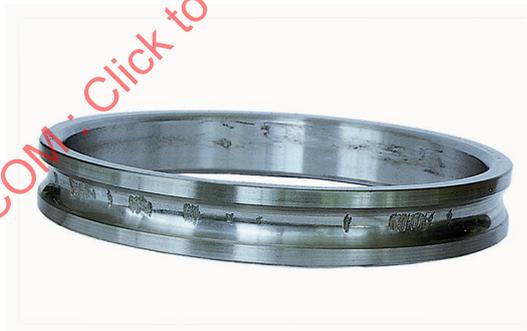
**Figure 27 — Spalling as a result of shock load deformation on the inner ring raceway of an angular contact ball bearing, resulting from impacts in radial direction, which further developed in spalling**

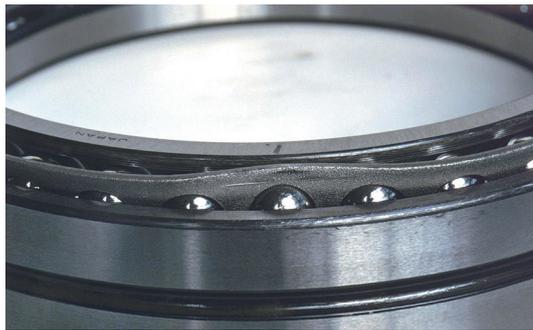
**Figure 28 — Cage deformation of an angular contact ball bearing caused by a shock load during handling**

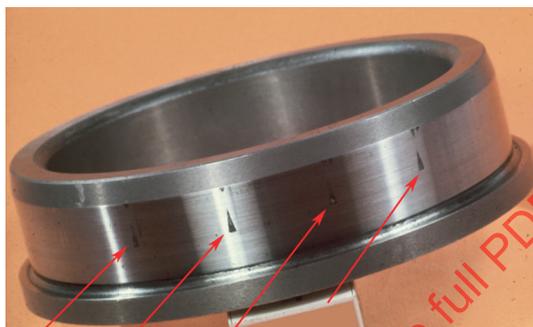
**Figure 29 — Indentations on the inner ring raceway of a cylindrical roller bearing caused by incorrect assembly**

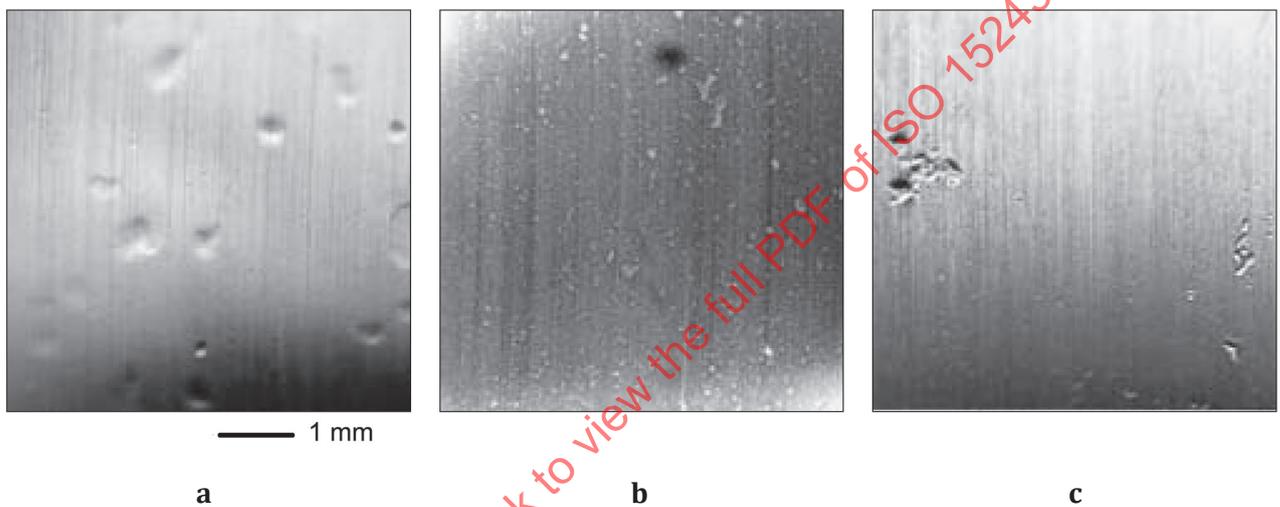
Figure 32 — Enlargements of indentations on raceways resulting from over-rolled particles

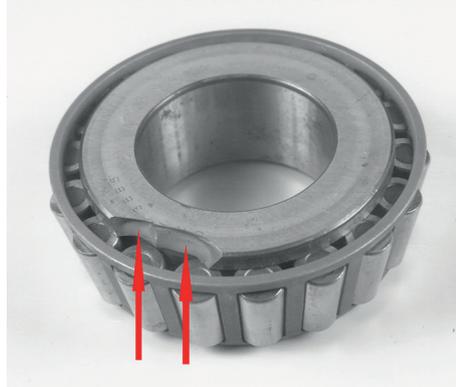
**Figure 33 — Forced fracture of a tapered roller bearing inner ring shoulder, caused by an impact load during assembly procedures**

Forced fracture is due to a stress concentration in excess of the material (tensile) strength and is caused by local over-stressing, e.g. from impact (see [Figure 33](#)), or by over-stressing due to an excessive interference fit, e.g. too high hoop stress (see [Figure 34](#)).

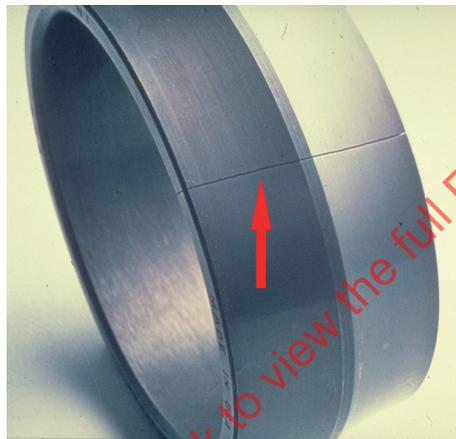
NOTE Fracture caused by an excessive interference fit during mounting, for example, by driving a tapered bore inner ring too far up the shaft taper.

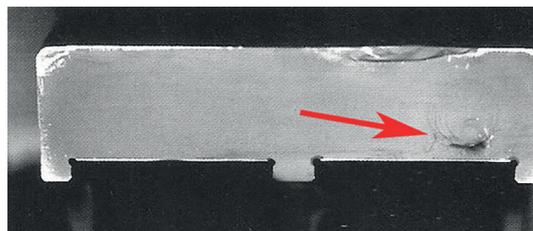
NOTE The origination of fracture is near the right raceway, centred in the characteristic sea shell signature left by a progressing fatigue crack (the damage above the outside surface is secondary and occurred when the ring fractured).

**Figure 35 — Section of fatigue fracture of a cam roller outer ring caused by bending**

Frequent exceeding of the fatigue strength limit under bending, tension or torsion conditions results in fatigue cracking. A crack is initiated at a stress raiser and propagates in steps over a part of the component cross-section, ultimately resulting in a forced fracture. Fatigue fracture occurs mainly on rings (see [Figure 35](#)) and cages (see [Figure 36](#)).

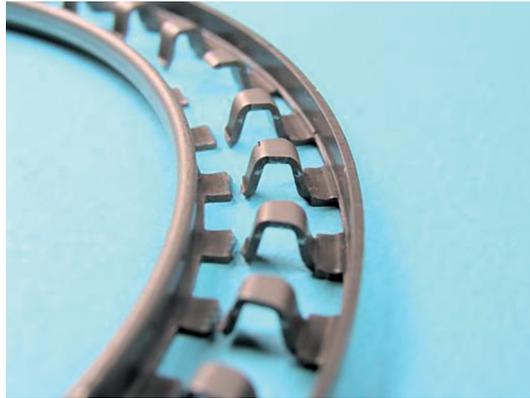
Figure 36 — Fatigue fracture of cage bars of a needle roller thrust bearing

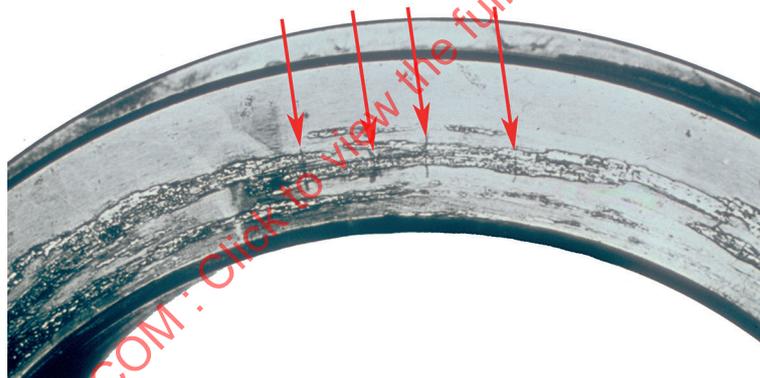
Figure 37 — Thermal cracks on the small end of the inner ring of a tapered roller bearing

Thermal cracking (heat cracking) is caused by high frictional heating due to sliding motion. Cracks usually appear at right angles to the direction of sliding (see [Figure 37](#)). Hardened steel components are generally sensitive to thermal cracking due to local rehardening of the surfaces in combination with the development of high residual tensile stress.

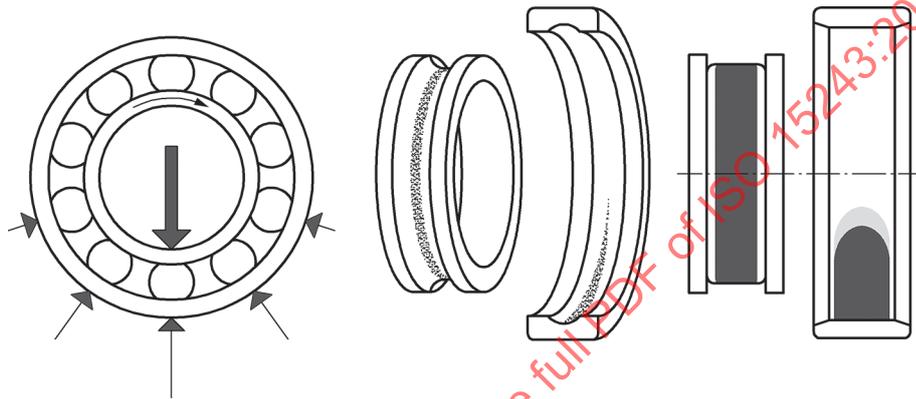
**Inner ring:** Running path pattern uniform in width, positioned in the middle of the raceway and extending around its entire circumference.

**Figure A.1 — Uni-directional radial load — Rotating inner ring — Stationary outer ring**

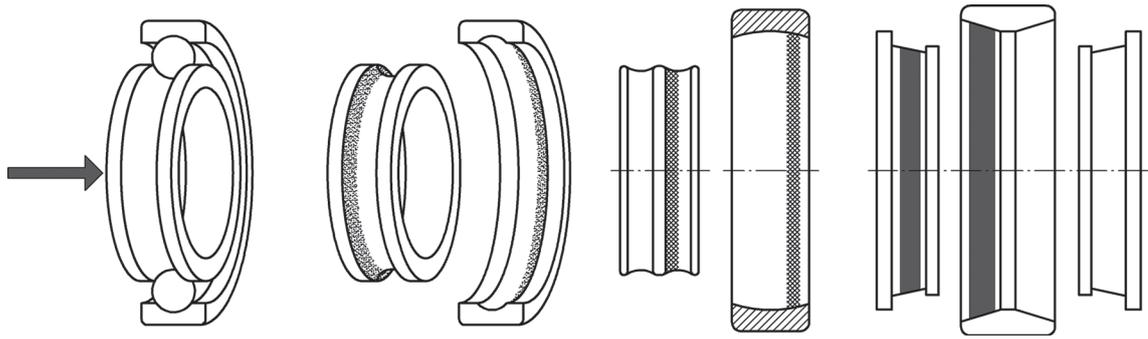
**Inner and outer rings:** Running path pattern uniform in width, axially displaced and may, or may not, extend around the entire circumference of the raceways of both rings.

**Figure A.4 — Uni-directional axial load — Rotating inner ring and/or outer ring**

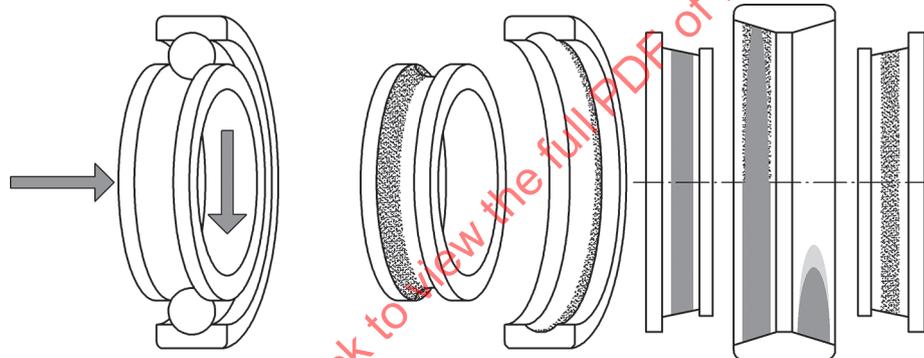
**Inner ring:** Running path pattern uniform in width, extending around the entire circumference of the raceway and axially displaced.

**Figure A.5 — Combination of uni-directional radial and axial load — Rotating inner ring — Stationary outer ring**

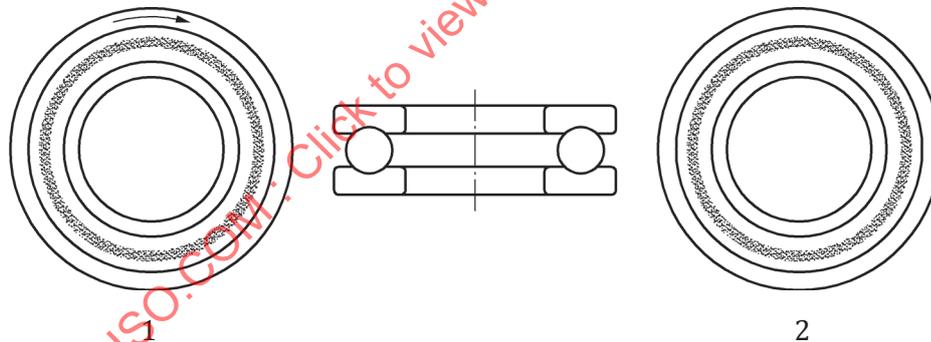
Figure A.9 — Uni-directional axial load — Rotating shaft washer — Stationary housing washer

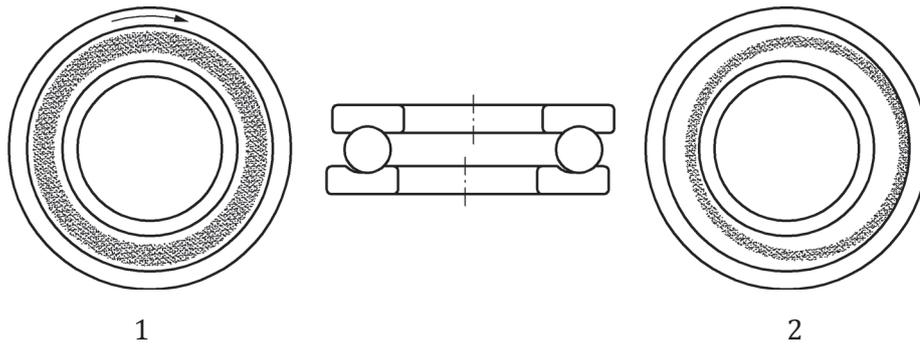
**Figure A.10 — Uni-directional axial load on eccentrically positioned housing washer relative to shaft washer — Rotating shaft washer — Stationary housing washer**

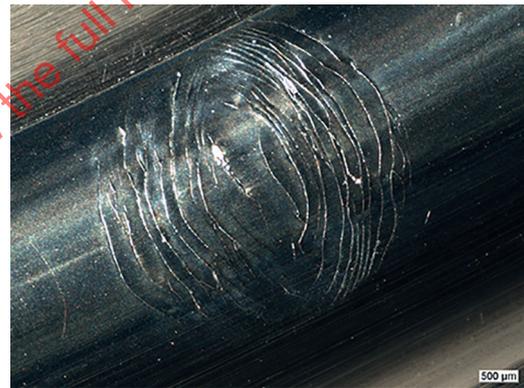
##### A.2.2.1.2 Spalling in an early stage on the outer ring raceway of an angular contact ball bearing

— Use a bearing with higher load-carrying capacity.

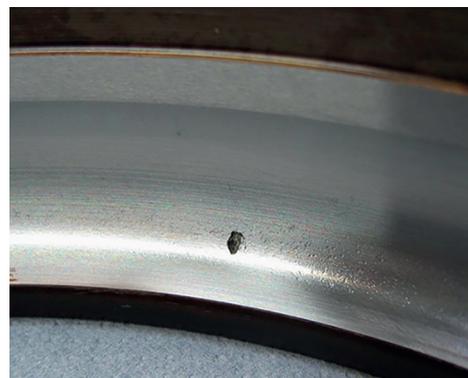
**A.2.2.1.3 Spalling in a more advanced stage on an outer ring raceway of an angular contact ball bearing**

- Use a bearing with higher load-carrying capacity.

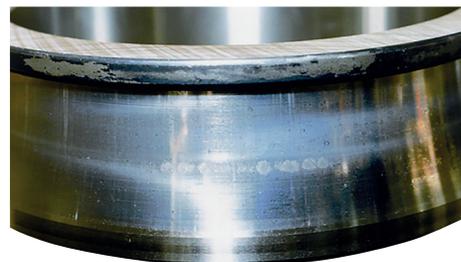
**A.2.2.2.2 Surface initiated fatigue on the inner ring raceway of a tapered roller bearing****Cause of failure**

- Improve lubrication.
- Apply correct preload.
- Ensure alignment.

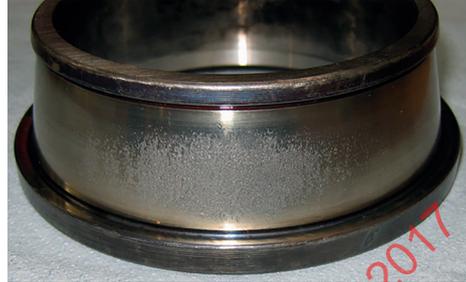
**A.2.2.2.3 Surface initiated fatigue on roller raceways of a needle roller bearing****Cause of failure**

- Improve lubrication.
- Realign the shaft and/or housings.

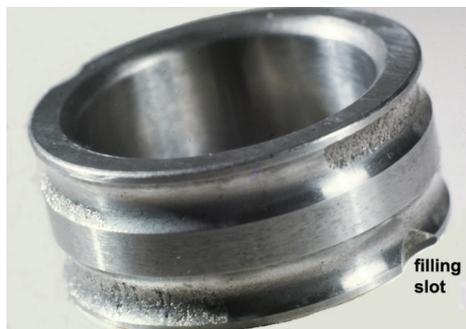
**A.2.2.2.5 Spalling on the inner ring raceway of an angular contact ball bearing**

- Improve the sealing.
- Review the lubrication for the operating conditions.

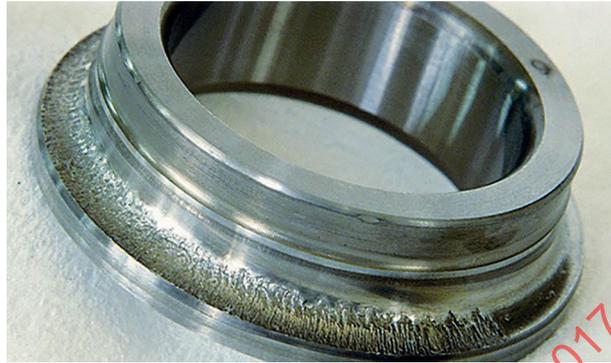
**A.2.2.2.6 Spalling (peeling) on the inner ring raceways of a tapered roller bearing**

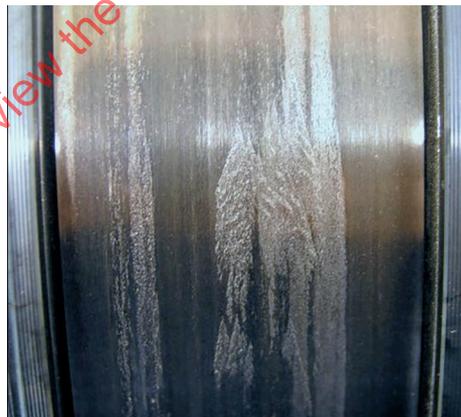
**A.2.3.2.2 Smearing on the large end face of a tapered roller**

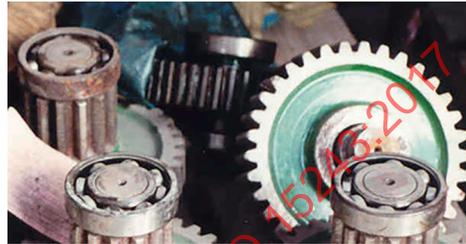
#### A.2.4.1.2 Corrosion, hand perspiration (fingerprint)

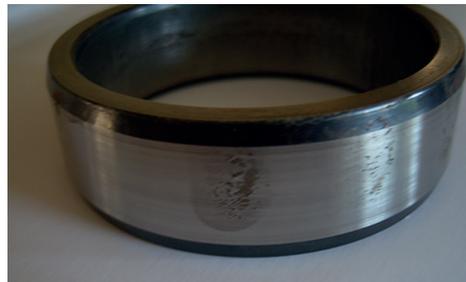
#### A.2.4.1.3 Contact corrosion on the inner ring raceway of an angular contact ball bearing

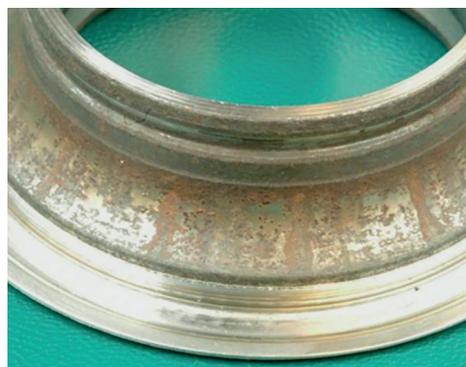
**A.2.4.1.4 Contact corrosion on the inner ring raceway of a tapered roller bearing, spacing equivalent to roller pitch**

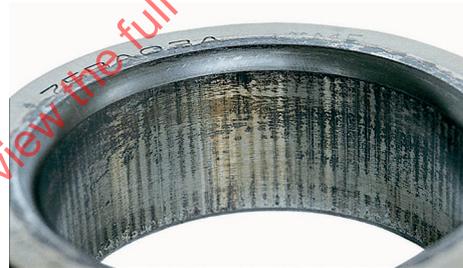
**A.2.4.2.2 Fretting corrosion on the inner ring bore of a ball bearing**

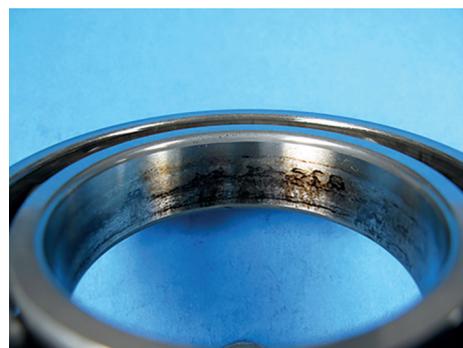
#### A.2.4.2.3 Fretting corrosion on the outside diameter of a spherical roller bearing

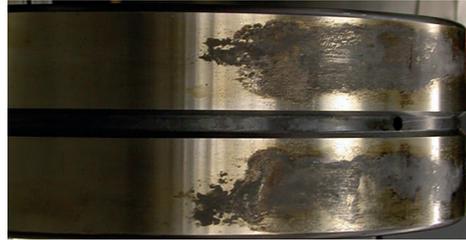
#### A.2.4.2.4 Fretting corrosion on the outside diameter of a deep groove ball bearing

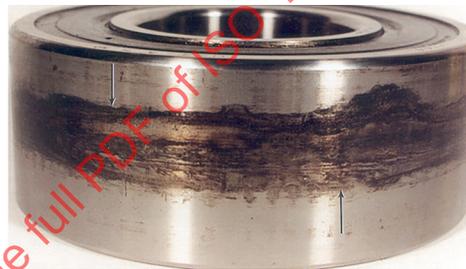
#### A.2.4.2.5 Fretting corrosion on the face of a deep groove ball bearing

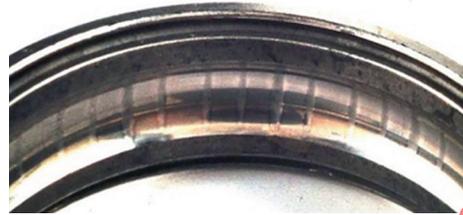
**A.2.4.3.2 False brinelling on the inner ring raceway of a deep groove ball bearing**

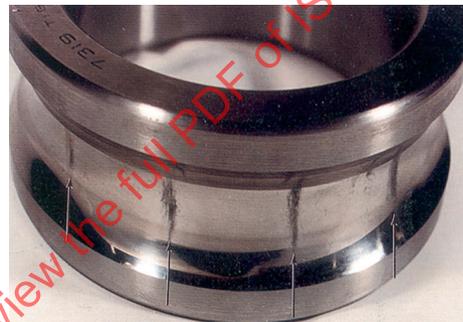
**A.2.4.3.3 False brinelling on the inner ring raceway of a needle roller bearing — Standby equipment**

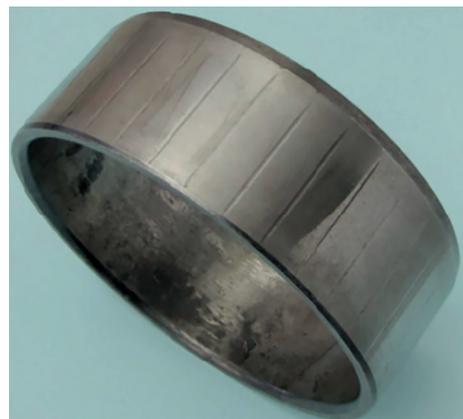
#### A.2.4.3.4 False brinelling on the outer ring raceway of a cylindrical roller bearing

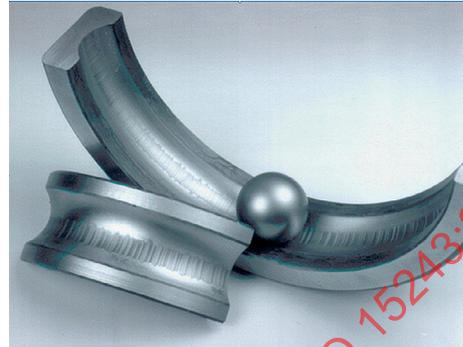
#### A.2.5.2.2 Fluting due to current leakage erosion on the inner ring raceway and rollers of a cylindrical roller bearing
