**Vitreous and porcelain enamels —
Glass-lined apparatus for process
plants —**

**Part 5:
Presentation and characterization of
defects**

Vitreous and porcelain enamels — Glass-lined apparatus for process plants —

Part 5: Presentation and characterization of defects

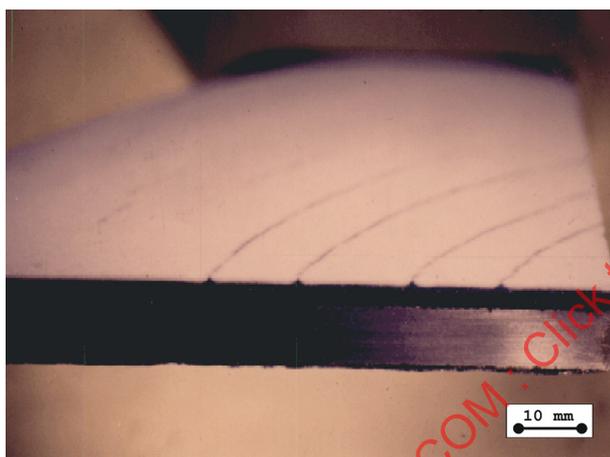
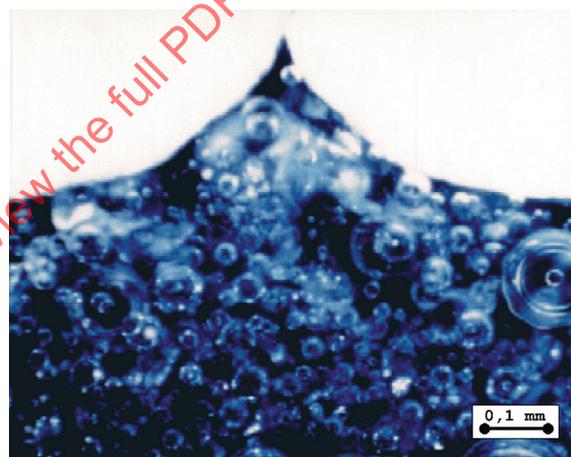
Figure 1 — Strain lines

Strain lines are lines that are always dark and running parallel, or concentrically in the usually blue or white glass cover coat (see Figure 1). In a severe case of strain lines, a number of bubbles or blisters in a single line can appear, forming a pearl line (4.1.4).

a) White cover coat with macroscopically detectable strain lines

b) Lateral view, white cover coat exploring leapt up dark ground coat

Strain lines arise during enamelling due to thermally or mechanically induced stress in the component. When heating up, the ground coat and the covering bisque cracks open. During firing, parts of the ground coat penetrate into the cover coat.

- a wrong combination of steel/ground coat/cover coat;
- weld seam made from non-suitable filler material;
- mixing zones in the weld metal;
- non-adapted temperature control during enamelling of constructively unfavourable components, e.g. components showing mass accumulation;

— plastic deformation of the component during enamelling.

Non-reparable enamelling defect.

Re-enamelling, taking into consideration the causes mentioned in [4.1.2.3](#).

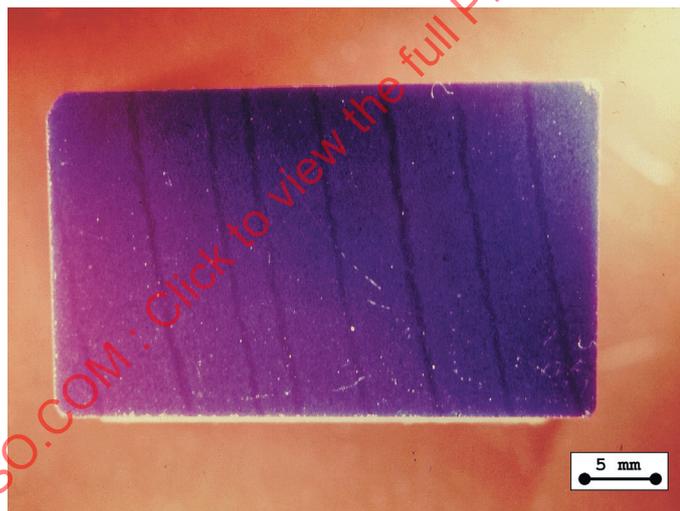
Figure 2 — Tearings

Tearings are mostly dark lines, running parallel or concentrically in the cover coat, i.e. lines that are always dark in blue enamel and either dark or light and transparent in white enamel. In contradiction to pearl lines (see [4.1.4](#)), the lines do not show large blisters and are closely related to strain lines (see [4.1.2](#)). Unlike strain lines, however, these lines are recessed (see [Figure 2](#)).

Tearings arise during enamelling due to thermally or mechanically induced stress in the component. When heating up, the enamel bisque and/or the enamel coating crack(s) open. These cracks merge again during firing. If only the cover coat is affected, dark lines appear. If the crack runs through to the metal surface, blisters in the form of pearl lines also (see [4.1.4](#)) arise along the crack (for causes, see [4.1.2.3](#)).

Non-reparable enamelling defect. As, without carrying out destructive testing, it cannot be determined whether parts of the ground coat leap up, toleration is generally not possible for safety reasons.

Re-enamelling, taking into consideration the causes mentioned in [4.1.3.3](#).

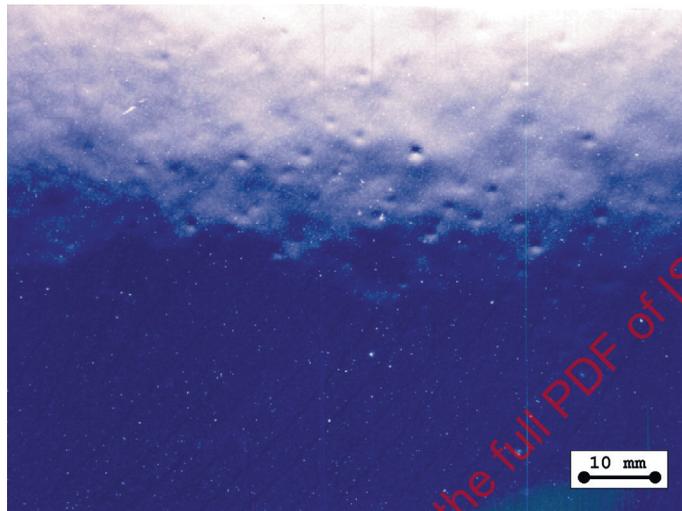
Pearl lines are blisters lying behind each other in a line, often combined with strain lines (see [4.1.1](#)) or tearings (see [4.1.2](#) and [Figure 3](#)).

Figure 3 — Pearl lines, i.e. series of blisters in line, in zones showing strain lines (see [4.1.2](#))

Pearl lines arise during enamelling due to thermally or mechanically induced restraints in the component. When heating up, the enamel bisque and the enamel coating crack open through to the steel. During firing, the metal oxidizes, a process accompanied by gas-forming reactions in the boundary layer. The lines run to form strain lines (see [4.1.2](#)), along which blisters and pores are positioned as if on a string of beads (for causes, see [4.1.2.3](#)).

Non-reparable defect.

Re-enamelling, taking into consideration the causes mentioned in [4.1.4.3](#).

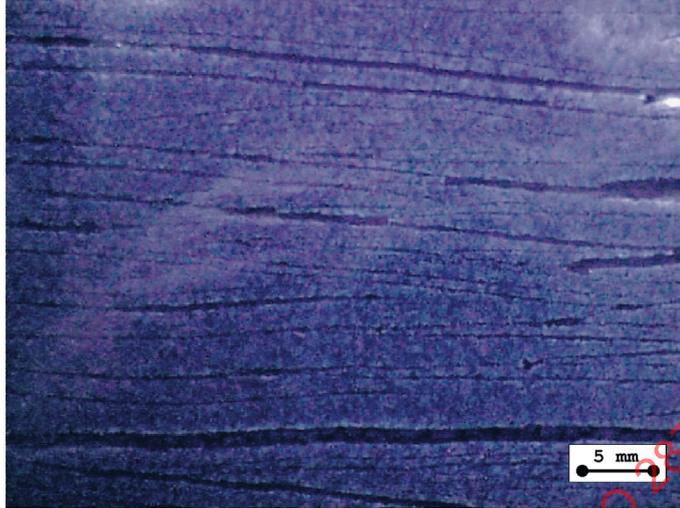
Shore lines are a group of parallel or nearly parallel lines appearing as a deviation in colour (darker in blue enamel and more transparent in white enamel). These lines, that are usually a few millimetres wide and at least one centimetre long, can be positioned anywhere on the enamel surface (see [Figure 4](#)).

Shore lines are usually wider than strain lines (see [4.1.2](#)), due to a greater width and irregular edges in the longitudinal direction.

Figure 4 — Dark blue shore lines on a blue enamel surface

Following the drying of the bisque, the smaller enamel particles concentrate on the surface and form a thin and lighter-coloured upper layer following enamelling. Therefore, the defects of this layer appear darker. In order to remove dust before firing, the enamel bisque is cleaned by means of a hand broom. If, in doing so, the surface of the bisque is slightly damaged, these scratch marks appear as dark lines following firing.

Shore lines are a colour defect and affect neither the resistance nor the mechanical strength negatively.

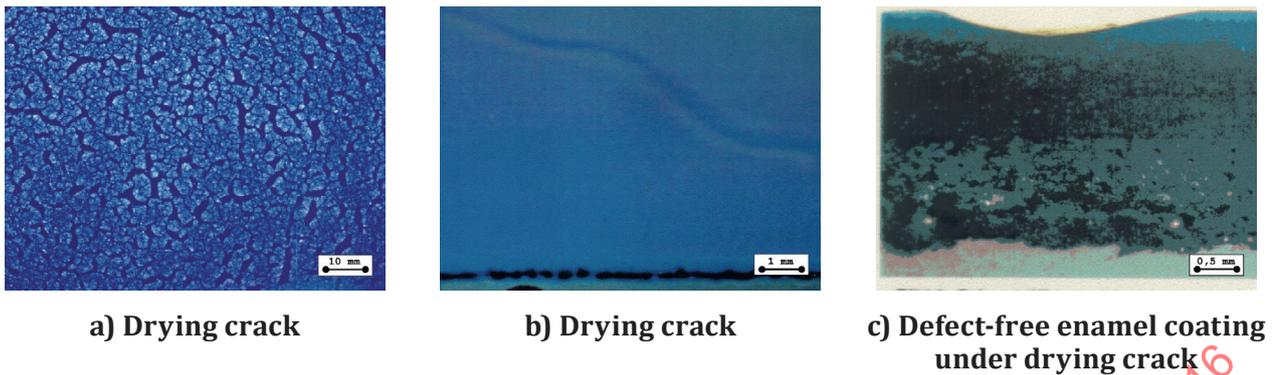
Drying cracks are wide and often netlike lines in the enamel, that are in most cases slightly recessed. Typical of these defects is the irregular, wound course of the lines. In the line itself, usually no blisters appear in the enamel. In the areas of mass accumulations of the steel, the lines can also be arranged orderly, similar to strain lines (see [4.1.2](#)). The overall irregular course, however, stays unchanged. The enamel coating under drying cracks is usually free of defects (see [Figure 5](#)).

Figure 5 — Drying cracks of different distinctness, as well as with underlying defect-free enamel coating

As a result of cracks in the enamel bisque, in the respective areas the enamel cannot merge to form a homogeneous coating during firing. The underlying enamel layer, that is mostly darker, becomes visible. Due to the contraction of the liquid enamel, the edges are in most cases slightly raised and have a higher proportion of fine blisters, visible in the form of a lighter colour. Unlike strain lines (see 4.1.2), drying cracks are not caused by construction. There are four major causes for the origin of these lines:

- knocking of the coated component before firing;
- firing of an incompletely dried bisque;
- unfavourable bisque structure of the applied enamel slip layer, due to application mistakes;
- intensive mechanical damage to the bisque.

Drying cracks are classified by their degree of distinctness. If they are only slightly distinct, they are surface features which affect neither the chemical resistance nor the mechanical strength: at the deepest points of the line, the agreed minimum coating thickness is maintained, and there are no large blisters to be seen at the edges of the lines. The defect may be kept unremedied. In the case of more distinct defects, those which extend over large areas, blisters in the edges or an intensive brightening of the enamel, the defect is a non-reparable enamelling defect.

In the case of distinct defects, repair by grinding and subsequent refiring.

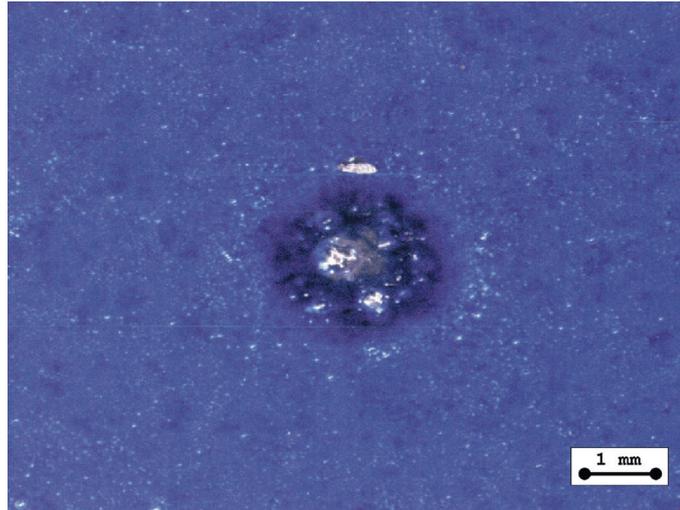
Figure 6 — Boiling defect

A boiling defect is a dark, greenish spot on the surface of the enamel, possibly combined with a small depression (see Figure 6).

A large blister in the ground coat rises to the surface of the enamel and draws the ground coat up behind it. The blister opens and partly or completely merges again. The ground coat lays punctiformly exposed in the otherwise intact enamel coating. In most cases, the reason for the gas-forming reaction is a contamination of the steel surface or an insufficient adaptation between the surface tension of the ground coating and that of the cover coat.

Reparable defect.

Insertion of a tantalum plug, if admissible, or refiring.

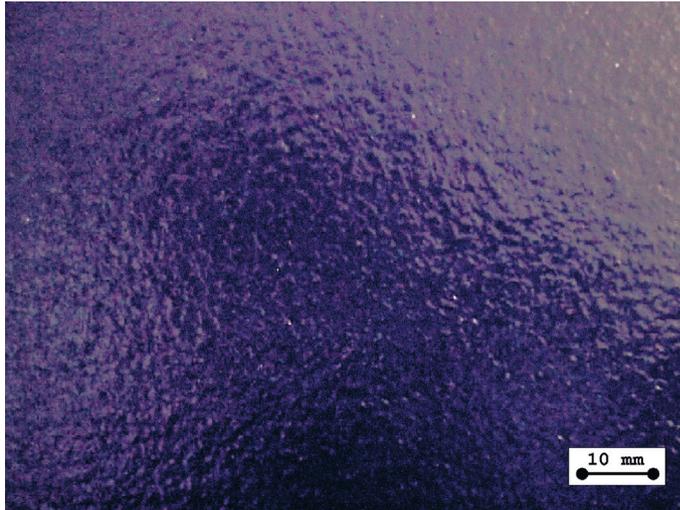
Underfired surfaces are rough, not smoothly fused areas in the cover coat affecting parts of the component (e.g. at mass accumulations, at the contact surfaces, at the collar) or the whole component (see [Figure 7](#)). Macroscopically rough, inadequately fused areas can easily be confounded with devitrified microscopically rough areas (see [4.3.2](#) and [Figure 8](#)).

Figure 7 — Rough enamel surface, caused by inadequately fused enamel with a glossy surface

As a result of too low a firing temperature and/or too short a soaking time, the enamel is not fused completely.

Non-reparable enamelling defect.

Refiring.

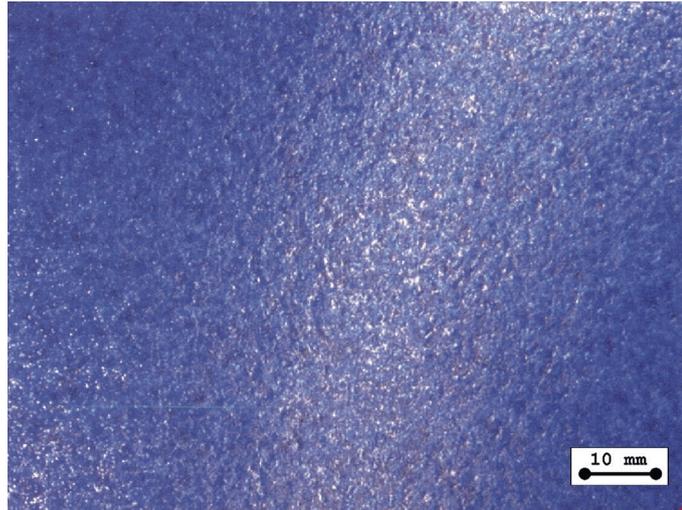
Eggshell enamel are areas in the cover coat affecting parts of or the whole component and appearing not to be smoothly fused. In these areas, the enamel is only slightly glossy. Possibly, the surface can be felt to be clearly rough. In these areas, the enamel can be of a lighter colour. This defect occurs only in glass enamel (see [Figure 8](#)).

Figure 8 — Eggshell or crystallized enamel with a matt and rough surface

The defect is caused by semi-crystallization. Causes promoting crystallization can be the following:

- too high a number of cycles;
- too long a holding time in the kiln at crystallization temperature, thus too long a period of nucleation and/or crystal growth;
- the composition of the enamel;
- contaminations in the enamel;
- surface crystallization by dust;
- poorly fused frit;
- an application mistake.

Non-reparable enamelling defect.

Refiring or re-enamelling.

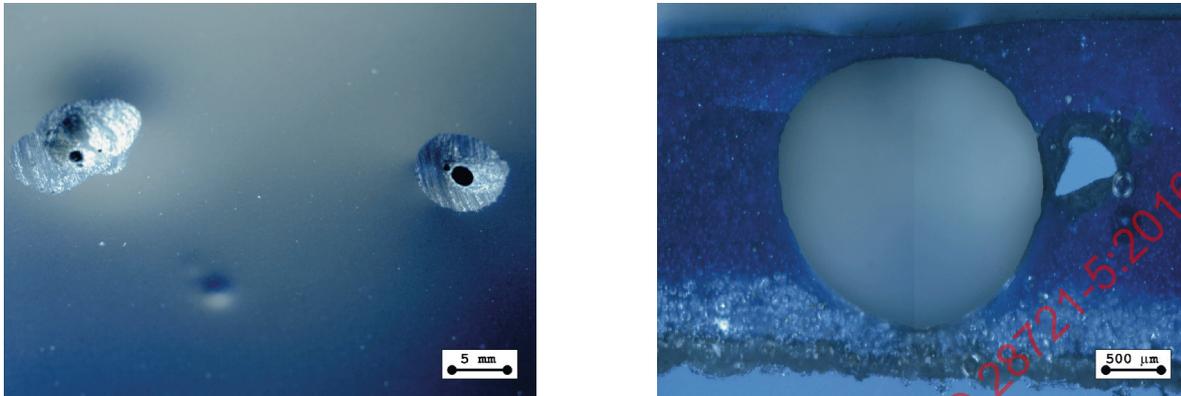
Figure 9 — Closed dimples

A dimple is a more or less recessed dent with underlying closed blister, or funnel-shaped indentation with underlying open blister. At these points, no discharge can be detected in the high-voltage test (see [Figure 9](#)).

a) Three closed dimples, two of which are ground b) Cross-grinding, showing the cause of the dimple (metal particles, here glossy white)

This defect can be ascribed to a local, strongly gas-forming reaction. The reasons for these reactions are various; it is possible that parts of the ground coat have been drawn up with a blister (see also [4.2](#)).

Reparable enamelling defect, if admissible.

Grinding or polishing, insertion of a tantalum plug, if admissible, or refiring with local application.

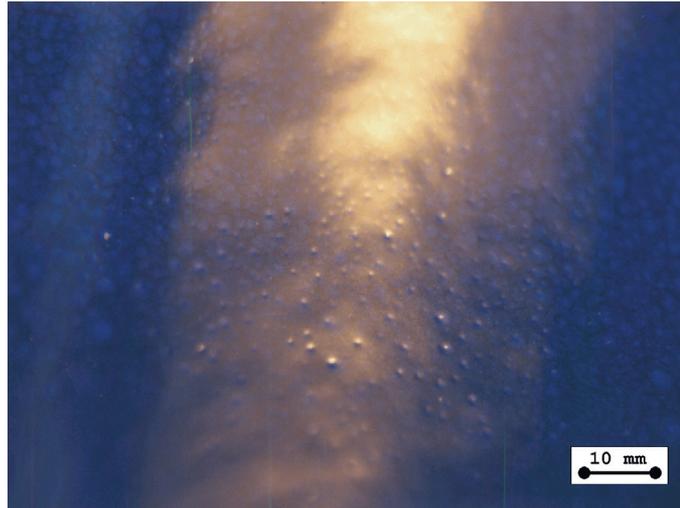
Pinholes are fine, pinhole-like indentations in the mostly smooth enamel surface. Pinholes can occur individually or in groups (see [Figure 10](#)).

Figure 10 — Pinholes, small crater-shaped indentations in the cover coat

Pinholes are the results of gas emissions occurring during the final firing of the cover coat. When cooling down, the blisters contract, resulting in pinhole-like indentations.

- a closed firing atmosphere;
- a thick enamel application;
- enamel slip that had been stored for too long (excessive addition of electrolytic salts due to loss of set of aged enamel slurry);
- applied slip that had been insufficiently dried;
- surface contaminations.

Surface defect opposed to the generally required smooth surface. The chemical resistance and the mechanical properties are not affected negatively, as long as the minimum coating thickness is maintained.

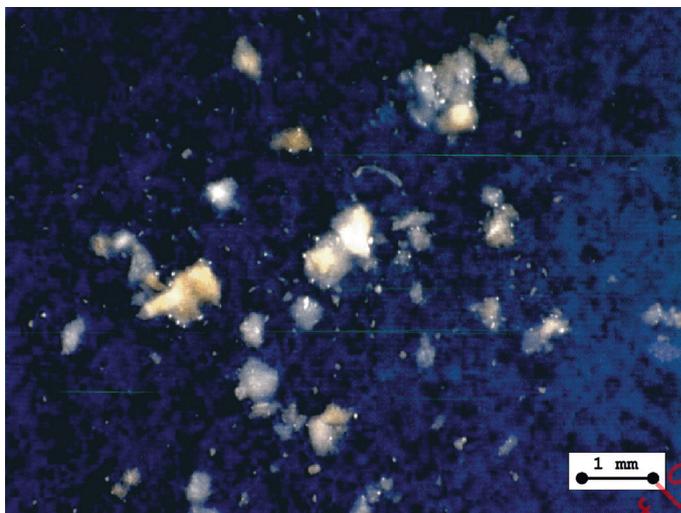
Chamotte, or refractory clay particles, are small white or yellow particles, about 1 mm long or less, that have superficially merged into the enamel surface (see [Figure 11](#)).

Figure 11 — Refractory clay particles in an enamel surface

Refractory clay particles originate from the refractory material of the fusing or enamelling kilns. During the firing of the enamel, they merge into the surface.

Reparable enamelling defect.

Grinding and polishing in order to remove larger particles. Dust-fine contaminations on the surface may be accepted in accordance with ISO 28721-1.

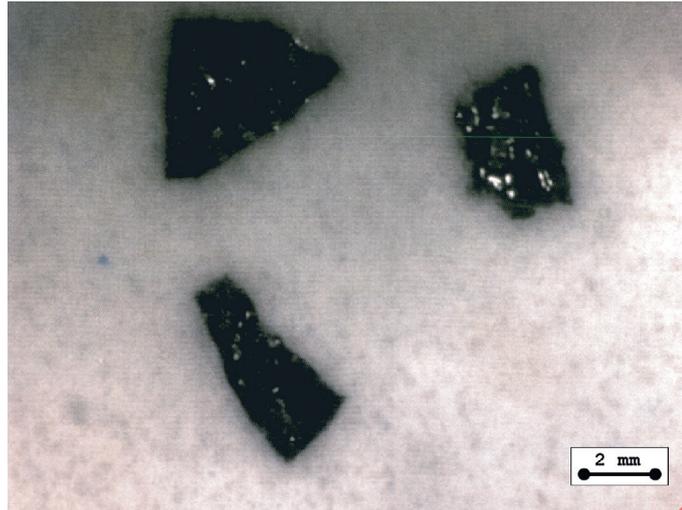
Scale particles are small black, sharp-edged discs of ferrous oxides merged into the enamel surface. The discs can be oriented parallel or not parallel to the enamel surface (see [Figure 12](#)).

Figure 12 — Scale particles in an enamel surface

Scale particles are contaminations in the firing chamber. When the kiln is opened, these particles are swirled due to convection, fall down onto the component and get stuck on the enamel. Primarily, this enamelling defect occurs in the vicinity of the large container openings.

Reparable enamelling defect.

In accordance with ISO 28721-1, or refiring with local application.

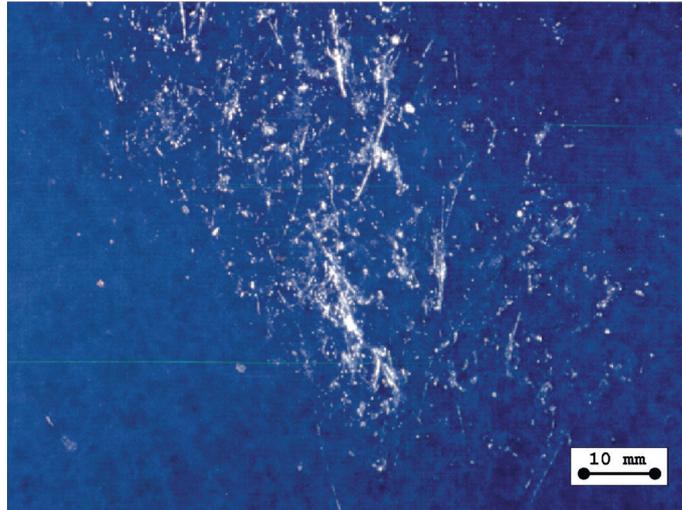
Ceramic fibres are thin white fibres, merged into the surface of the enamel (see [Figure 13](#)).

Figure 13 — Ceramic fibres in an enamel surface

Ceramic fibres are part of the insulating material of the enamelling kilns and occur loosely scattered in the firing chamber in the form of contaminations. During enamel firing, they can merge into the surface.

Reparable enamelling defect.

In accordance with ISO 28721-1, or refiring with local application.

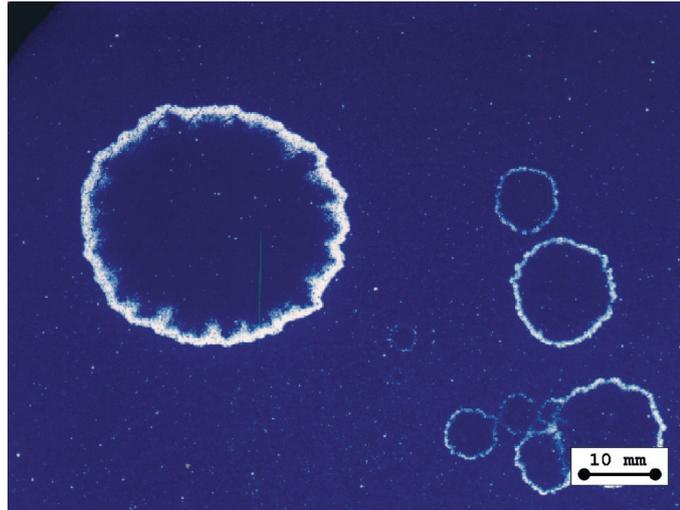
Water marks are individual or several stains in the enamel surface with light-coloured borders (see [Figure 14](#)).

Figure 14 — Water stains on an enamel surface

Water marks are caused by drops of water or sweat on the enamel bisque. Here, due to migration processes, salts are mobilized and transported to the edges of the drops. There, they crystallize and are subsequently fired in.

Optical enamelling defect; the chemical resistance and the mechanical properties of the enamel are not affected negatively.
