**Plain bearings — Appearance and
characterization of damage to metallic
hydrodynamic bearings —**

**Part 2:
Cavitation erosion and its
countermeasures**

STANDARDSISO.COM : Click to view the full PDF of ISO 7146-2:2008

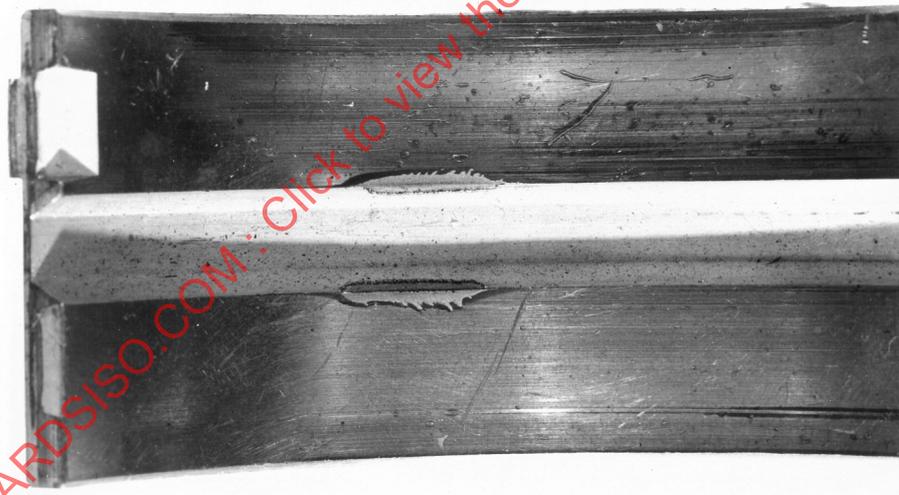
Figure 6 — Flow cavitation erosion on both groove sides of the lower half of a center main bearing in a turbo charged 6-cylinder diesel engine

- a) at the edge of oil holes (see Figure 4);
- b) at the downstream end of partial oil grooves in big-end bearings (see Figure 5);
- c) on the side faces and adjacent bearing surface of circumferential oil grooves (see Figure 6);
- d) adjacent to the joint face relief of a big-end bearing and a main bearing (see Figures 7 and 8);
- e) in deep scores and indentation in bearing surfaces.

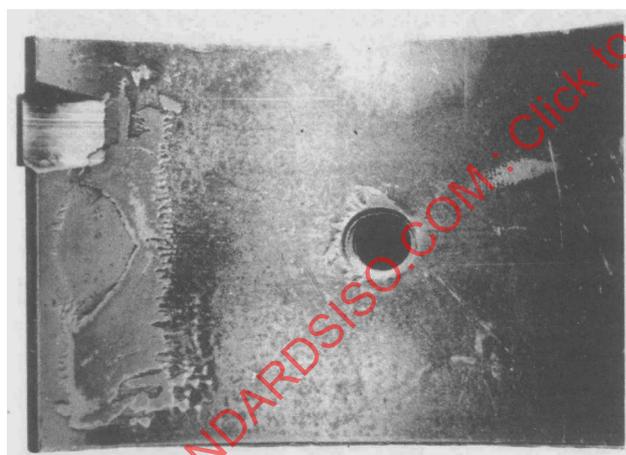
NOTE Only the lining material is damaged.

Figure 8 — Flow cavitation erosion adjacent to the joint face relief of a main bearing and a big-end bearing of an automotive diesel engine

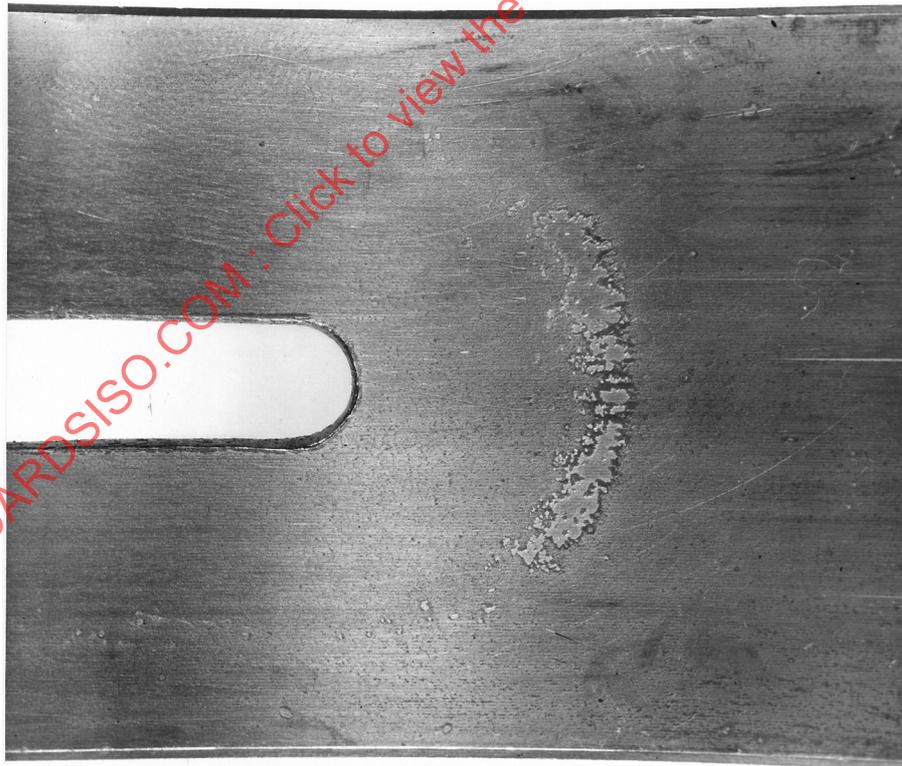
Figure 9 — Impact cavitation erosion at the end of 210° groove in a main bearing

The erosion usually takes the form of a kidney, ring or half-moon. Figure 9 shows a typical example of the impact cavitation erosion behind and at some distance from the downstream end of a partial-circumferential oil groove in a lower half main bearing, where the journal is provided with drillings for supplying oil to a big-end bearing in a high-speed engine. Figure 10 depicts the damage at two circumferentially different spots, as the engine has run at two different constant speeds. Similar erosion has also been experienced near the end of an oil bleed slot in the rod half of a big-end bearing (see Figure 11).

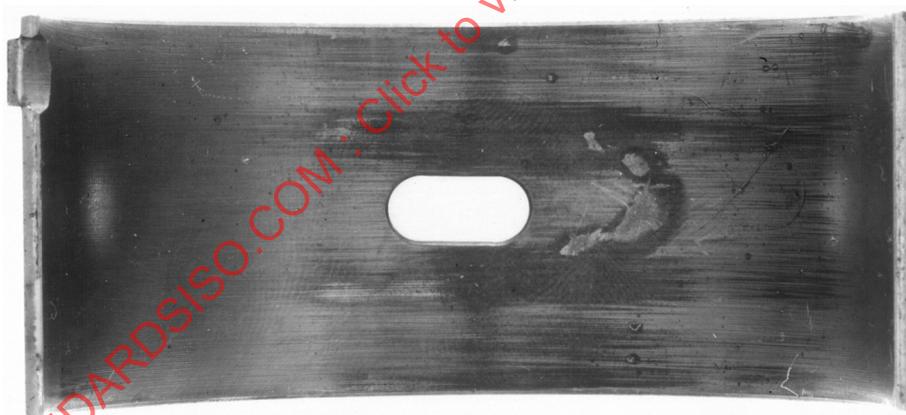
Figure 11 — Impact cavitation erosion near the end of an oil bleed slot in the rod half of a big-end bearing

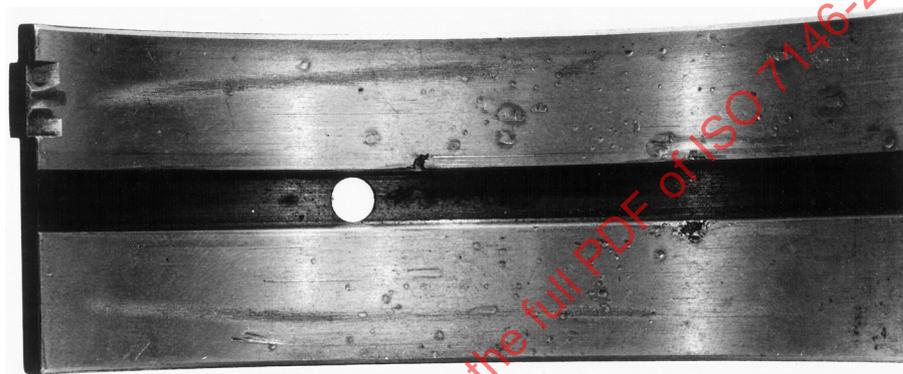
Figure 12 — Suction cavitation erosion in the upper half main bearing of a diesel engine

This erosion takes place only in dynamically loaded bearings. It has been experienced on the upper halves of main bearings and near the circumferential centre lines of the bearing lands. The damage took a long lancet-like form in a mild case (see Figure 12), and other forms (see Figures 13 and 14) in severe cases.
