**Additive manufacturing of metals —  
Non-destructive testing and evaluation  
— Defect detection in parts**

# Additive manufacturing of metals — Non-destructive testing and evaluation — Defect detection in parts

This document categorises additive manufacturing (AM) defects in DED and PBF laser and electron beam category of processes, provides a review of relevant current NDT standards, details NDT methods that are specific to AM and complex 3D geometries and outlines existing non-destructive testing techniques that are applicable to some AM types of defects.

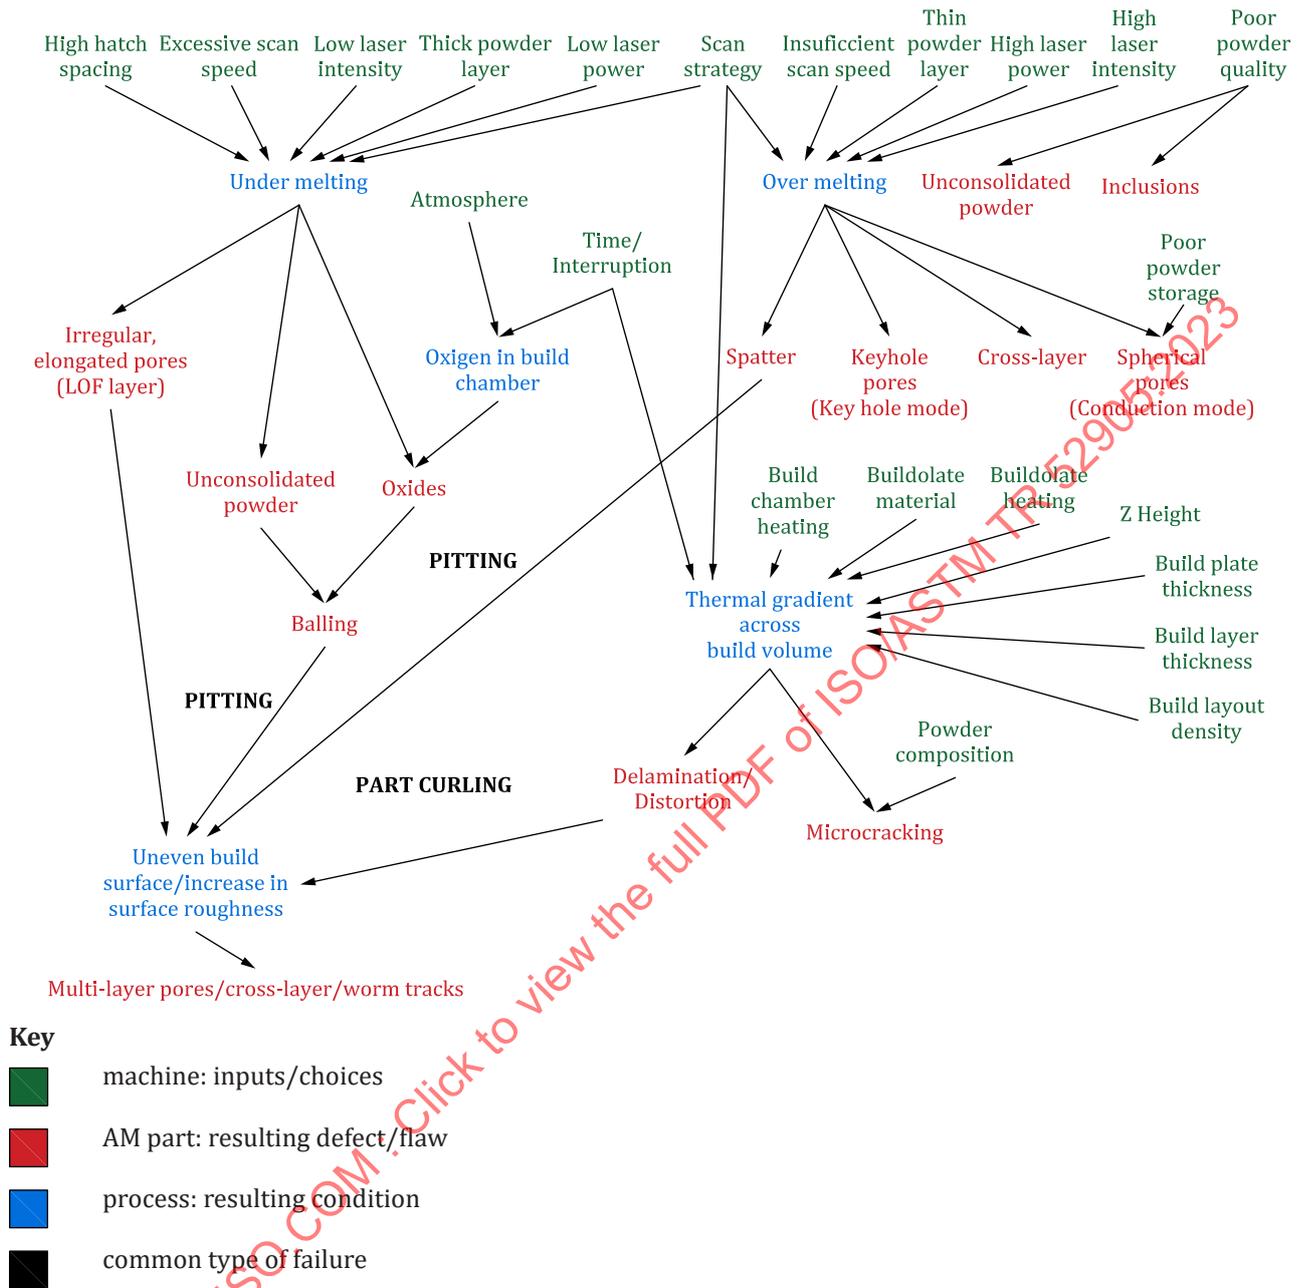
Figure 1 — Causes, mode of failures and defect formation in PBF AM (see ISO/ASTM 52900)

The flowchart displayed in [Figure 1](#) gives an idea of the complexity of flaw generation within the PBF process. As can be seen, the generation of one flaw type can result in an anomalous processing condition, which in turn generates a second flaw. For example, the presence of a thick layer or low laser (or electron beam) power can lead to under-melting, which in turn can lead to unconsolidated powder. Coupled with the tendency of the power source to decrease the surface energy of unconsolidated powder under the action of surface tension, ensuing ball formation may arise due to shrinkage and worsened wetting, leading to pitting, an uneven build surface, or an increase in surface roughness; see EN 1330-2.

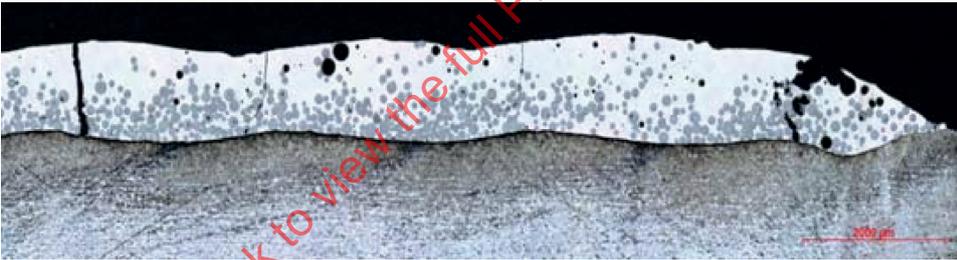
<p>Incomplete fusion</p>	<p>Fusion between the entire base metal surfaces and between adjoining welds are not complete. This occurs when new material has been used and the build parameters have not been optimised. Typically, this flaw is eliminated as the process improved when all parameters have been optimised.</p>

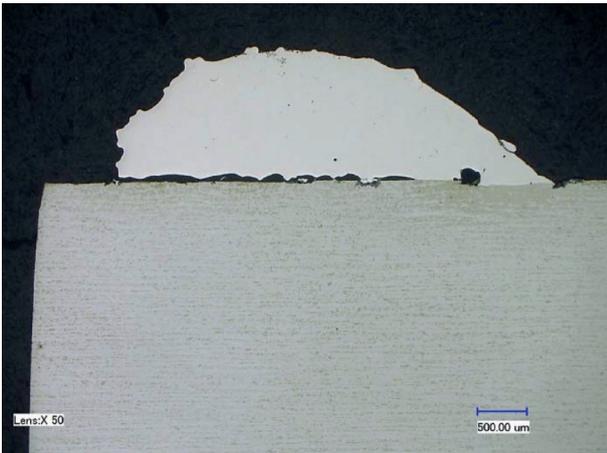
<p>Undercuts at the toe of the welds between adjoining weld beads</p>	<p>A groove melted into the base metal adjacent to the weld toe or weld face and left unfilled by weld metal.</p>

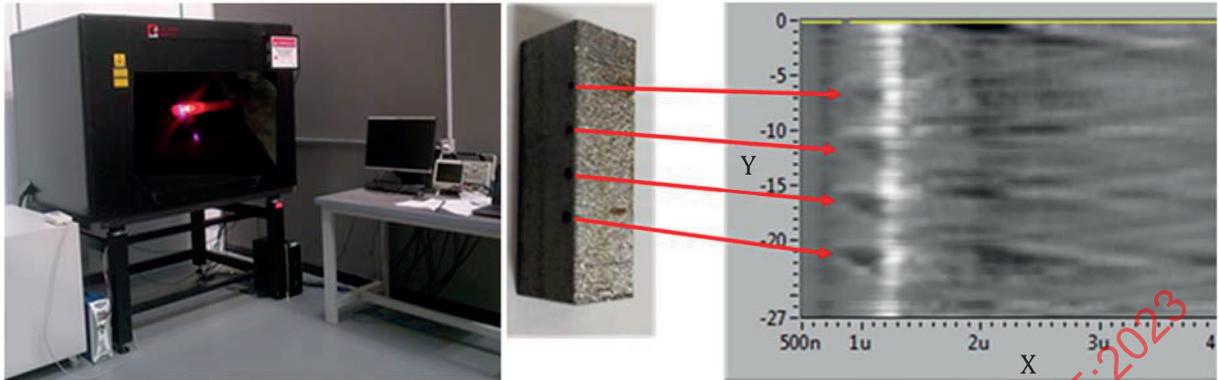
Figure 2 — LU system (left); and L-PBF sample calibration sample with B-Scan results identifying detected features (right)

LU has shown good capability to detect laser machined notches with dimensions as small as 50 µm × 75 µm × 50 µm (L × D × W) on DED samples as built, that is without any post build surface finishing. The method can be used on curved or difficult to access areas and is capable to work at elevated temperatures, therefore is suitable for Laser-PBF and DED AM processes ([Figure 2](#) and [Figure 3](#))<sup>[31]</sup>.

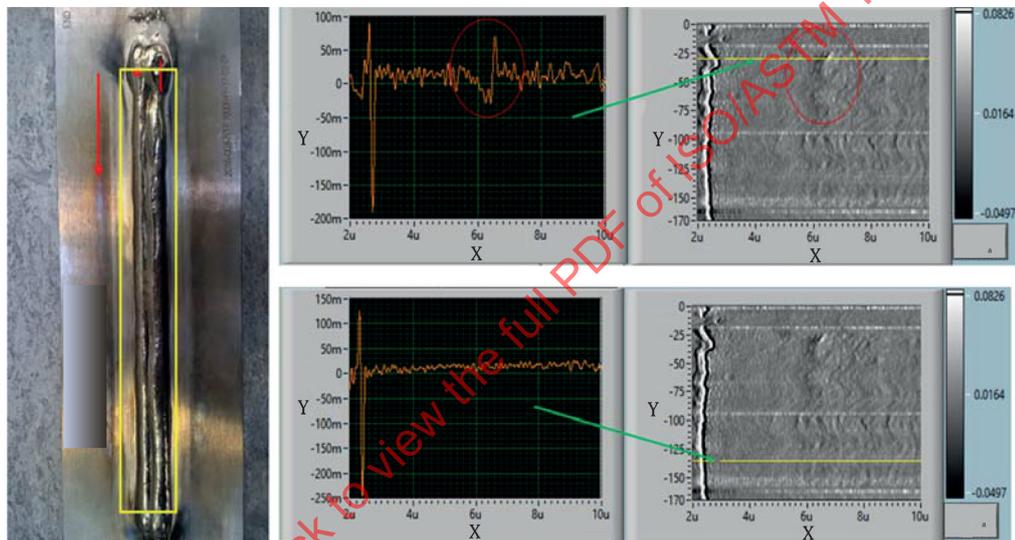
Figure 3 — Photograph of DED sample with scan details (left); A-Scans (centre); and B-Scans showing an area with LOF (right)

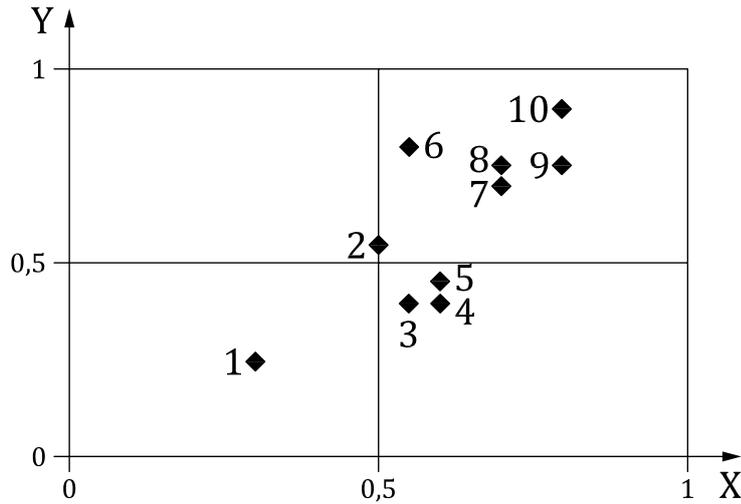
Figure 4 summarises the review carried out for NDE technologies applicable for in-situ monitoring and inspection for AM parts. This diagram shows that optical methods are the easiest and capable ones for the in-process monitoring and inspection methods attempted to scope. Nevertheless, other methods such as LU and X-ray based potentially would have better results but integration and development are more complex. A more comprehensive review can be found in ASTM WK73289.

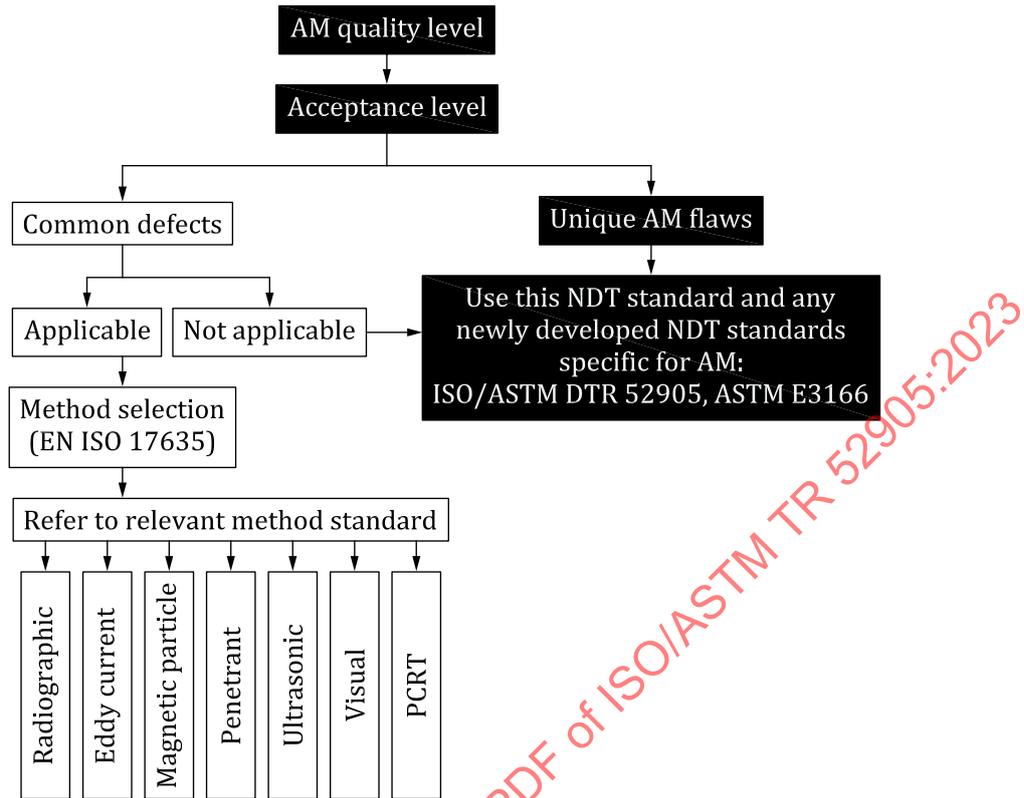
**Figure 5 — Proposed NDT standards structure for additive manufacturing. The black boxes indicate development of new NDT standards for AM**

Based on the review of the current standards, a new structure for NDT standards for AM is proposed as shown in [Figure 5](#). This structure is built on the current welding standards structure shown by the light boxes. The required development of new standards is shown by the dark boxes.

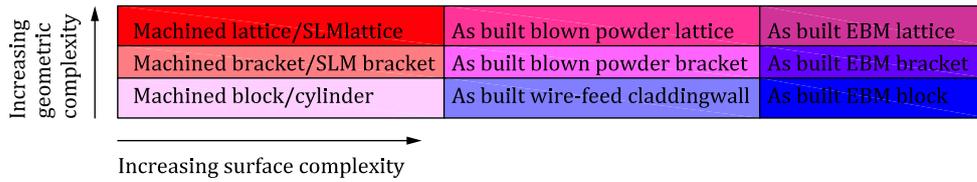
**Figure 6 — Examples of different AM parts considered for the capability matrix** (parts range from less complexity in the bottom left corner to more complex in the top right)

A study to establish the potential detection capability of the NDE method for post-build and In-process for AM was developed in References [\[22\]](#) and [\[33\]](#). A selector tool has been created in order to demonstrate the capability of each NDT method for inspecting AM parts. This tool considers the micro and macro complexity of the part, and the potential defects of interest as listed in [Clause 6](#). The tool considers a range of component structures and surface finishes, ranging from simple machined blocks/cylinders to inspection of as built EBM (rougher) lattice components. [Figure 6](#) shows an example of the different part categories considered in the matrix of capabilities. From bottom to top the geometric complexity of the part increases, and from left to right the surface complexity increases.

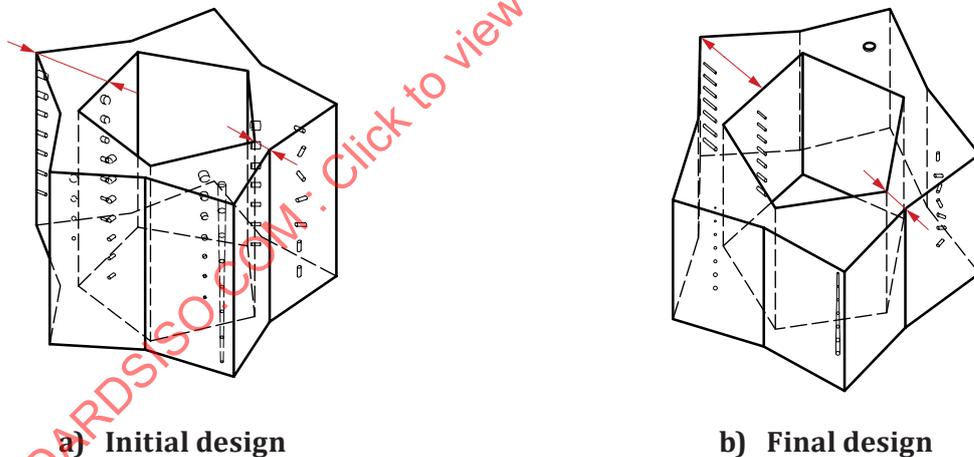
**Figure 8 – Proposed specimen designs to assess the detectability of layer defects, cross-layer defects, unconsolidated powder and trapped powder** (the red arrows indicated the maximum and minimum material thickness of the specimen)

This specimen will be used to assess the detectability of identified AM typical layer defects, cross-layer defects, unconsolidated powder/trapped powder and inclusions. The seeding technique is one of the proposed methods in ISO/ASTM TR 52906, CAD seeding technique. The specimen has a cross-section of a 5 point star as shown in [Figure 8](#). The dimensions shown in the design are general guidance only. The dimensions of the artefact are dependent on several factors including the material, accelerating voltage (kV), and type of filter. The exact dimensions will be determined using XCT Standard: EN 16016-2. For example, using 450 kV, 500  $\mu\text{m}$  Gadolinium oxysulphide scintillation screen and 3 mm Pb filter, XCT can achieve 10 % transmission on 80 mm of aluminium. This level of transmission can give an optimal signal-to-noise ratio in the CT image. In this case, the total material thickness of the artefact can not exceed 80 mm if the scan is rotated on the star axis. The red arrows in [Figure 8](#) indicated the thickness. Details of the preliminary star artefacts design and final design specifying seeded defects location and their distribution are presented in detail in [Annex C, Figure C.1](#) (Preliminary star-shape) and [Figure C.2](#) (Final star-shape).

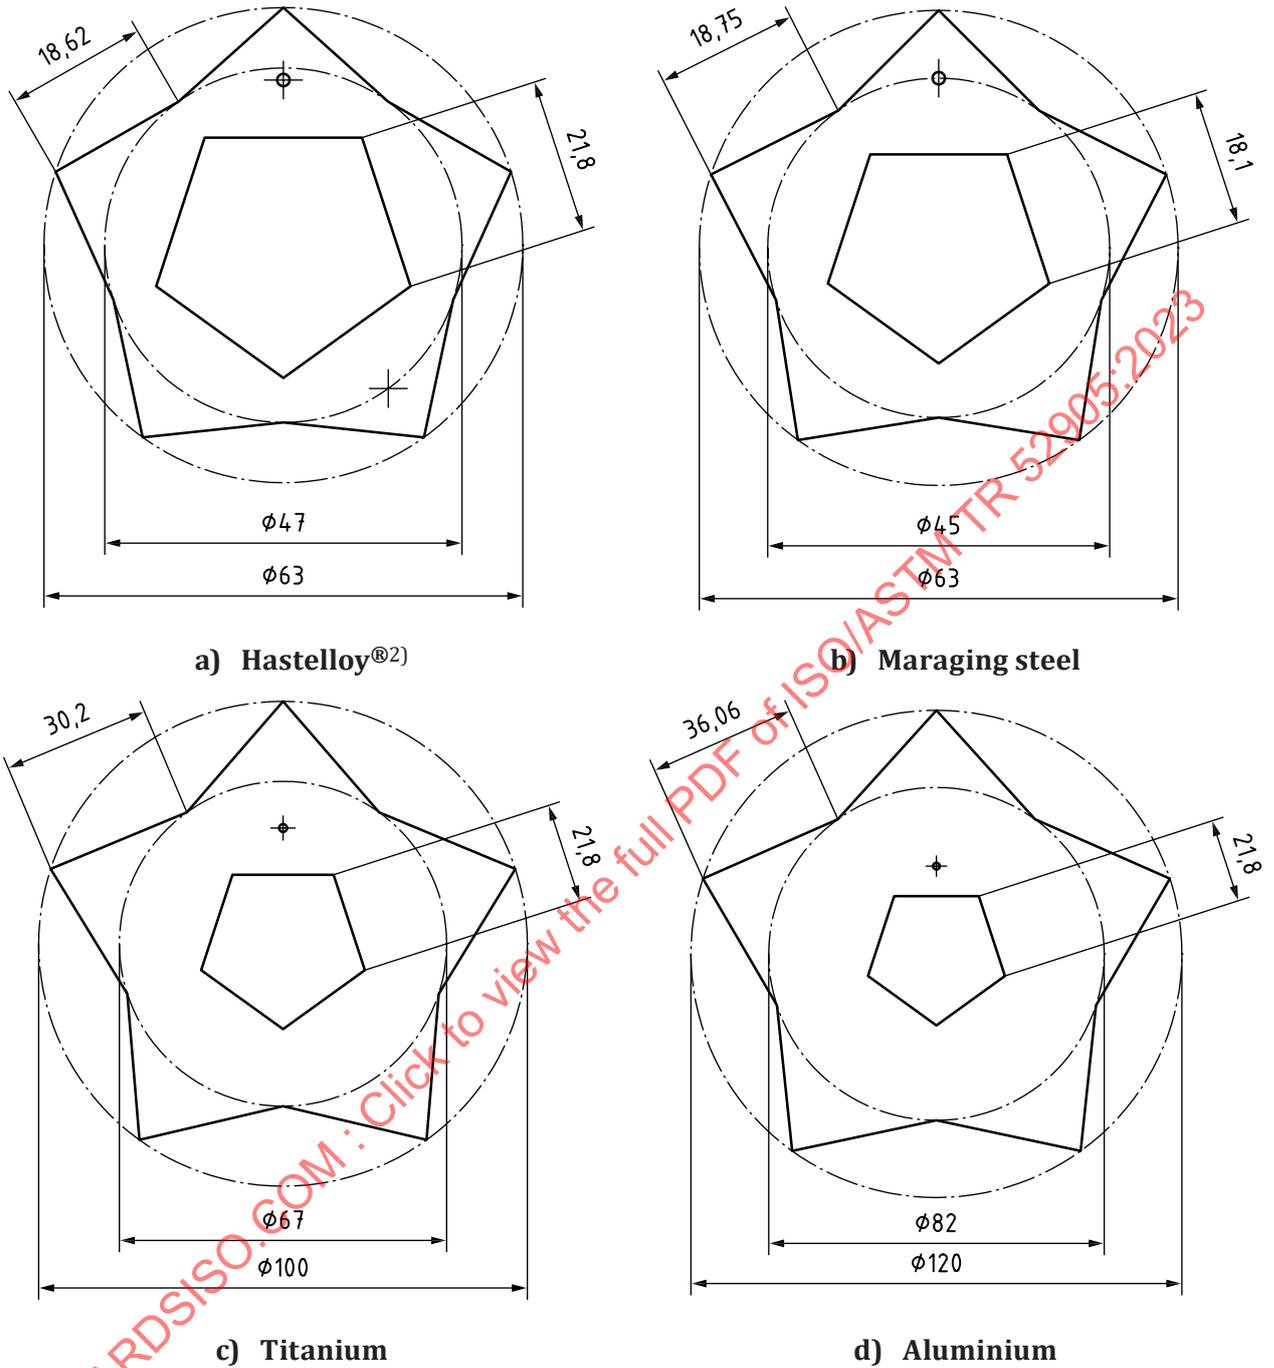
Figure 10 — Artefact material design comparison for the new star design

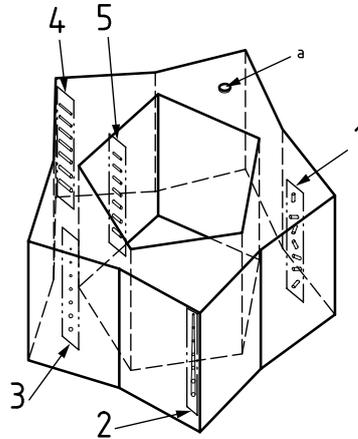
NOTE Details of the defects on the tip sections are shown in region (1) to (5).

Figure 11 — Proposed specimen design 1 (S1) to assess the detectability of layer defects, cross-layer defects, unconsolidated powder and trapped powder

Figure 11 shows the defects on the tip sections of the star, which covers the region (1) to (5), while Figure 12 shows the defects on the inner pentagon, which covers the region (1) to (5) too. However, noted the position of the seeded defects varied with design 1 shown in Figure 11. Table 11 show the dimensions of the defects seeded on the star artefacts.

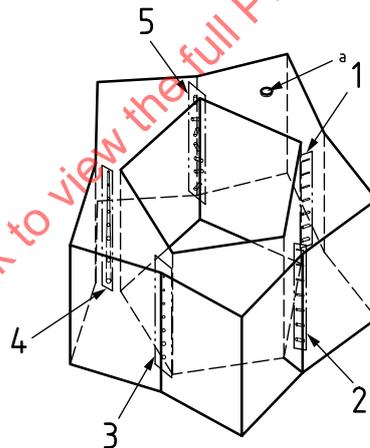
NOTE Details of the defects in the inner pentagon are shown in region (1) to (5).

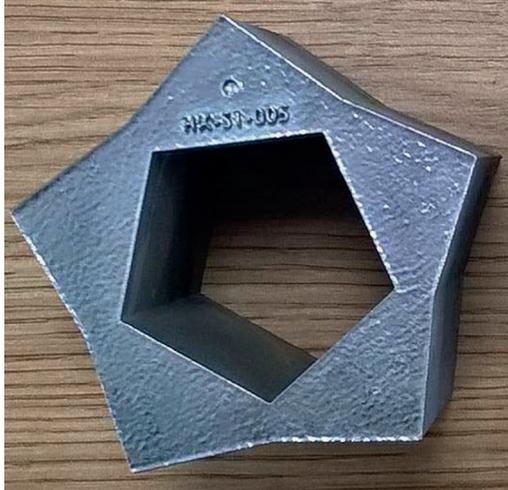
a) Hastelloy<sup>®</sup>

The defects are located in critical areas or locations at a different depth to ensure they are representative of flaws that can be generated during the AM process. [Figure 15](#) shows examples of the star artefact builds for Hastelloy<sup>®3)</sup> and Titanium.

**Figure 15 — Hastelloy<sup>®</sup> and titanium star artefact build using EOS system**

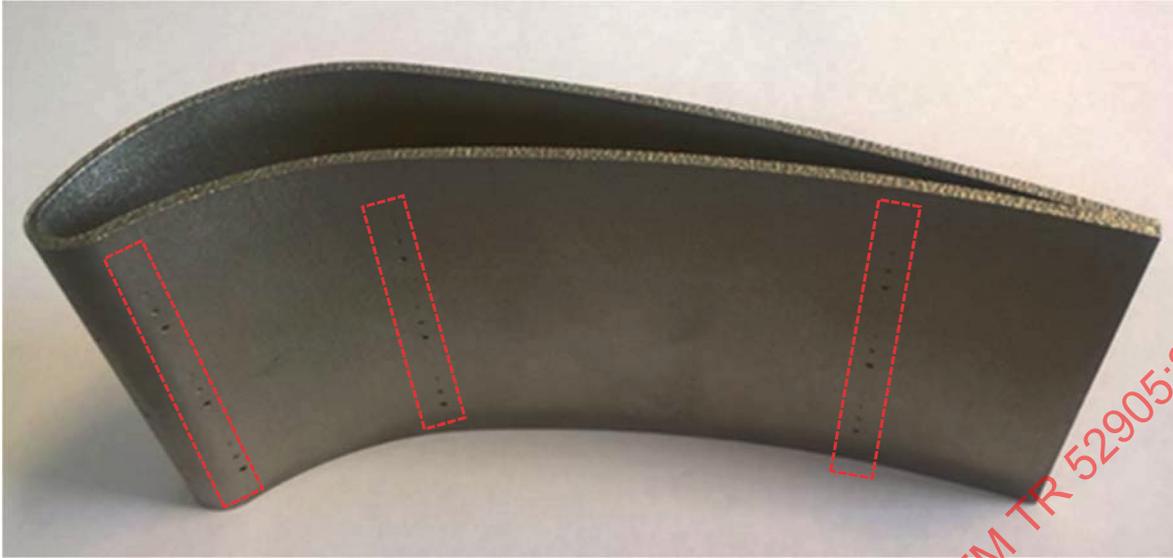
**Figure 16 — Generic airfoils build as à la carte design provided by GE power** (red rectangles show simulated defects manufactured by PBF)

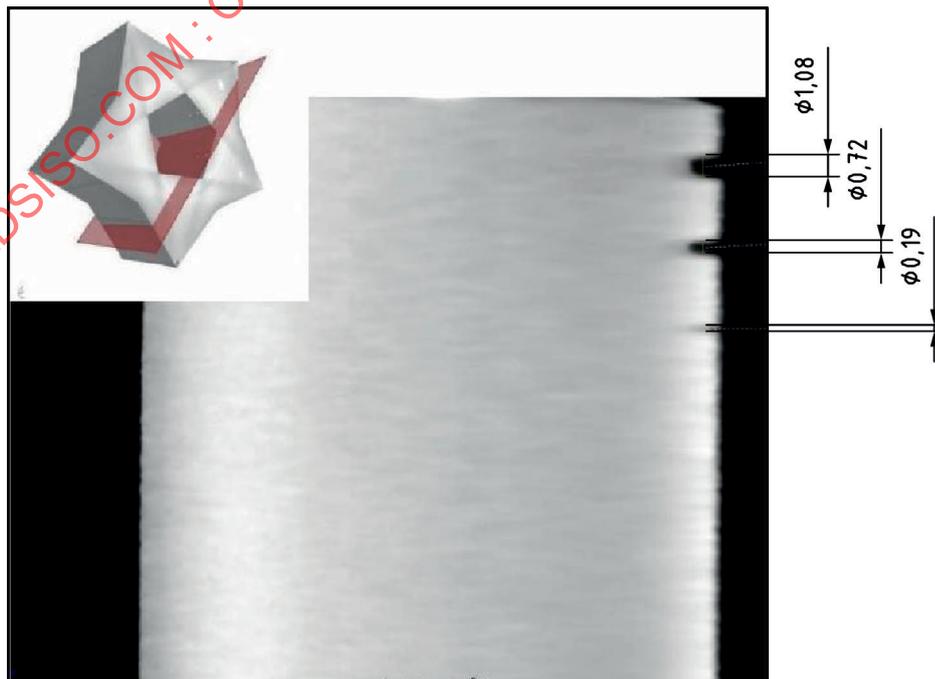
**Figure 18 — Image of the sample  $S1_{(PBF)}$  obtained by NI (CONRAD 2)**

**Titanium star artefact** - The results for the Titanium star reference as  $S1_{(SLM)}$  inspected by NI on the seeded ROI's indicated that defects seeded on the inner faces with geometries from 0,19 mm to 1,08 mm were detected ([Figure 18](#)) and visualised by SX ([Figure 19](#)). The sample labelled as  $S2_{(EBM)}$  the minimum size of the seeded defects resolved was from 0,240 mm to 1,34 mm as shown in [Figure 20](#) and imaging by SX in [Figure 21](#).

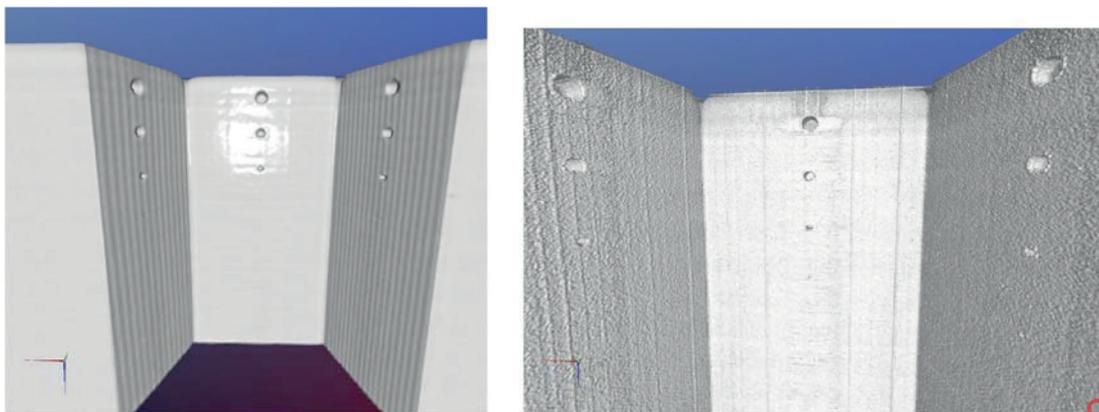
Figure 19 — Image of region 1 on sample S1<sub>(PBF)</sub> obtained by SX (ID19)

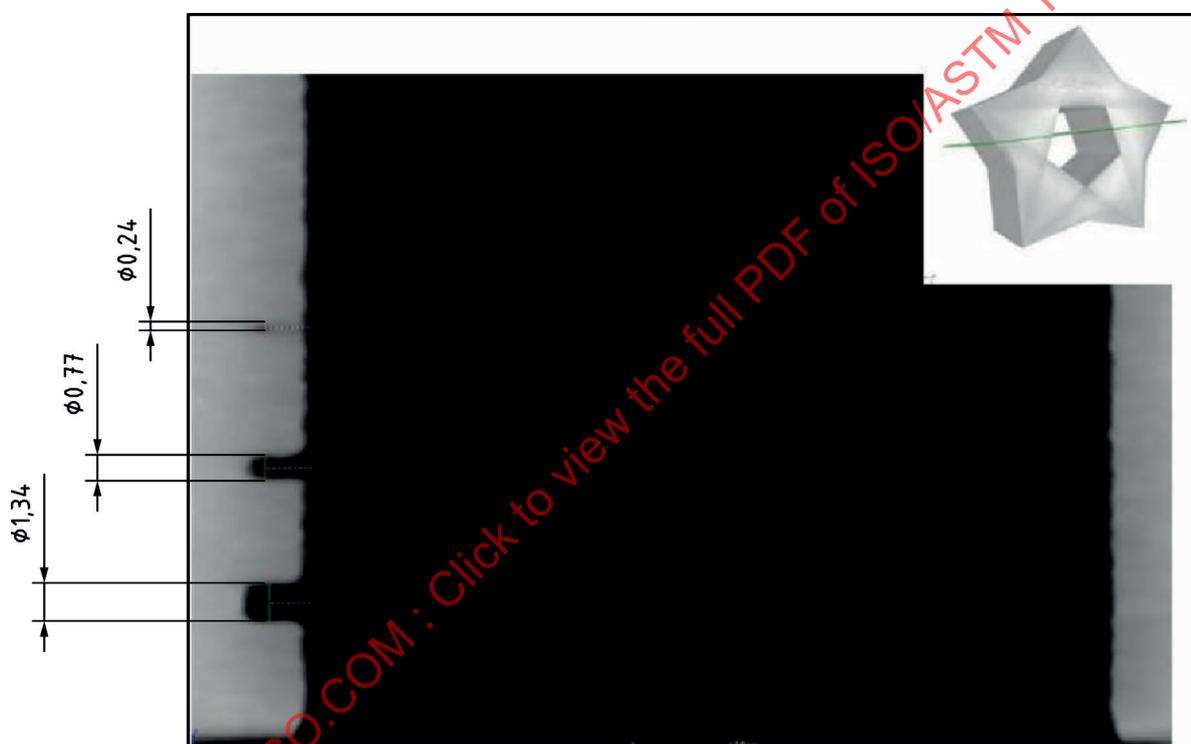
Figure 20 — NI image of the sample S1<sub>(EBM)</sub> obtained by NI (CONRAD 2)

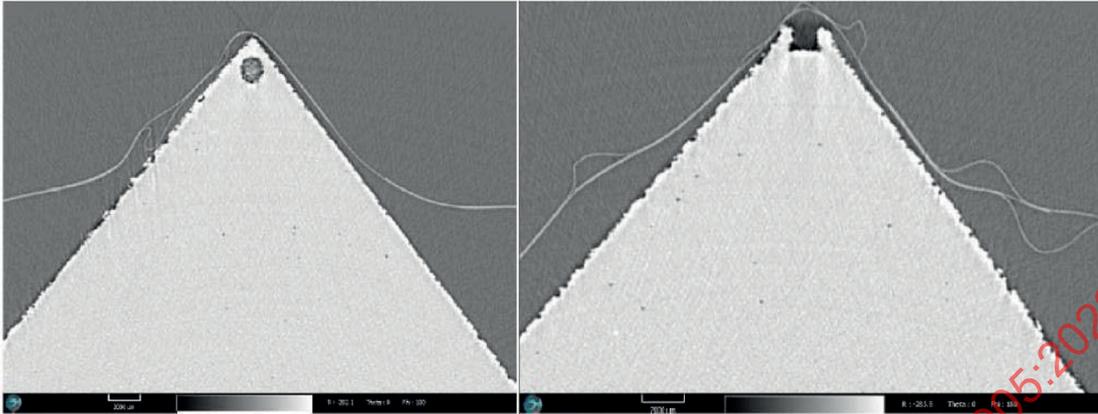
Figure 21 — Image of the sample  $S1_{(EBM)}$  obtained by SX (ID19)

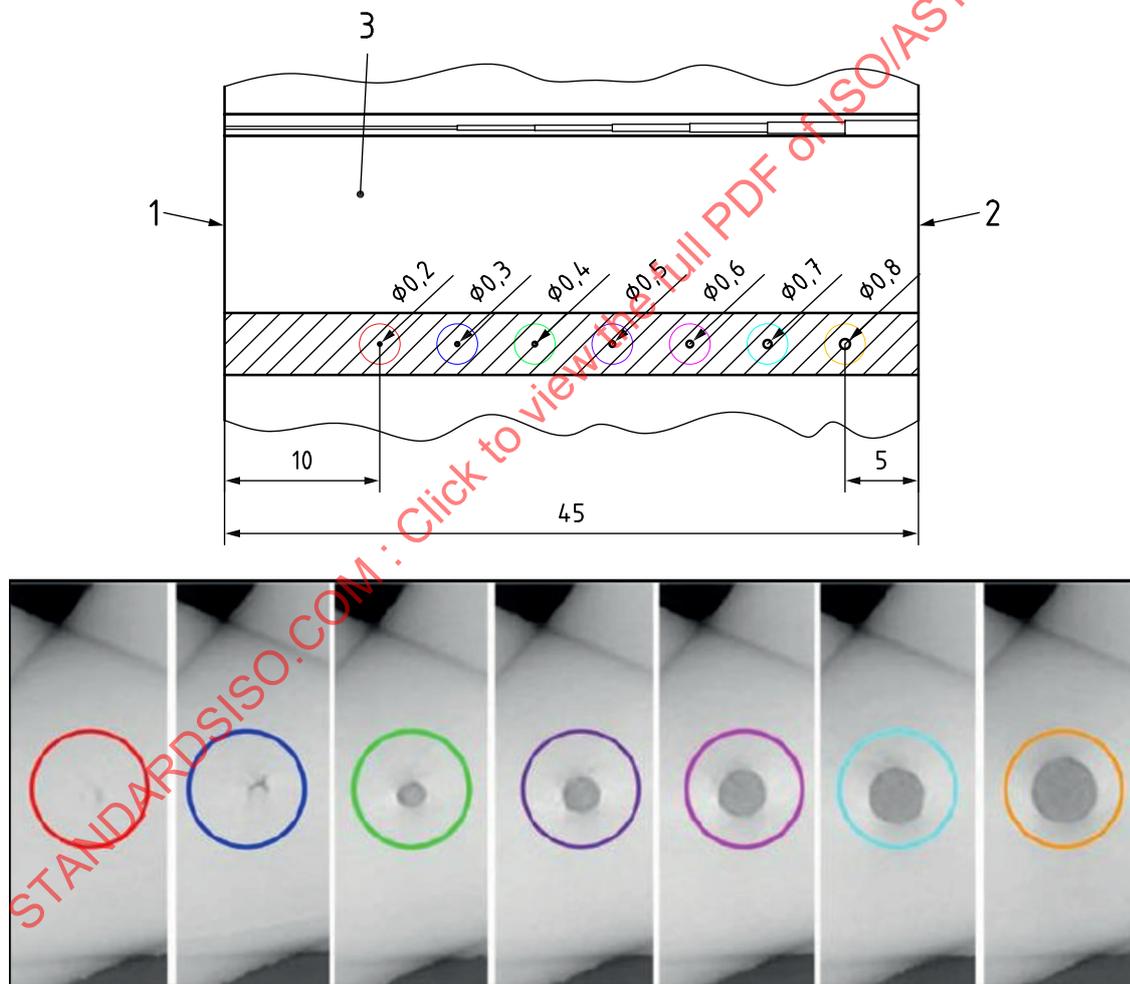
**Figure 23 — XCT results from CoCr star region 3 (S2) showing the 7 spherical cavities built in the bulk of the star, with diameter varying from 0,2 mm to 0,8 mm**

**CoCr Star artefact** - The microtomography analysis performed with the high-energy synchrotron radiation on the Co-Cr star artefacts evidenced the technique was capable to detect defects with a size over 100 µm. [Figure 23](#) and [Figure 24](#) show an example of the XCT images obtained from Co-Cr star version 2 in region 3 (spheres) and region 4 (vertical cylinders) respectively. In addition, the images corroborated that the AM process using the PBF EOS M290 system was capable of building all the artificial defects seeded on the CAD drawing both full-size CoCr start artefact.

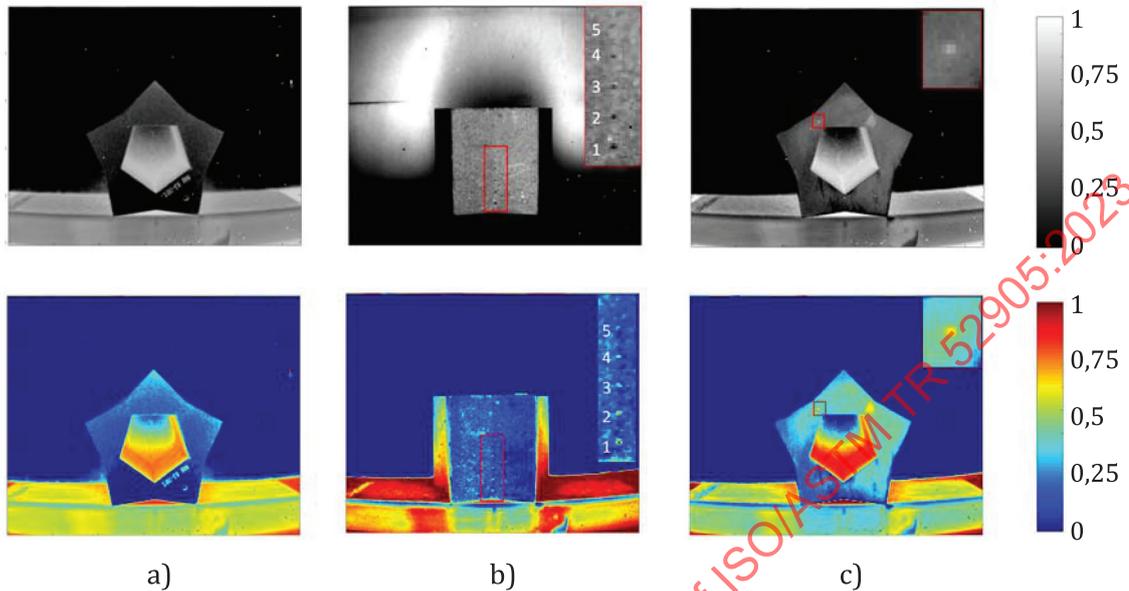
**Figure 25 — Flash thermography inspection on star artefact MS-S2-002**

Representative thermal images using flash thermography are shown in [Figure 25](#) and [Figure 26](#) for Maraging steel and Hastelloy<sup>®11)</sup> respectively. Other examples of the flash thermography images are presented in [Figure G.3](#) and [Figure G.4](#).

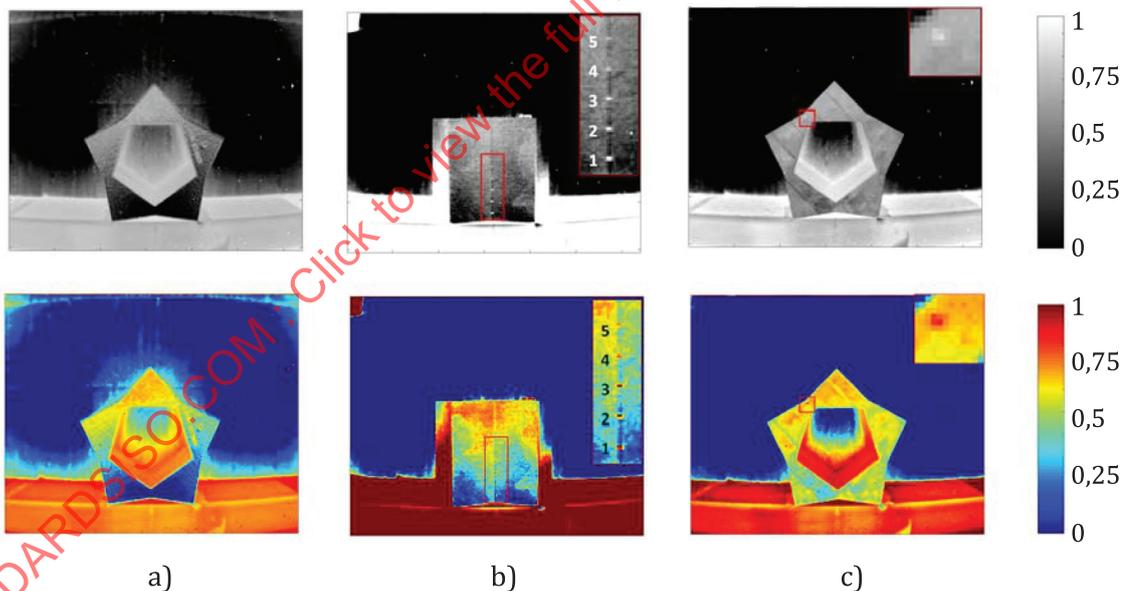
**Figure 26 — Flash thermography inspection on star artefact Hx-S2-003**

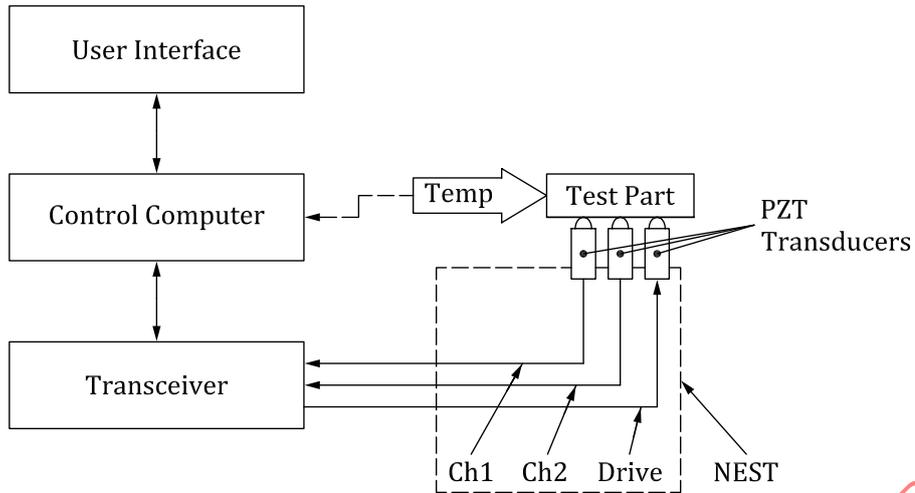
Figure 33 — Typical PCRT system schematic

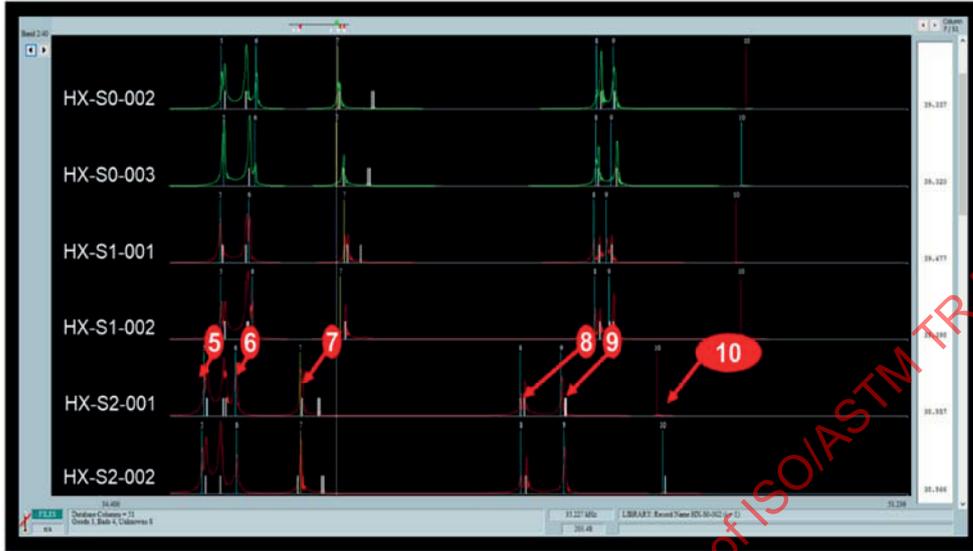
Figure 35 — PCRT spectra for Hastelloy®, 34 kHz to 51 kHz (resonance frequencies 5 to 10)

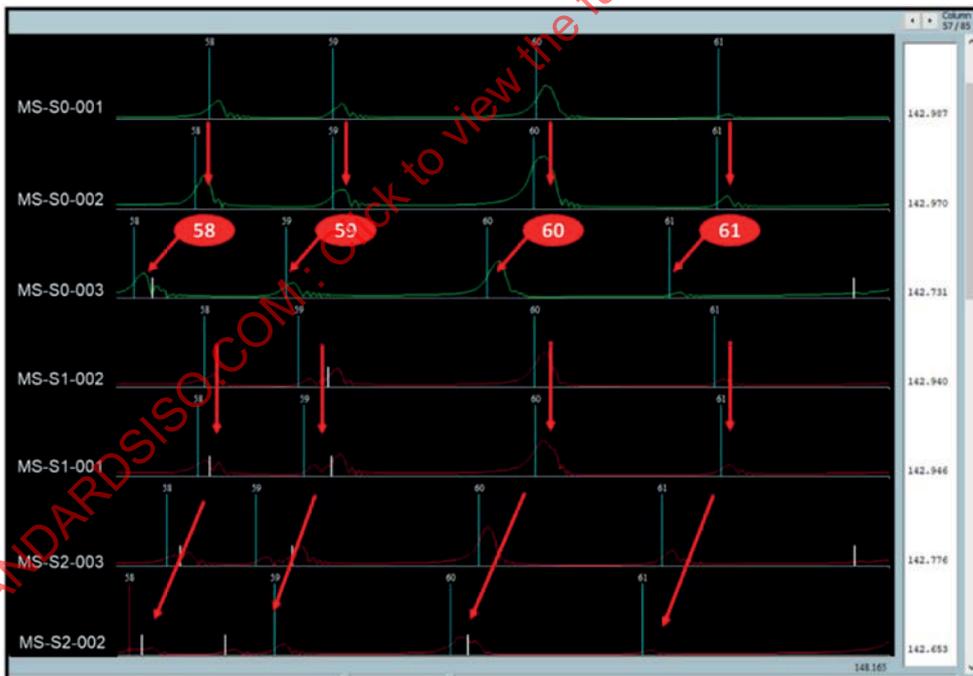
Figure 36 — PCRT spectra for Maraging steel, 144 kHz to 148 kHz (resonance frequencies 58 to 61)

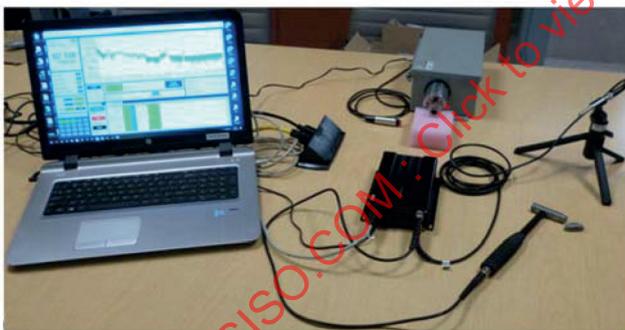
a) Global set up

The data were collected in the frequency range between 500 Hz and 50 kHz using the setup display in [Figure 39](#).

**Figure 39 — Experimental set up for RAM tests**

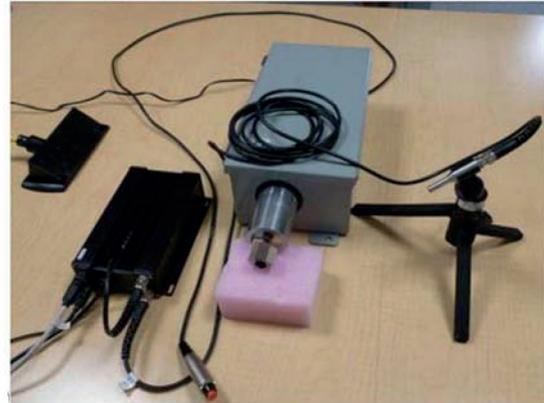
b) Positioning of the star artefact in front of the automatic hammer

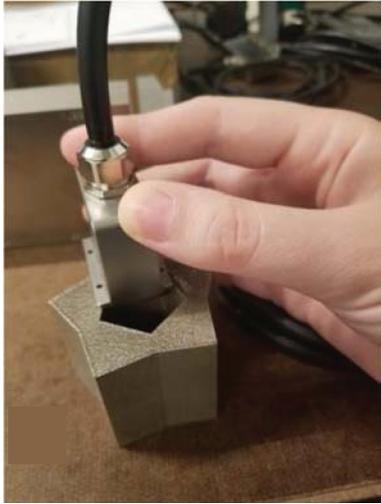
To inspect the stainless steel star a 32/128 channel Omniscan MX instrument with a 10 MHz, 128 elements, linear phased array transducer was used. The inspection was performed in air and the transducer was positioned from top to the bottom and the sides of the star as shown in [Figure 45](#).

a) Top to bottom

Figure 45 — Position of the transducer during inspection at EWI

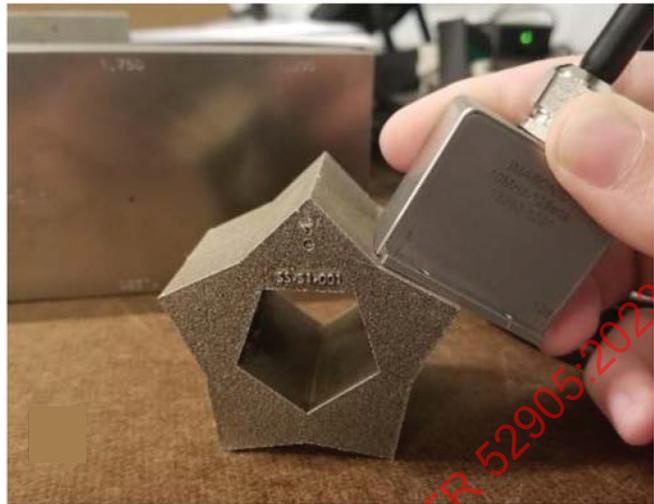
b) Sideways

NOTE For test at OKOS and TPAC only side inspection was performed.

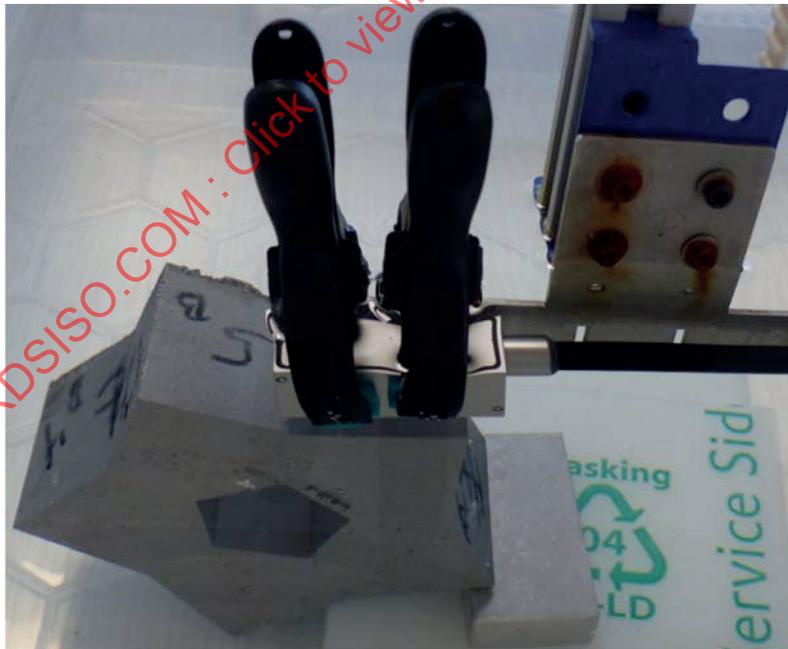
a) Phase array

To inspect the aluminium star artefacts using PAUT-TFM, the OEMPA instrument to acquire the data with a high rate (150 MB/s) was used. The probe is 32 mm long and was composed of 128 transducers separated from each other by 0,25 mm (centre to centre). It is shown in [Figure 46a](#). For the conventional UT (water tank) a single transducer was operated as presented in [Figure 46b](#). The characteristic and parameters of the ultrasonic test performed using conventional UT and PAUT are presented in [Annex H](#).

**Figure 46 — Set up for inspection of the aluminium start artefacts by phase array and conventional UT**

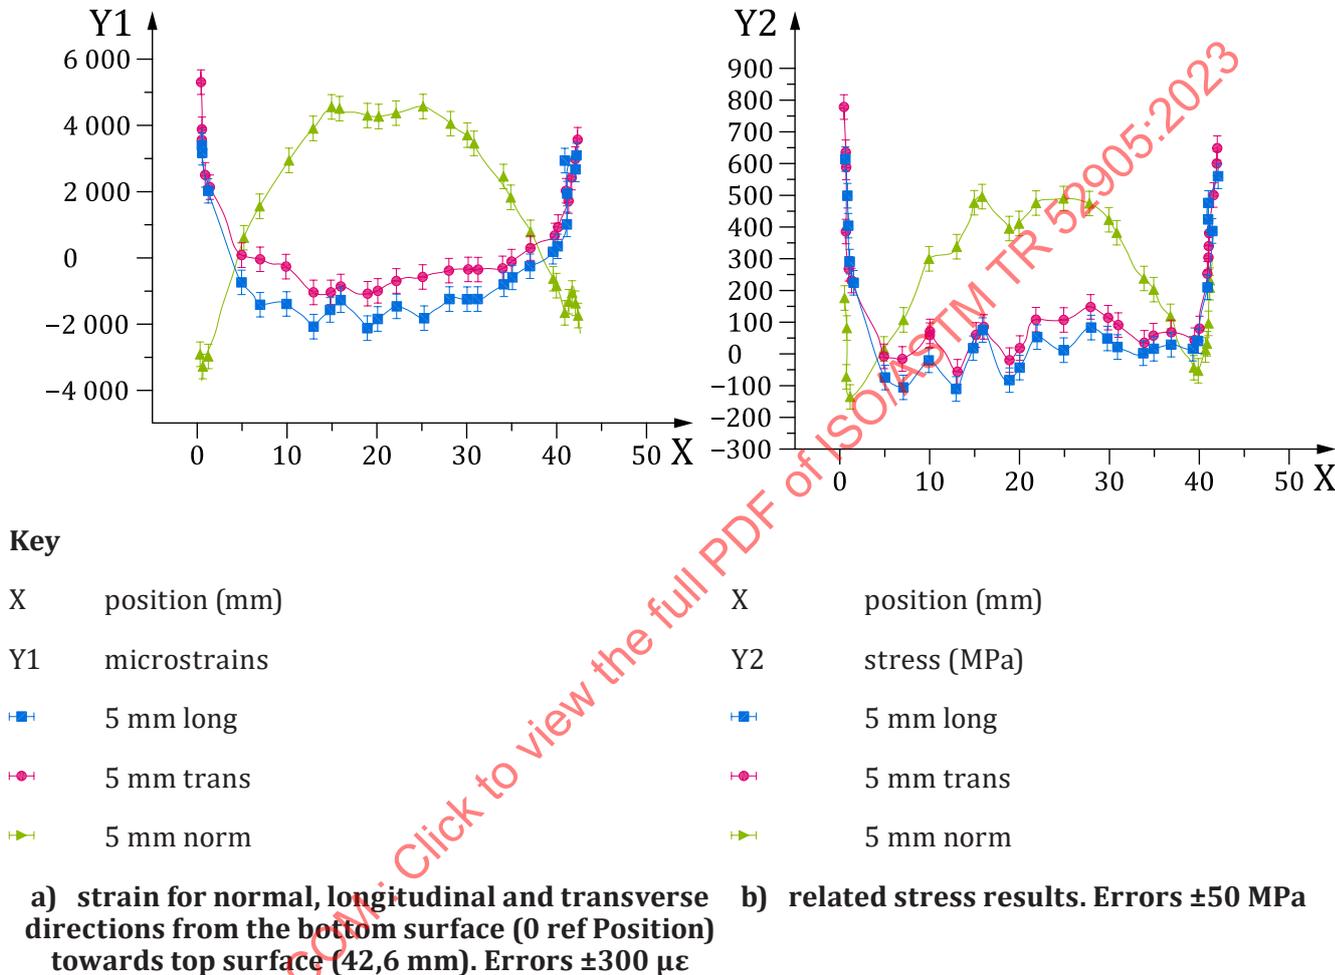
**Figure 48 — Strain tendencies of the three geometrical principal directions from the bottom (near previous base plate) to the top (finishing surface)**

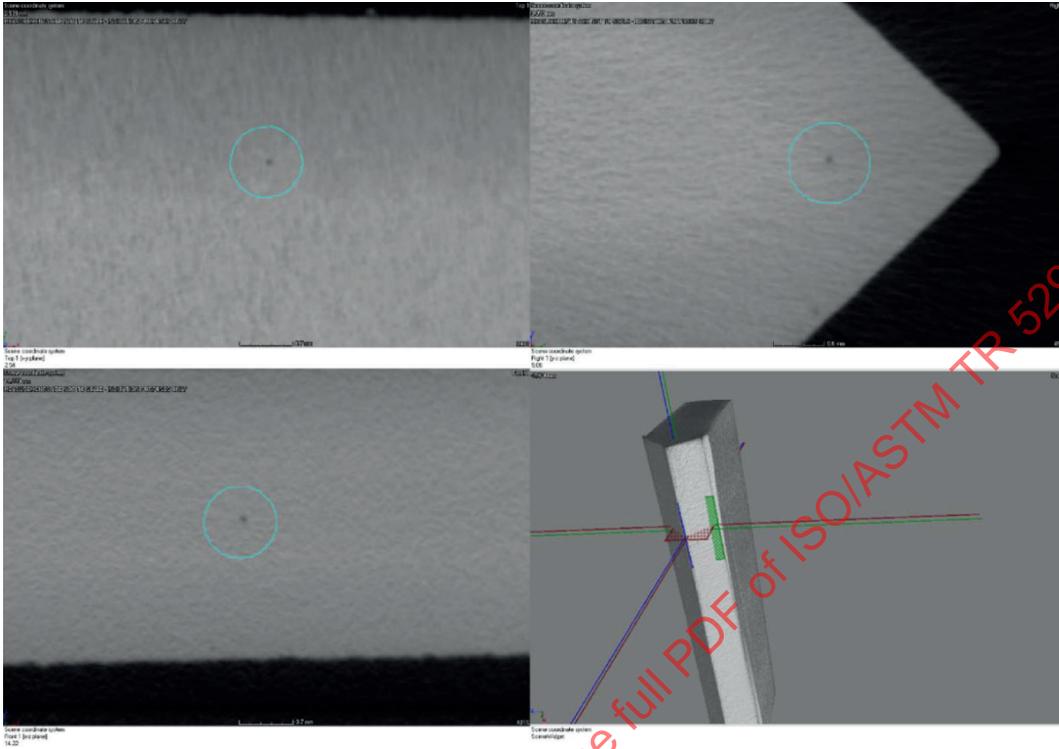
**Figure 54 — XCT images showing an indication (Indication 1, in circle blue) that is likely to be a sphere containing trapped powder with size 0,2 mm diameter**

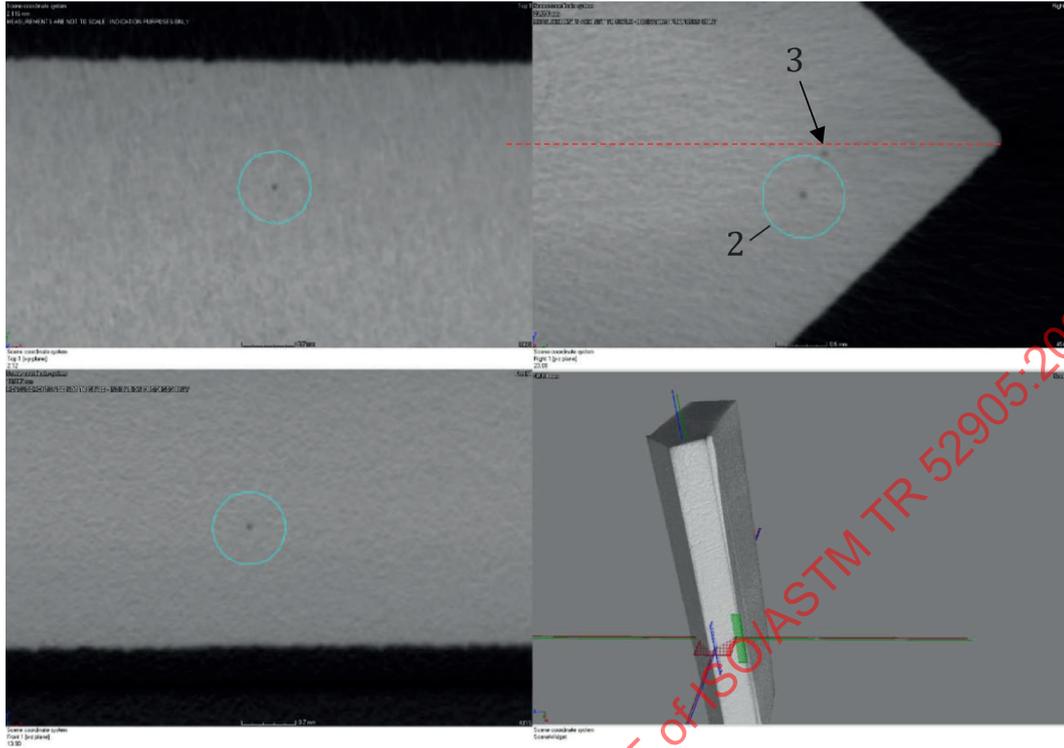
Figure 55 — XCT image showing indication 2 (in circle blue) and indication 3 (out circle blue)

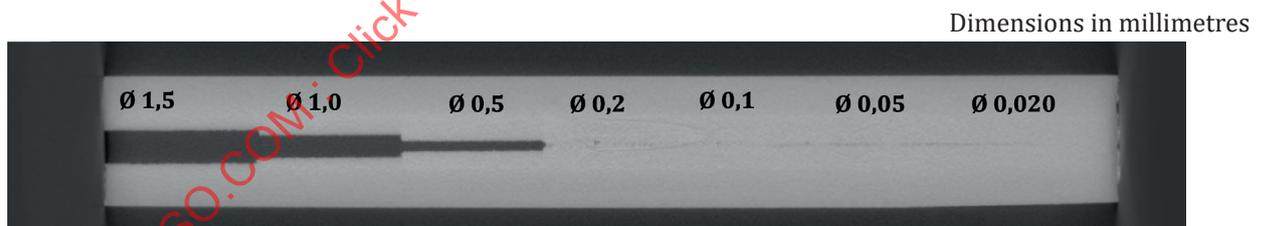
Figure 56 — XCT image showing the cross section through the vertical cylinders

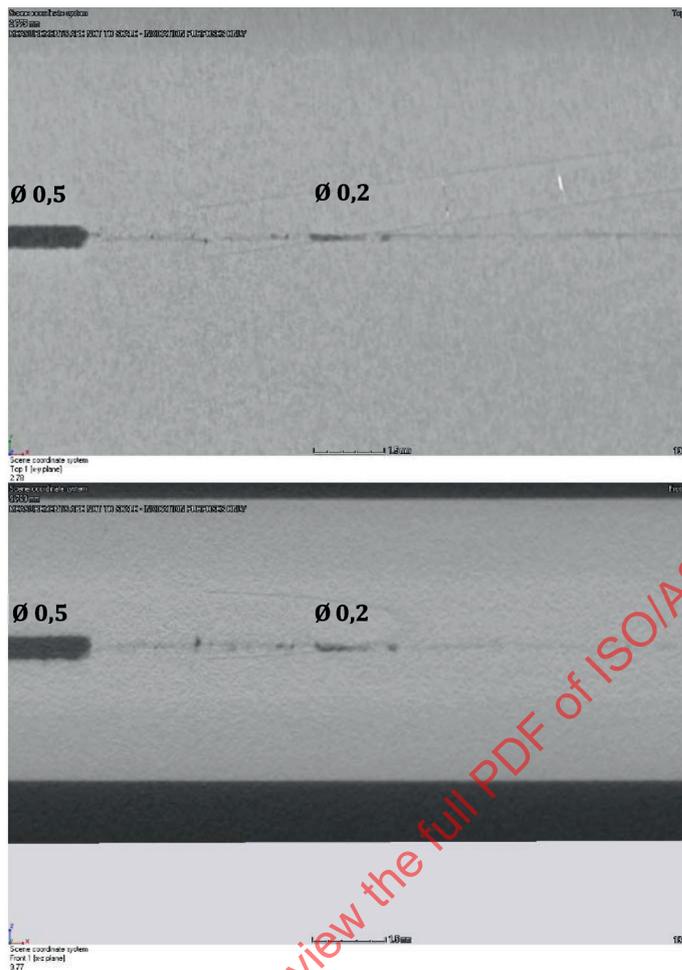
Figure 57 — XCT image showing the close up view of the 0,5 mm and 0,2 mm cylinder’s diameter in Section 2
