SERVICE DAMAGE LIMITS FOR AIRCRAFT HYDRAULIC TUBING

PREPARED BY
SAE SUBCOMMITTEE G-3E,
AEROSPACE TUBING INSTALLATIONS,
OF SAE COMMITTEE G-3, AEROSPACE
FITTINGS, HOSE & TUBING
ASSEMBLIES

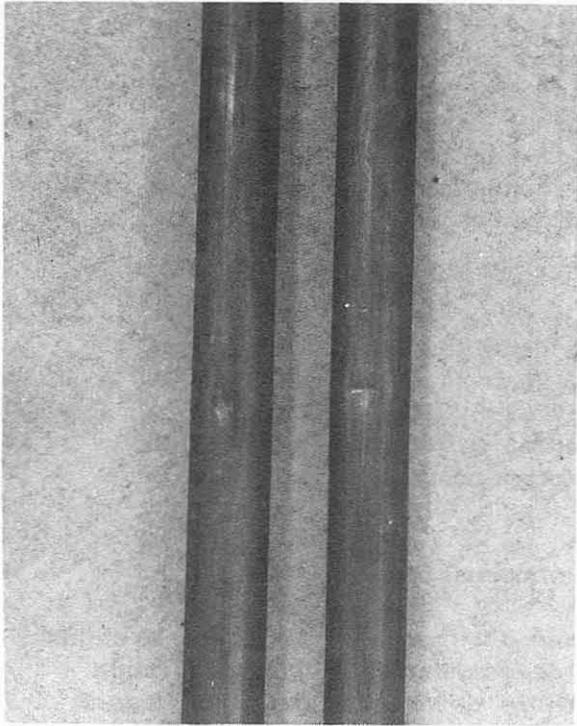
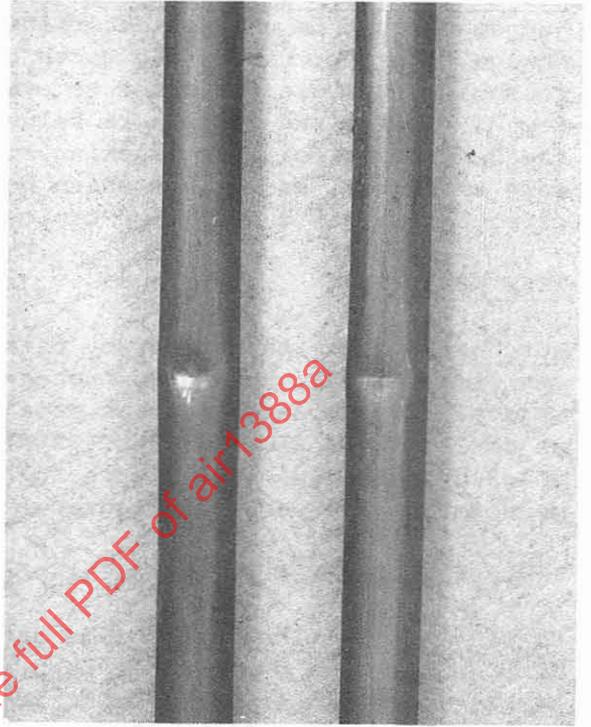
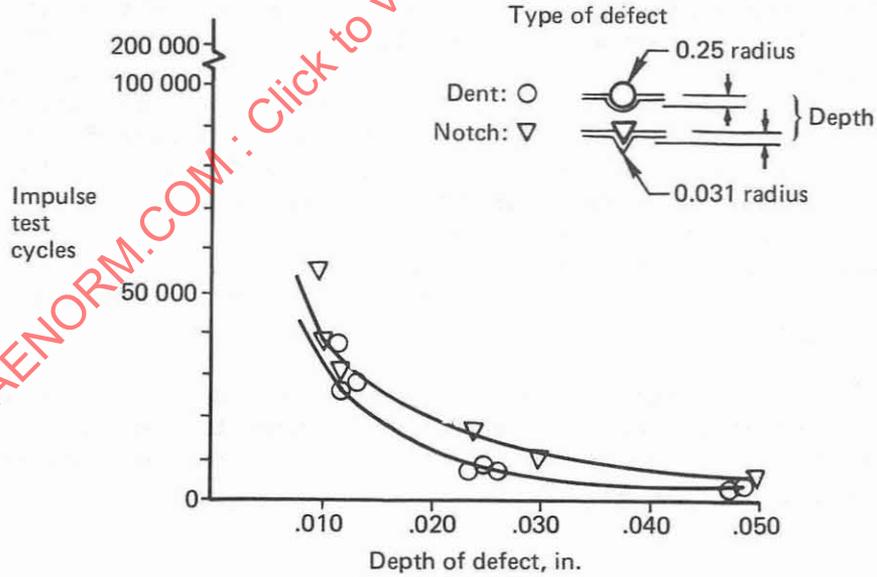
FIGURE 1. IMPULSE TEST PERFORMANCE OF 3/8 BY 0.018 3A1-2.5V CW TITANIUM TUBING WITH VARIOUS DEFECTS

Dent and Notch 0.010 In. Deep

Dent and Notch 0.050 In. Deep

Notches: It may be noteworthy that the round dent was found to be more detrimental than the sharp, notch-type dent, such as might be caused by a sharp object. This observation was made for MIL-T-7081 6061T6 aluminum tubing as well as for AMS 5561 21Cr-6Ni-9Mn (CRES), AMS 4944 3Al-2.5V (CW), and AMS 4943 3Al-2.5V annealed, (see Figure 13). Typical comparisons of impulse test performance are shown in Figures 1 and 2.

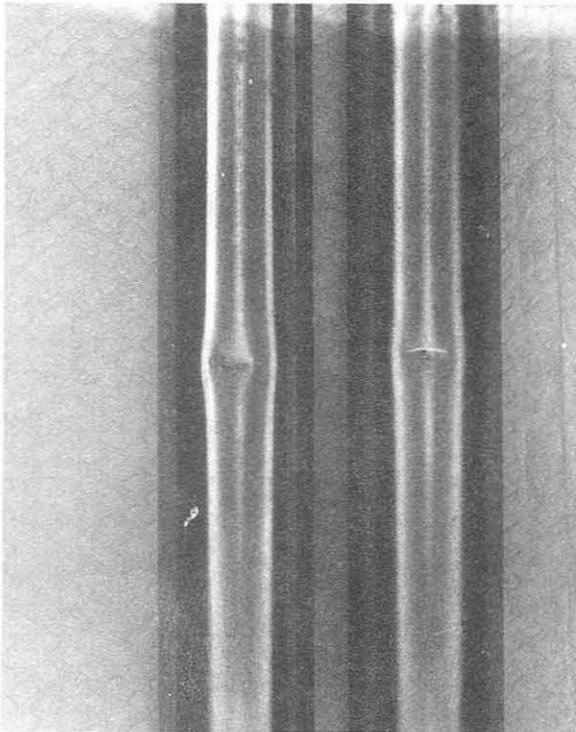
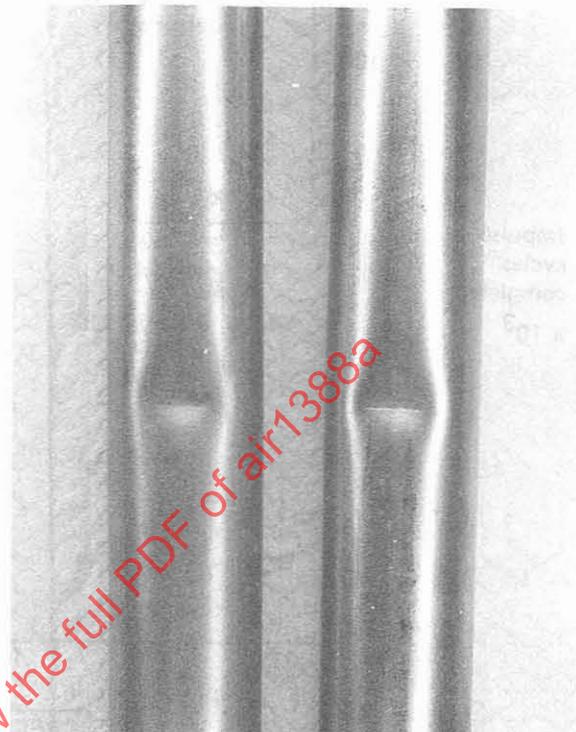
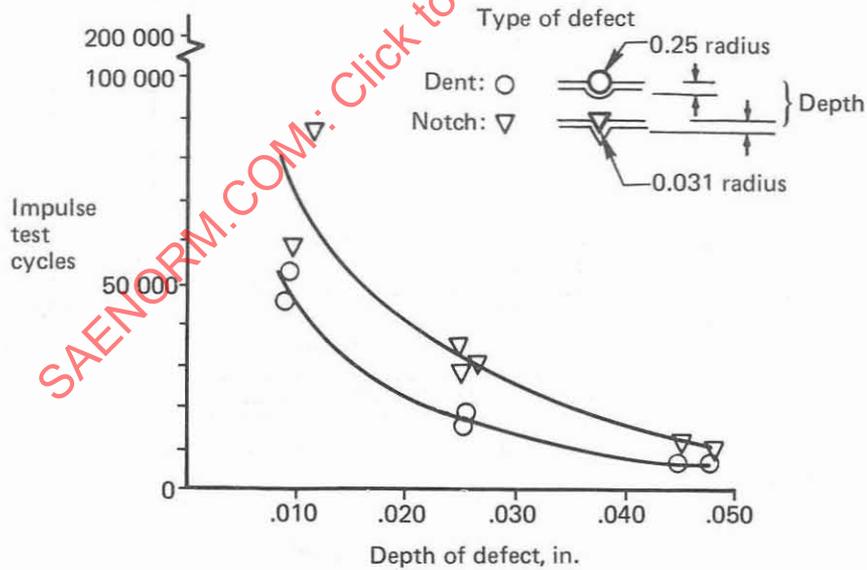
FIGURE 2. IMPULSE TEST PERFORMANCE OF 3/4 BY 0.039 3A1-2.5V CW TITANIUM TUBING WITH VARIOUS DEFECTS

Dent and Notch 0.025 In. Deep

Dent and Notch 0.050 In. Deep

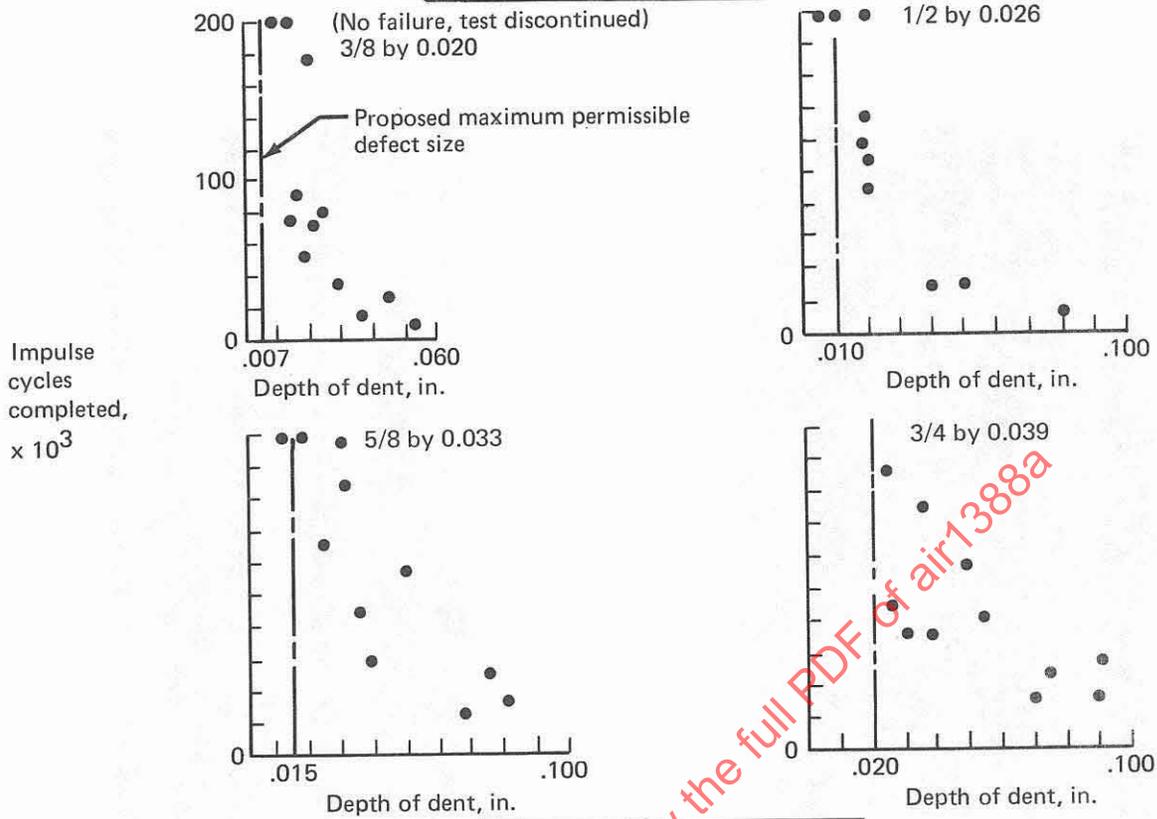
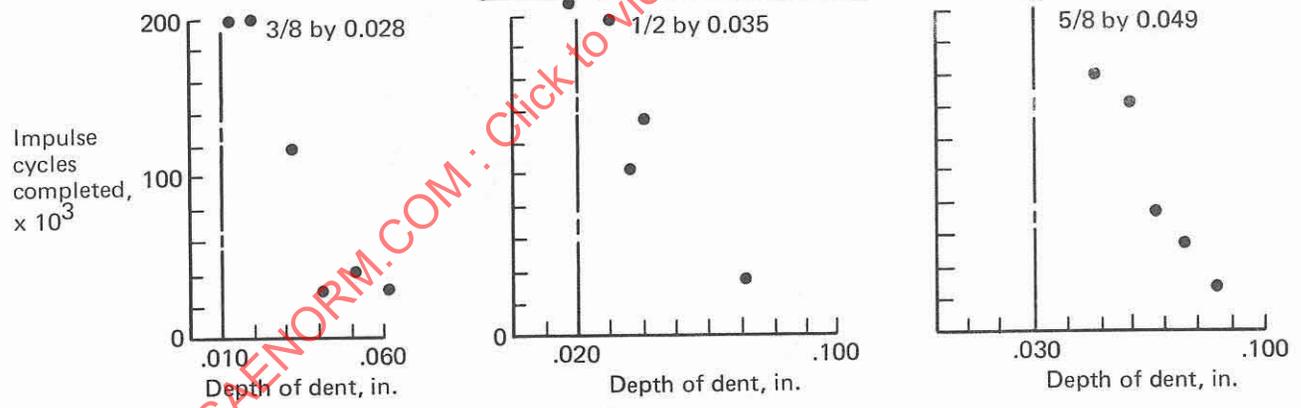
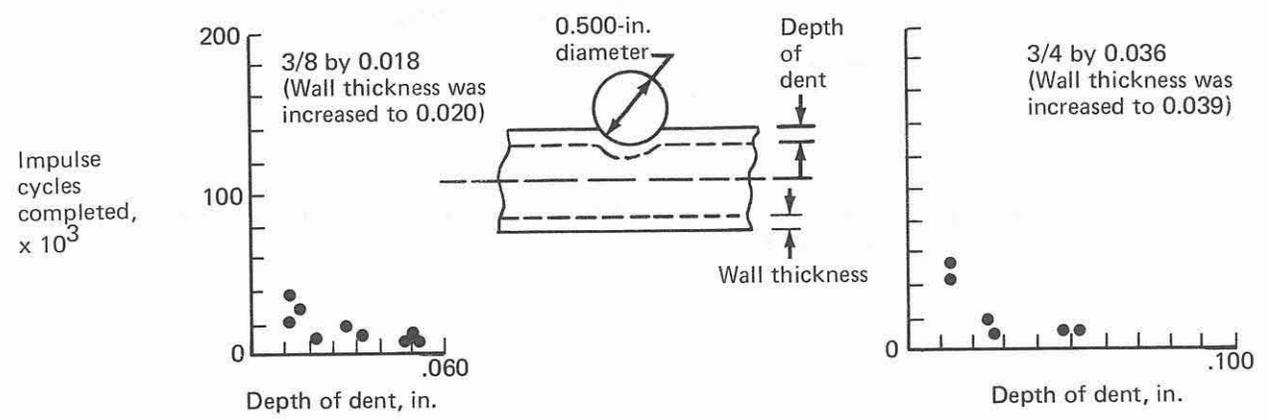
FIGURE 3. IMPULSE TEST DATA, DENTED TUBING, 3000-PSI SYSTEM

CRES 21Cr-6Ni-9Mn, AMS 5561 Type II

CRES 304 1/8 Hard, MIL-T-6845

Titanium 3Al-2.5V CW BMS 7-234

Chafing and Denting Depth: The data in Figures 3 through 15 indicate a sudden drop in the test performance when a critical defect depth is reached, thus permitting a conservative selection of acceptable defect levels. Figures 3 through 12 contain a compilation of impulse test data for 21Cr-6Ni-9Mn, 304 1/8 hard CRES, 3Al-2.5V CW 3000 psi, and 3Al-2.5V annealed 3000 psi tubing, having dents, notches, and chafes of varying depth. They illustrate the basis for the permissible limits recommended in Table 1, and for estimating the defect limits in tubing sizes that were not tested. Figures 13 and 14 indicate that dents and chafes severely reduce the impulse life of aluminum return line tubing in the larger sizes. Figures 11 and 12 contains the test results for chafing damage in 21-6-9 3000 psi hydraulic tubing. No burst tests for chafed 304 1/8H tubing were conducted; instead, the chafing limits are recommended for 21Cr-6Ni-9Mn were calculated to be more than safe for use with 304 1/8 hard tubing also. The effect of chafing and denting on 3Al-2.5V CW tubing was tested in all sizes used in 3000 psi systems. Figure 15 compares the effect of tube size and defect type on 3Al-2.5V titanium tubing.
