VISUAL INSPECTION GUIDE FOR INSTALLED HOSE ASSEMBLIES

1. SCOPE: This recommended practice covers visible surface defects on aerospace hose assemblies which have been installed and are functioning within a working environment at the time of visual inspection.

PREPARED BY
SAE COMMITTEE G-3
AEROSPACE FITTINGS, HOSE AND TUBING ASSEMBLIES

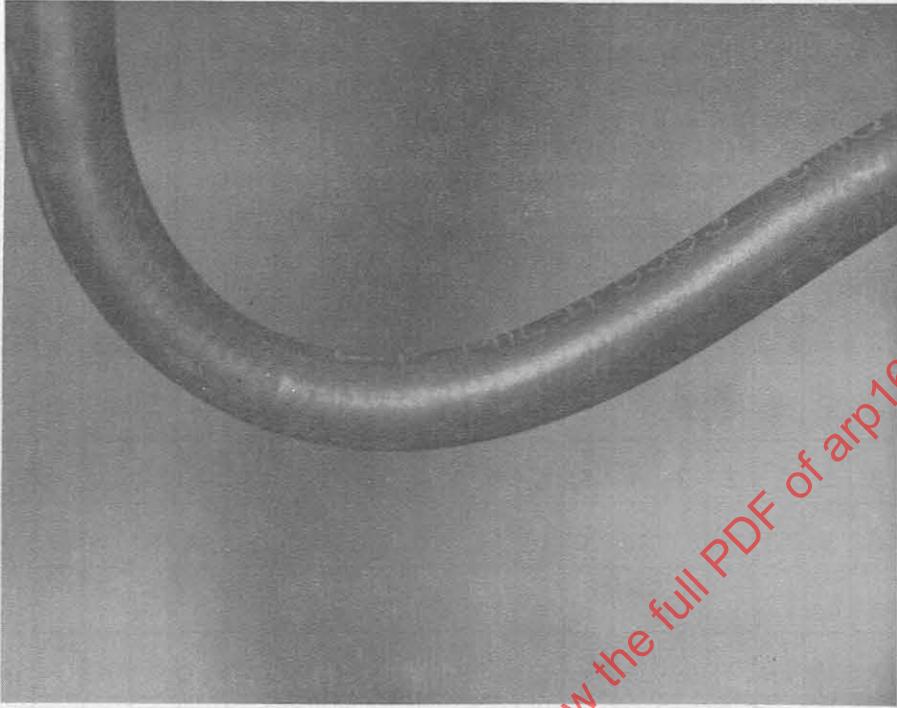
PLATE 1

5. IDENTIFICATION OF DEFECTS:
- 5.1 Kinked: Minor in body of low pressure hose.
Major if near fitting, indicating possible heavy stress, or in high pressure hose assemblies.

Kinked Assemblies - Minor and Major. Low Pressure Rubber
Hose (MIL-H-5593).

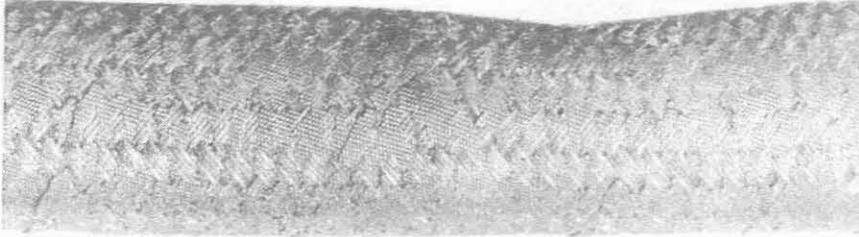
PLATE 3

Kinked Assemblies - Minor and Major. Medium Pressure Rubber
Hose with Fabric Cover.

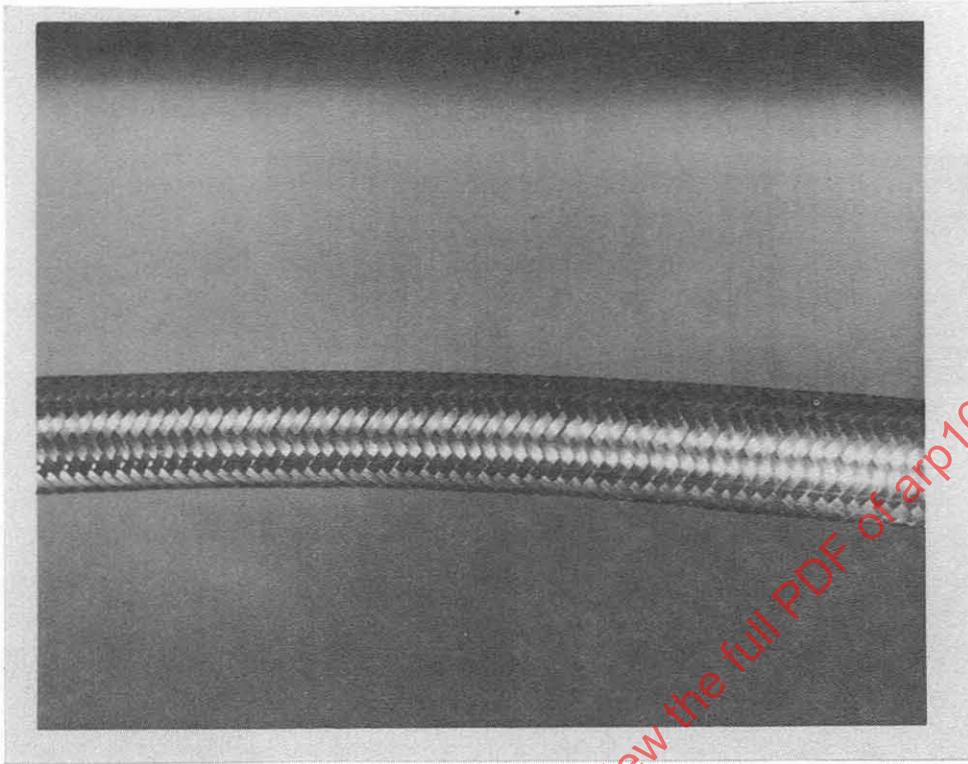
PLATE 5

Kinked Assemblies - Minor and Major. Medium Pressure Rubber
Hose with Stainless Steel Reinforcement
(Mil-H-83797).

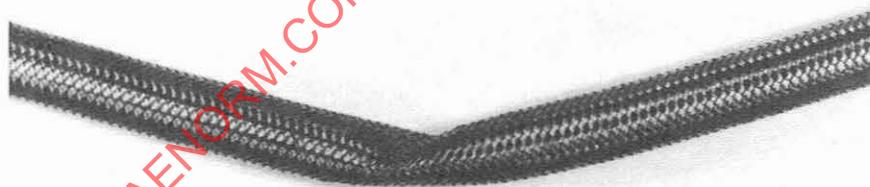
PLATE 8

Kinked Assemblies - Minor and Major. Low and Medium Pressure
Teflon Hose (MIL-H-25579/MIL-H-27267).

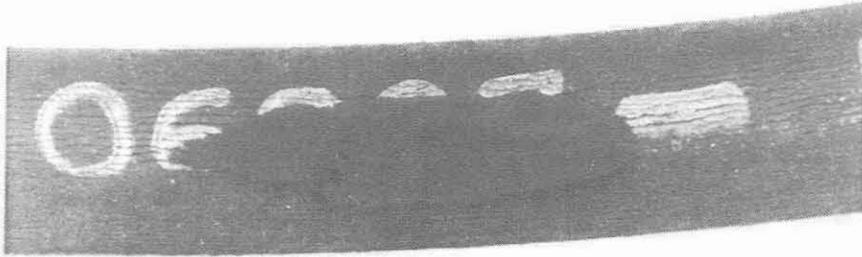
PLATE 9

- 5.3 Abrasion: Minor if confined to no more than two wires.
Major if extended throughout one plait or from one plait to
another.
Minor for rubber covered hose if confined to rubber cover of
hose.
Major for rubber covered hose if wire is exposed.

Abrasion - Minor and Major. Low Pressure Rubber Hose (MIL-H-5593).

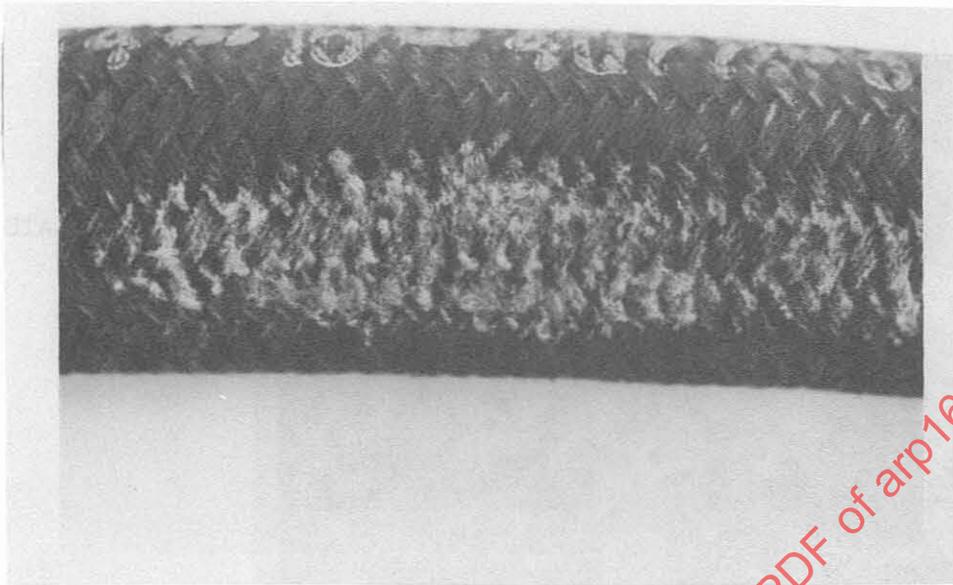
PLATE 11

Abrasion - Minor and Major. Medium Pressure Rubber Hose with Fabric Cover. (MIL-H-8794C).

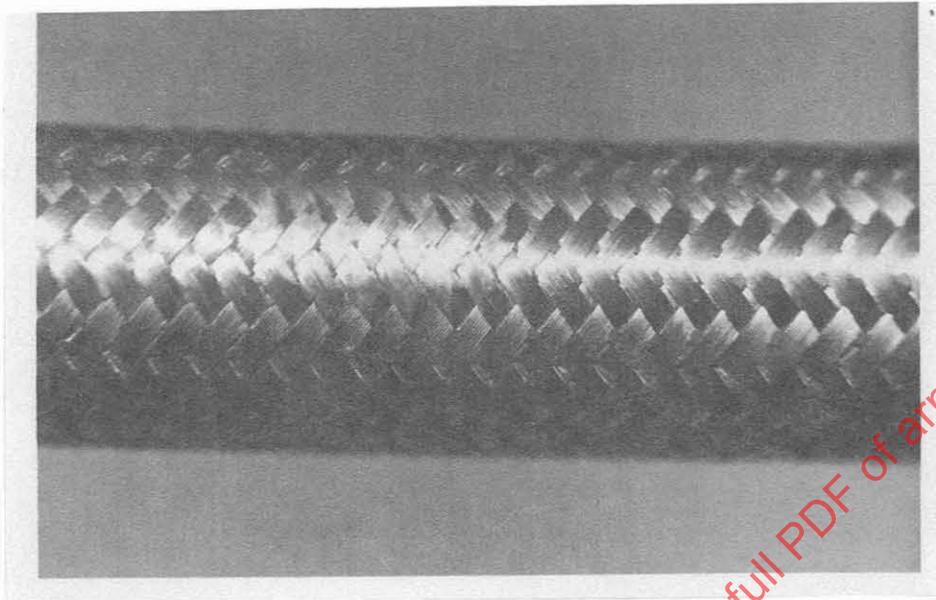
PLATE 13

Abrasion - Minor and Major. Medium Pressure Rubber Hose
with Stainless Steel Reinforcement.
(MIL-H-83797).

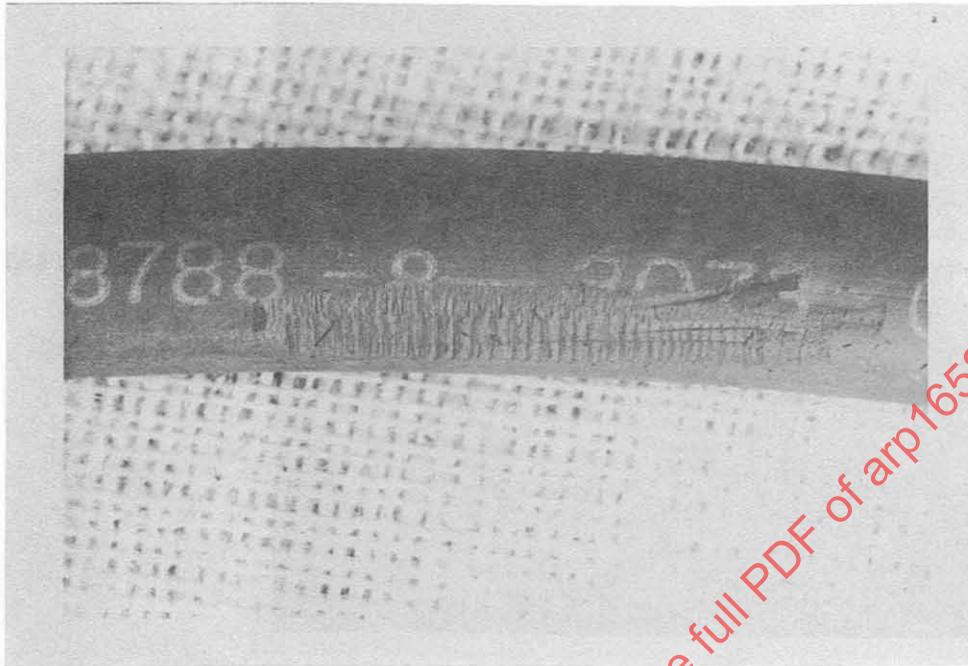
PLATE 15

Abrasion - Minor and Major. High Pressure Rubber Hose with Rubber Cover. (MIL-H-8788B).

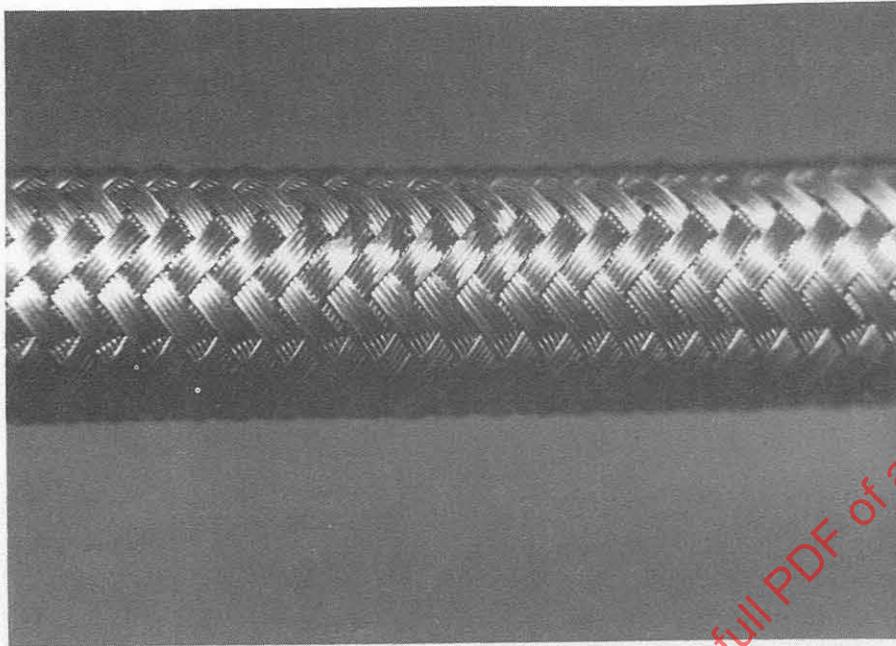
PLATE 17

Abrasion - Minor and Major. Low and Medium Pressure Teflon Hose.
(MIL-H-25579C/MIL-H-27267A).

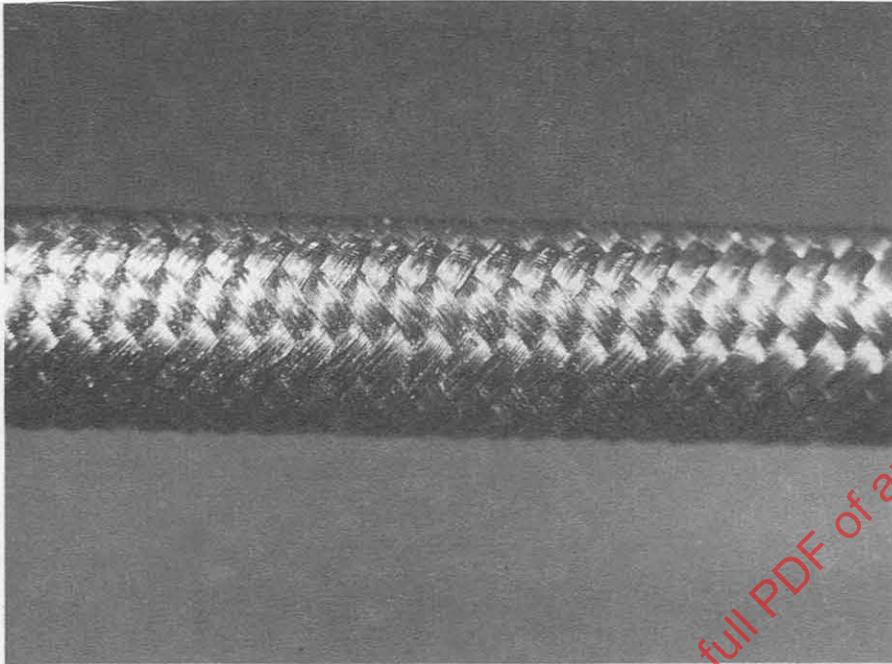
PLATE 19

Abrasion - Minor and Major. High Pressure Teflon Hose.
(MIL-H-38360).

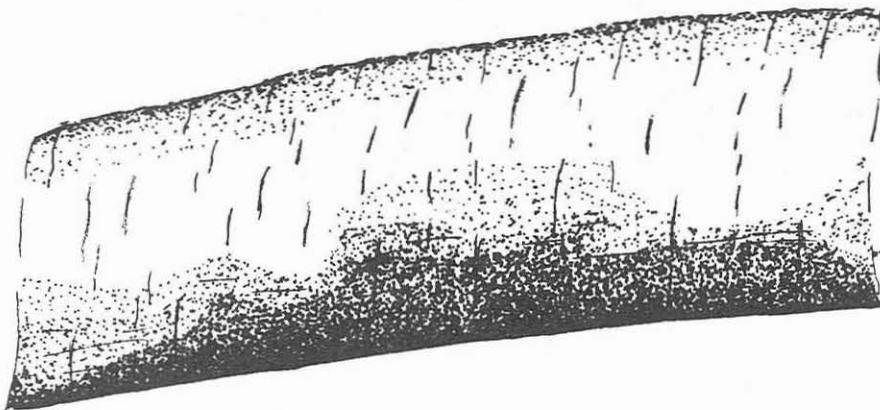
PLATE 21

- 6.18 Weathering: The surface deterioration of a hose cover during outdoor exposure, such as checking, cracking, crazing or chalking.
- 6.19 Wire Throw-Out: In braided hose, a broken end or ends in the wire reinforcements protruding from the surface of the braid.

Weathering - Minor and Major. Low Pressure Rubber Hose.
(MIL-H-5593).

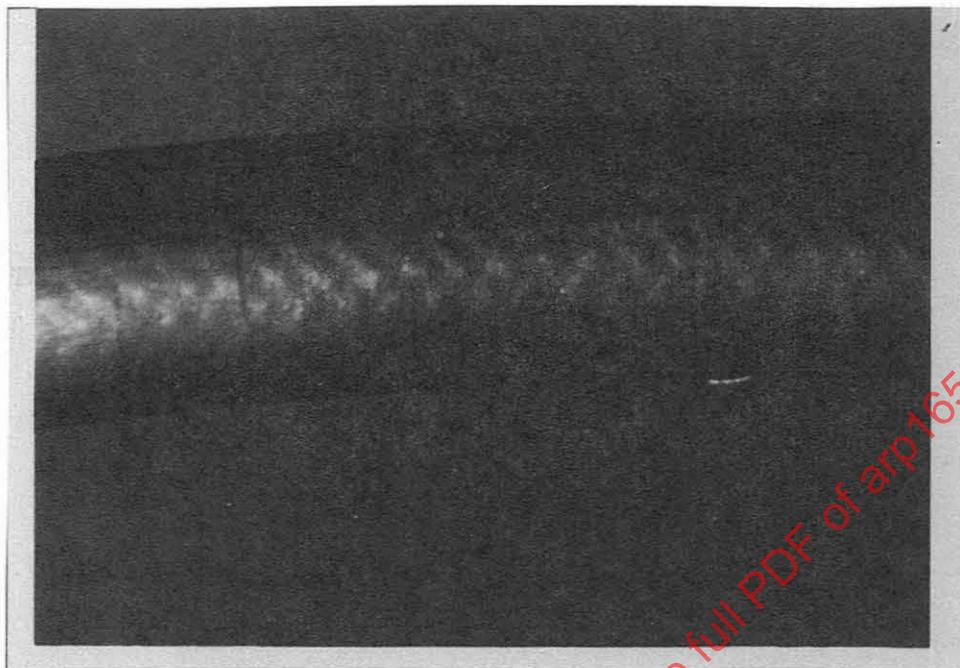
PLATE 25

- 6.9 Crazing: A surface effect on elastomeric hose cover material characterized by multitudinous minute cracks.
- 6.10 Heat Damage: Charring, chalking, or hardening and cracking of hose cover caused by excessive or prolonged exposure to heat. Other evidence may include fluid leakage from socket where fitting or coupling is attached to hose.

Heat Cracking - Minor and Major. Low Pressure Rubber Hose.
(MIL-H-5593).

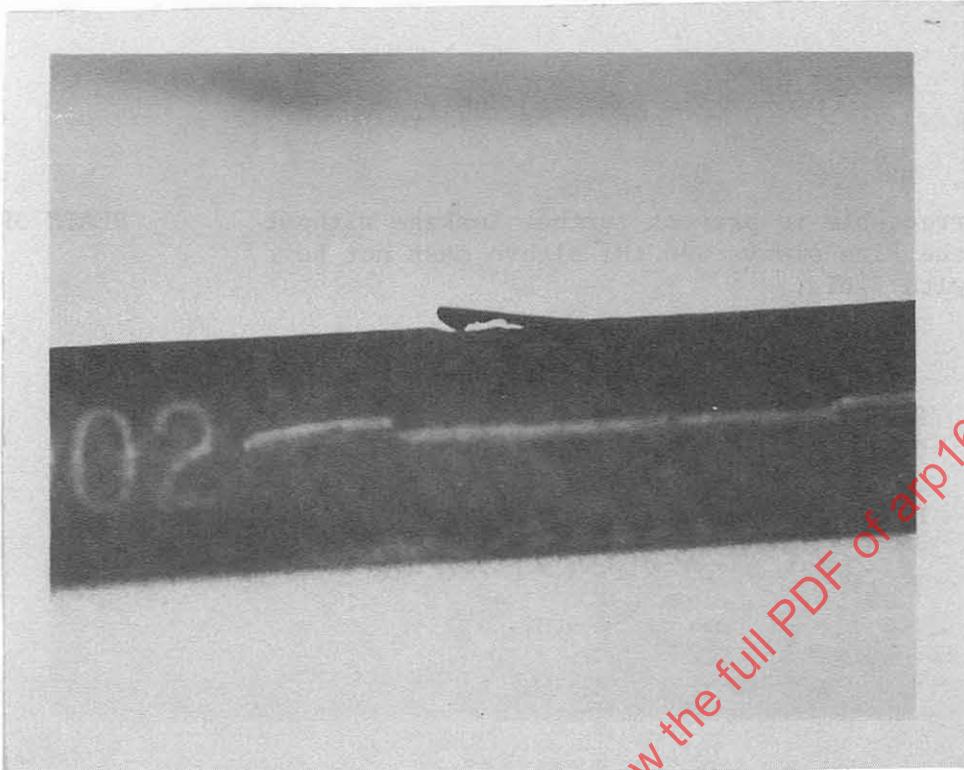
PLATE 41

- 6.15 Tears: A sharp break or fissure in the surface of a hose cover, generally caused by strain and service conditions.
- 6.16 Torn Sleeve: A firesleeve which evidences surface tear, or which has been stretched in two or fissured to the degree that it will no longer provide adequate fire protection to the hose assembly.

Tears - Minor and Major. Low Pressure Rubber Hose.
(MIL-H-5593).

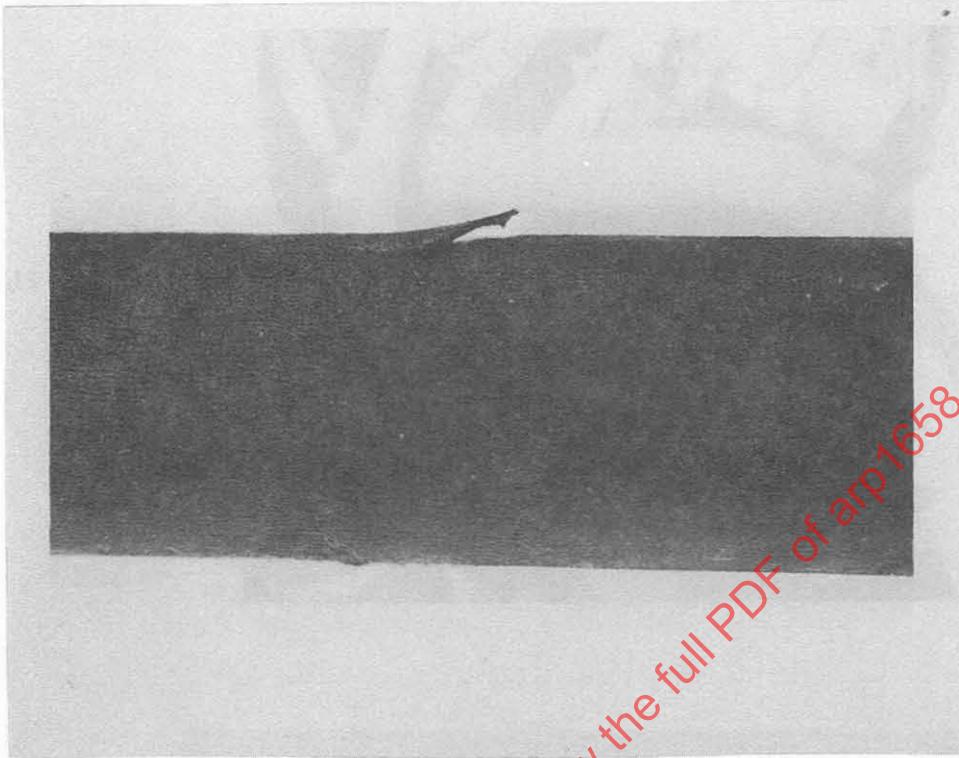
PLATE 43

Tears - Minor and Major. High Pressure Rubber Hose with Rubber Covering. (MIL-H-8788B).

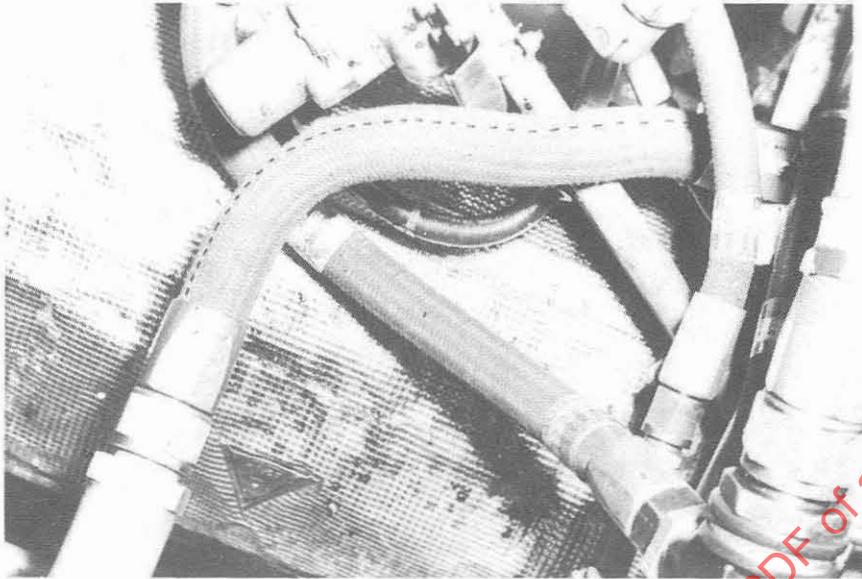
PLATE 45

- 5.4 Corrosion: Major if any detectable corrosion of wire.
- 5.5 Twisted: Major if wires are broken or liner cannot be rounded out.
Major on all spirally reinforced hose.

- 6.17 Twist: A hose or hose assembly subjected to internal pressures or improperly installed so that each end of the hose is turned awkwardly about the hose axis in opposing directions.

Twist - Minor and Major. Medium Pressure Rubber Hose with Fabric Cover. (MIL-H-8794C).

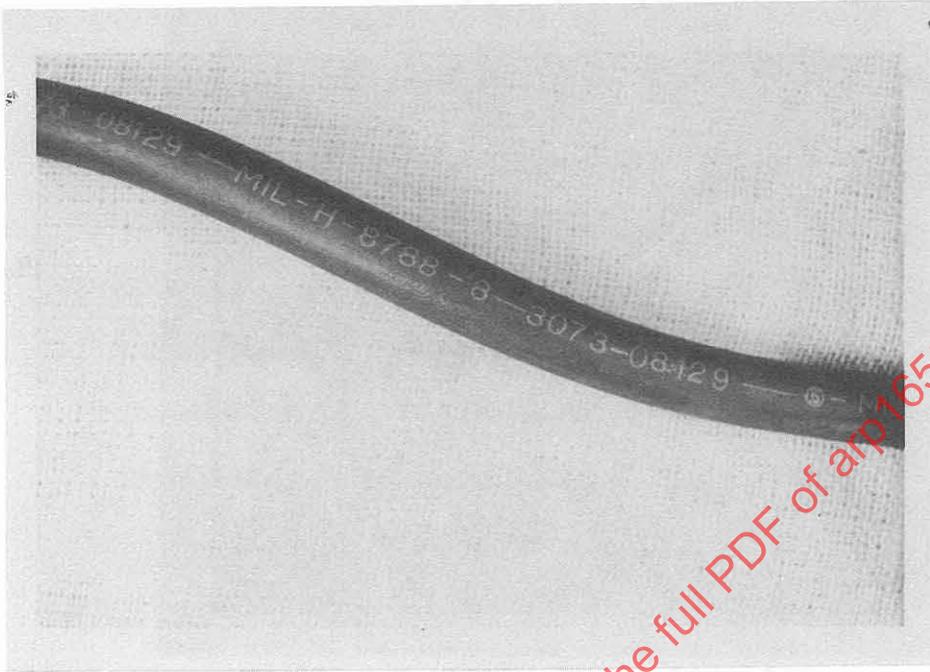
PLATE 47

Twist - Minor and Major. High Pressure Rubber Hose with Rubber Cover. (MIL-H-8788B).

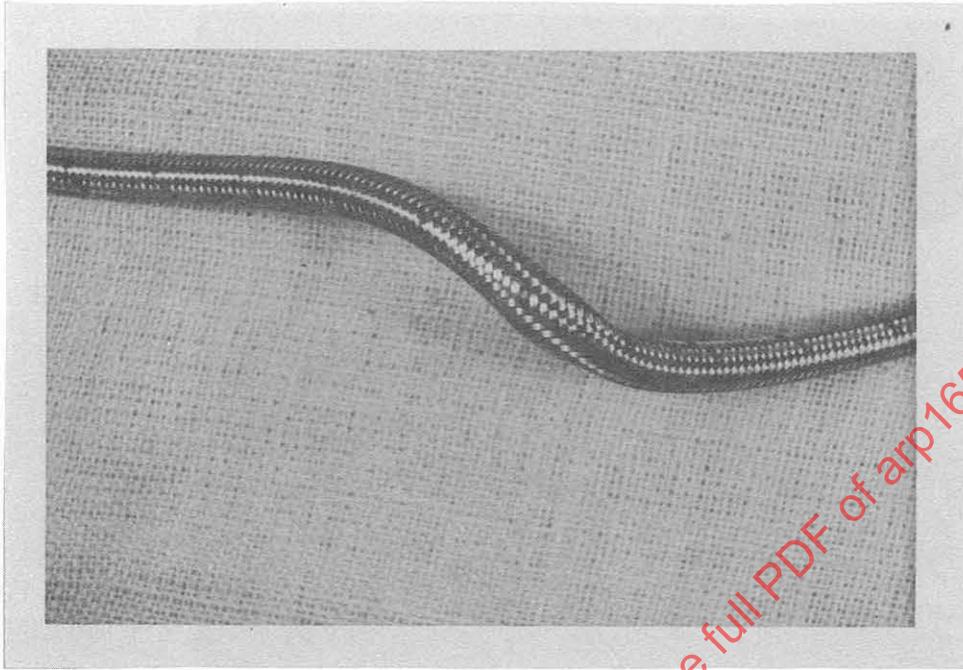
PLATE 49

Twist - Minor and Major. Low and Medium Pressure Teflon Hose.
(MIL-H-25579C/MIL-H-27267A).

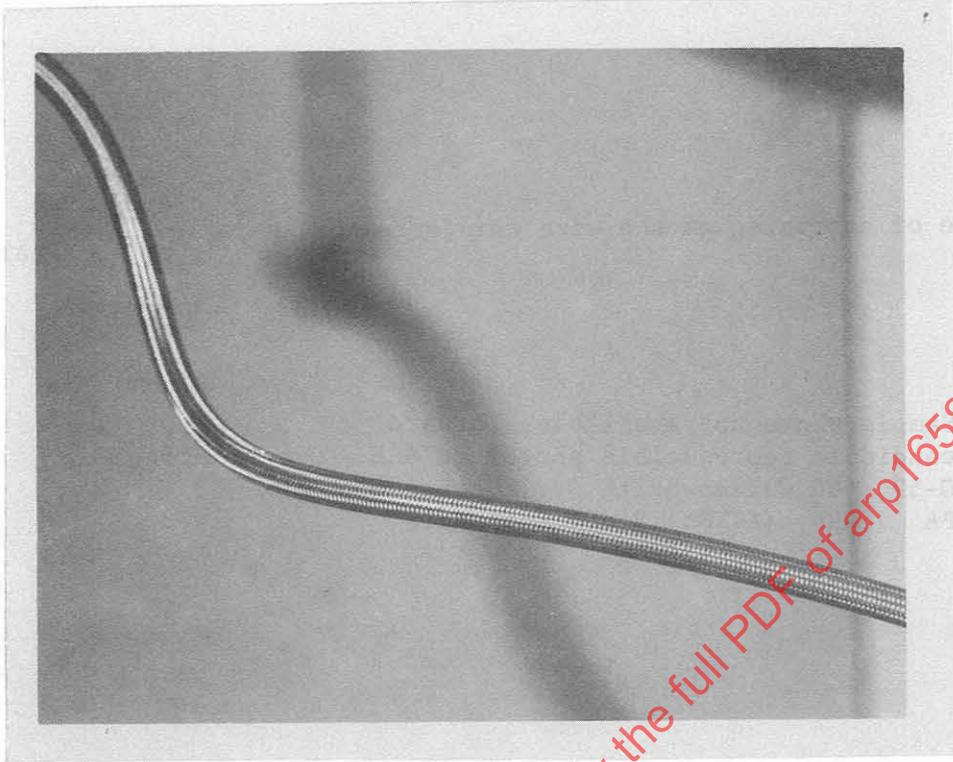
PLATE 51

Twist - Minor and Major. High Pressure Teflon Hose.
(MIL-H-38360).

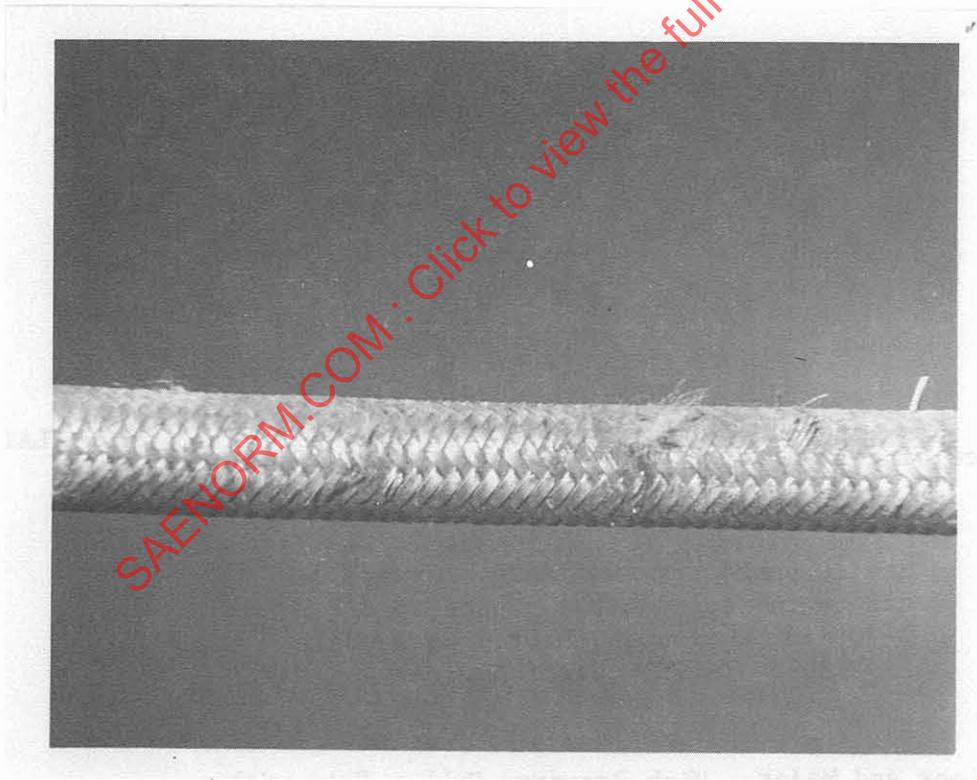
PLATE 56

- 6.5 Checking: Short, shallow cracks on the surface of an elastomeric hose
cover material resulting from damaging action of environmental conditions.
- 6.6 Corrosion: A physical discoloration of hose cover or reinforcement
indicative of material degradation due to extreme heat, chemical attack,
weathering, oxidation, etc.

Corrosion - Minor and Major. Medium Pressure Rubber Hose with Stainless Steel reinforcement. (MIL-H-83797).

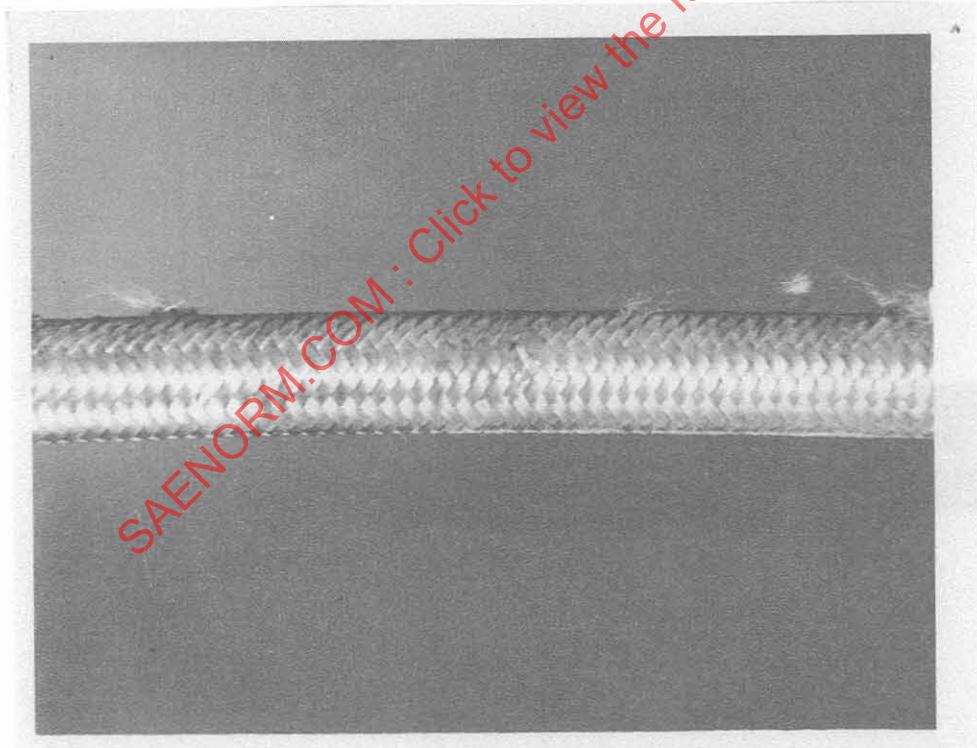
PLATE 62

Corrosion - Minor and Major. High Pressure Teflon Hose.
(MIL-H-38360).

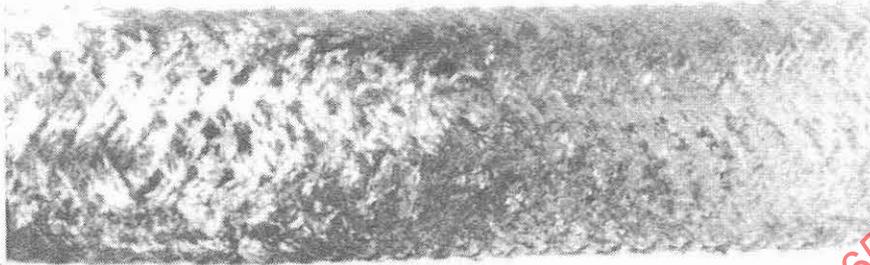
PLATE 63

Heat Damage - Minor and Major. Medium Pressure Rubber Hose with Fabric Cover. (MIL-H-8794C).

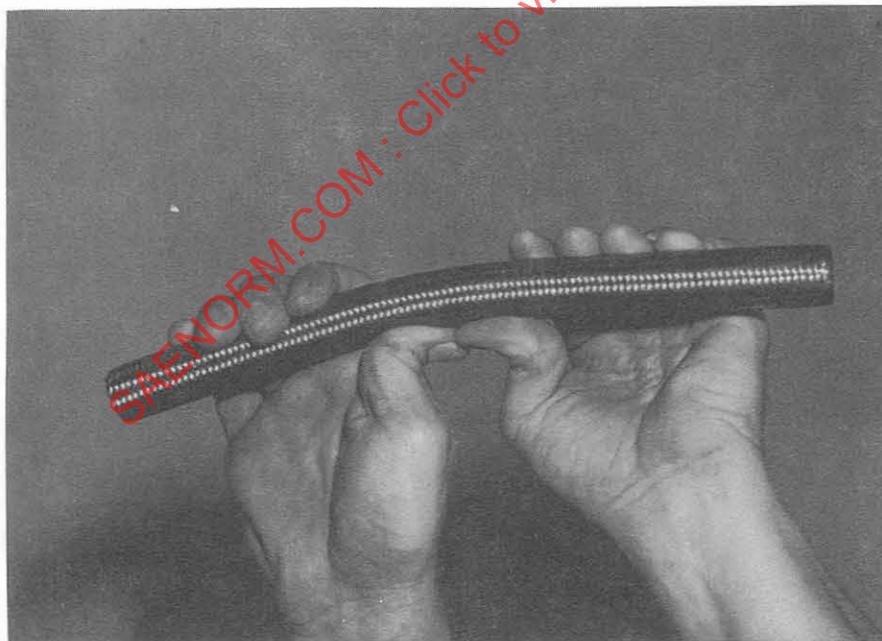
PLATE 66

Heat Damage - Minor and Major. Medium Pressure Rubber Hose with Stainless Steel Reinforcement. (MIL-H-83797).

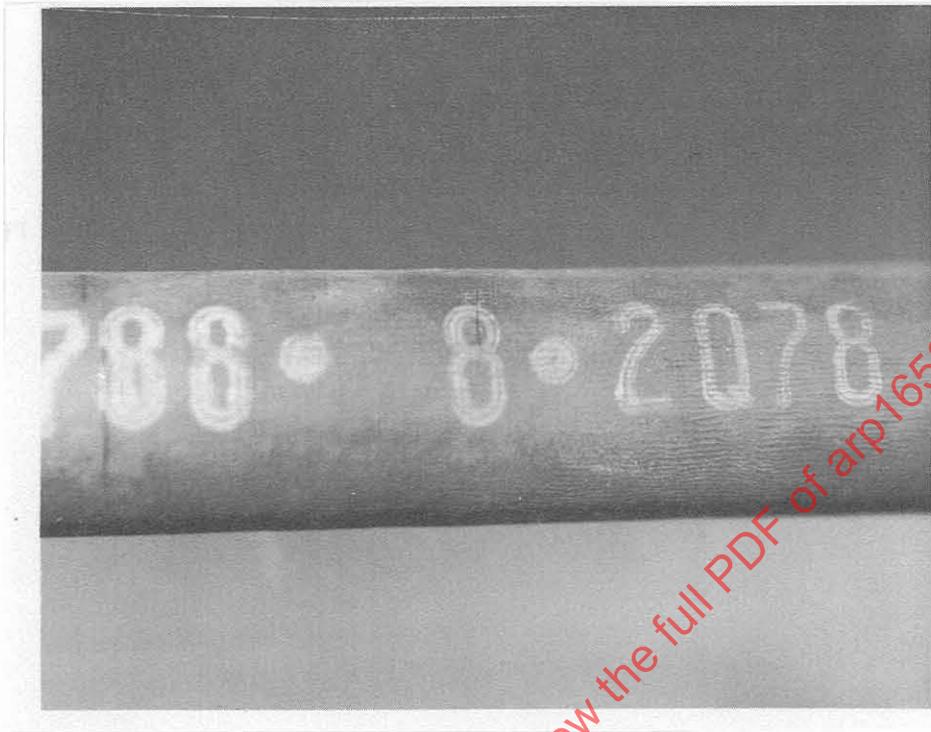
PLATE 67

Heat Damage - Minor and Major. High Pressure Rubber Hose with Rubber Cover. (MIL-H-8788B).
