AEROSPACE RECOMMENDED PRACTICE	ARP1658™	REV. C
	Issued 1982-03 Reaffirmed 2014-10 Revised 2024-02	
Superseding ARP1658B		
Hose Assemblies, Installed, Visual Inspection Guide for

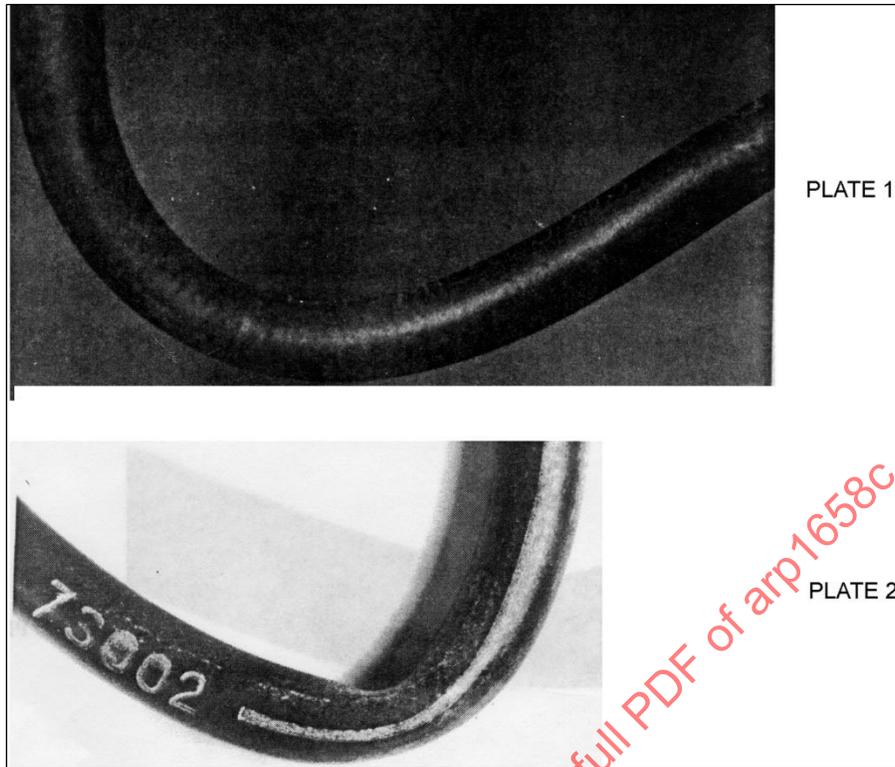
Figure 2 - Kinked assemblies - minor and major low-pressure rubber hose (MIL-H-5593)

Minor: In body of low-pressure hose.

Major: If near fitting, indicating possible heavy stress, or in medium- or high-pressure hose assemblies.

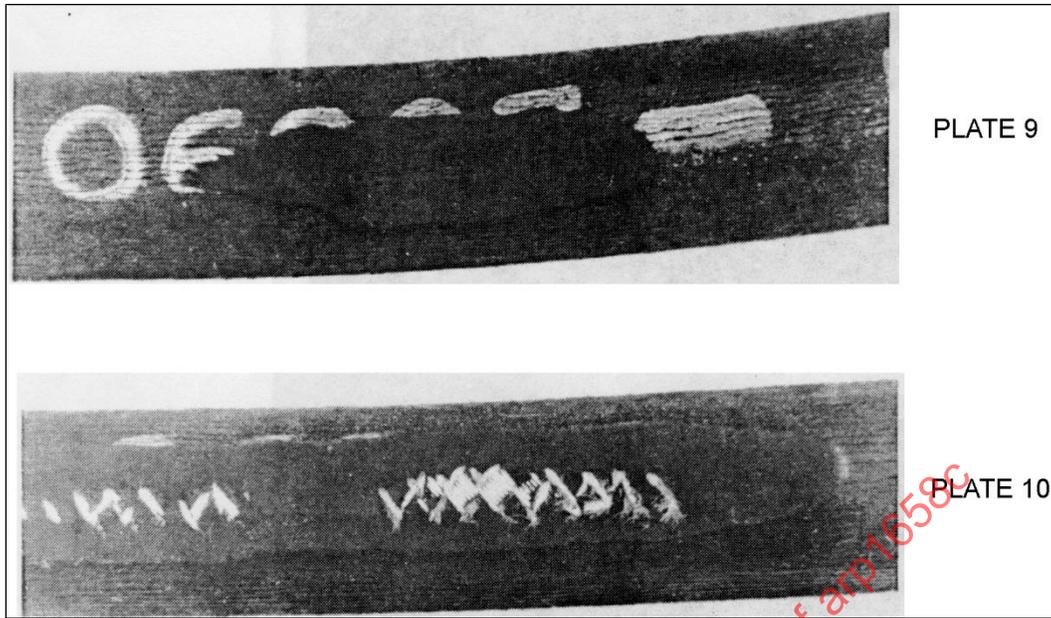
**Figure 6 - Abrasion - minor and major
low-pressure rubber hose
(MIL-H-5593)**

Minor: For rubber covered hose if confined to rubber cover of hose.

Major: For rubber covered hose if wire is exposed.

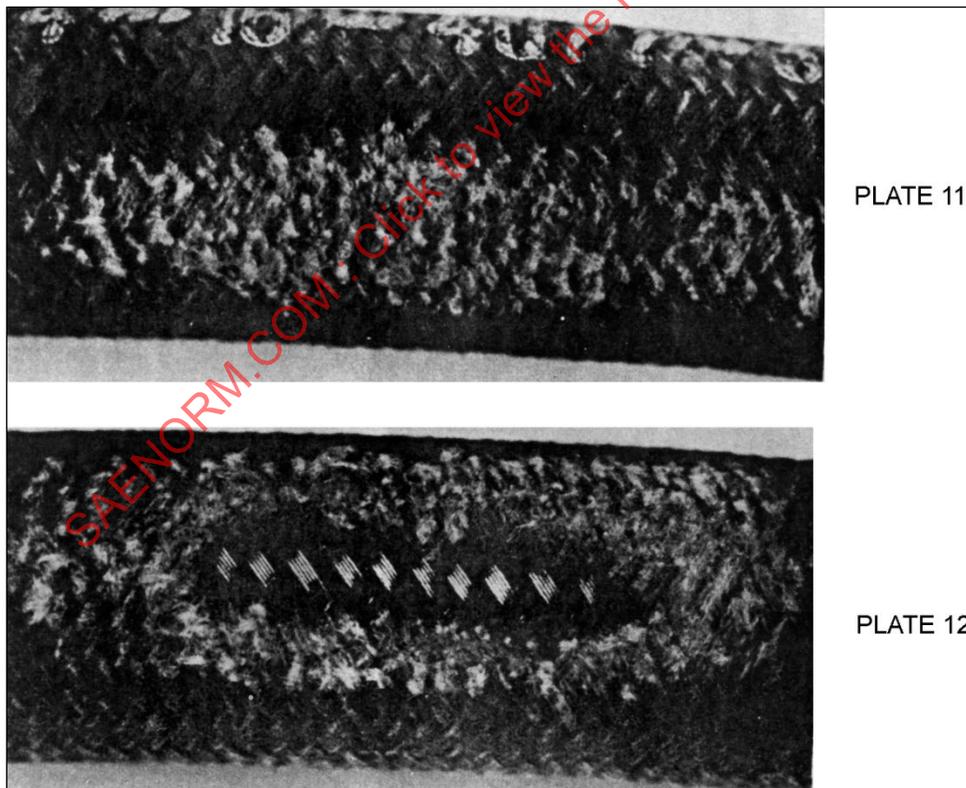
**Figure 7 - Abrasion - minor and major
medium-pressure rubber hose with fabric cover
(MIL-H-8794)**

Minor: If confined to no more than two wires.

Major: If extended throughout one plait or from one plait to another.

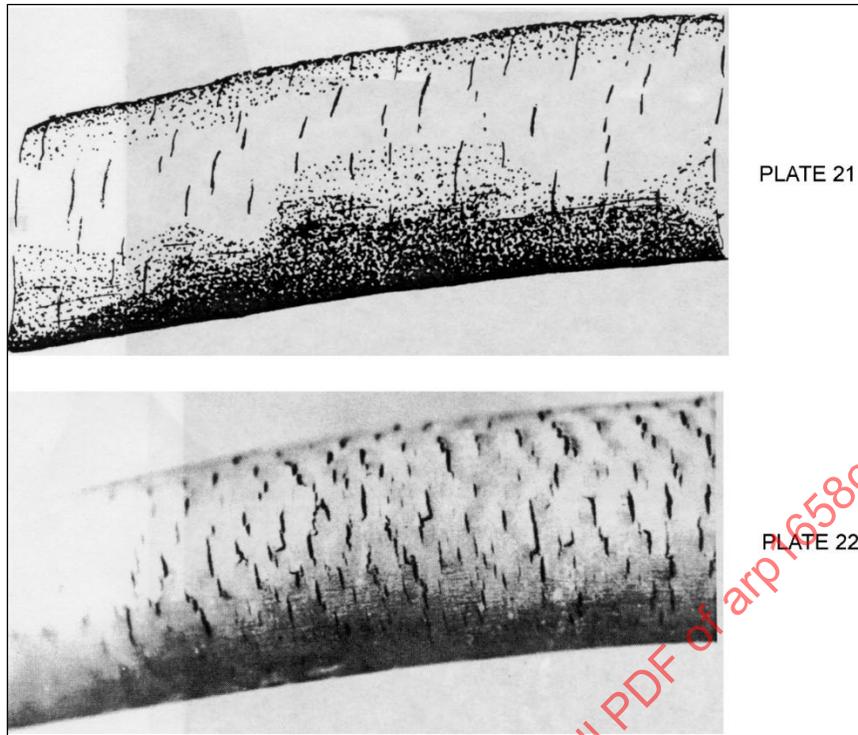
Figure 12 - Weathering - minor and major low-pressure rubber hose (MIL-H-5593)

WEATHERING: The surface deterioration of a hose cover during outdoor exposure, such as checking, cracking, crazing, or chalking.

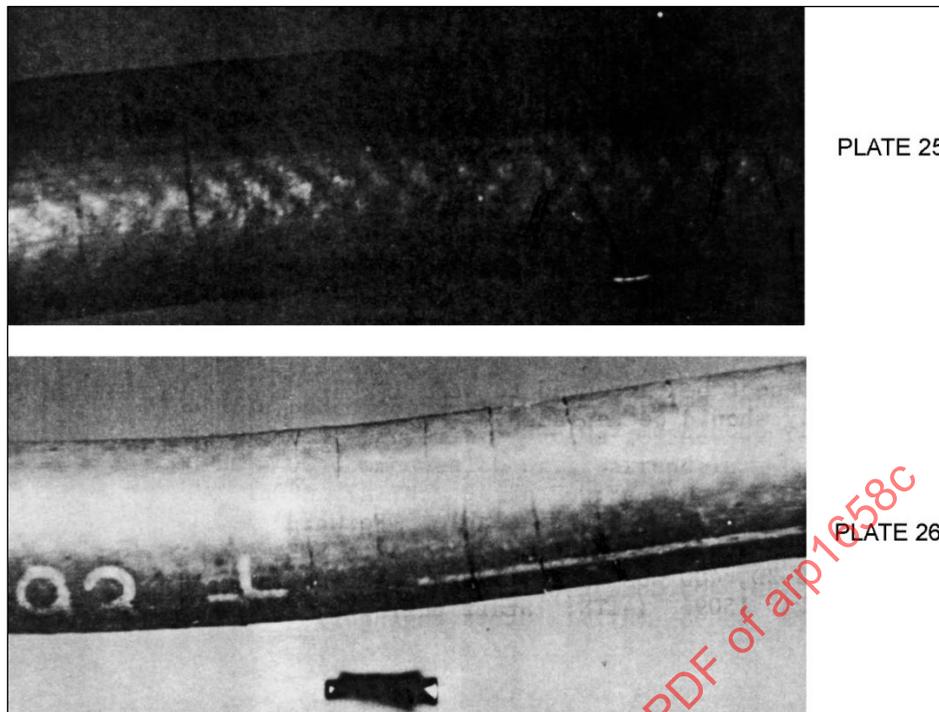
**Figure 14 - Heat cracking - minor and major
low-pressure rubber hose
(MIL-H-5593)**

HEAT DAMAGE: Charring, chalking, or hardening and cracking of hose cover caused by excessive or prolonged exposure to heat. Other evidence may include fluid leakage from socket where fitting or coupling is attached to hose.

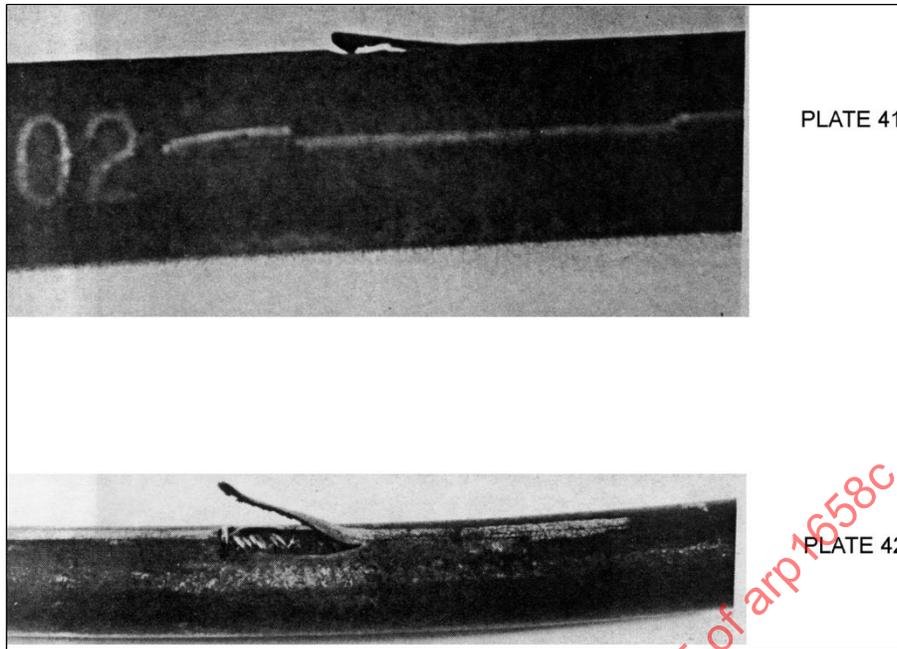
**Figure 22 - Tears - minor and major
low-pressure rubber hose
(MIL-H-5593)**

TEARS: A sharp break or fissure in the surface of a hose cover, generally caused by strain and service conditions.

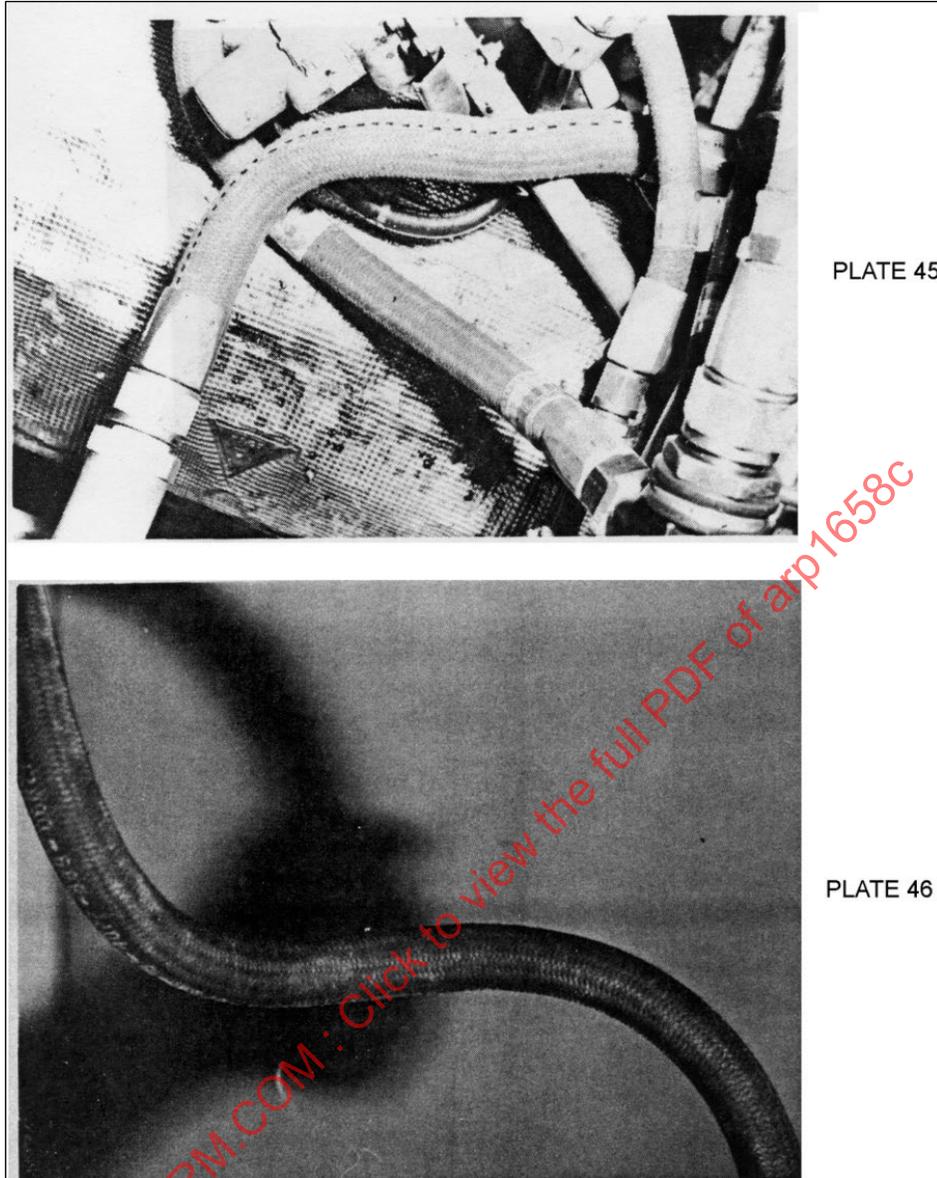
**Figure 24 - Twist - minor and major
medium-pressure rubber hose with fabric cover
(MIL-H-8794)**

Minor: On all spirally reinforced hose.

Major: If wires are broken or liner cannot be rounded out.
