# CORROSION OF A193 GRADE B7 BOLT MATERIAL IN BWR SODIUM PENTABORATE SOLUTIONS

STP-NU-068

Date of Issuance: March 14, 2014

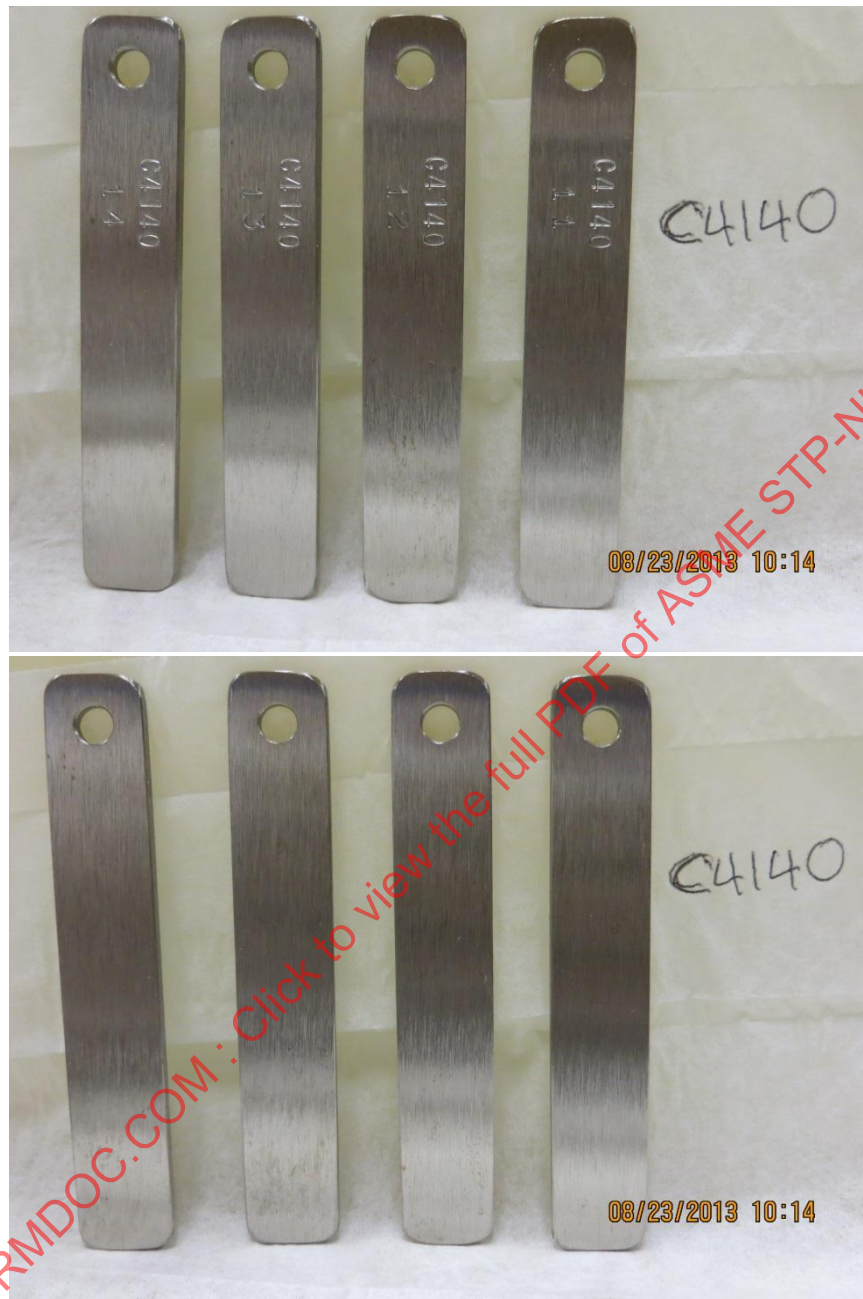
**Figure 3-12: C4140 Test Coupons 11, 12, 13 and 14 after Two Months of Exposure**

Visual observations of the coupons throughout the exposure indicated minimum corrosion of all materials. All solutions remained clear. Coupons were initially removed for inspection on July 17 after ~22 days of exposure. They were rinsed with demineralized water (~0.1 µS/cm) and then air dried for several hours before visual inspection and weighing. There was no visual indication of corrosion on any of the coupons, and the coupons were not photographed. They were again removed after two months of exposure, weighed, visually inspected and photographed (Figure 3-7 to Figure 3-10). There were no indications of general or localized corrosion on the surfaces of any of the materials. However, there was a slight dulling of the C4140 coupon surfaces.
