AIR4092

## INVESTIGATION OF PTFE "MELT" PHENOMENON FOR HIGH PRESSURE HOSES

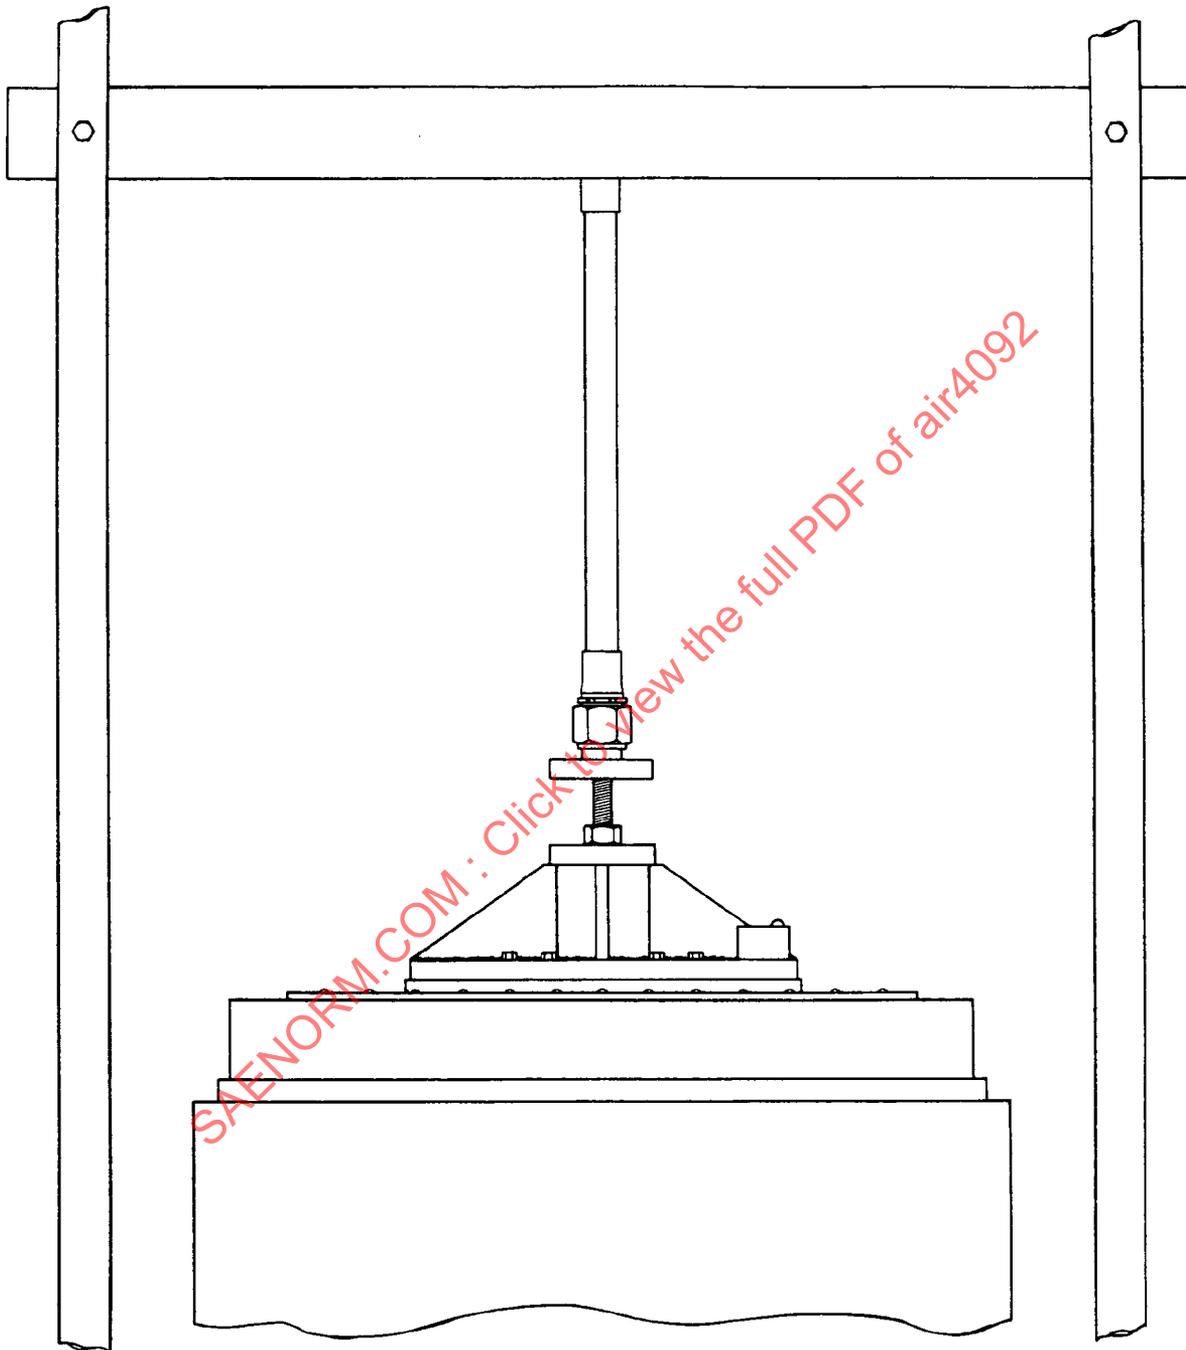
FIGURE 3

1. 18 in long, "230" Series, -8 size assemblies using straight to straight flared fittings. This is the lightweight, high pressure hose (see Fig. 1). Conforms to AS1339 and AS115 (bare hose) and MIL-H-38360.
2. 18 in long assembly is identical to sample 1, except it has an integral silicone firesleeve (see Fig. 2). Conforms to AS1339 and AS115 (integral firesleeve) 15 min and MIL-H-38360.
3. 18 in long assembly, "660" Series, -8 size assemblies using straight to straight flared fitting. This is the heavy duty spiral-wrapped, high pressure hose (see Fig. 3). Conforms to AS 604 and AS 621 (bare hose) and MIL-H-38360.
