AEROSPACE HYDRAULICS AND ACTUATION LESSONS LEARNED

SAE AIR4543

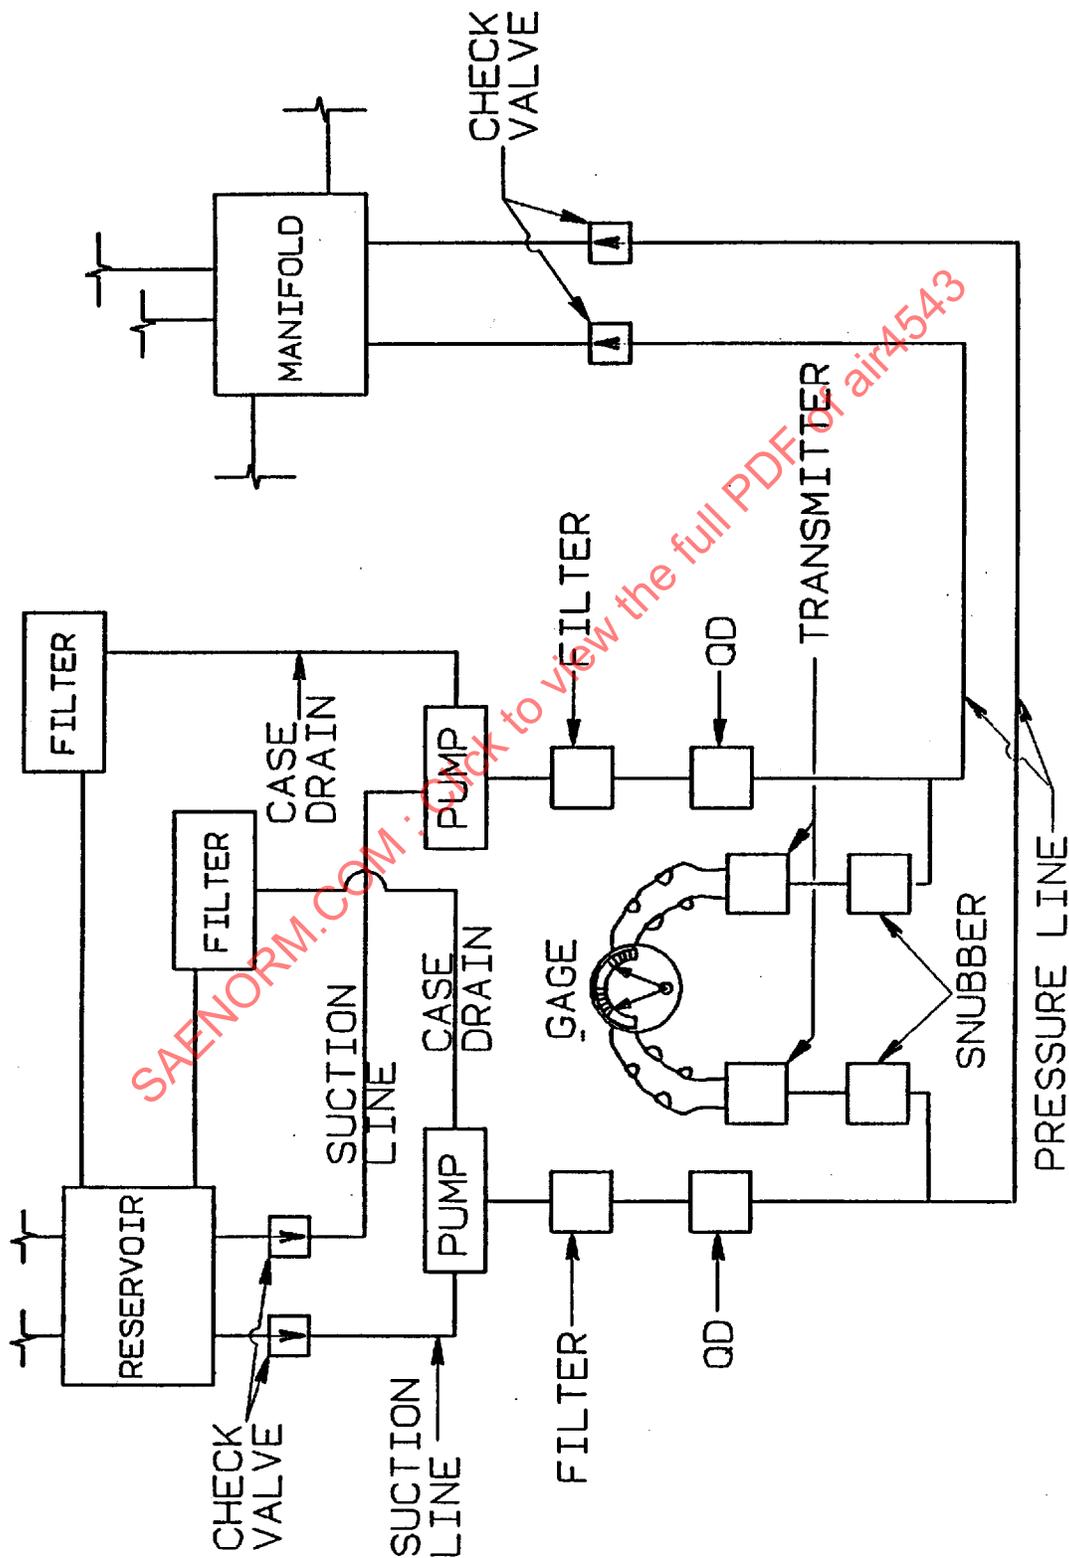
FIGURE 3.1.7 (Continued)

- ISSUE:**
1. On the initial engine run of a twin engine aircraft the R/H pump suction line burst.
 2. The line was replaced and the R/H engine started - no problem.
 3. The L/H engine was started and the R/H suction line burst.
 4. The line was replaced and the L/H engine started - no problem.
 5. The R/H engine was then started and the R/H suction line burst.

- SOLUTION:**
1. The R/H pump compensator was found to have a slightly lower pressure setting than required.
 2. A failed pump outlet check valve created a reverse pumping situation on the R/H side.
 3. Pump and check valve were replaced.

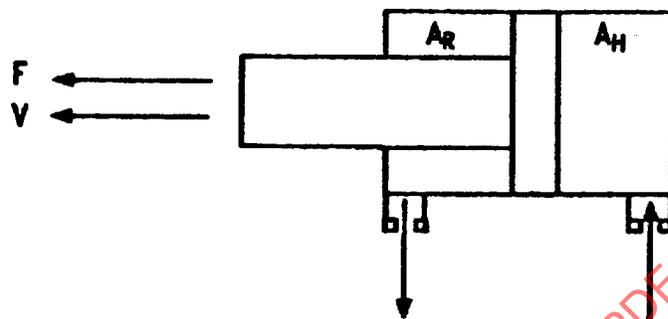
ISSUE: Velocity control restrictors must be sized to prevent overpressure and cavitation.

$$F = \left[P_R + \frac{A_R^2 V^2 C_1^2}{C_R^2} \right] A_H - \left[P_S - \frac{A_H^2 V^2 C_1^2}{C_H^2} \right] A_H$$

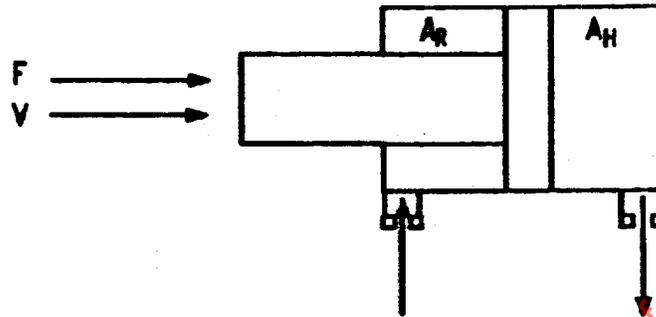
ISSUE: Velocity control restrictors must be sized to prevent overpressure and cavitation.

$$F = \left[P_R + \frac{A_H^2 V^2 C_1^2}{C_H^2} \right] A_H - \left[P_S - \frac{A_R^2 V^2 C_1^2}{C_R^2} \right] A_R$$
