AEROSPACE INFORMATION REPORT

SAE AIR4543

Issued 1992-01
 Revised 2000-06

Aerospace Hydraulics and Actuation Lessons Learned

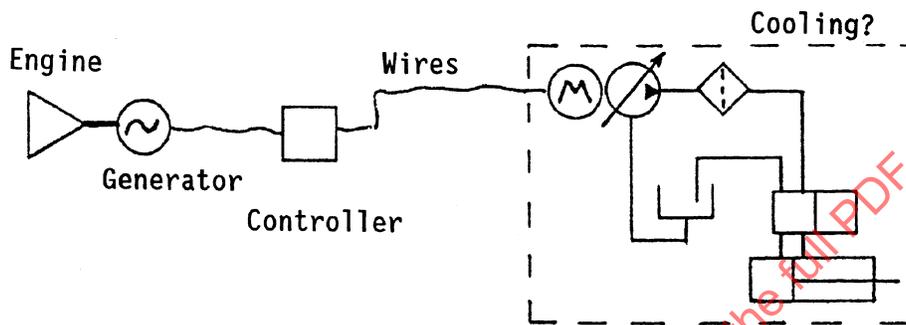
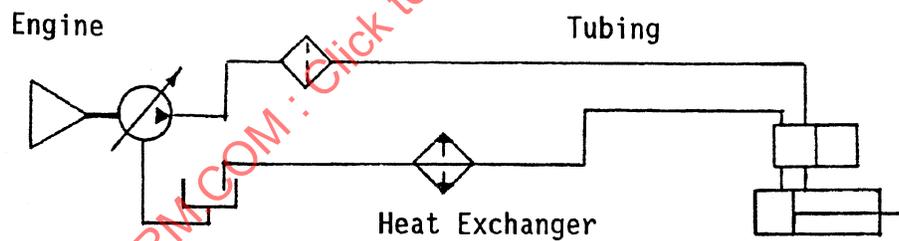
FIGURE 3.1.2 - Biased Trade Studies

ISSUE: Trade studies often fail to assess all influences on the air vehicle.

Frequently in such trade studies the following issues are not compared:

- Cooling
- Power transmission
- Power conversion

SOLUTION: Conduct the trade study from the point of original power generation (usually the engine) to the point of final utilization.

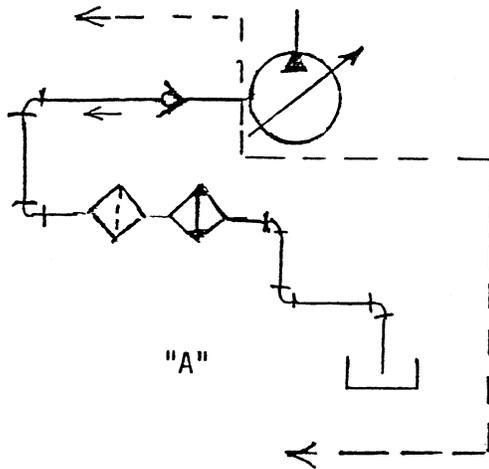
FIGURE 3.1.5 - Pump or Motor Case Drain Line Design

ISSUE: Restrictions in the hydraulic pump/motor case drain plumbing can cause high pressure and subsequent failure of the pump/motor case. Restrictions can be caused by too small diameter tubing, long tubing lengths, or improper component installation. The restrictions can result in high line pressure drop, resulting in high pressures in the pump or motor case. Pump and motor cases are generally designed to a 500 psi proof pressure or less.

Design pressure (pump/motor case) must be higher than any combination of A:

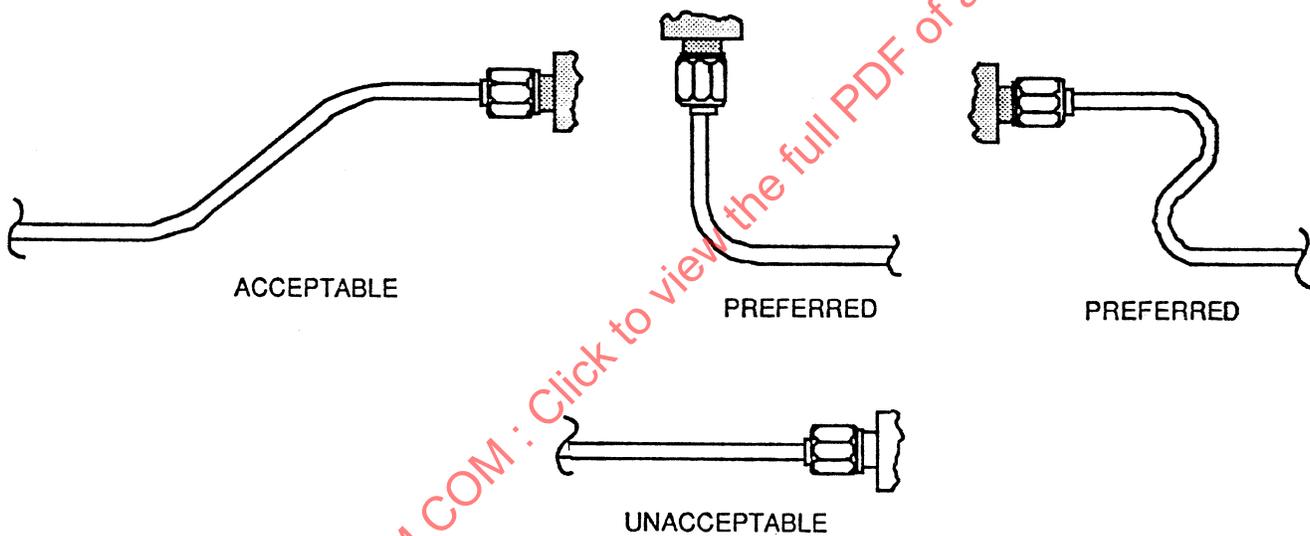
FIGURE 3.1.14 - Hydraulic Component Installation/Tubing Tolerances

- ISSUE:
1. During initial installations, tubes without flexibility cannot be sufficiently extended for fit.
 2. Tubes without flexibility sustain damage from pressure surges and vibration.

SOLUTION: Incorporate bend(s) in the hydraulic tubing to increase the tolerances and dissipate surges.

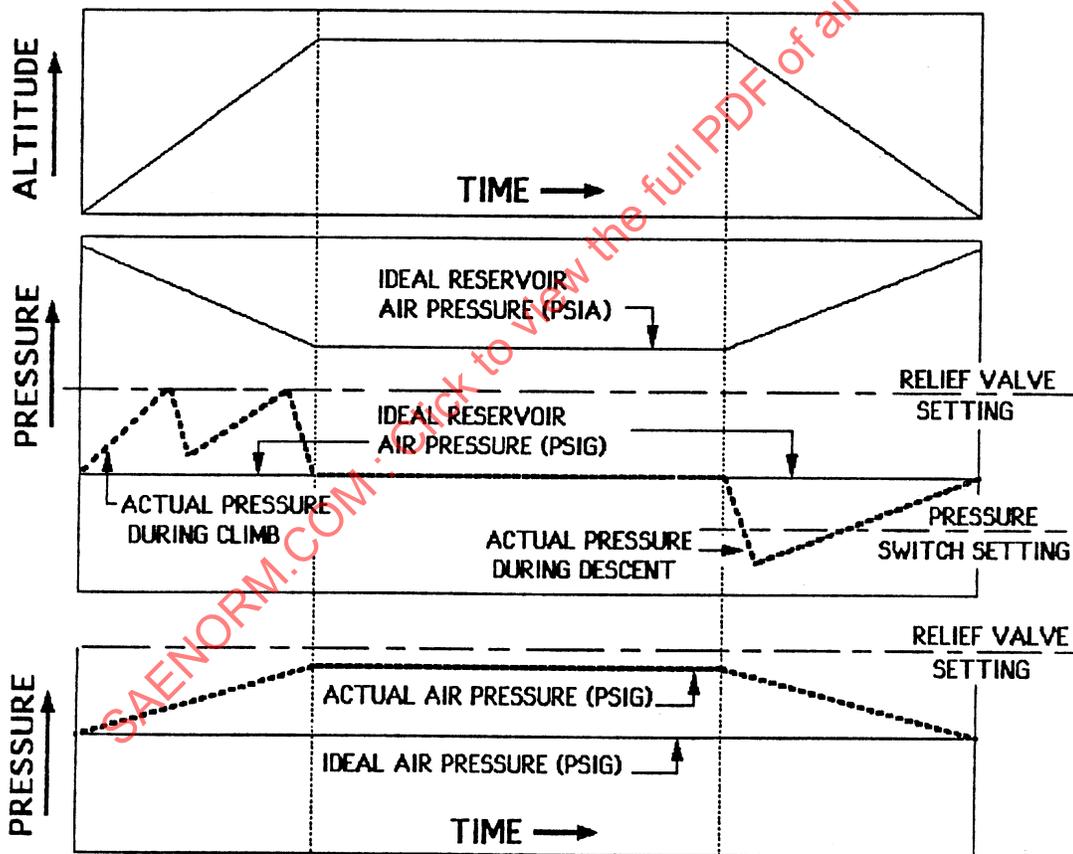
FIGURE 3.1.17 - Spurious Hydraulic Reservoir Low Air Pressure Warning

- ISSUE:
1. During aircraft descent, hydraulic reservoir low air pressure warnings occurred although the reservoir pneumatic pressurization system was fully serviceable.
 2. The engine bleed air pressure with engines at flight idle was less than the pressure switch setting.

SOLUTION: Either reset the pressure switch to be less than the minimum bleed pressure or set the relief valve so that it does not operate during aircraft climb.

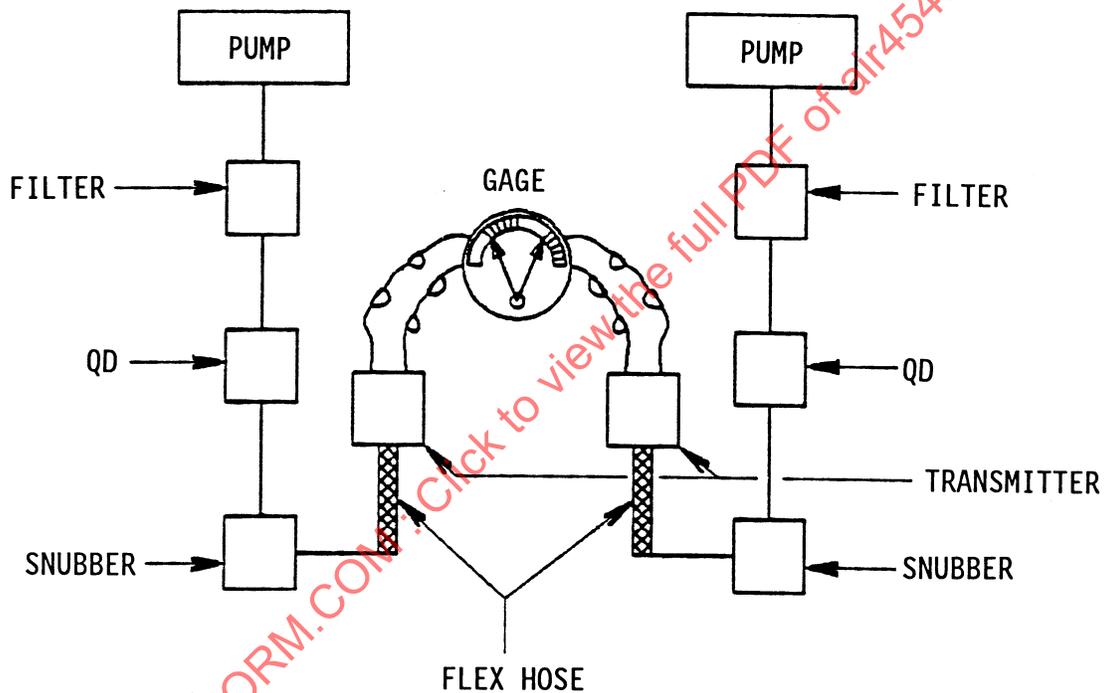
FIGURE 3.1.18 - False Pressure Transmitter Indication

ISSUE: While both pumps were off one gage indicated a pressure reading. It was discovered that the inner lining of the flex hose collapsed and had acted like a check valve.

SOLUTION: Replace the flex hose.

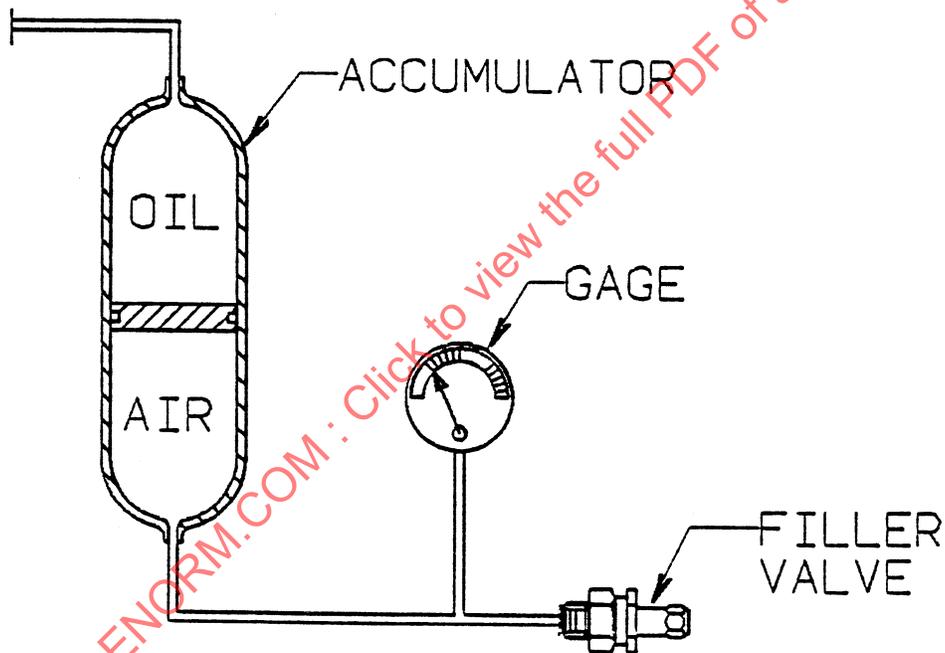
FIGURE 3.2.1.3 - False Accumulator Gage Reading

- ISSUE:
1. The line and filler valve volume on the air side of the accumulator were not correctly included in the air side calculations.
 2. The fill valve had been relocated after initial sizing. The accumulator piston bottomed before reaching 3000 psi.

SOLUTION: The accumulator precharge was recalculated and adjusted to the correct value.

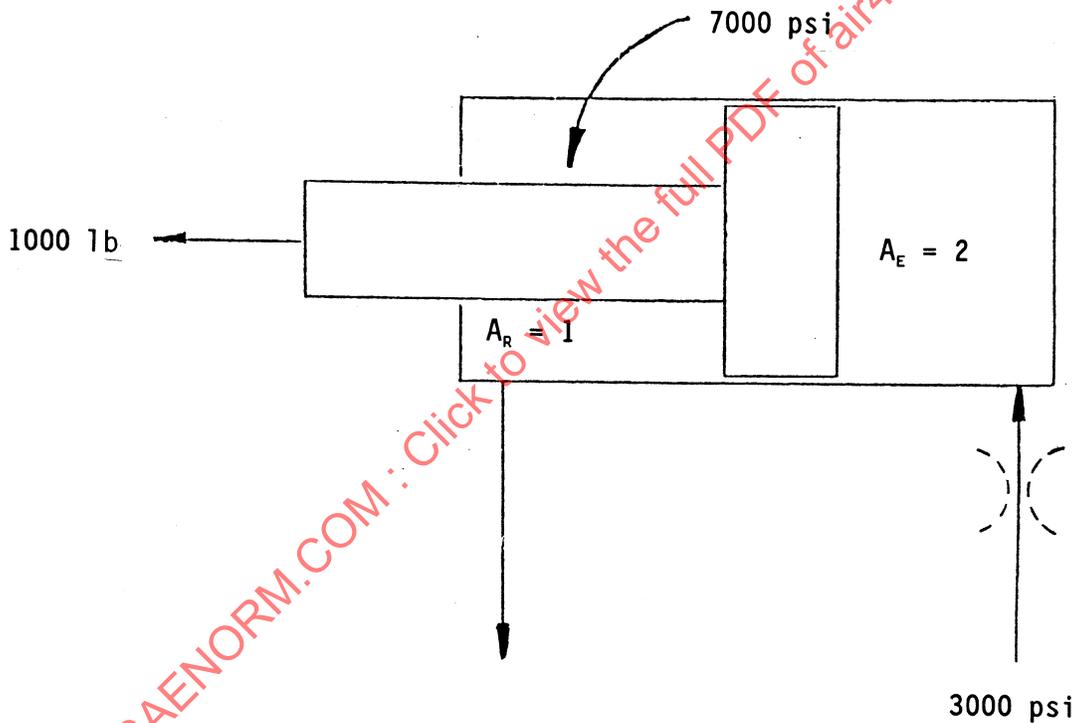
FIGURE 3.2.2.1 - Pressure Intensification in Extending Cylinder

ISSUE: There have been many cases where designers failed to recognize the high pressure that can occur on the retract side of a cylinder due to pressure intensification and/or an aiding load.

SOLUTION: Include a restrictor in the extend line so that the extend pressure is reduced to an acceptable level.

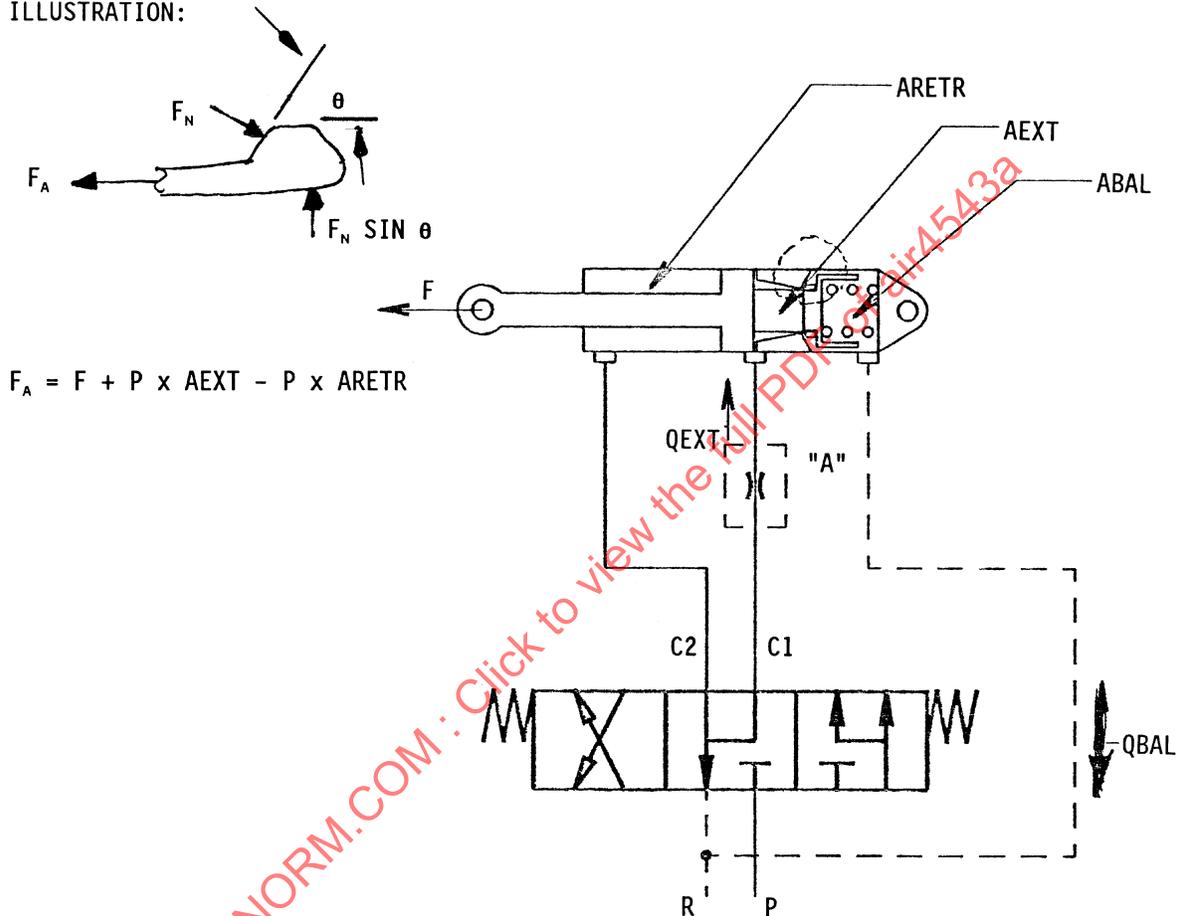
FIGURE 3.2.2.3 - Galling of the Cylinder Lock Mechanism When Unlocked Under High Loads

ISSUE: The contact area approaches zero at the point of lock release.

- SOLUTION:
1. Size port and line to ABAL for high transient flow.
 2. Relieve external F on fingers by application of retract pressure before application of extend pressure.
 3. Choke the inlet flow Q_{EXT} at "A" to reduce the rate of pressure rise to $AEXT$.
 4. Use one selector valve per actuator.
 5. Guide and lock piston hardness to be much higher than lock fingers.

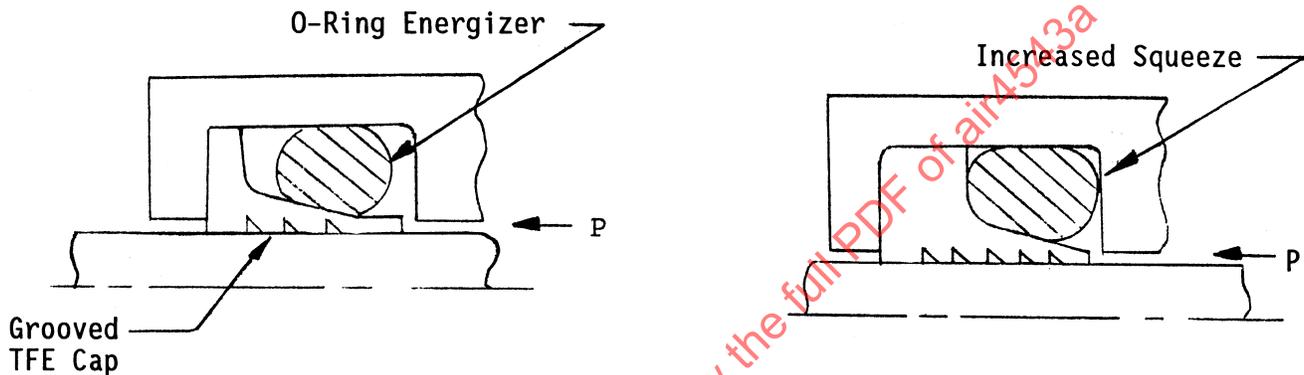
ILLUSTRATION 1

PROBLEM: REJECTION OF LOW FRICTION ACTUATORS FOR DYNAMIC LEAKAGE

ISSUE: Actuators designed and qualified for low friction (manual reversion) applications sometimes fail leakage tests for no apparent reason. TFE capped rod seals, such as shown in Illustration 1, are usually employed to meet low friction.

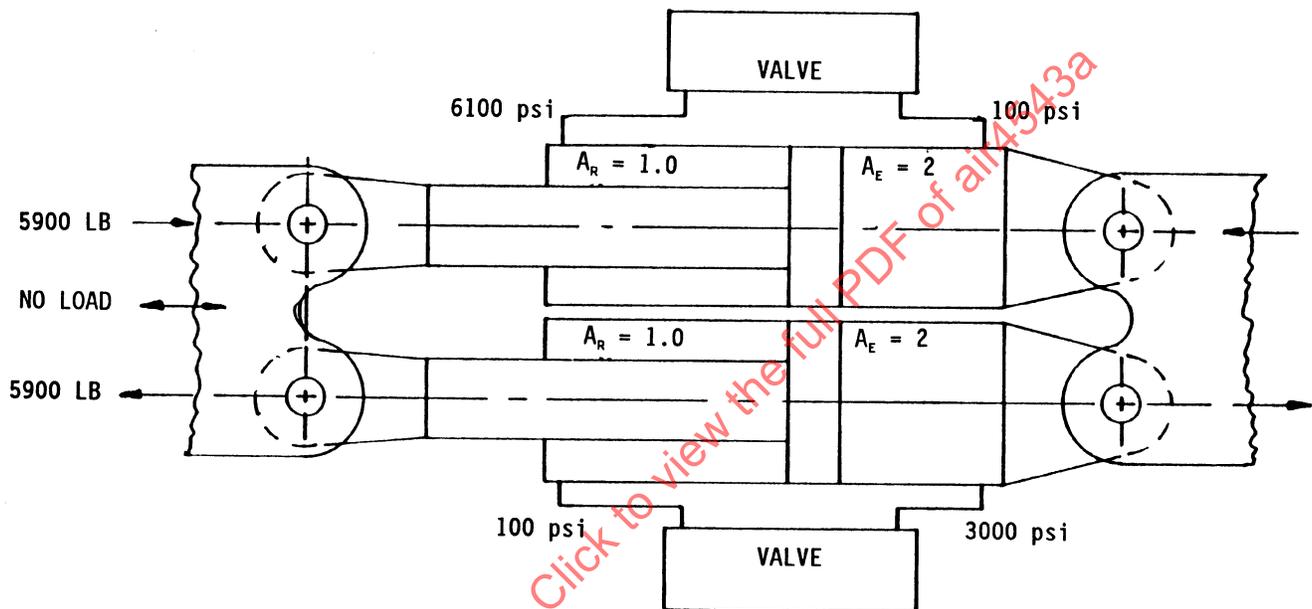
FIGURE 3.2.2.6 - Fatigue Damage to Loaded Structure and Cylinders

ISSUE: Force fight in side-by-side cylinders driven by separate valves.

- SOLUTION:
1. Use a single tandem valve for control pressure matching.
 2. Mechanically couple separate valves for control pressure matching.
 3. Use pressure transducers and electronic equalization to match control pressures.
 4. Use underlapped separate servovalves to match control pressures at null (may still have a dynamic force fight problem).

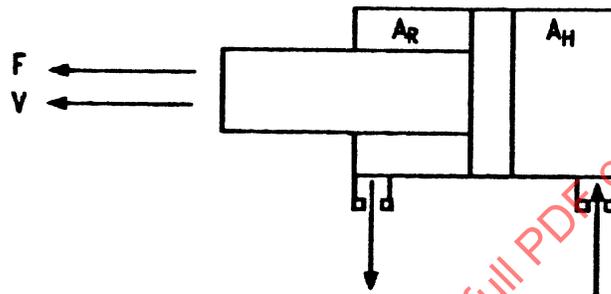
ISSUE: Velocity control restrictors must be sized to prevent overpressure and cavitation.

SOLUTION:

$$F = \left[P_R + \frac{A_R^2 V^2 C_1^2}{C_R^2} \right] A_H - \left[P_S - \frac{A_H^2 V^2 C_1^2}{C_H^2} \right] A_H$$

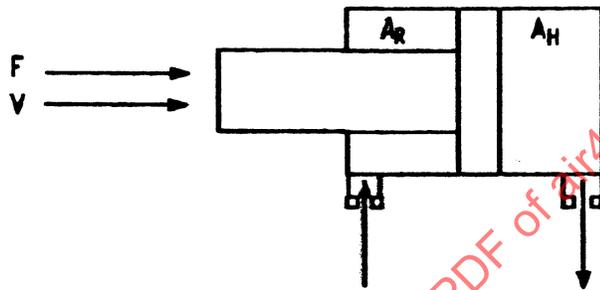
PROBLEM: VELOCITY CONTROL OF RETRACTING ACTUATOR
 ISSUE: Velocity control restrictors must be sized to prevent overpressure and cavitation.

SOLUTION:

$$F = \left[P_R + \frac{A_H^2 V^2 C_1^2}{C_H^2} \right] A_H - \left[P_S - \frac{A_R^2 V^2 C_1^2}{C_R^2} \right] A_R$$

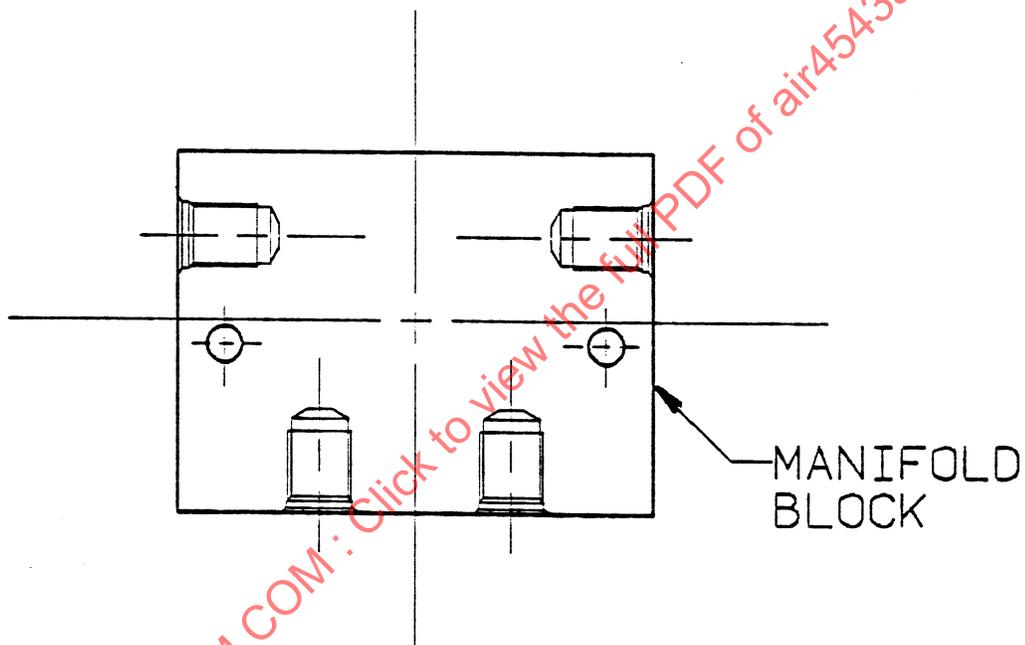
ISSUE: No hydraulic oil was being delivered to the L/H aileron actuator. After extensive troubleshooting, it was found that a manifold block passage had not been drilled.

SOLUTION: Although the manifold had passed inspection it was decided to replace it. Afterwards the aileron worked.

Never take for granted that any part is per the drawing.

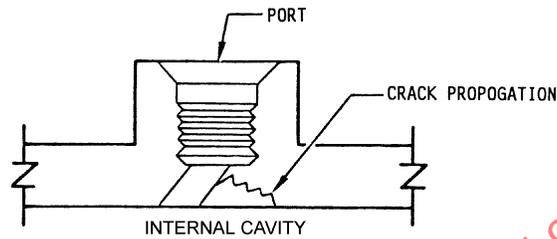
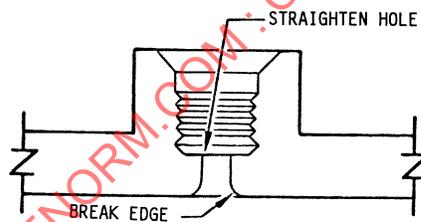
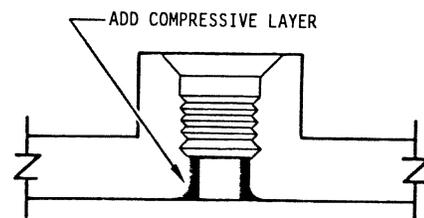
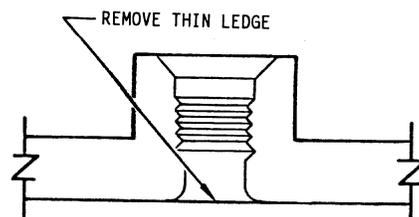
FIGURE 3.2.2.13 - Aluminum Manifold Fatigue

ISSUE: Early fatigue failures due to notch effect of hole intersections.

- SOLUTION:
1. Keep hole intersection angles as near 90° as possible (Illustration 1)
 2. Break edges at hole intersections (Illustration 1)
 3. Add a localized compressive stress layer if feasible (various methods) (Illustration 2)
 4. Design to avoid - remove discontinuities where possible (Illustration 3)

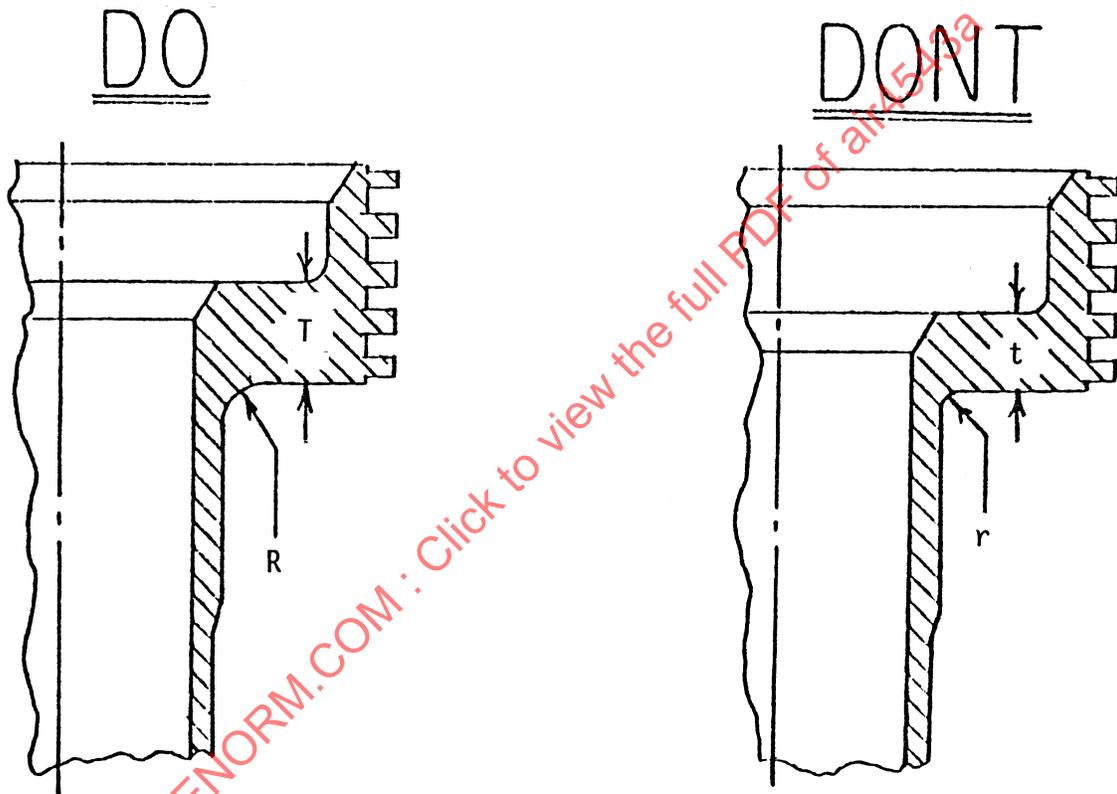
FIGURE 3.2.2.14 - Piston Head Separation

ISSUE: Hydraulic cylinder piston heads have separated from the piston rods at the fillet between the head and rod.

SOLUTION: Design pistons with ample wall thickness (T) and generous fillet radii (R). Consideration must be given to peak transient loading. The type loading, whether pure tensile or combined tensile and bending, must be considered in relation to the stress distribution at the piston head fillet to prevent stress risers.

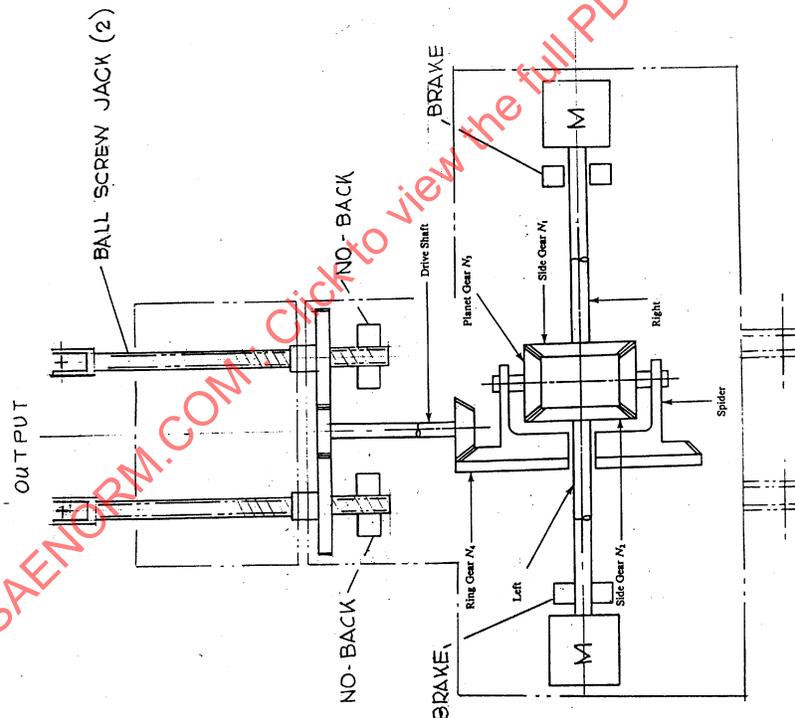
FIGURE 3.2.2.20 - Latent Failures in the Design of Flight Control Components

ISSUE: Redundancy is frequently employed in the attempt to meet safety and reliability requirements of flight control systems or components. In order to meet the safety requirements, latent failures are sometimes inadvertently incorporated into the design. The subsequent reliability analysis may not properly take into account the actual failure rate of the system or component. In the pitch trim actuator the failure of the mechanical no-backs was undetected because the electro-magnetic brakes at the motors prevented the output from being back driven even after failure of the no-backs. A subsequent failure (open) in the gear train caused the output to be back-driven (the ball screws are reversible) by the air loads at a high rate with no restraint except the inertia of the components.

SOLUTION: Carefully examine the component or system for latent failures. If found, the best solution is simply to alter the design and eliminate the latent failure mode. The next best approach is to properly take into account the exposure of the latent failure mode in determining the actual system failure rate. Hopefully the resultant net failure rate is acceptable for the application being considered. If not, a redesign is in order. Alternately, a reduction in the exposure time of the latent mode may be an option.

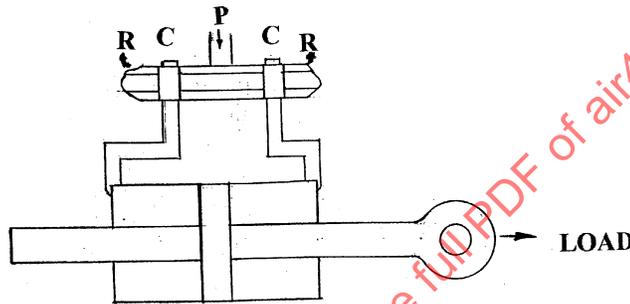
- PROBLEM:** EARLY PRESSURE FATIGUE FAILURES OF FLY BY WIRE ACTUATORS
- ISSUE:** Fly by wire servoactuator barrel and end closure pressure fatigue failures occurred in a very short period of use due to a combination of servo valve overlap conditions and continuous small movement commands which kept the valve within the overlap region.
- ILLUSTRATION:**

To meet low valve leakage requirements, the supplier provided valves with overlap - long overlap cylinder to return lands and shorter overlap pressure to cylinder lands, tending toward high "no load" null pressures. Combined with an aiding air load, the resisting cylinder pressure may reach a very high pressure value. For example: A constant 1500 psi extend force pressure load could require the resisting cylinder chamber pressure to approach 4500 psi in a 3000 psi system when the valve is in the overlap region and the actuator is extending, depending on the ratio of the overlap lengths.

Combining this condition with small amplitude, low frequency computer generated commands while the aircraft is flying straight and level results in cylinder chamber pressure cycles in the resisting cylinder chamber approaching a 3000 psi to 4500 psi range while retracting and extending respectively. If the commands are continuous, even at low frequencies, a substantial number of high pressure cycles may be experienced in a short time even if there is virtually no load change.

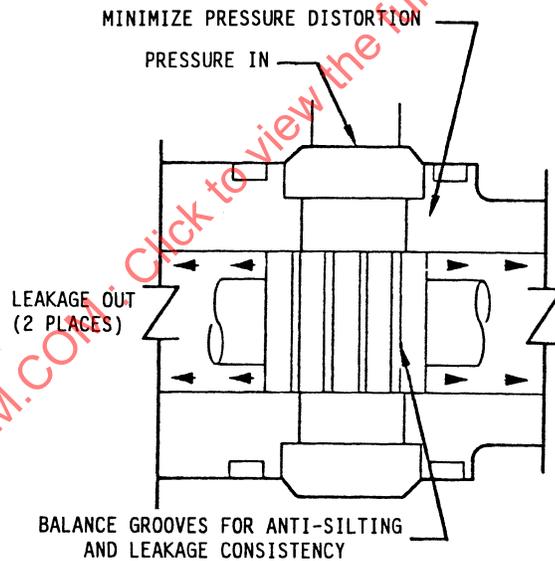
FIGURE 3.2.3.1 - Valve Rejections Due to Supplier/Contractor Fluid Filtration Variances

- ISSUE:
1. Applies more to lap assembly valves than poppet-seat valves.
 2. Finer filtration may result in significant increased leakage.
 - a. Particularly if the valve is designed with a relatively thin sleeve and the designer is counting on hydraulic damming or silting to diminish leakage as a function of time.
 - b. Low leakage lap assembly type valves are particularly subject to leakage increase when using finer filtered test fluid.

- SOLUTION:
1. Use better design practices.
 - a. More rigid sleeve/spool/structure/balance grooves
 - b. Balance grooves to minimize variances and prevent silting
 2. Test per requirements (supplier and contractor); use the same level of filtration.

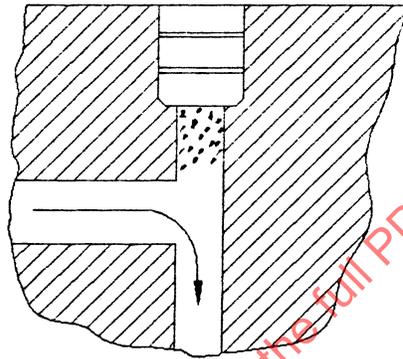
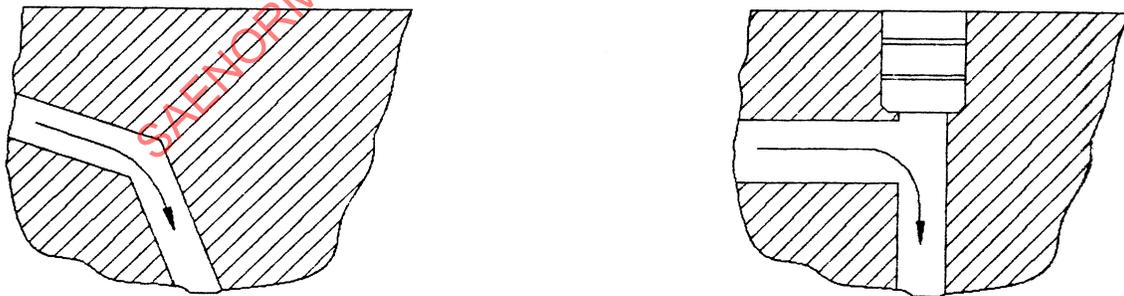
FIGURE 3.2.3.4 - Entrapped Contamination

ISSUE: Dead end passages collect the contaminant.

- SOLUTION:
1. Reroute the flow passage to eliminate potential traps where flow will flush the contaminant through the valve.
 2. Reduce the trap size.

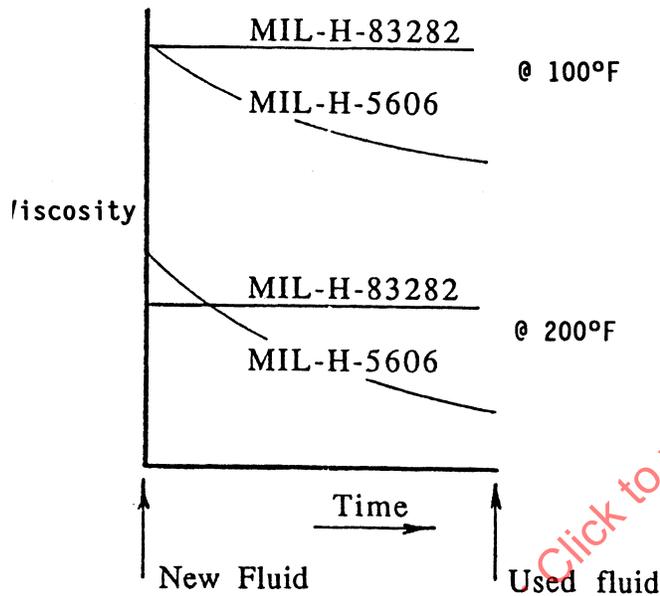
ISSUE: Acceptance tests with new fluid are unacceptable with used fluid.

A low leakage requirement may test acceptably with a high viscosity, new, fluid and unacceptably with a low viscosity, used, fluid.

SOLUTION: Specify that test benches be operated for 8 h through orifices to shear fluid prior to conducting critical leakage acceptance tests.

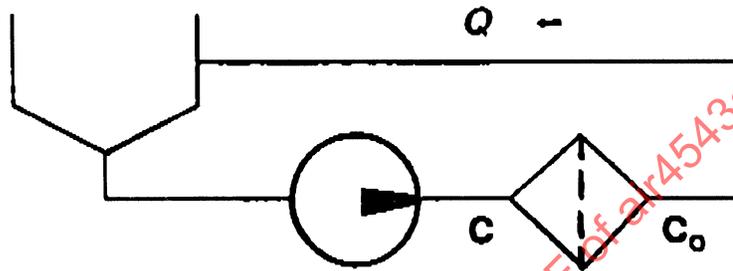
ISSUE: Hydraulic system cleanup time is excessive after contamination due to a component failure or from external contaminant ingress.

Equation expressing the variation in the concentration of particles over time, assuming an initial concentration (C_i), an idealized system with instantaneous mixing in the reservoir and no contamination "traps" in the system:

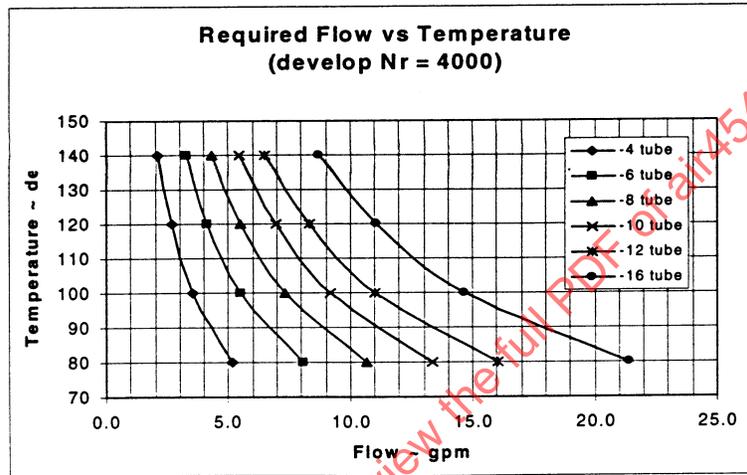
FIGURE 3.2.3.17 - Flushing System to Class 6

ISSUE: It was reported that a section of hydraulic plumbing would not clean up to a NAS1638 Class 6 with flushing.

SOLUTION: It was determined that the flow rate and fluid temperature being used were not per written guidelines. System cleanup is fast and repeatable when flushing flow rate creates a Reynolds number => 4000 and fluid temperature is 120 to 130 °F.

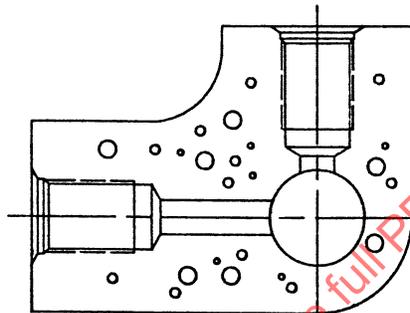
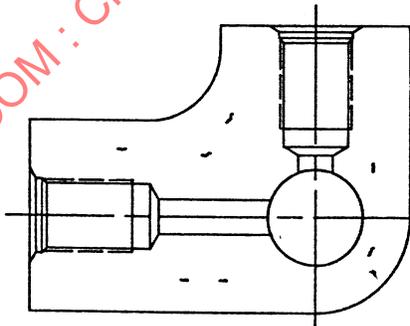
FIGURE 3.2.4.1 - Casting Fatigue

ISSUE: Casting "porosity" caused short fatigue life.

SOLUTION: Hot isostatic press (HIP) casting to reduce internal porosity size.

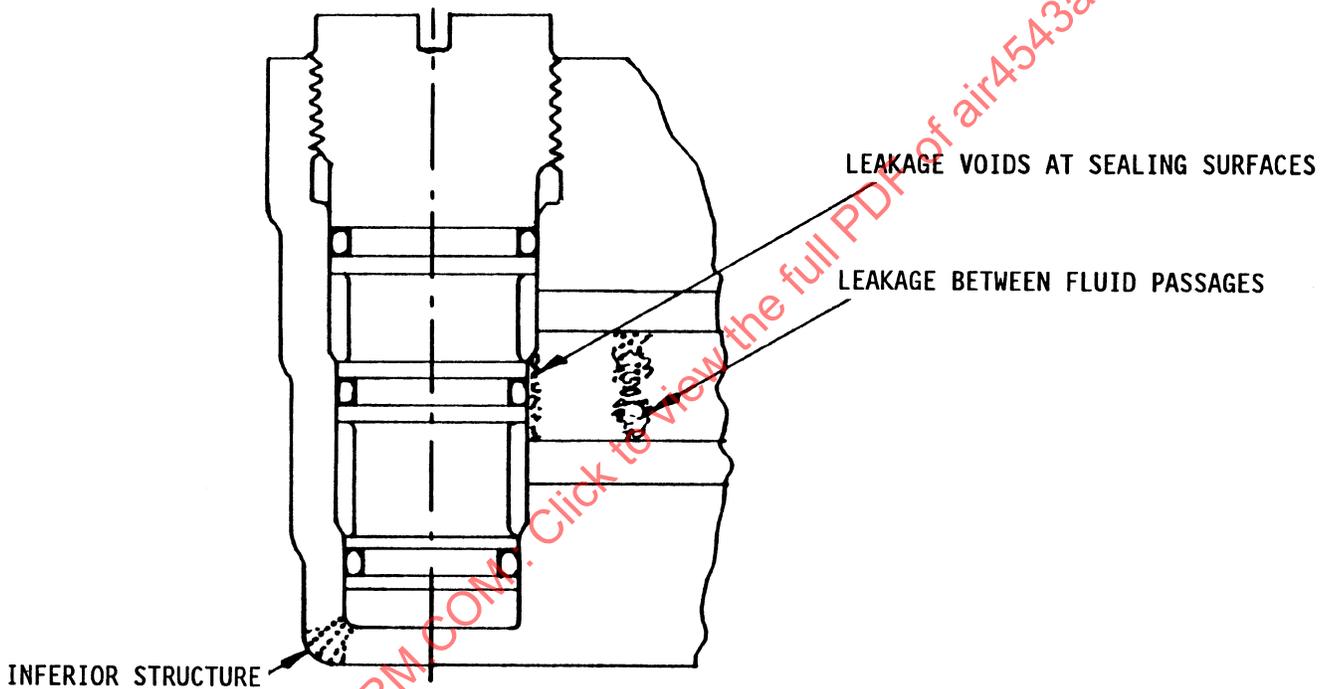
FIGURE 3.2.4.7 - Leakage and Inferior Structural Integrity Associated With Porosity in Cast Manifolds

ISSUE: Trapped gases and/or inadequate gates and risers result in shrinkage voids and porosity in manifold castings.

- SOLUTION:
1. Improve the casting gates, risers, and vents.
 2. Use the vacuum casting process to reduce trapped gases.
 3. Use hipping of the castings to reduce internal porosity.
 4. Impregnate the castings to improve sealing.
 5. Weld repair the larger defects and voids.

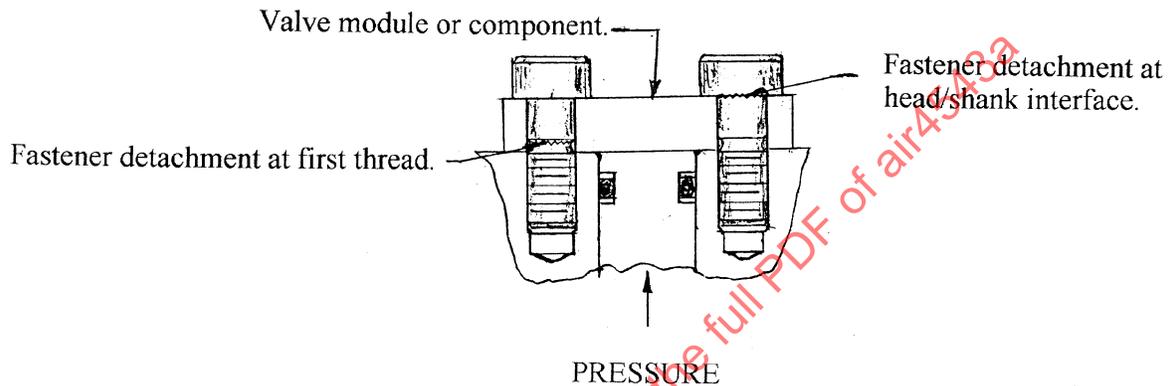
ISSUE: Early "in-service" failures of fasteners due to the process of hydrogen embrittlement.

Hydrogen embrittlement may occur when atomic hydrogen is present in a metal under load and diffuses over time to the higher stressed areas, promoting crack growth until failure. It is usually associated with high strength steel materials and electroplating, i.e., a process that involves hydrogen and a material that is susceptible to the process.

1. There have been several incidents wherein all four heads of a four screw or bolt pattern have "popped off" and the hydraulic system was lost.
2. Numerous incidents have occurred wherein heads "popped off", while installed on a unit and sitting on the shelf, due simply to initial, proper preloading plus the presence of diffused hydrogen induced during the fastener manufacturing process.
3. Proper processing primarily involves timely baking after plating for a proven time period and insuring that all fasteners in the baking lot are properly processed.

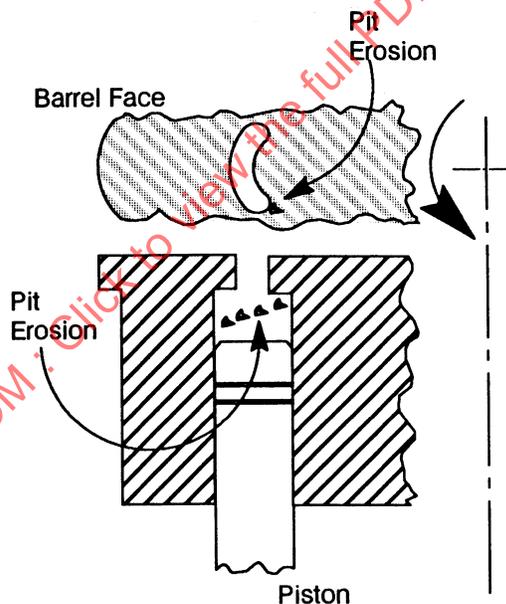
FIGURE 3.2.5.1 - Pump Cavitation/Erosion

- ISSUE:**
1. Implosion/erosion in pumps
 2. Low output flow
 3. Noise
 4. Vibration/excessive wear

- SOLUTION:**
1. Dynamic analysis of inlet filling component
 2. Streamline inlet filling (lines)
 3. Size inlet lines to match pump requirements (pressure)
 4. Contour filling of pump inlet coverage
 5. Increase inlet pressure

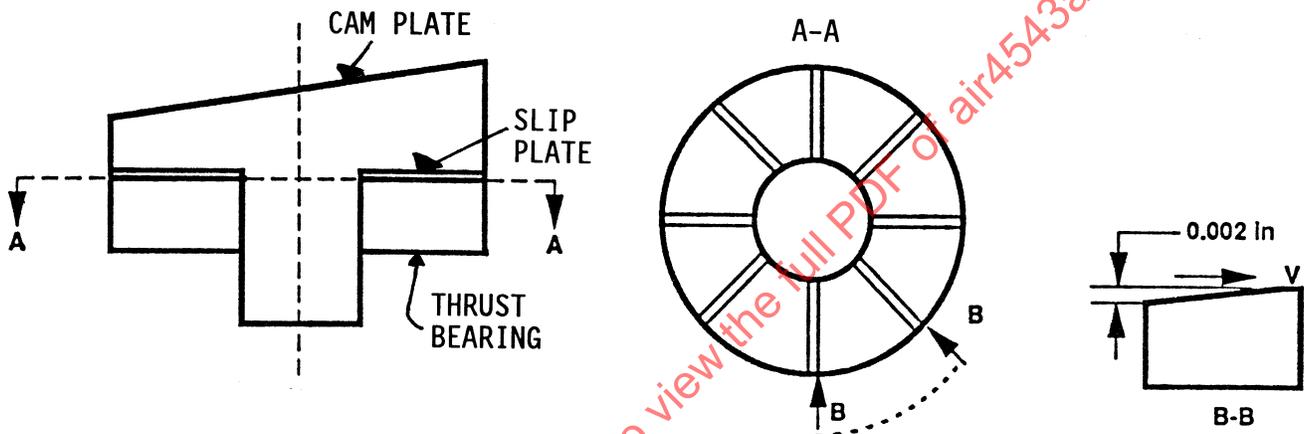
FIGURE 3.2.5.5 - Early Pump Failures Due to Rapid Air-Turbine Starts of the B-52 Hydraulic Packs (Ten Per Shipset)

PROBLEM: EARLY PUMP FAILURES DUE TO RAPID AIR-TURBINE STARTS OF THE B-52 HYDRAULIC PACKS (TEN PER SHIPSET)

ISSUE: The turbines accelerated to full speed of 37 500 rpm (3750 at the pump shaft) in 1 s. The flat bronze thrust bearings galled due to failure of the oil film to carry the load.

SOLUTION: The bearing pads were tapered to aid the development of a positive load-bearing oil film.

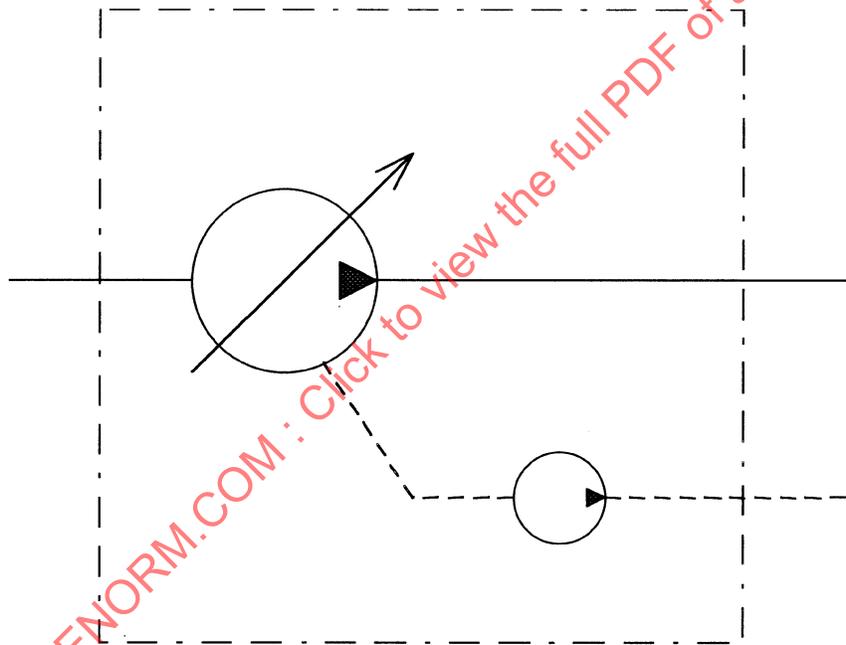
Scavenge Pump Schematic

ISSUE: High pump case back pressures occur due to case drain line routing, contaminated filters, flow surges and restrictions. This results in pump overheating due to reduced case flow, deterioration of wear surfaces due to high internal pressure loading, fatigue of pump cases due to pressure spikes, high discharge pressures, and excessive heat rejection caused by higher discharge pressures, pump deterioration, pressure loading, and high fluid temperature.

SOLUTION: Incorporate case scavenge device to provide positive case drain flow.

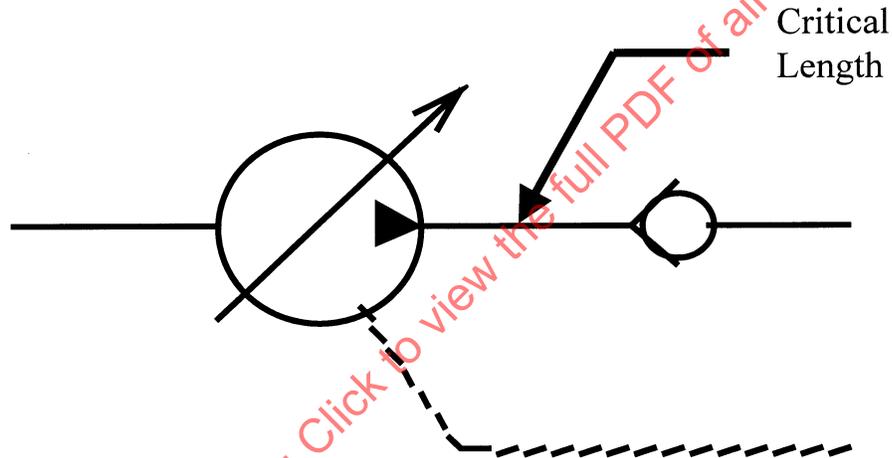
FIGURE 3.2.5.12 - Pump Instability Caused by Check Valve

ISSUE: Pump instability due to close proximity of outlet check valve to pump. Location of the check valve in the pump outlet line can have a great impact on pump stability. Locating check valve too close to pump requires additional design considerations. Additional leakage may also be required to improve stability which results in reduced efficiency and increased power loss.

- SOLUTION:
1. Locate check valve as far away from pump outlet as possible.
 - a. Improves stability
 - b. Allows for lower internal leakage
 - c. Improves performance
 - d. Increases life
 2. If check valve must be located close to pump, then special design considerations are required.
 - a. Yoke over stroke angle
 - b. Compensator spool clearances
 - c. Compensator spool overlap
 - d. Compensator spring rate
 3. Check valve location and associated system volumes must be known early in pump design process to prevent problems and delays later in the program.

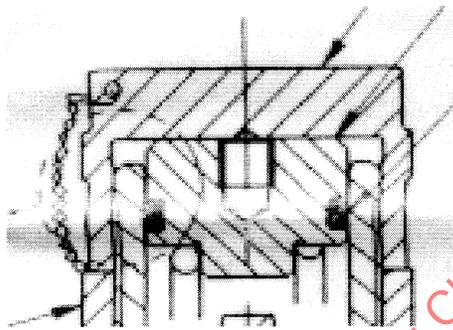
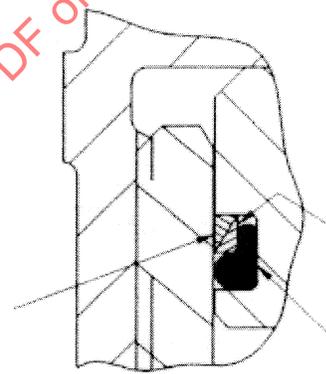
ISSUE: Because of the orientation of the pump in the aircraft, the compensator valve would be directly exposed to the flame. Seal damage and resulting external leakage would result.

SOLUTION: Incorporate special seal design with metal backups. This approach offers the advantages of:

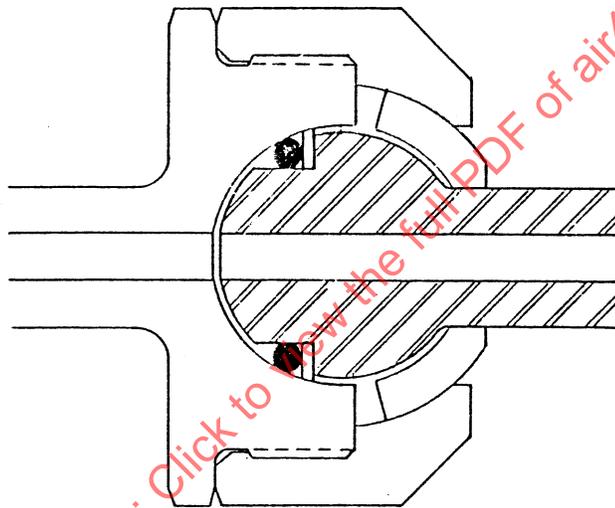
FIGURE 3.2.6.1 - Spherical Ball Swivel Leakage

PROBLEM: SPHERICAL BALL SWIVEL LEAKAGE

ISSUE: Many spherical ball swivels tend to leak when initially pressurized. This is caused by the ball moving, within the clearance space, away from the seal.

- SOLUTION:
1. Use coiled tube rather than spherical swivels, if possible.
 2. Increase seal squeeze, and reduce ball to housing clearance as much as possible in the design of the swivel.

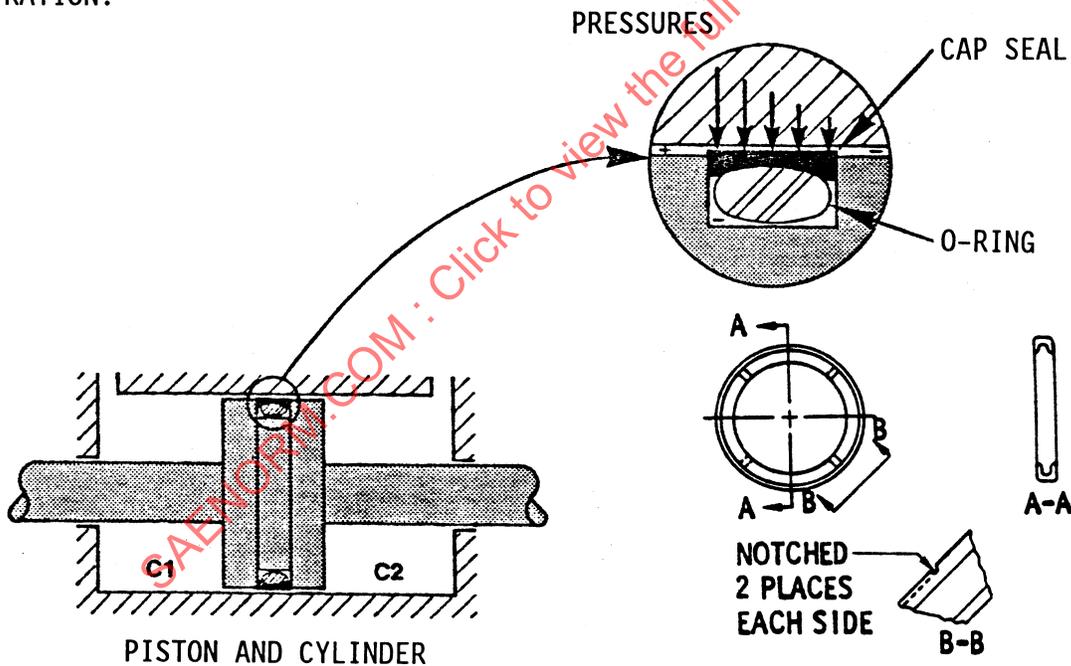
FIGURE 3.2.6.2 - Servoactuator Piston Seal Blowby

- ISSUE:
1. Use of the TFE cap seal to improve wear life of piston head O-ring may result in piston stalling following a command to reverse the direction.
 2. Edge of TFE cap may seal on the sidewall of the seal groove following the reversal of cylinder pressures. This can momentarily trap lower pressure under the cap seal and allow bypass flow over the top of the seal.
 3. Without the sidewall notches, the piston cap may seal on the sidewall of the groove rather than on cylinder I.D. This can result in leakage flow from C-1 to C-2.

SOLUTION: Specify the addition of notches on the sidewalls of TFE or similar piston cap seals. Refer to AIR1243 for more discussion.

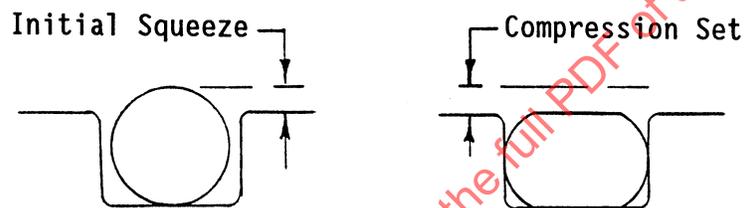
ILLUSTRATION 1

ISSUE: Small cross-section static seals, typically 0.070 in diameter, per MS28775 or MIL-P-83461 (nitrile) are prone to leakage failures. A contributing factor may be local "necking down" caused by uneven installation stretch forces for large sizes. However, the primary problem is due to compression set of the elastomer, which is critical for small cross-sections. High temperature operation for a few hours results in a permanent loss of squeeze with leakage pronounced at normal as well as colder temperatures and low pressures (see Illustration 1).

- SOLUTION:**
1. Where external seepage would result, avoid small cross-section seals, especially for sizes above a 2 in diameter. Where they must be used, the elastomer compound should be changed:
 - a. Fluorocarbon per MIL-R-83485 has been successful in solving problems where the temporary loss of squeeze below -40°F due to the coefficient of shrinkage can be accepted, i.e., slight seepage at low temperature.
 - b. Phosphonitrilic fluoroelastomer (PNF) per MIL-P-87175 has been successful solving problems where squeeze must be maintained down to -65°F .
 - c. Fluorosilicone per MIL-R-25988 may prove to be an acceptable lower cost alternate to PNF in certain applications such as face seals.

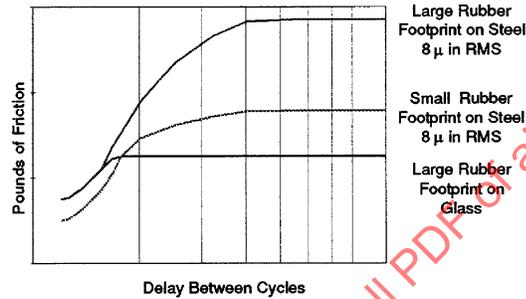
FIGURE 3.2.6.14 - Stiction of a Rubber Seal on a Reservoir Piston Caused Pump Cavitation

ISSUE: During start-up, with a day or more of system idle time, an aircraft experienced pump cavitation because of the loss of reservoir pressurization.

Loss of pressurization was traced to the sticking of the reservoir piston rubber O-ring seal on the reservoir housing.

The reservoir housing material is aluminum with hardcoat (Type 3) anodize. The hardcoat finish on the micro level looks like a dried lake bed. A crusty surface with voids and crevices.

The dynamic seal used was a design with a large rubber footprint.

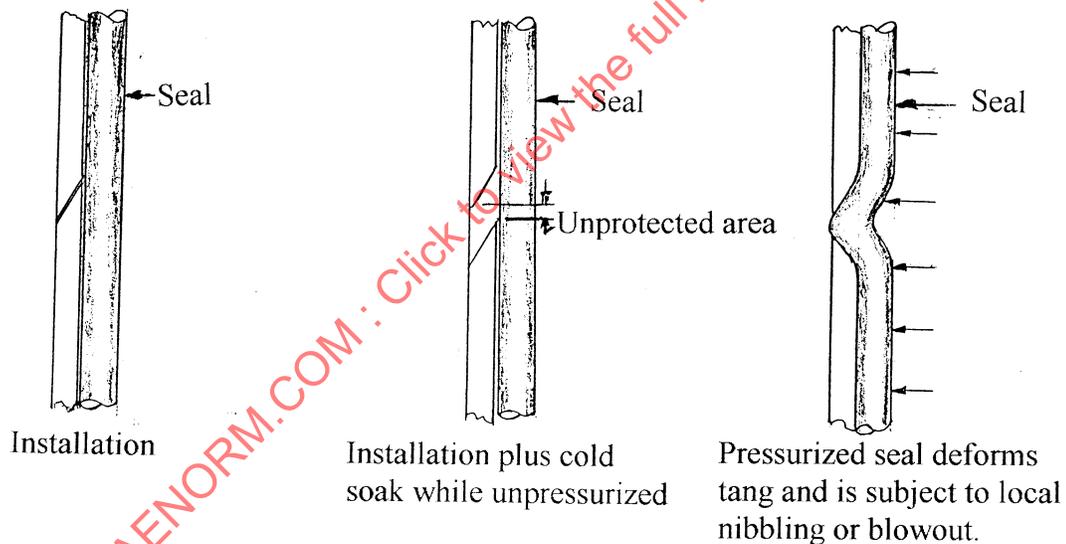
FIGURE 3.2.6.22 - Seal Nibbling Caused by Large Scarf Cut Backup Ring

ISSUE: When subjected to low temperatures with zero or very low pressure applied, Teflon backup rings will shrink. On large size static seals (approximately 4 in bores and larger sizes), 0.052/0.045 in thickness MS28774 scarf cut backups will gap beyond the scarf cut length with conditions of an initial room temperature followed by a cold soak at approximately -40 °F and with zero or very low pressure applied. Subsequent high pressure application, while in the shrunken condition, will drive the elastomer into the gap and subject it to possible blowout or nibbling failures.

- SOLUTION:**
1. Use uncut Teflon backups for larger bore sizes. Do not use MS28774 which are not designed for current gland standards.
 2. An applied axial seal pressure of approximately 100 psi or greater will prevent shrinkage at low temperatures. (Considers elastic modulus of Teflon, coefficient of friction of Teflon on a smooth metal surface and the projected axial force on the backup due to pressure); however, this is not a situation that one would live with.
