AEROSPACE INFORMATION REPORT

SAE AIR4543

Issued 1992-01
 Revised 2000-06

Aerospace Hydraulics and Actuation Lessons Learned

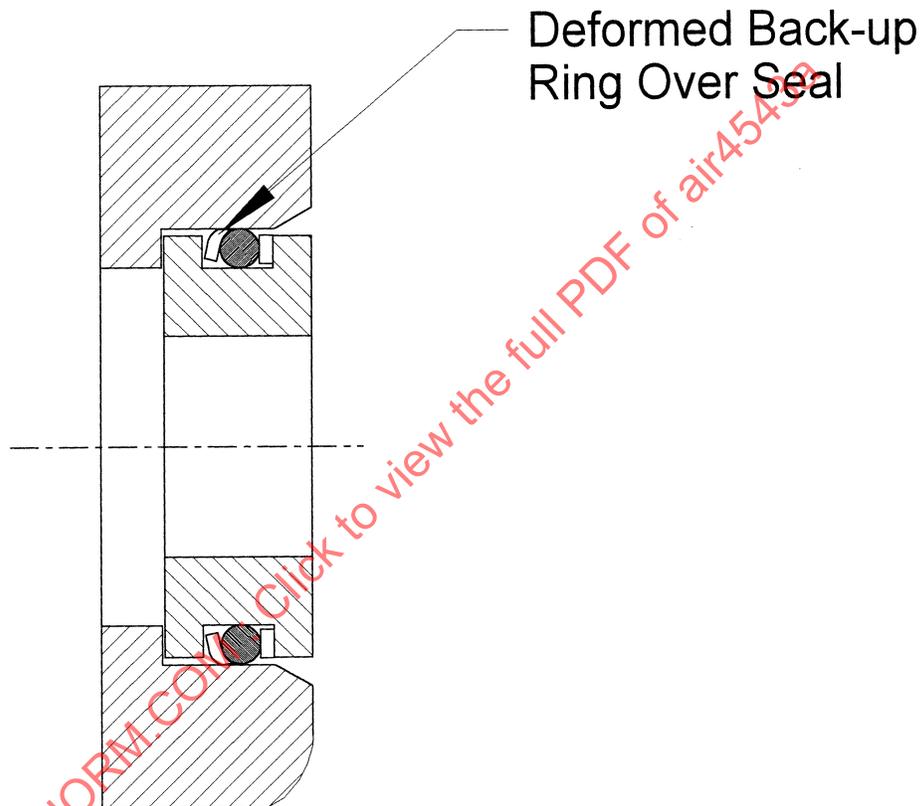
ISSUE: Installation of O-ring seal with two backups resulted in first backup deforming over O-ring.

Use Only One Back-up Ring

SOLUTION: Change design to eliminate upstream backup, i.e., single backup design which has short insertion of backup ring.

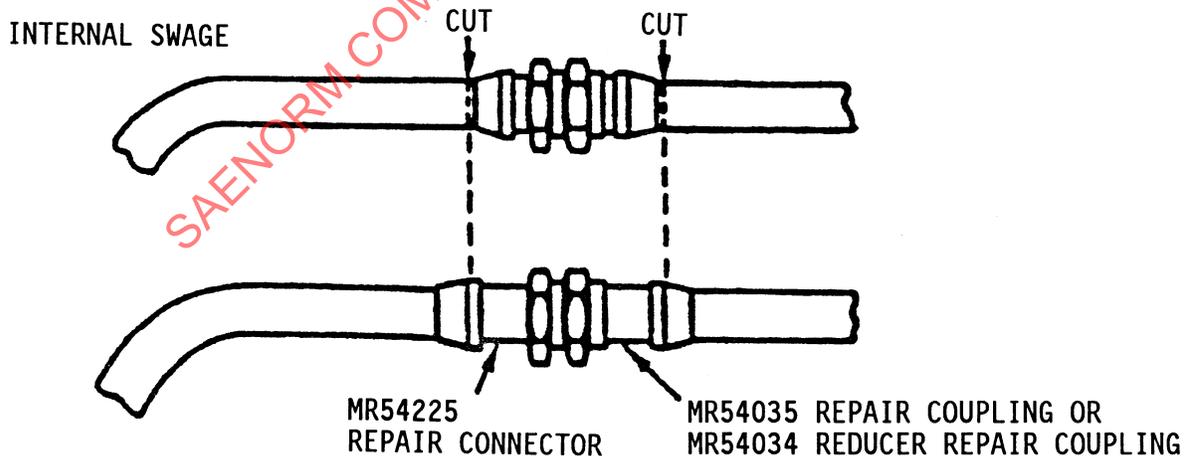
FIGURE 3.2.7.2 - Leaking Fittings

- ISSUE:**
1. A repair fitting is an option for leaky and/or damaged fittings if a sufficient clearance and straight tubing section is available.
 2. Leaky or damaged fittings cannot be repaired.

SOLUTION: Allow sufficient clearance and straight tubing sections at fittings so that repair fittings may be employed.

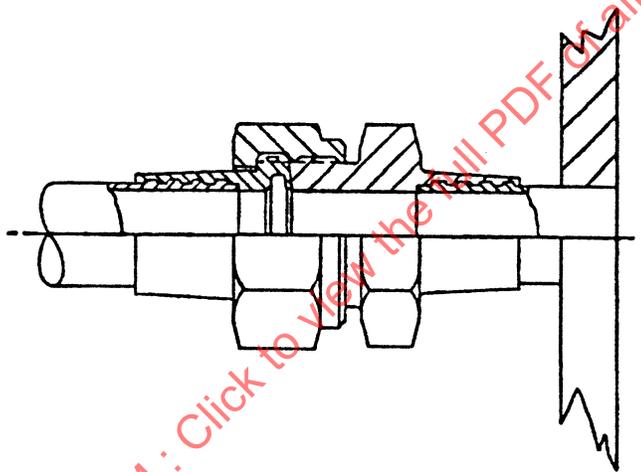
FIGURE 3.2.7.3 - Male/Female Lip Seal Connection Damage

- ISSUE:
1. When a male/female connection of a permanent installation or tubing is damaged, the female connector usually sustains the damage.
 2. The female fitting is more susceptible to damage since the male fitting is more durable and can be dressed.

SOLUTION: Incorporate the female fitting on the removable component. The male end can be repaired in place.

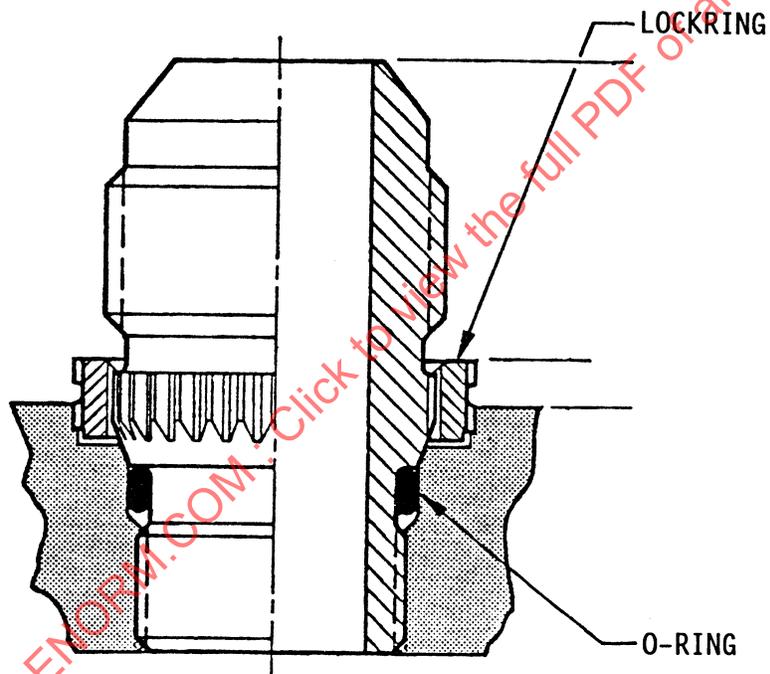
FIGURE 3.2.7.4 - Damaged Ports

- ISSUE:
1. A component with a damaged port can be salvaged if removable boss fittings are employed.
 2. When the port of a component is suddenly impacted (dropped, struck) and damaged, the component is discarded if the port is not replaceable.

SOLUTION: Removable boss fittings should be employed whenever possible.
