(R) Aerospace Hydraulics and Actuation Lessons Learned

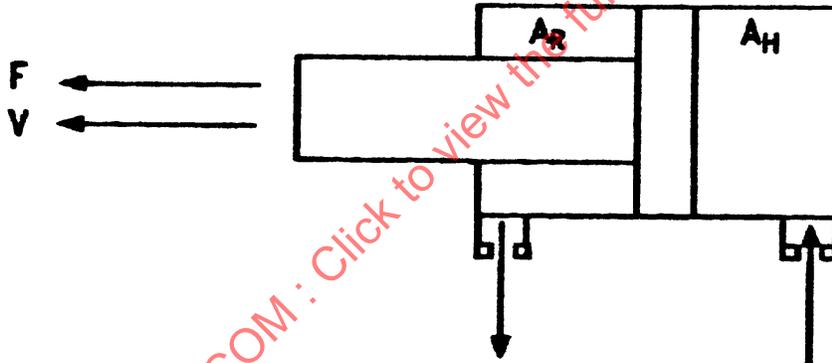
PROBLEM: Damage caused by poor velocity control of extending actuator.

ISSUE: Velocity control restrictors must be sized to prevent overpressure and cavitation.

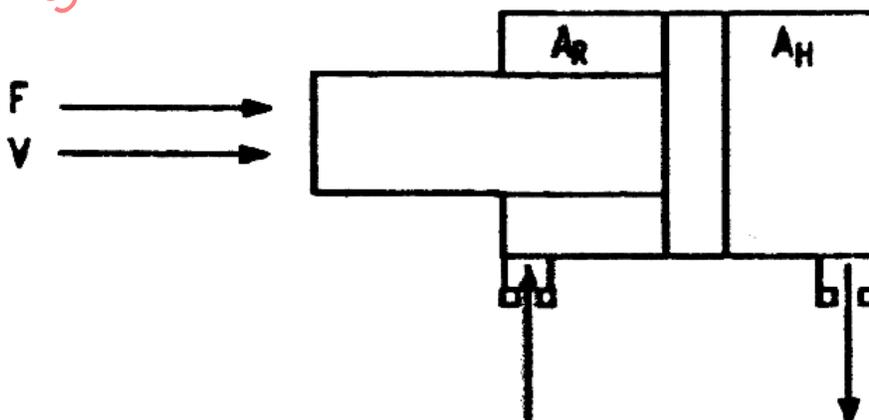
PROBLEM: Damage caused by poor velocity control of retracting actuator.

ISSUE: Velocity control restrictors must be sized to prevent overpressure and cavitation.

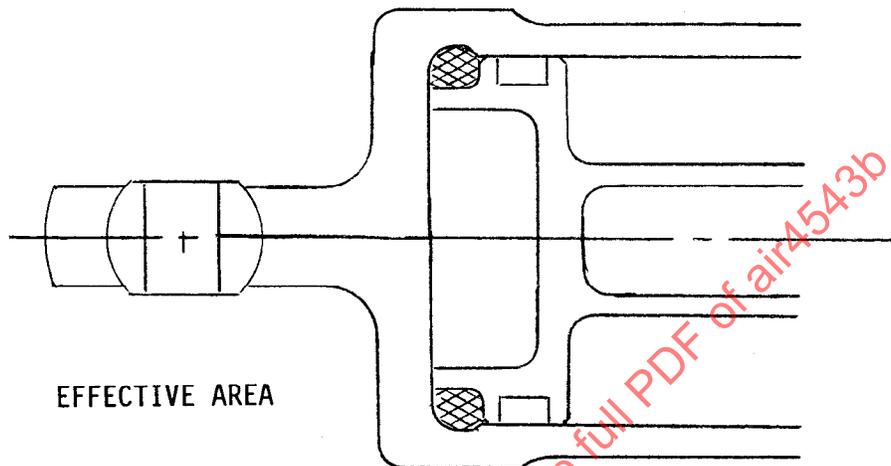
PROBLEM: Fully retracted actuator fails to extend against load.

ISSUE: Piston retract stop ring acts as face valve, reducing extend area.

SOLUTION: Add flow slot in retract stop ring to assure that full head area is pressurized.

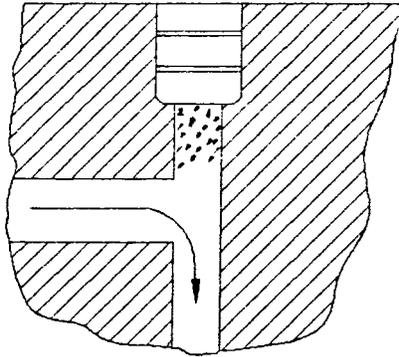
ISSUE: Dead end passages collect the contaminant.

- Reroute the flow passage to eliminate potential traps where flow will flush the contaminant through the valve.
- Reduce the trap size.

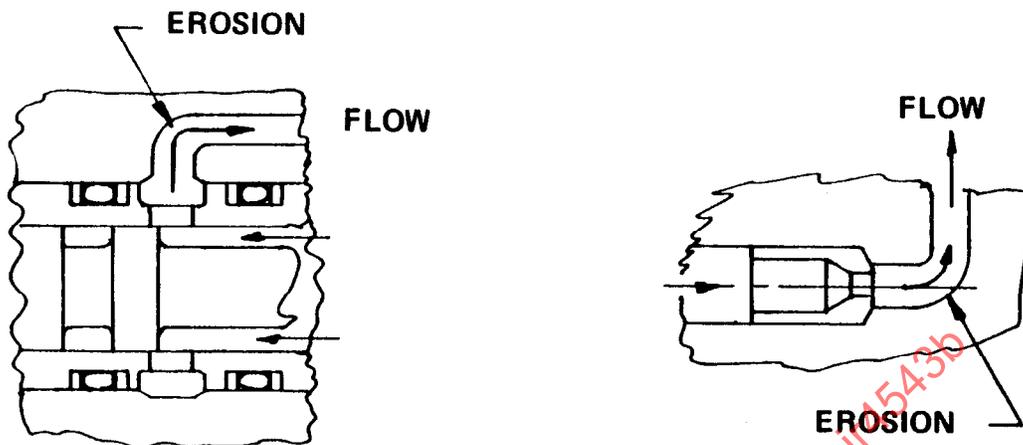
PROBLEM: Erosion of aluminum valve bodies due to jet action of restrictors.

ISSUE: High pressure impingement or deflected flow of fluid can erode through aluminum valve manifolds.

- Reduce restrictor exhaust velocity by using multiple series orifices.
- Move restrictor exhaust jet away from the manifold wall so that fluid can expand and reduce velocity prior to impingement on the wall.
- Reduce restrictor exhaust jet energy concentration by using multiple smaller parallel orifices.
- Incorporate the steel deflector or jet diffuser downstream of the restrictor.

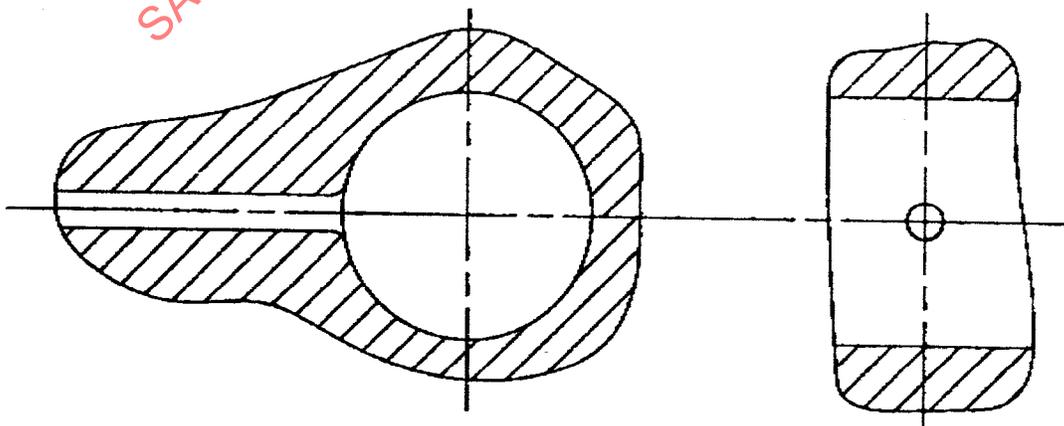
ISSUE: Small bores intersecting large bores increase stress, $K = 2.5$.

SOLUTION: Simulate an elliptical intersection, $K = 1.5$. Put radius of .030 to .040 in (0.7 to 1.0 mm) on edges.

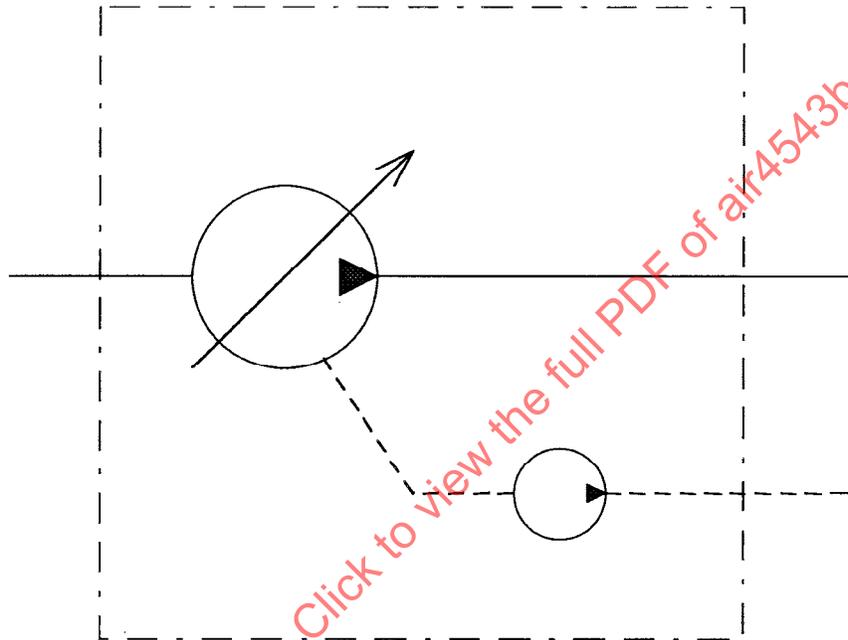
SCAVENGE PUMP SCHEMATIC

ISSUE: High pump case back pressures occur due to case drain line routing, contaminated filters, flow surges and restrictions. This results in pump overheating due to reduced case flow, deterioration of wear surfaces due to high internal pressure loading, fatigue of pump cases due to pressure spikes, high discharge pressures, and excessive heat rejection caused by higher discharge pressures, pump deterioration, pressure loading, and high fluid temperature.

SOLUTION: Incorporate case scavenge device to provide positive case drain flow.

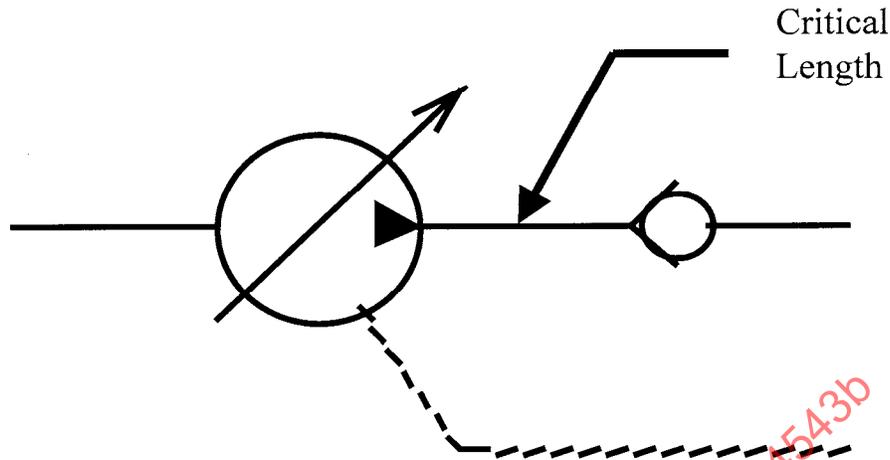
ISSUE: Pump instability due to close proximity of outlet check valve to pump. Location of the check valve in the pump outlet line can have a great impact on pump stability. Locating check valve too close to pump requires additional design considerations. Additional leakage may also be required to improve stability which results in reduced efficiency and increased power loss.

- a. Locate check valve as far away from pump outlet as possible.
 1. Improves stability
 2. Allows for lower internal leakage
 3. Improves performance
 4. Increases life
- b. If check valve must be located close to pump, then special design considerations are required.
 1. Yoke over stroke angle
 2. Compensator spool clearances
 3. Compensator spool overlap
 4. Compensator spring rate
- c. Check valve location and associated system volumes must be known early in pump design process to prevent problems and delays later in the program.

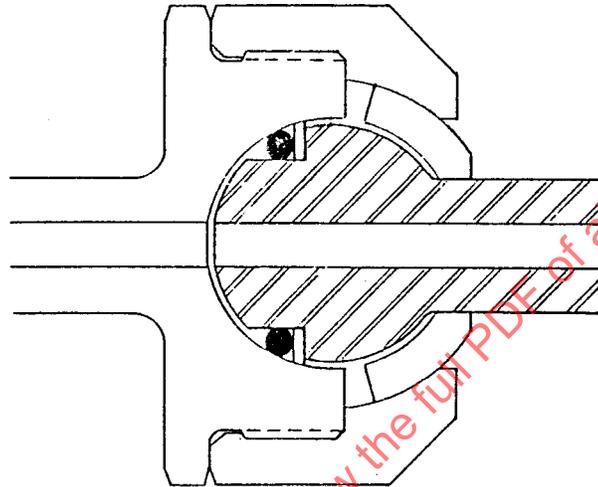
ISSUE: Many spherical ball swivels tend to leak when initially pressurized. This is caused by the ball moving, within the clearance space, away from the seal.

- a. Use coiled tube rather than spherical swivels, if possible.
- b. Increase seal squeeze, and reduce ball to housing clearance as much as possible in the design of the swivel.

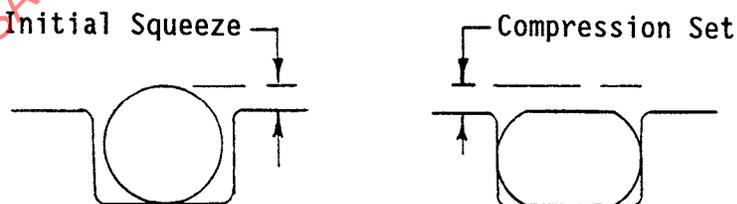
ISSUE: Small cross-section static seals, typically 0.070 in (1.8 mm) diameter, per MS28775 (superceded by SAE AS28775) or MIL-P-83461 (Nitrile) (superceded by AMS-P-83461) are prone to leakage failures. A contributing factor may be local "necking down" caused by uneven installation stretch forces for large sizes. However, the primary problem is due to compression set of the elastomer, which is critical for small cross-sections. High temperature operation for a few hours results in a permanent loss of squeeze with leakage pronounced at normal as well as colder temperatures and low pressures.

Where external seepage would result, avoid small cross-section seals especially for sizes above a 2 in (51 mm) diameter. Where they must be used, the elastomer compound should be changed:

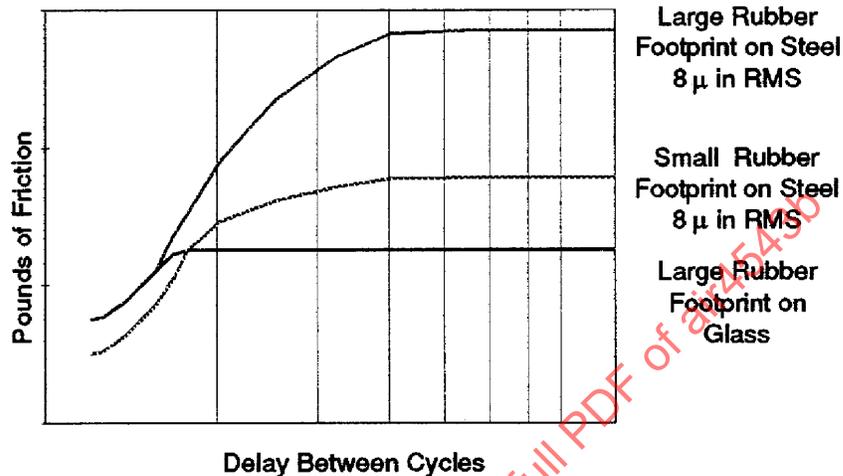
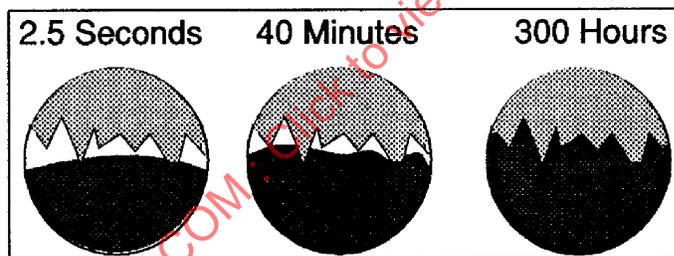
Hard coat anodize and a large rubber footprint is an unfavorable combination. The rubber extrudes into the voids and crevices of the hard coat. The degree of elastomer imbedding is time dependent but reaches a finite value $\approx 100\%$. The force required to shear is proportional to the amount of imbedded rubber and potentially can exceed the force available from the reservoir pressurization device.

SOLUTION: Be cognizant of the micro-surface, its relationship with seals and select seals and finishes appropriately. For this particular application, a new low pressure seal with a small controlled rubber footprint was selected. This limited the amount of extruded rubber, therefore, reducing the shear force required to an acceptable level.

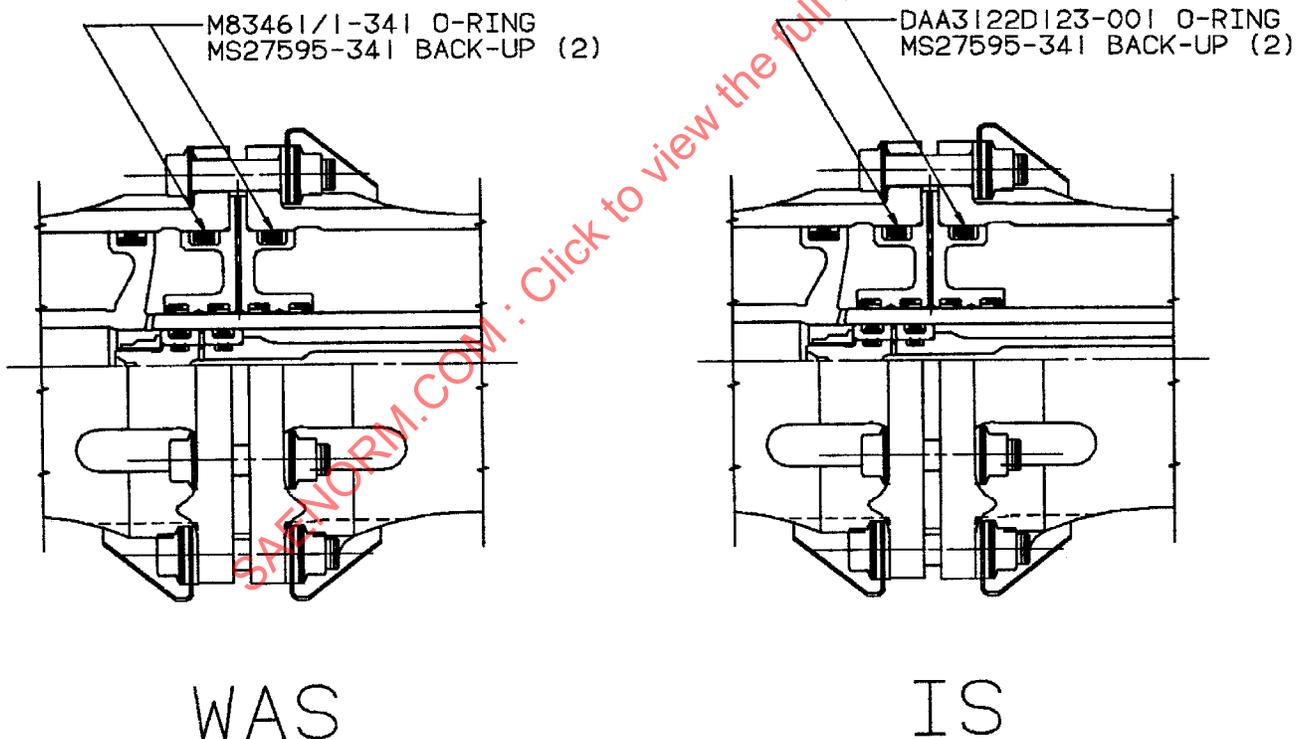
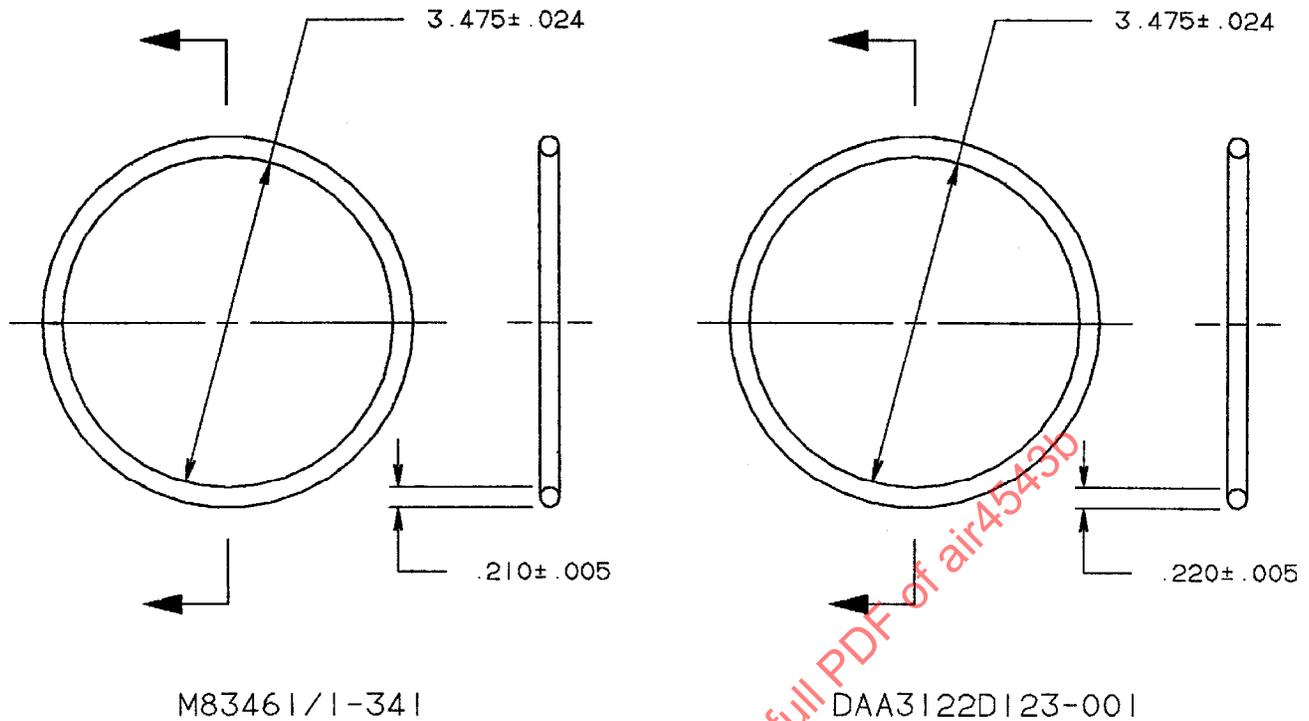
ISSUE: Leakage occurred at 4000 lbf/in² (27 600 kPa) when barrel would be expected to breathe by approximately 0.001 in (0.03 mm). Parker Handbook says high temperature Nitrile good to -20 °F (-29 °C).

SOLUTION: Changed to DAA3122D123 seal wherein cross section was enlarged by 0.010 in (0.3 mm). Minimum squeeze now 9.71% or 0.021 in (0.5 mm) passed test.

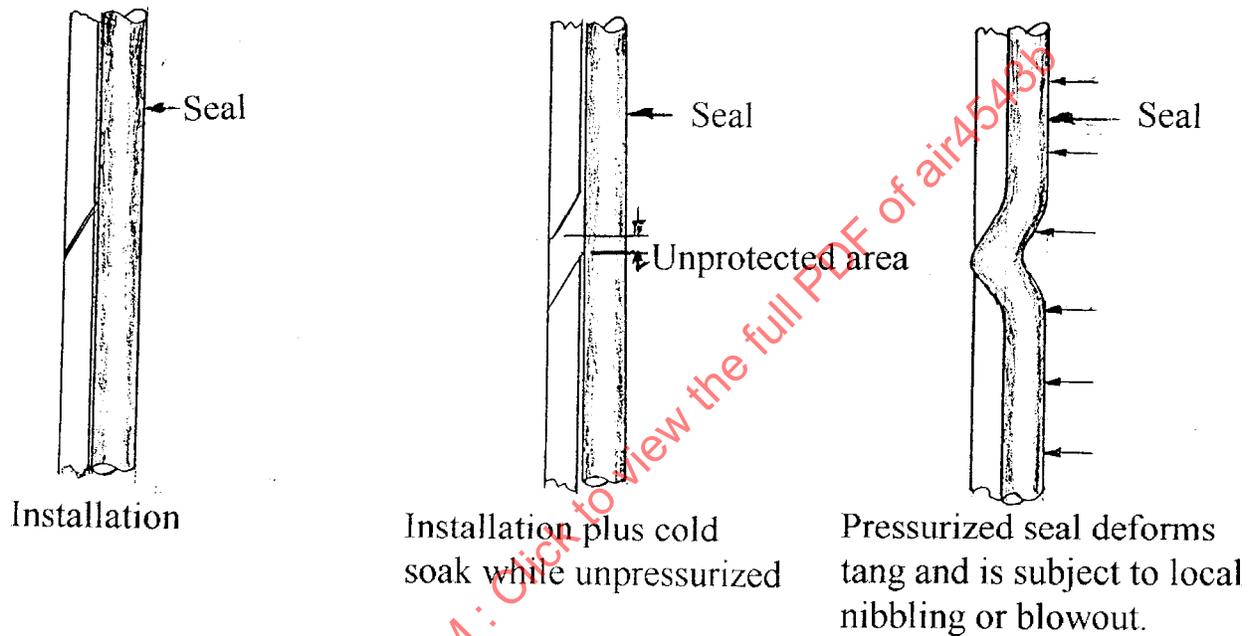
PROBLEM: Large diameter scarf-cut Teflon backup rings may allow seal nibbling or blowout.

ISSUE: When subjected to low temperatures with zero or very low pressure applied, Teflon backup rings will shrink. On large size static seals [approximately 4 in (102 mm) bores and larger sizes], 0.052/0.045 in (1.3/1.1 mm) thickness MS28774 (inactive for new design, no known superceding document, AS4716 is relevant SAE document) scarf cut backups will gap beyond the scarf cut length with conditions of an initial room temperature followed by a cold soak at approximately -40 °F (-40 °C) and with zero or very low pressure applied. Subsequent high pressure application, while in the shrunken condition, will drive the elastomer into the gap and subject it to possible blowout or nibbling failures.

- Use uncut Teflon backups for larger bore sizes. Do not use MS28774 (inactive for new design) which are not designed for current gland standards.
- An applied axial seal pressure of approximately 100 lbf/in² (690 kPa) or greater will prevent shrinkage at low temperatures. (Considers elastic modulus of Teflon, coefficient of friction of Teflon on a smooth metal surface and the projected axial force on the backup due to pressure.) However, this is not a situation that one would live with.

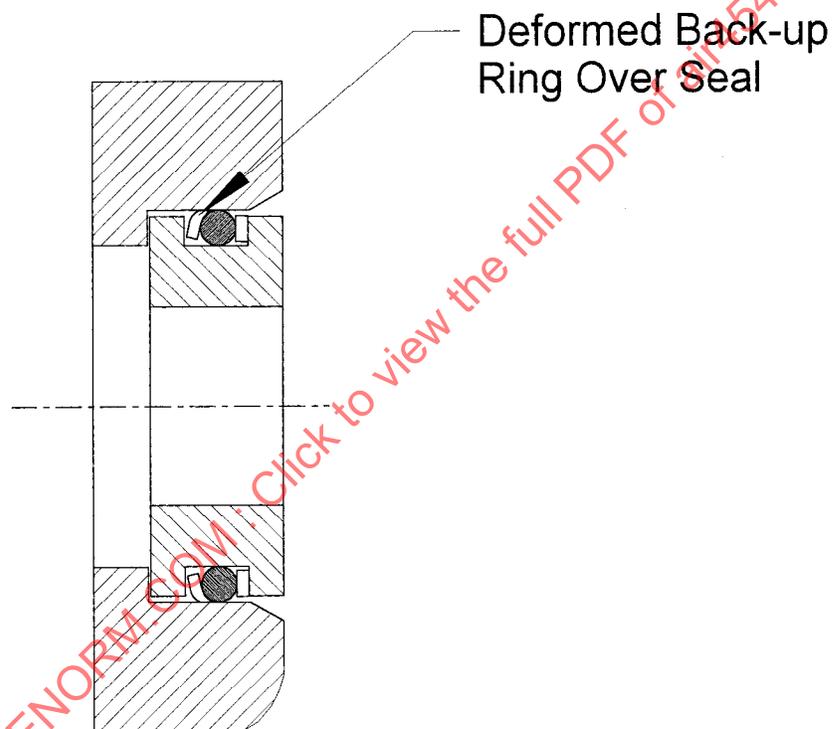
ISSUE: Installation of O-ring seal with two backups resulted in first backup deforming over O-ring.

Use Only One Back-up Ring

SOLUTION: Change design to eliminate upstream backup, i.e., single backup design which has short insertion of backup ring.

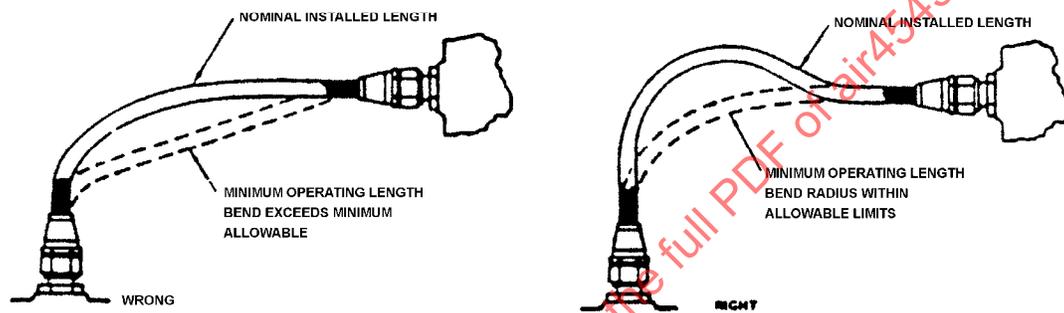
PROBLEM: Hose assemblies with short hose flex lengths may be inadequate to function properly having the desired flexibility traditionally expected of a hose. This is especially true with the higher pressure wire-reinforced hose styles which are made of a heavier wire construction.

Proper length including at least one hose bend

SOLUTION: Design installations and specify hose assemblies that have sufficient hose length with bends to allow for proper function. Refer to AIR1569, "Handling and Installation Practice for Aerospace Hose Assemblies" for additional information.

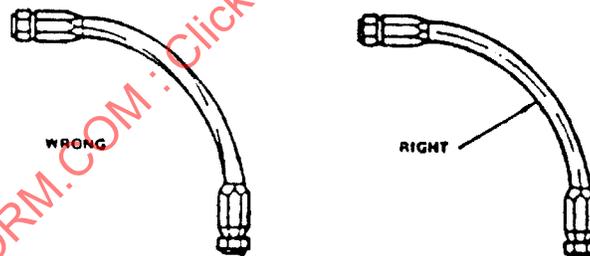
Proper routing to withstand motions/deflections

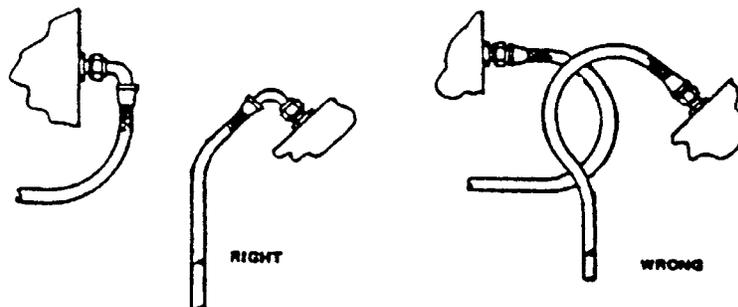
Proper installation to eliminate twisting

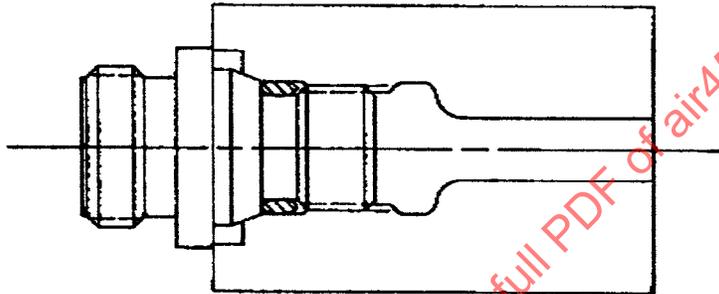
Standard -6 Rosan Port

PROBLEM: Boss fatigue failure.

ISSUE: "Wet" thread configuration caused short failure life 700,000 cycles.

SOLUTION: "Dry" thread increased fatigue life to 2.8 million cycles by incorporation of an O-ring and back-up at bottom of thread.

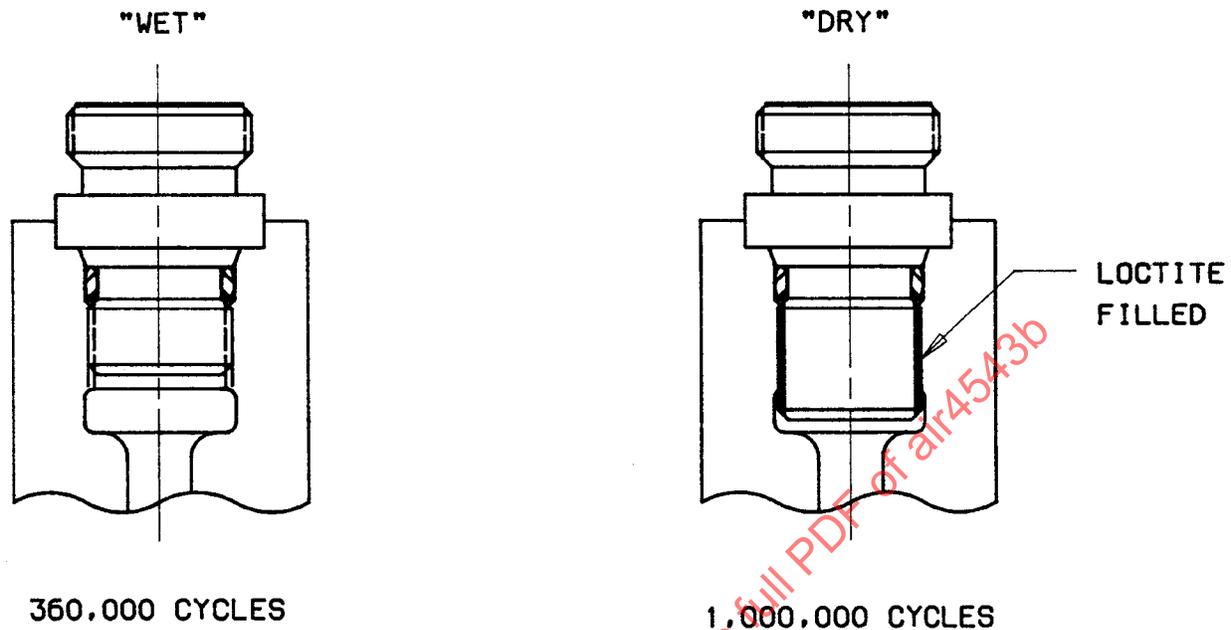
PROBLEM: Low port fatigue life with aluminum 7075-T73.

ISSUE: "Wet" threads reduce life at 7500 lbf/in² (51 700 kPa), 200 °F (93 °C).

SOLUTION: Use "dry" threads with plug threads extended beyond port threads.

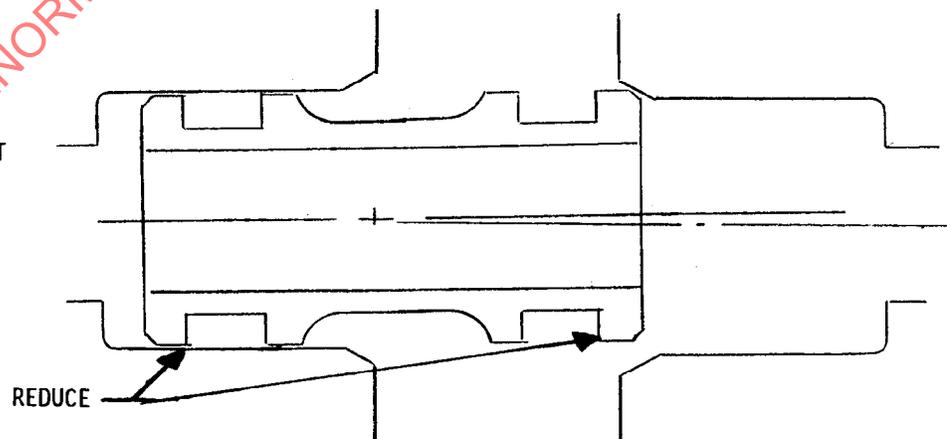
LAND/BORE FIT DOES
NOT ALLOW ADEQUATE
ANGULAR MIS-ALIGNMENT

SOLUTION: Reduce the diameter of the seal lands furthest from the interface to provide angular play.

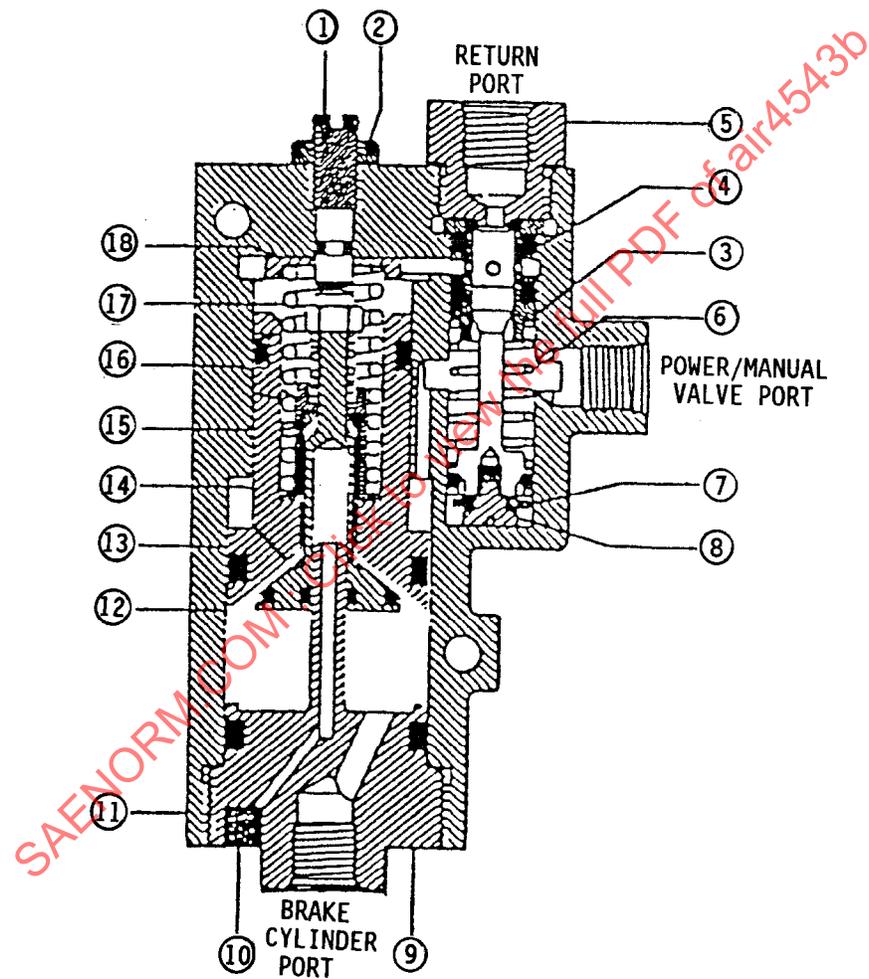
- a. Many hydraulic components have areas requiring atmospheric vents protected by filter screens.
- b. Some screens have been totally clogged by improper painting.

- a. Do not paint vent holes.
- b. Insure that the design aids vent hole recognition.

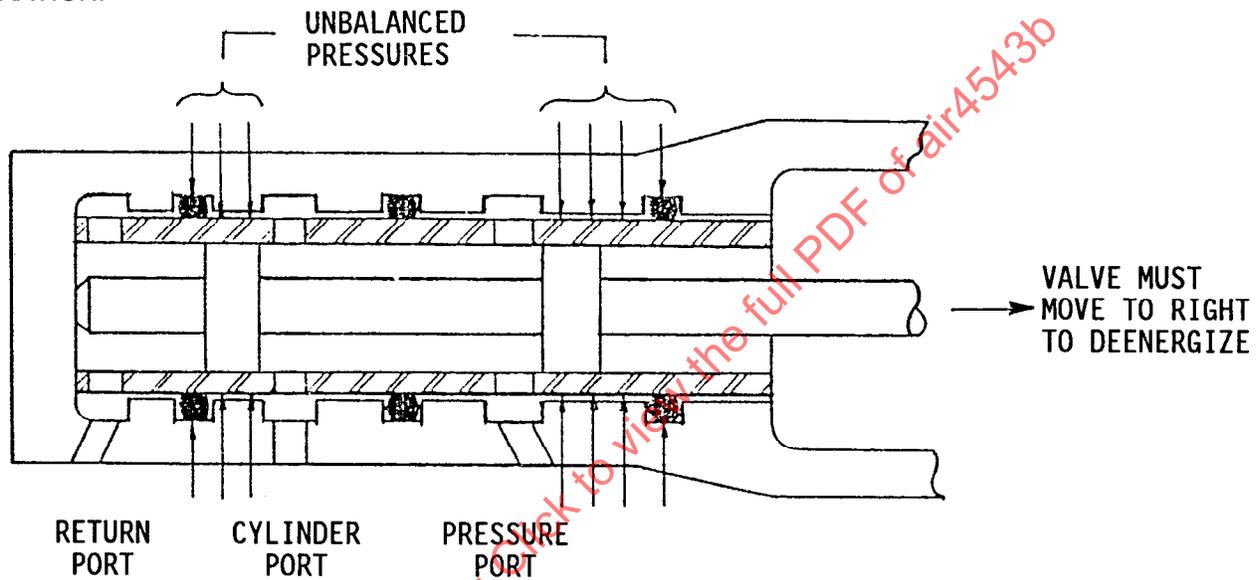
PROBLEM: Unbalanced pressures cause sleeve to pinch valve slider.

ISSUE: Many valves have hung up or failed to operate because a high pressure on the outside of a sleeve was not balanced by an equal pressure inside the sleeve. In the valve shown, the controller would not return to the de-energized position.

- Attempt to balance the pressures inside and outside of the sleeve so that there will be no reduction in sleeve diameter.
- When complete balancing is not possible, increase the clearance between the sleeve and slider. Include an acceptance test to demonstrate valve operation at a pressure higher than that to be experienced in service.
- Incorporate at least three pressure balance grooves in each controller land.

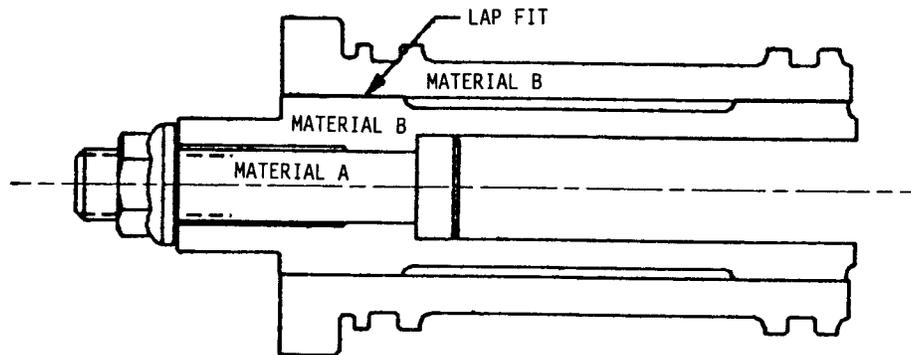
- Spool is clamped/loaded with different materials of A and B.
- Lap fitted diametral clearance changes due to axial load increasing from differential thermal expansion axially.

SOLUTION: Increase lap clearance during manufacturing.

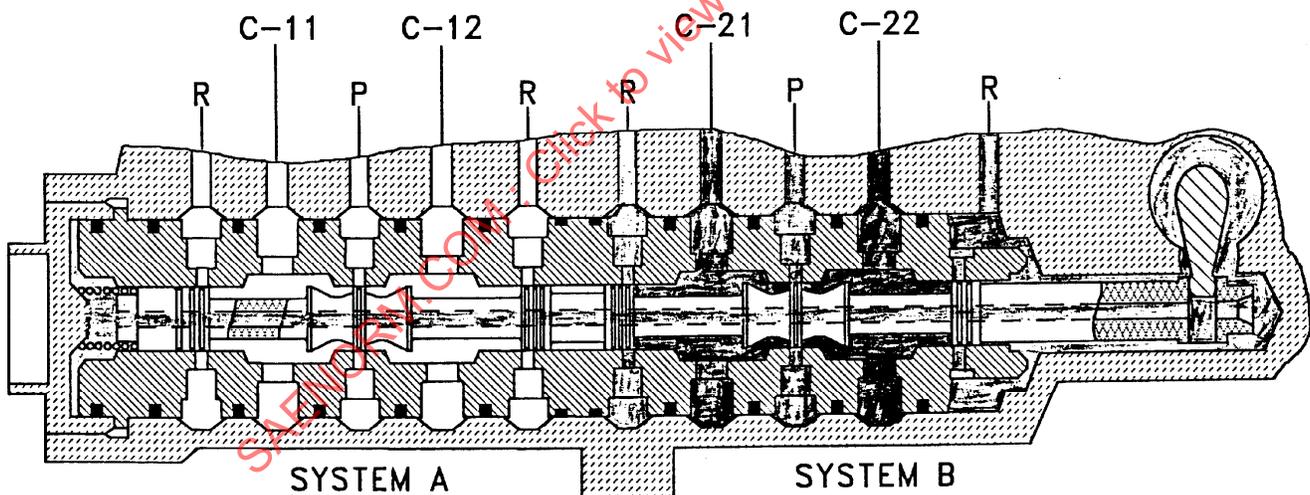
ILLUSTRATION 1 – CURRENT VALVE DESIGN

ISSUE: Pressure impulses in valve return act on valve spool and cause valve oscillations.

SOLUTION: Mask ends of spool from pressure impulses.

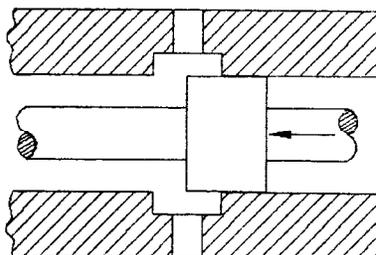
ISSUE: Spool land having to cross by an undercut in the valve sleeve.

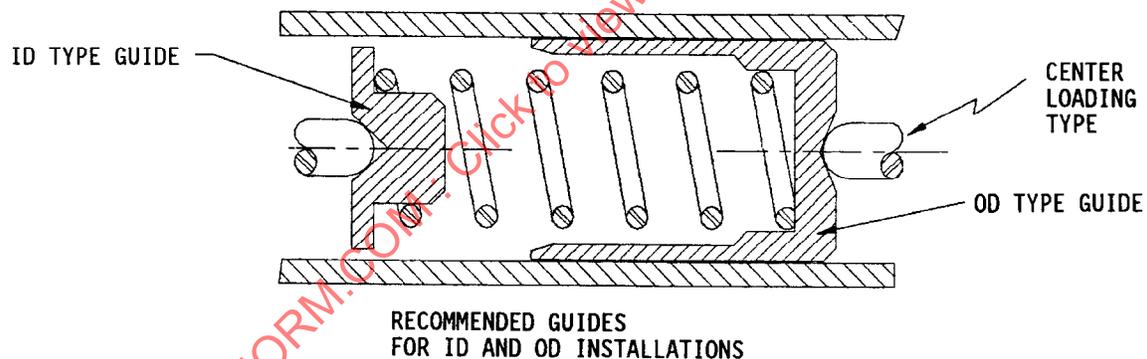
PROBLEM: Spring friction in valves.

ISSUE: Inadequate or improper guide.

- Provide guide, with chamfers, at both ends of the spring (ID or OD) for 1-1/2 to 2 coils.
- Increase the clearance between the guides and bore diameter.
- Where possible, eliminate the side loading by centering the spring load.

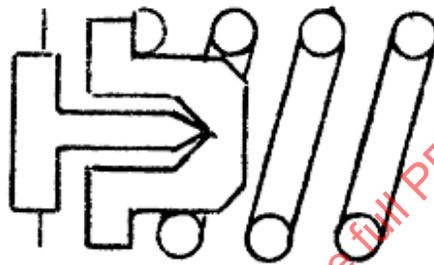
ISSUE: Spring pivots, located outside of the spring, cause the spring to buckle and bear against the valve spool.

SOLUTION: Locate pivot within the spring.

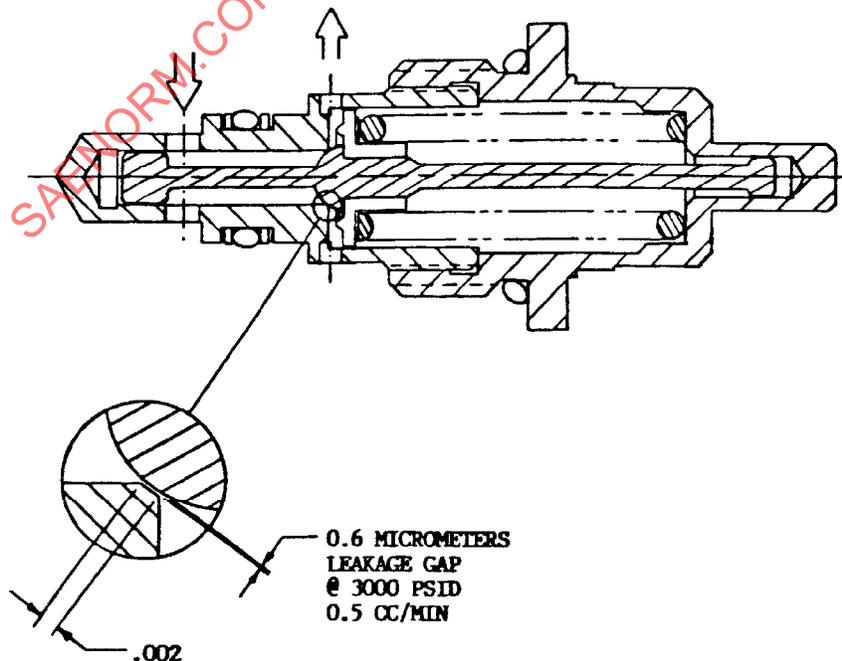
PROBLEM: Poppet style metal-to-metal relief valves for high pressure hydraulic systems (3000 lbf/in² (20 700 kPa) and up) demonstrate erratic shutoff performance for leakages less than 1 cc/min. High reject levels (10 to 20%) occur between the valve manufacturer and the system contractor, resulting in costly documentation, retest and often, Not-As-States reports.

ISSUE: Relief valve leakage is usually measured on decreasing pressure tests at slightly below the cracking pressure. Net poppet force, hence seat stress, is low since the upstream pressure force is only slightly less than the spring force. Low seat stress means microscopic voids from seat imperfections and fluid particles.

SOLUTION: Assure that the valve leakage specification is realistic. Consistent shutoff to 1 or 2 drops per minute can be achieved with ideal conditions but not in real hydraulic environments. Elastomeric sealing may be required for repeatable near zero leakage.

Assure test conditions are the same at the valve manufacturer and system contractor, and that they accurately simulate the valve's end use.
