**Plain bearings — Appearance and  
characterization of damage to metallic  
hydrodynamic bearings —**

**Part 1:  
General**

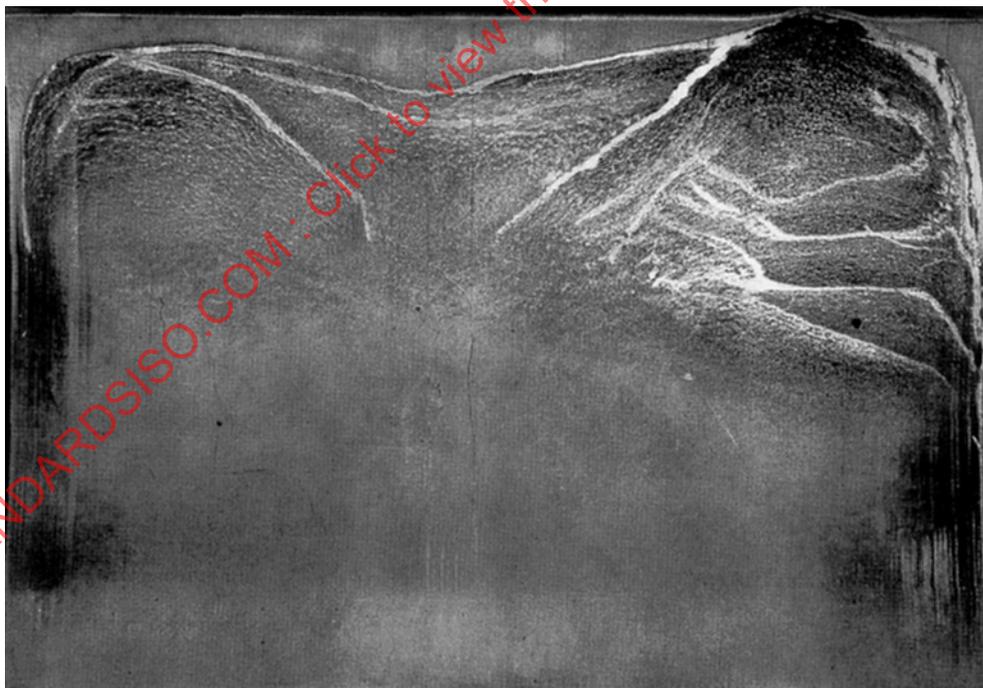
Figure 3 — Creep deformation, shown by crack-free semicircular bulges in the direction of rotation (material: steel/tin-based white metal)

Creep deformation: shallow depressions of bearing material in the region of maximum load and temperature, beginning smooth and ending in crack-free semicircular bulges in the direction of rotation, sometimes like crests of waves (see Figure 3).

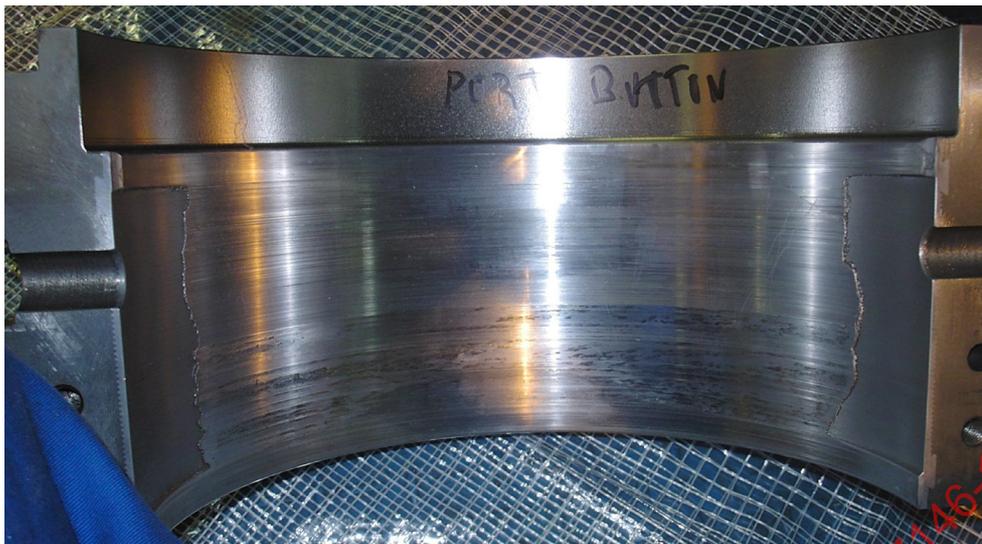
Figure 4 — Propeller shaft bearing, showing the effects of too slow a speed in relation to load capacity (material: steel/tin-based white metal)

Traces of mixed lubrication (see Figure 4), depositions, thermal cracks.

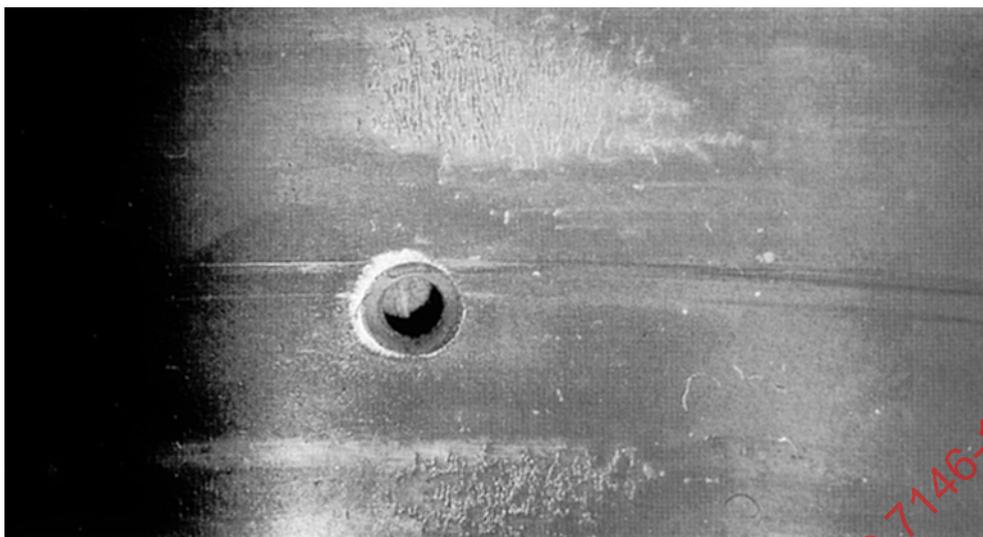
b) section from Figure 7 a) showing the lower half at increased magnification

Figure 7 — Cracks in the electroplated overlay (material: steel/lead bronze/electroplated overlay)

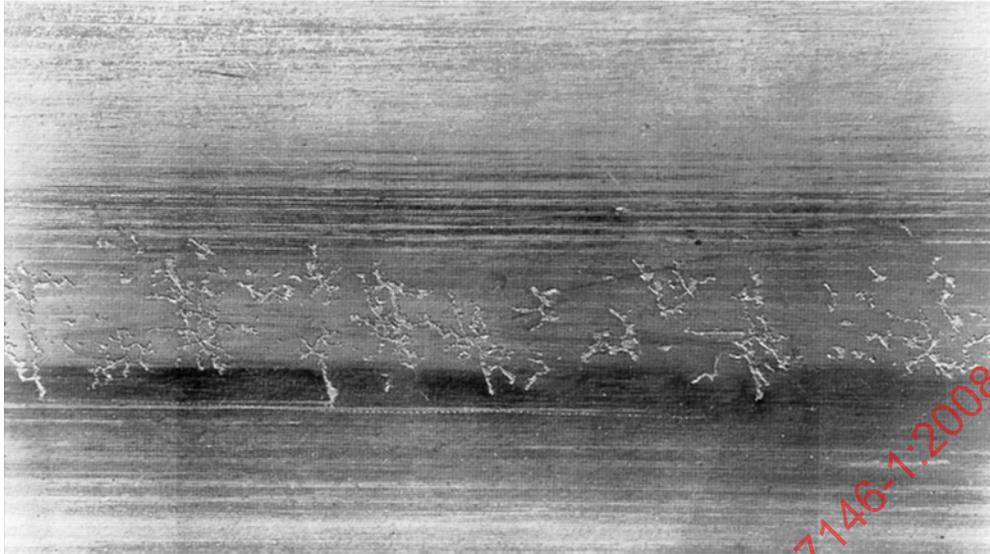
**Figure 8 — Cracks in the overlay of a multilayer bearing in a narrow area of high loading (material: steel/lead bronze/electroplated overlay)**

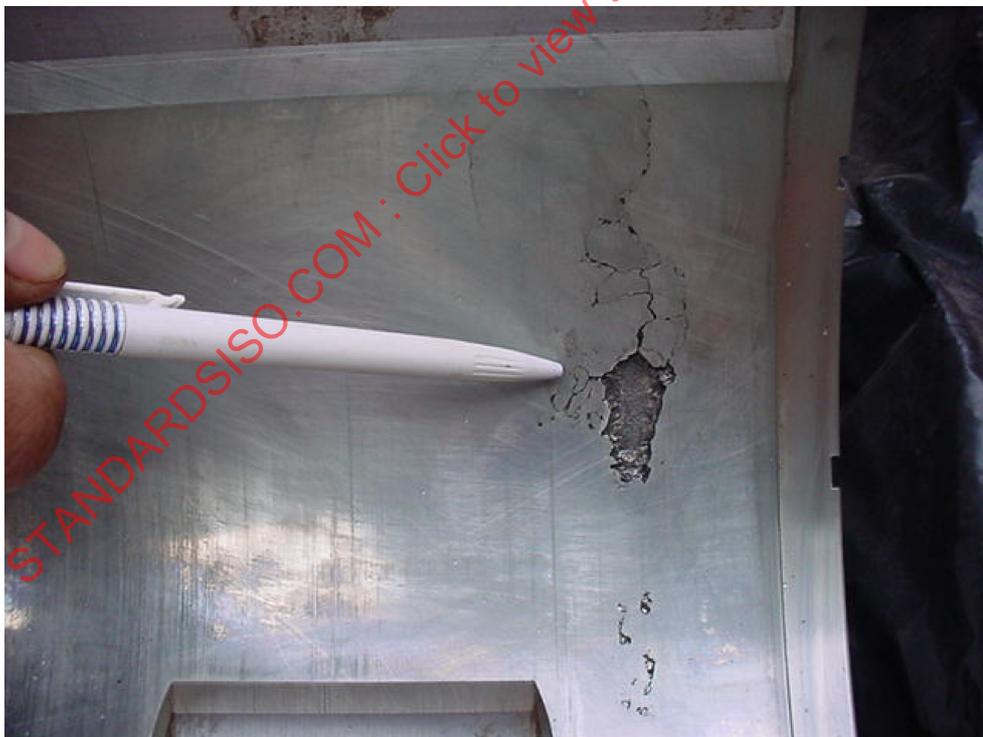
Figure 10 — Fatigue cracks and material relief by dynamic overload  
(material: steel/tin-based white metal)

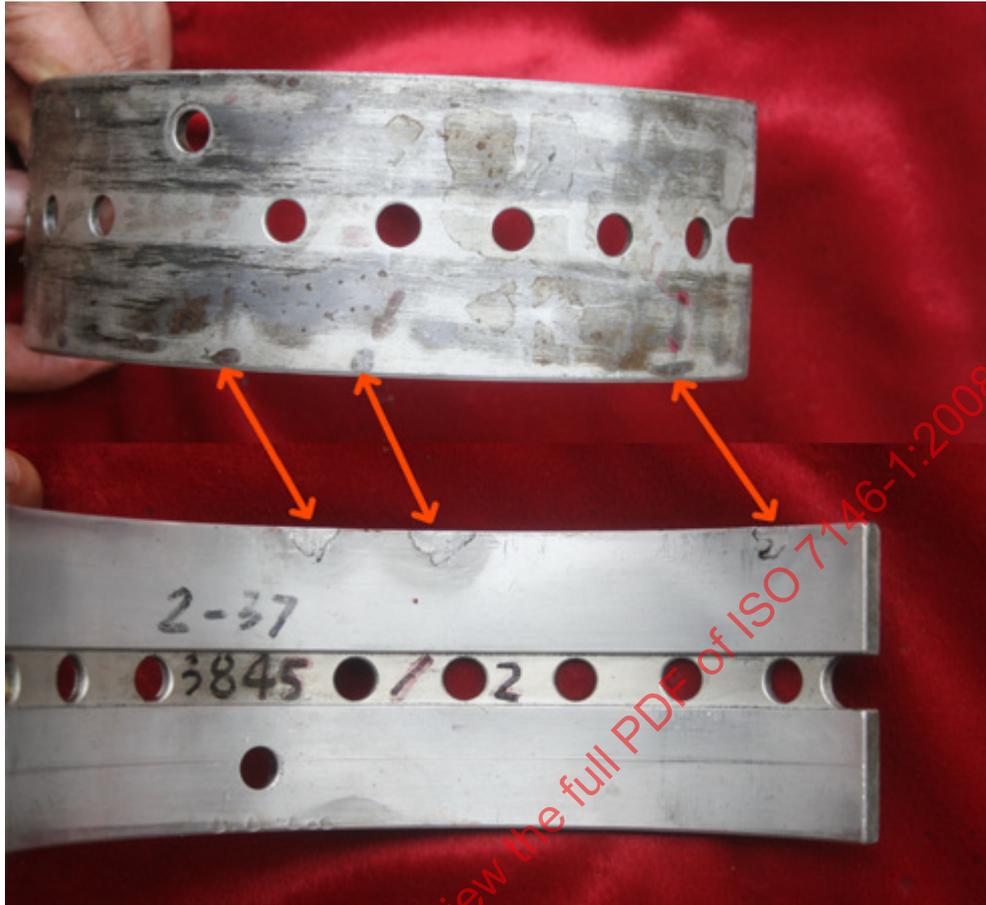
Figure 11 — Material relief by dynamic overload because of insufficient fit on the bearing back  
(see also 7.2)

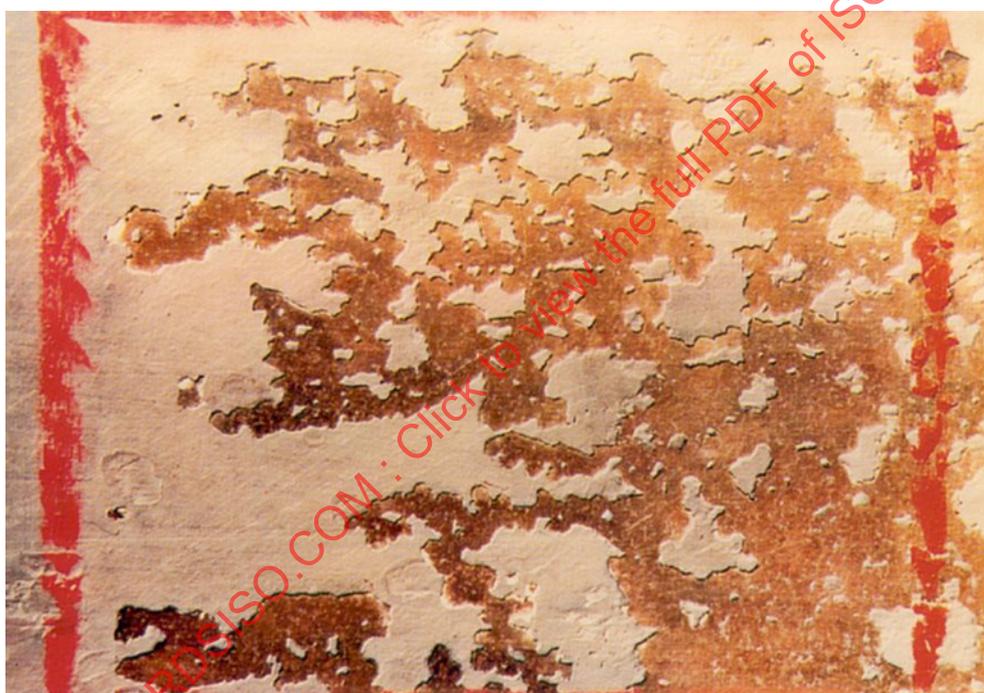
b) section from Figure 12 a): clear illustration of the defect at increased magnification

Figure 12 — Detachment of the overlay leaving occasional residual islands relieved by a dark background (material: steel/lead bronze/electroplated overlay)

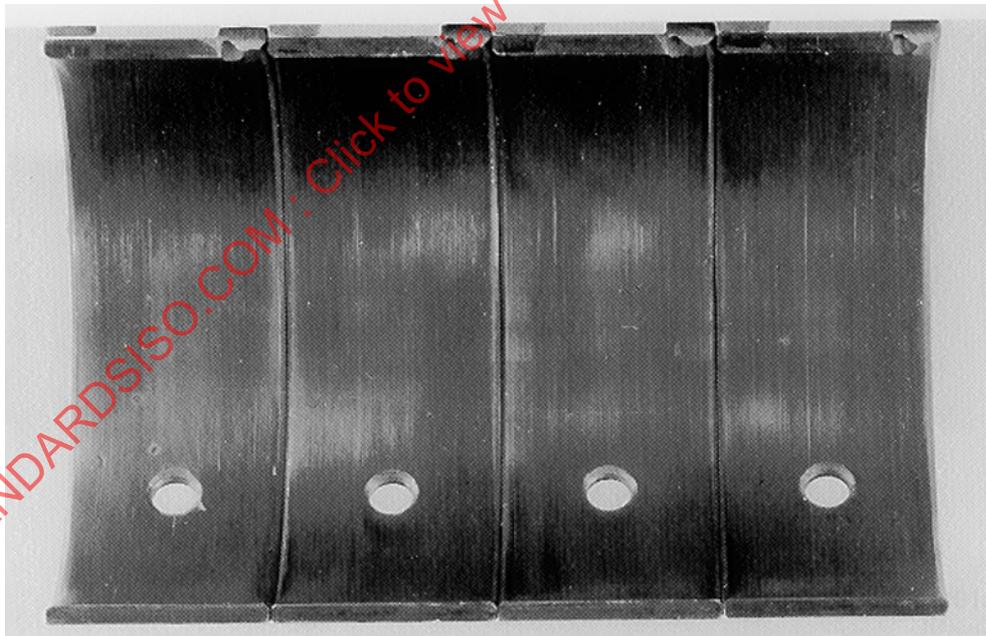
Figure 13 — Running-in polishing and burnishing in the main loaded area of a thin-walled bearing (material: steel/AISn)

Polishing happens during a short period of mixed lubrication on start and stop conditions. As long as this polishing does not give rise to a detectable reduction in wall thickness, such running-in marks are normal. This is not damage in the sense of the definitions of this part of ISO 7146 (see Figure 13).

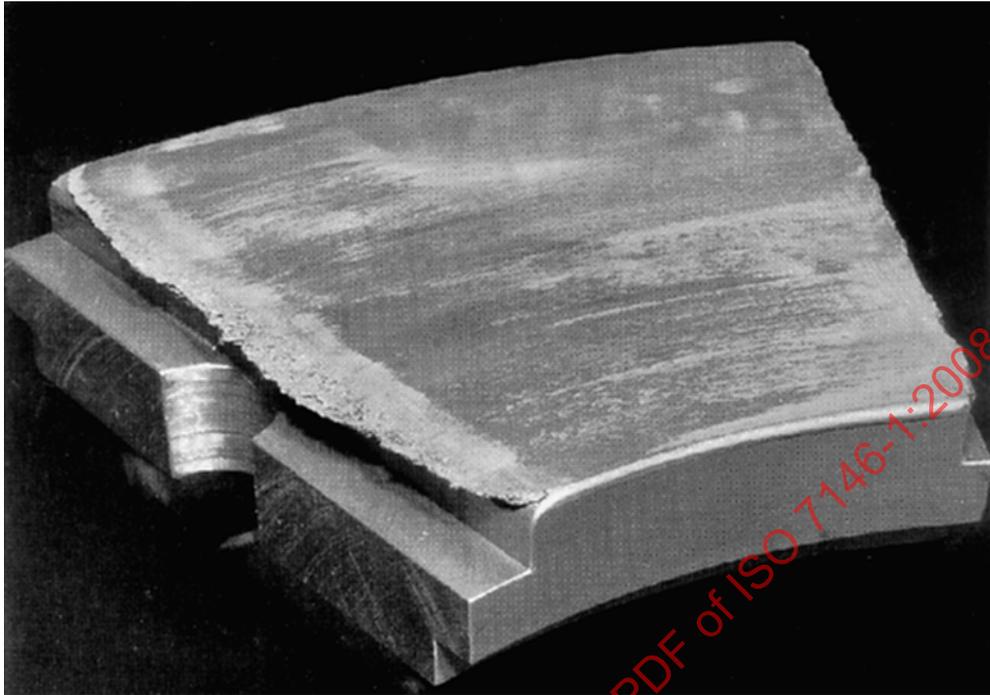
Figure 16 — Wear by friction due to segment assembling on different levels — worn material from one segment deposited on the leading edge of the next segment in the direction of rotation — the segment shown gets a reduction in oil supply (secondary damage characteristic: loss of lubricant) (material: steel/tin-based white metal)

Segmented plain bearings experiencing appreciable wear at high rubbing surface temperatures often initially show traces of mixed lubrication; later, worn material from one segment is deposited on the leading edge of the next segment in the direction of rotation (see Figure 16).

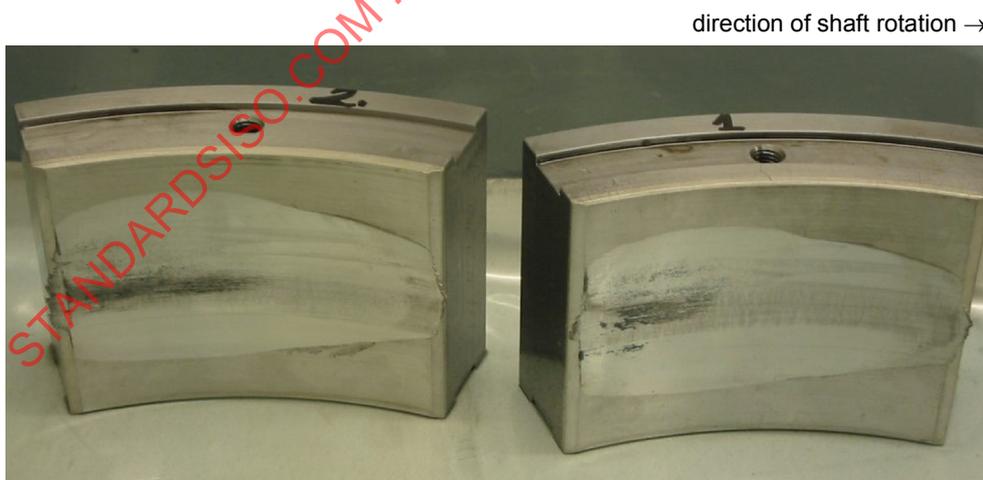
Figure 18 — Creep deformation due to overheating with formation of black depositions (material: steel/tin-based white metal)

Creep deformation: shallow depressions of bearing material in the region of maximum load and temperature, initially smooth and ending in crack-free semicircular bulges in the direction of rotation, sometimes like crests of wave (see Figure 18).

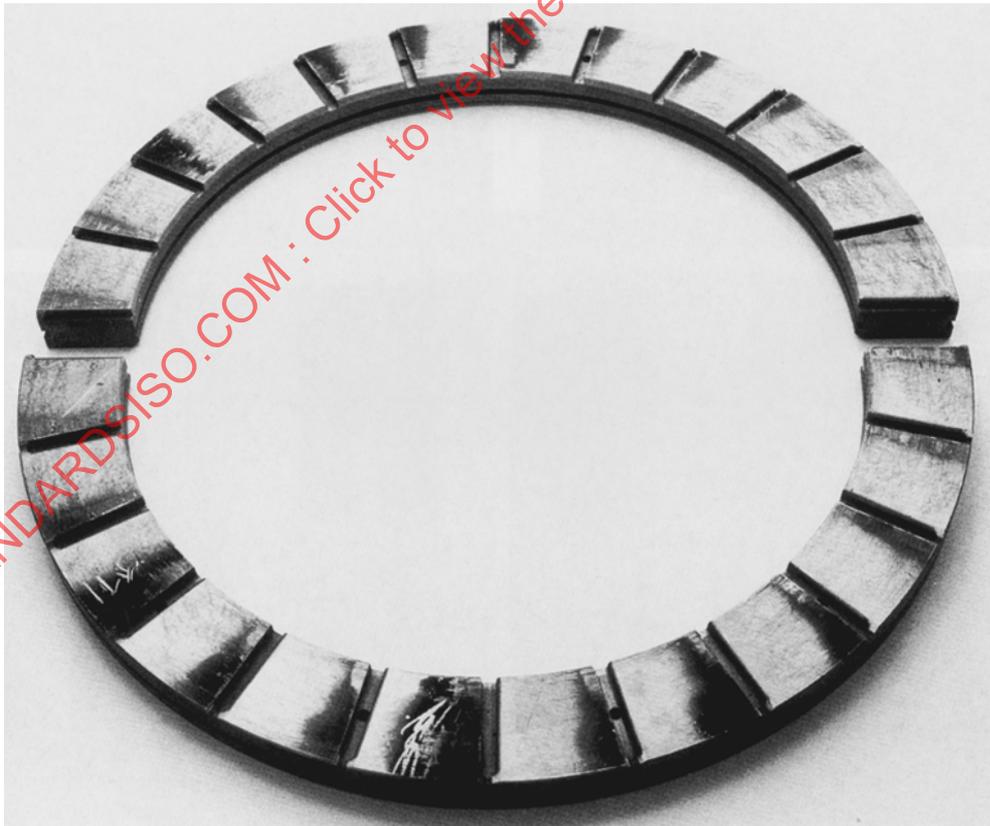
NOTE The black/brown deposit is easily removed using the thumbnail (see lowest segment).

**Figure 20 — Deposit of oil carbon on a thrust bearing ring (material: steel/tin-based white metal)**

Brown or black deposits appear on the bearing surface, but not as a result of chemical attack between the bearing material and the lubricant. The discoloration is due to very thin lacquer-like oxidized layers in areas of maximum temperature. It is relatively soft and can generally be removed using a solvent cleaning fluid or scratched off using a pointed instrument (see Figure 20).

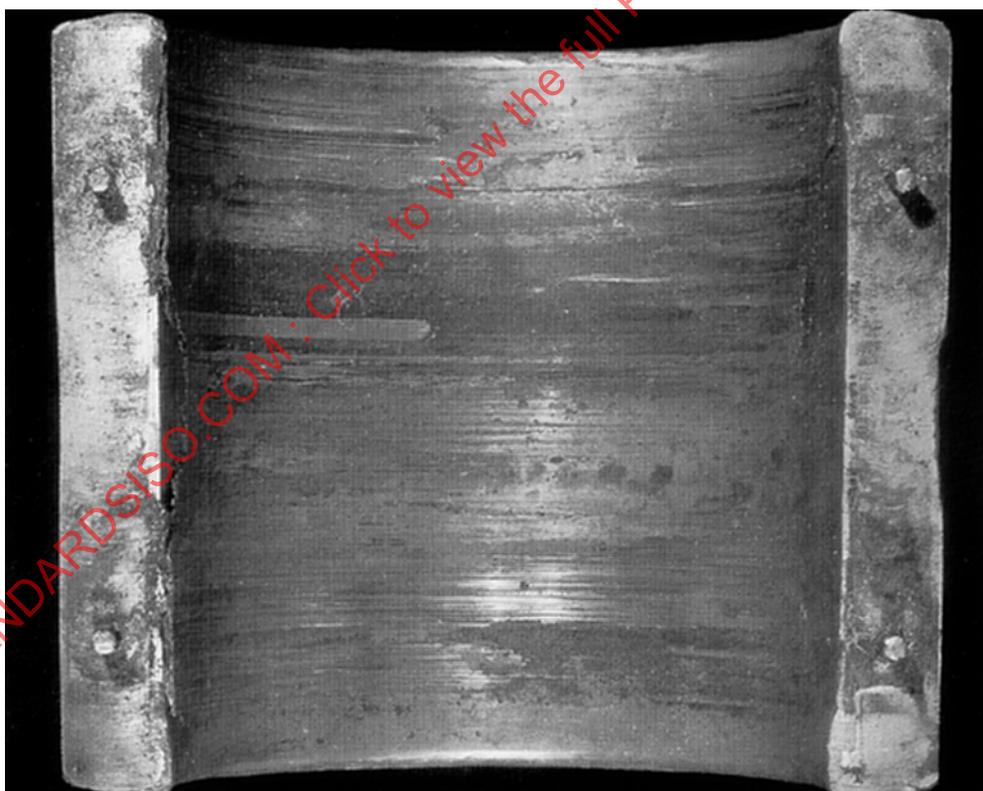
Figure 23 — Destruction of bearing metal due to loss of lubricant in a thick-walled bearing (material: steel/tin-based white metal)

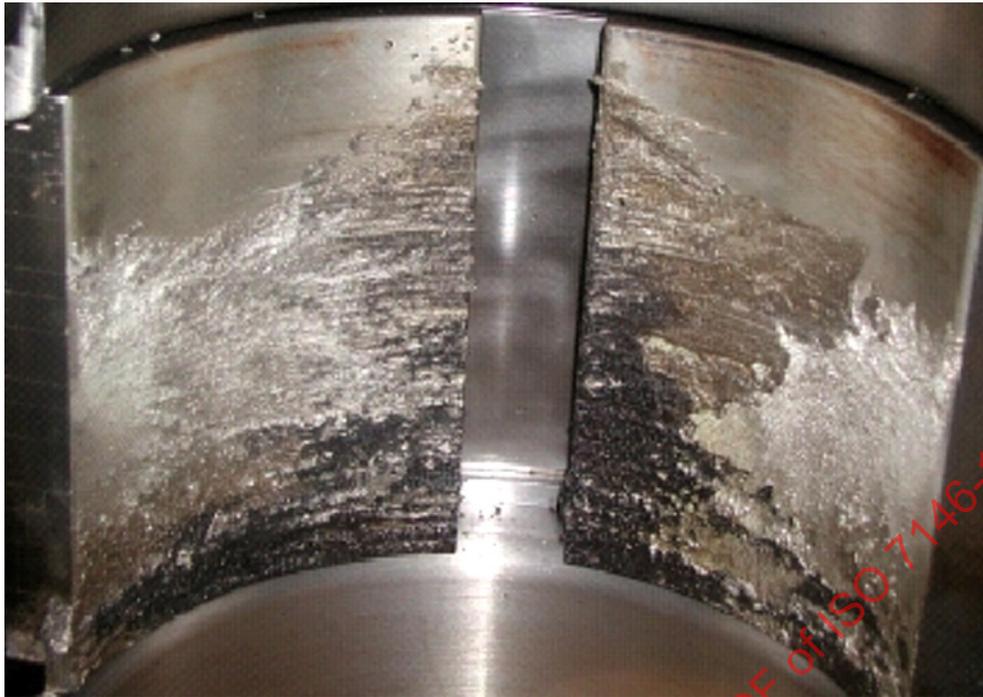
Figure 27 — Coloured surface due to loss of lubricant, melting out, seizure  
(material: steel/tin-based white metal)

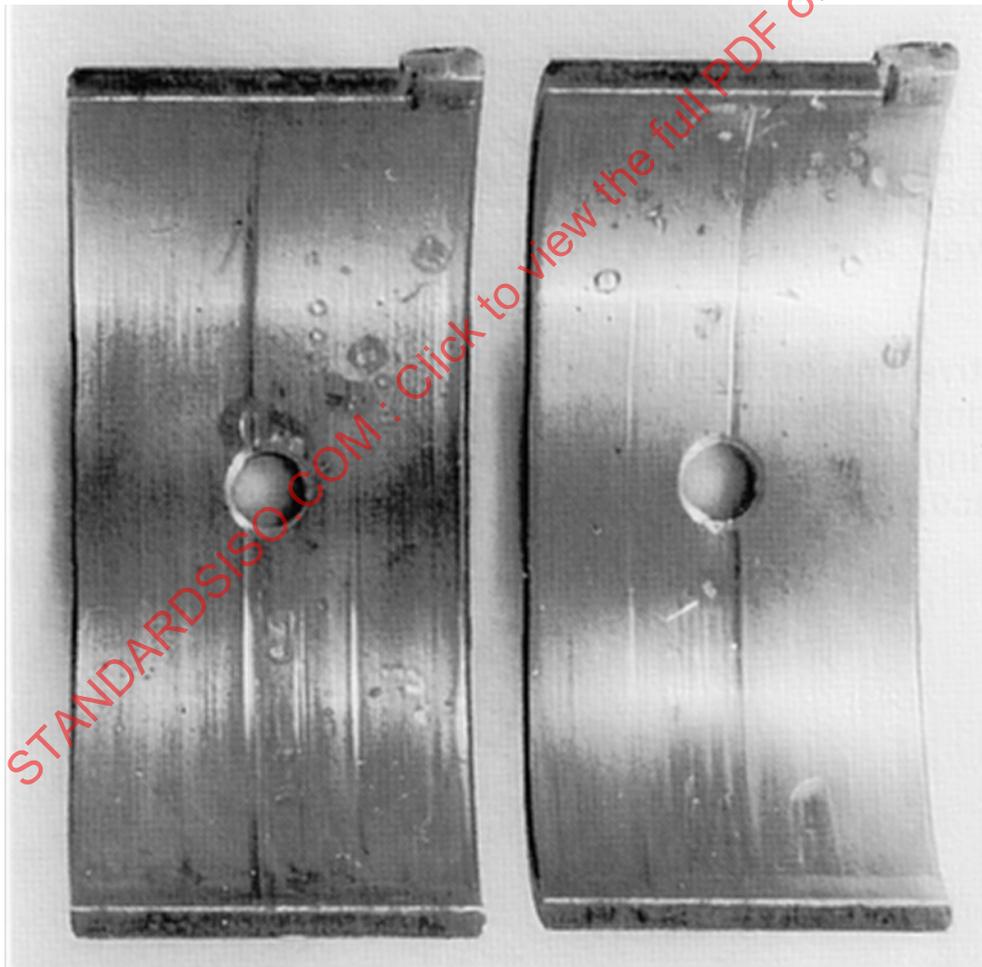
**Figure 29 — Embedding of particles, characteristic of embedding, see Figure 28, and migration tracks (material: steel/AlSn)**

Particle-migration tracks (see Figures 29, 32, 33 and 34).

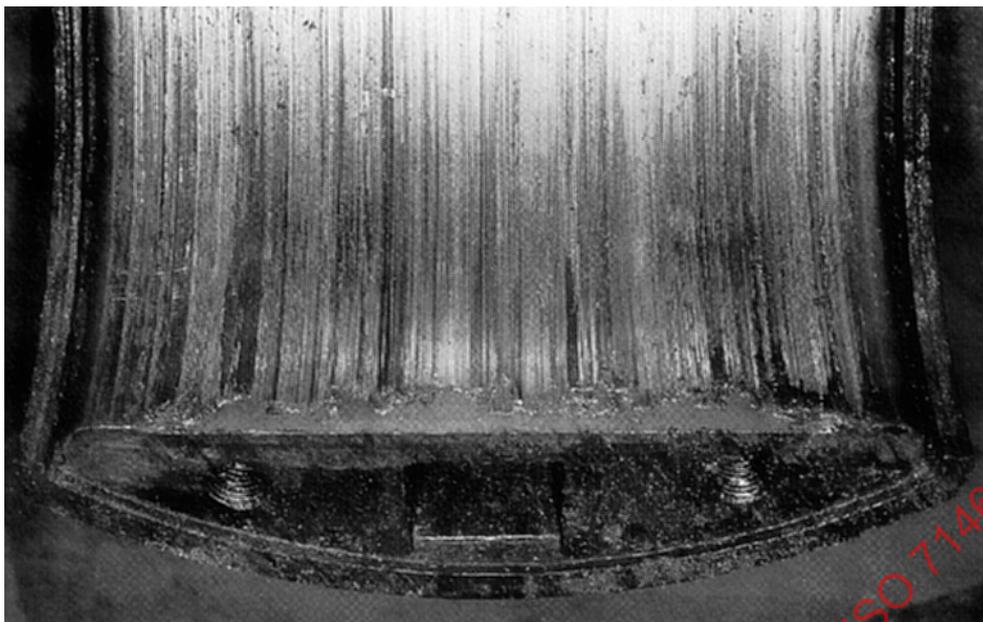
Figure 32 — Cement mill bearing with contamination by cement particles entrained by the oil as a result of damaged seals. Particle-migration tracks are visible (material: steel/tin-based white metal)

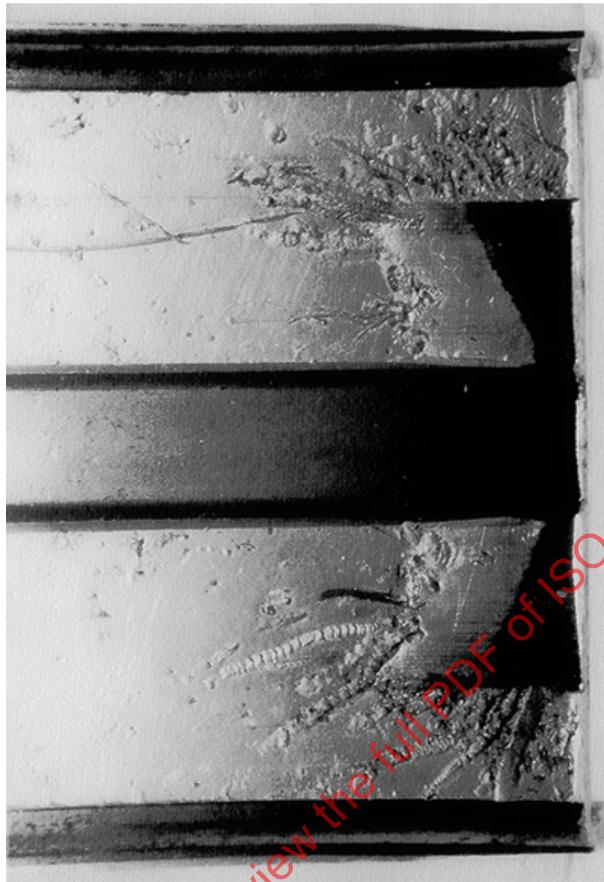
Figure 34 — Particle-migration tracks concentrated to the pocket area of a thin-walled bearing  
(material: steel/AlSn)

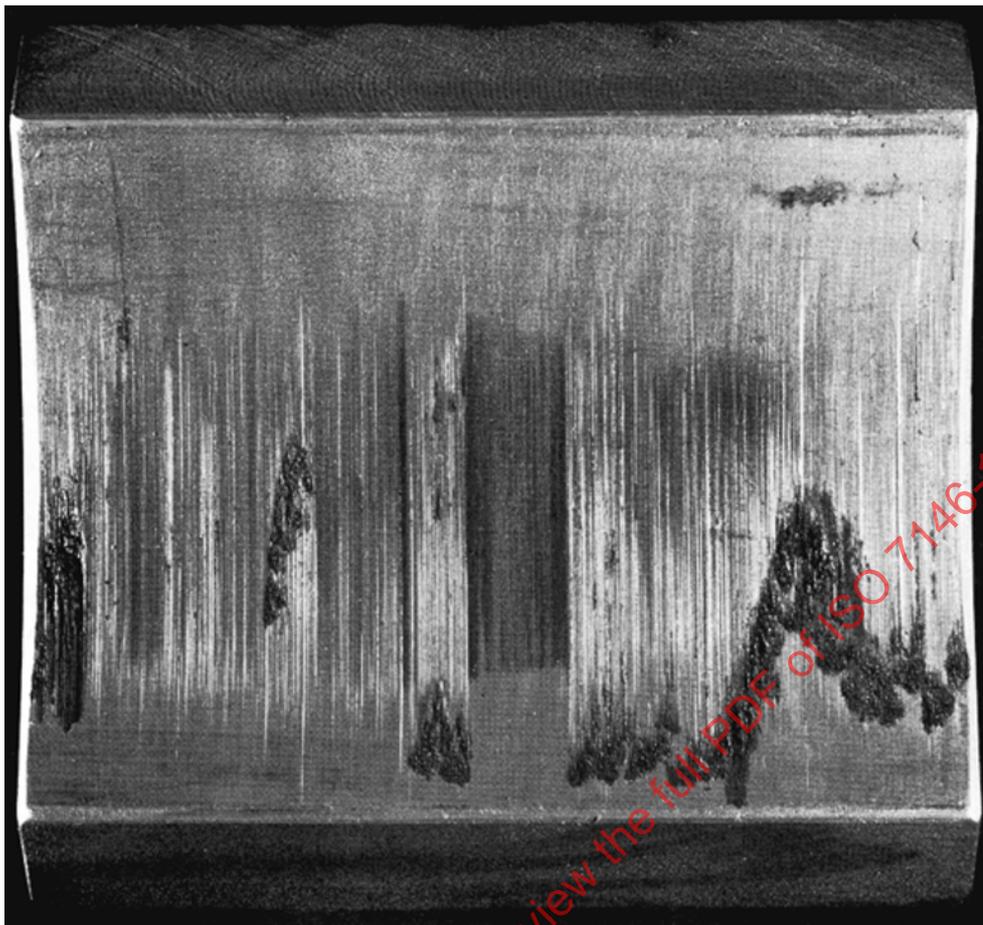
a) wire wool on a journal pad (material: steel/tin-based white metal)

b) wire wool on the shaft

Figure 35 — Attack caused by abrasive and adhesive effects in the initial stage (wire wool) (material: steel)

The formation of wire wool can be caused by hard foreign particles partially embedded in the bearing surface cut into the rotating shaft thereby removing material from the shaft surface. Wire wool formed in this way can also be once more embedded in the bearing metal and usually brings about total failure very quickly (see Figure 35).

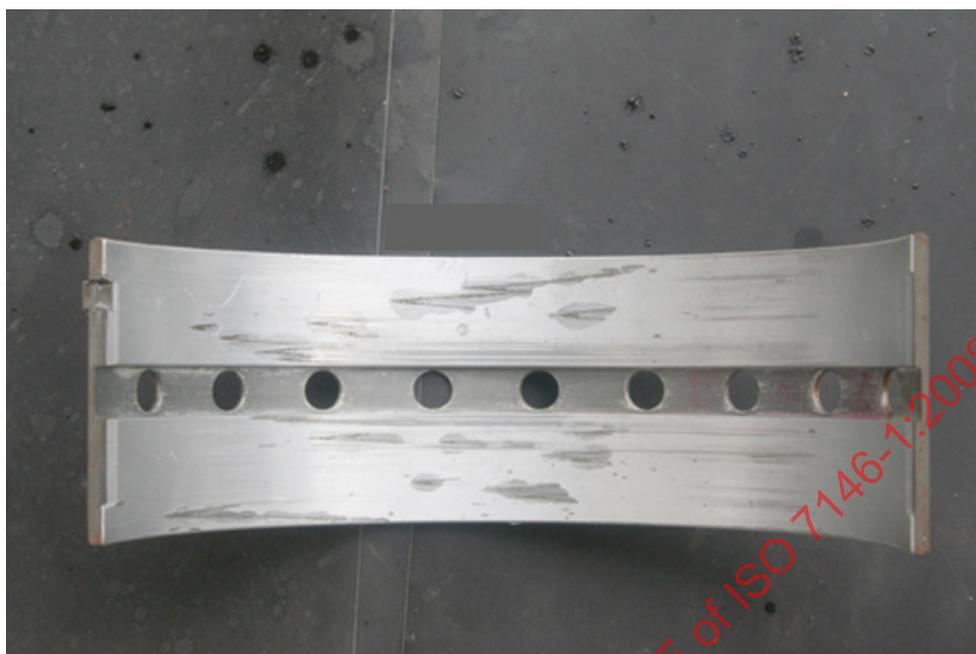
direction of shaft rotation →

**Figure 36 — Chevron-like defect caused by particles from iron nitride compound layer of nitrified shafts (material: steel/lead bronze/electroplated overlay)**

Chevron appearances are particle-migration tracks generated by hard particles. The chevrons point in a direction opposite to the direction of rotation of the journal (see Figure 36).

Chevron appearances: The migration tracks are caused by particles originating from the surface of nitrided journals. Particles with magnetic properties spall from the journal due to insufficient grinding and removal of the white friable layer.

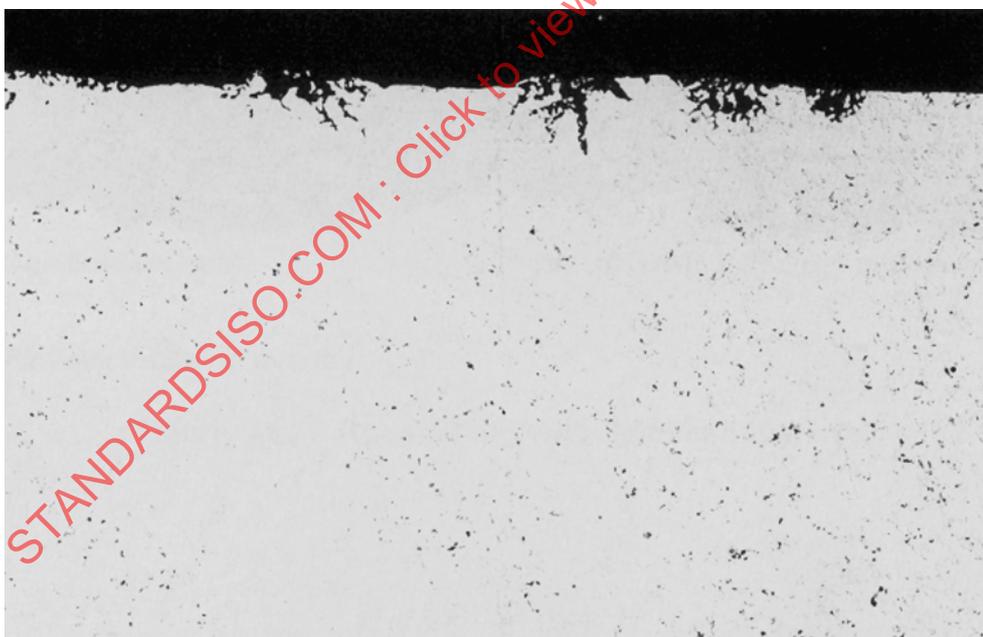
Figure 40 — Corrosion of the surface layer with selective attack on copper and lead in a tin-based material, unetched (material: steel/tin-based white metal)

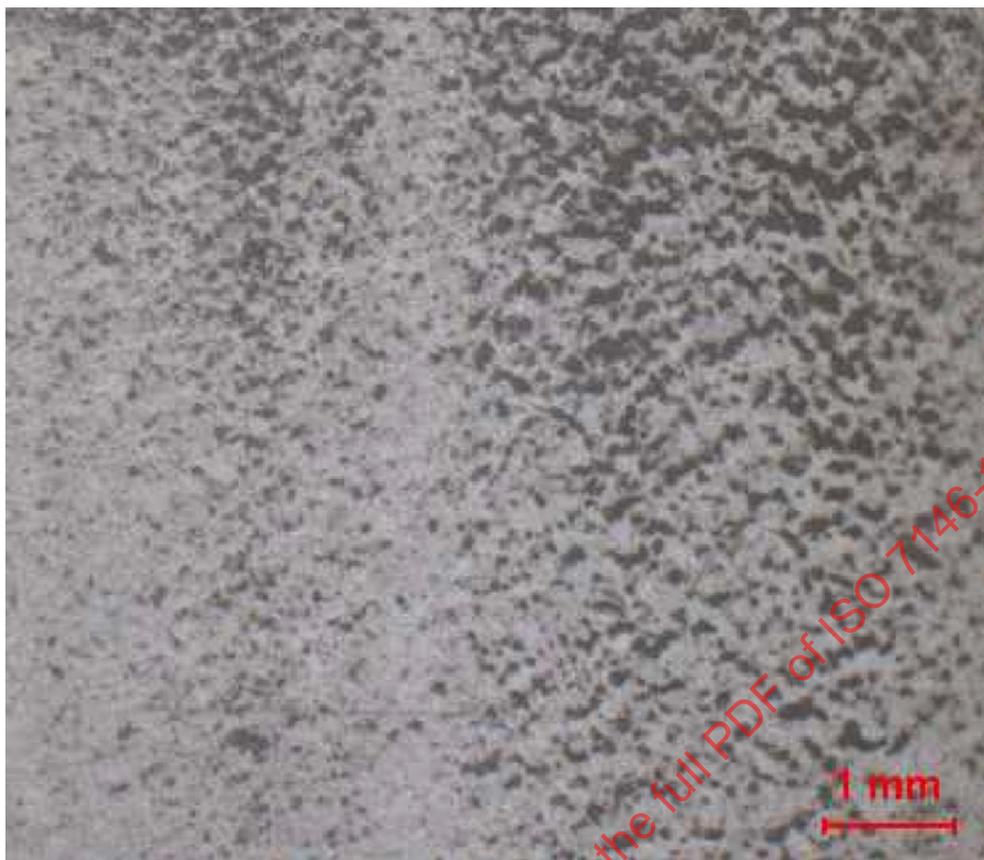
Figure 42 — Deposit of oil carbon on galvanic surface

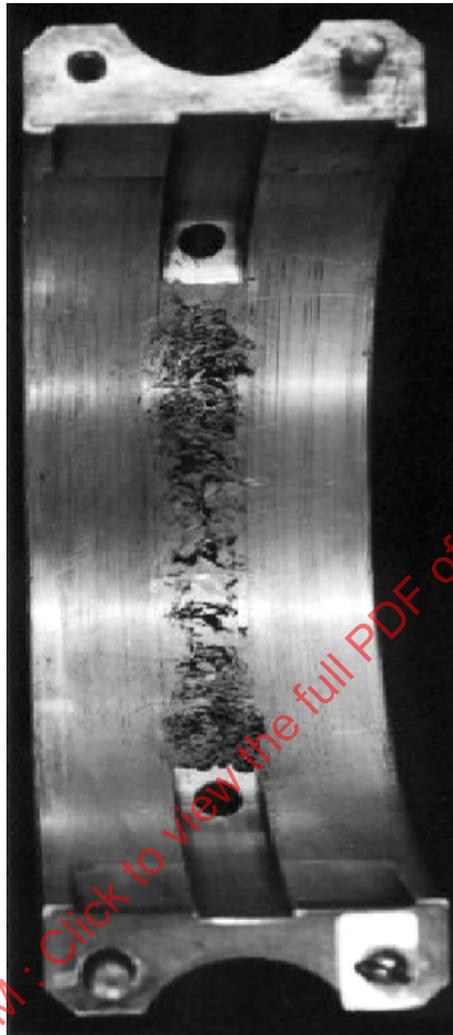
Figure 43 — Typical cavitation erosion on a thick-walled bearing (material: steel/tin-based white metal)

6.8.4 Typical examples (see Figures 43 and 44)

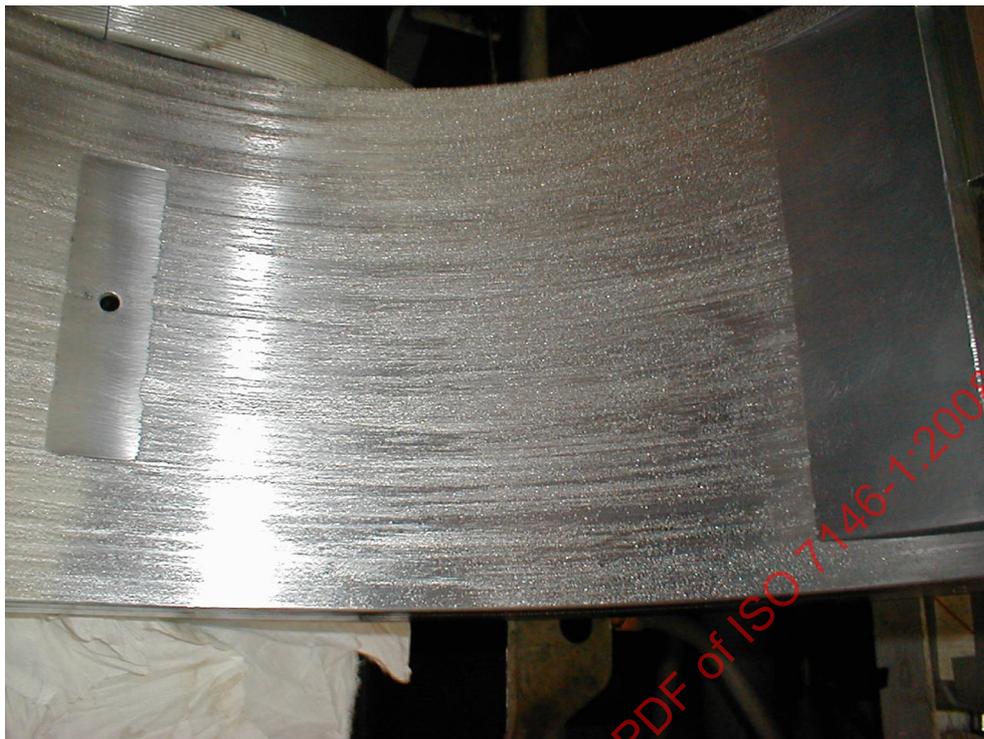
Figure 46 — Formation of electric arc craters
