**Plain bearings — Appearance and
characterization of damage to metallic
hydrodynamic bearings —**

**Part 1:
General**

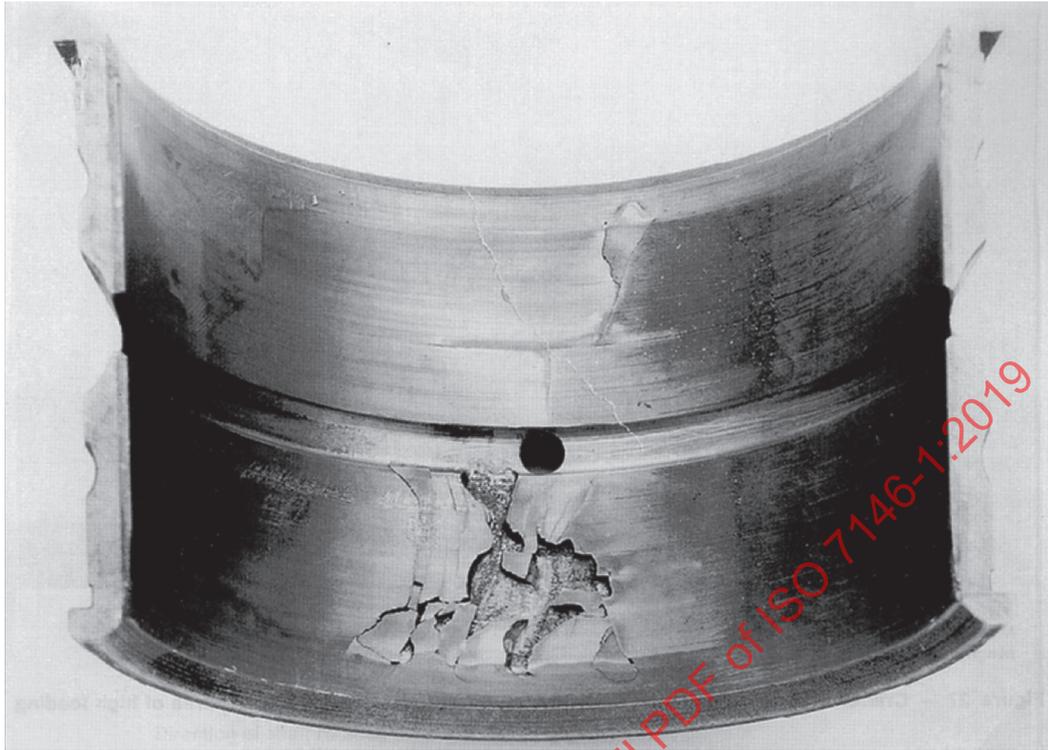
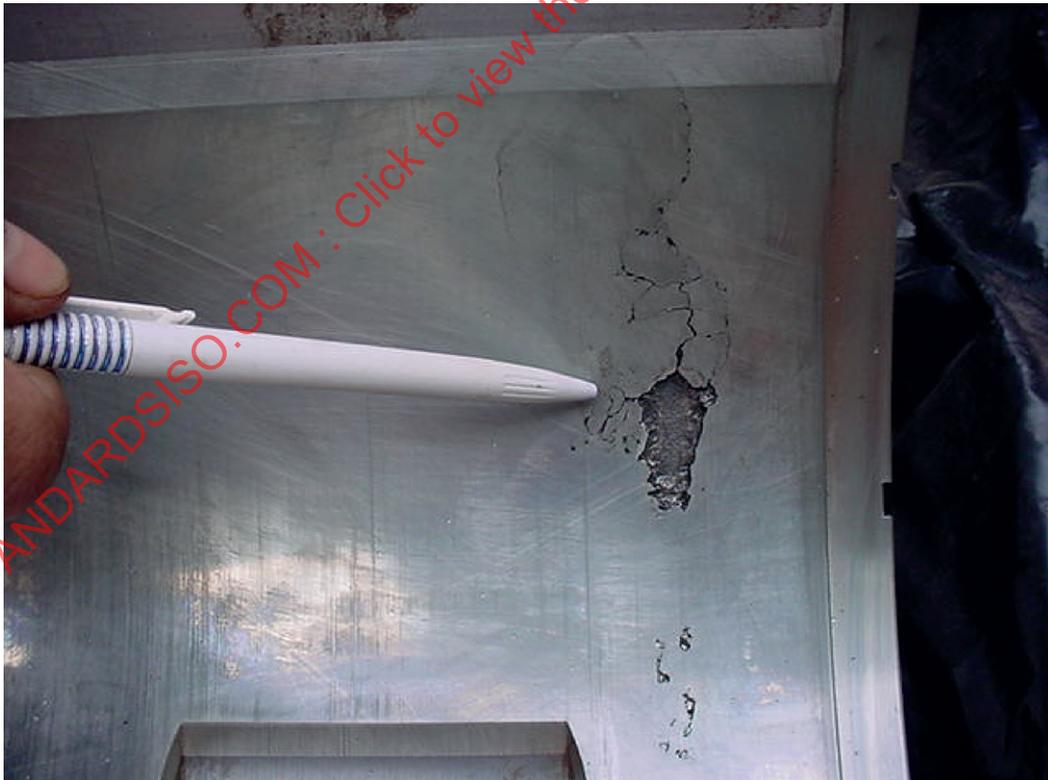
**Figure 10 — Fatigue cracks and material relief by dynamic overload
(material: steel/tin-based white metal)**

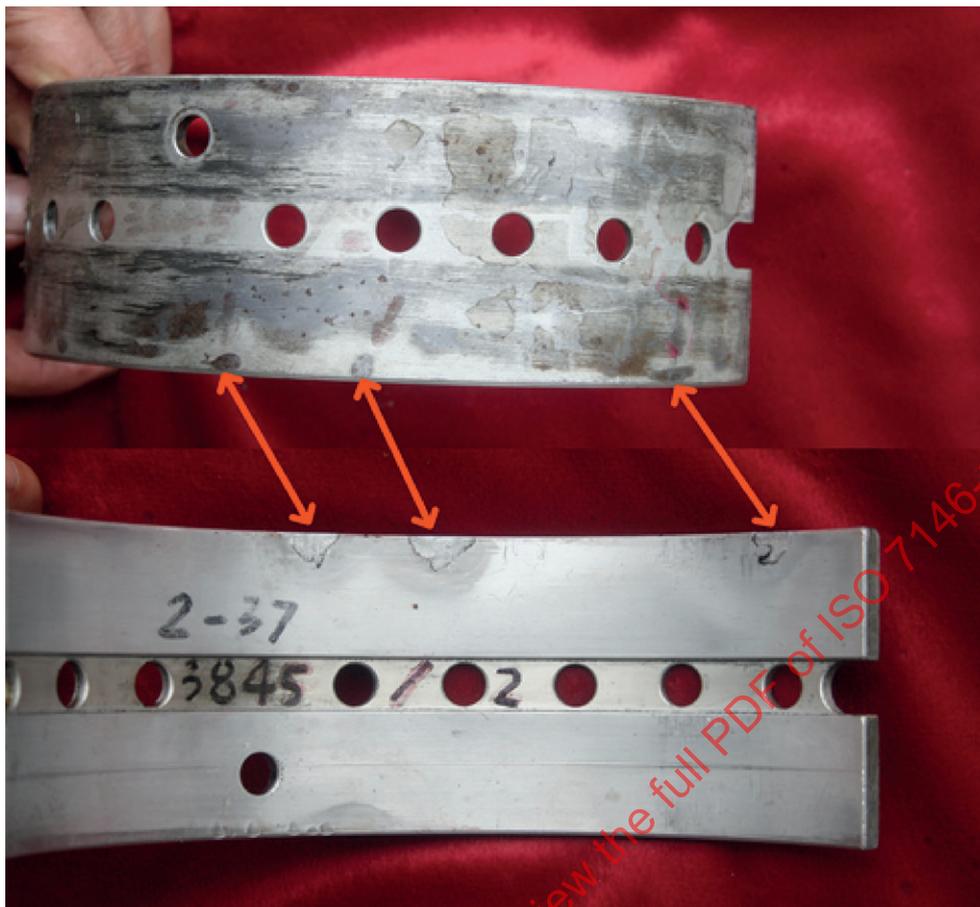
Figure 11 — Material relief by dynamic overload because of insufficient fit on the bearing back
(see also [7.2](#))

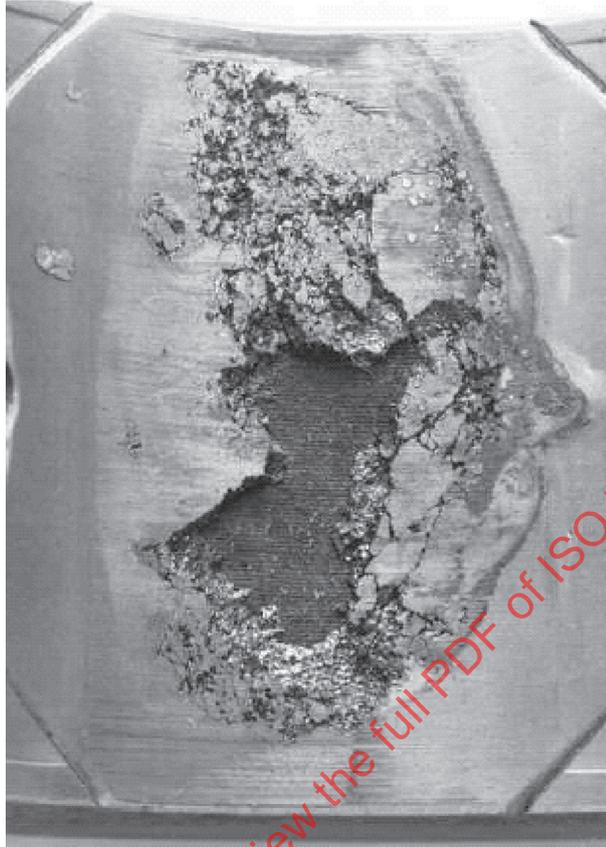
**Figure 21 — Radial segments with thermal cracks and worn material
(material: steel/tin-based white metal)**

Thermal cracks have an irregular unsystematic orientation characteristic. These typical appearances can be characterized as creep deformation, traces of mixed lubrication and worn material (see [Figure 21](#)).

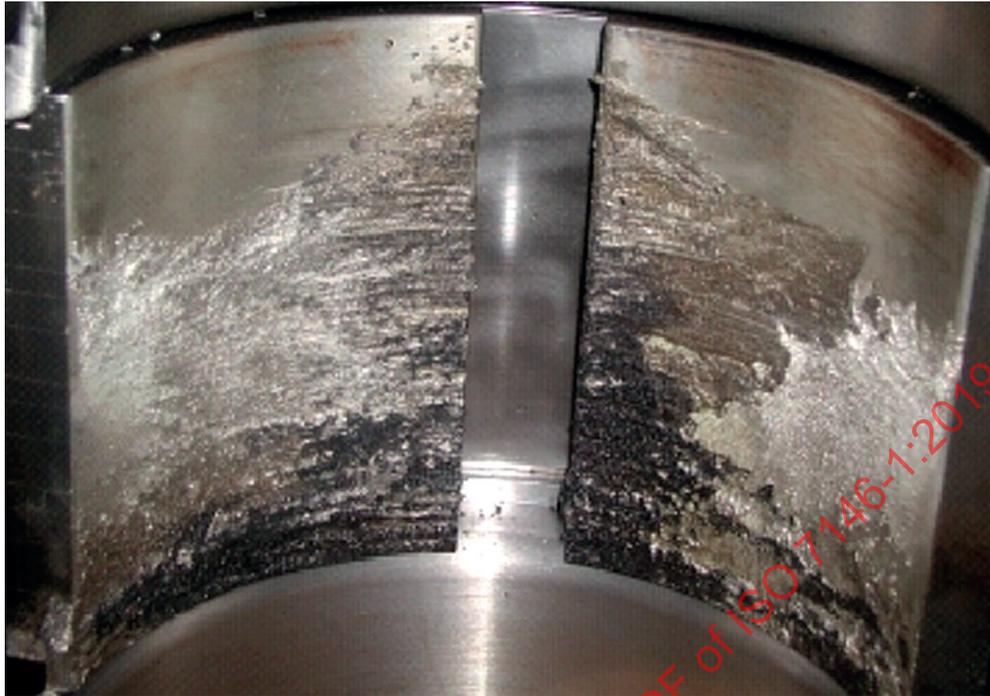
Figure 27 — Coloured surface due to loss of lubricant, melting out, seizure (material: steel/tin-based white metal)

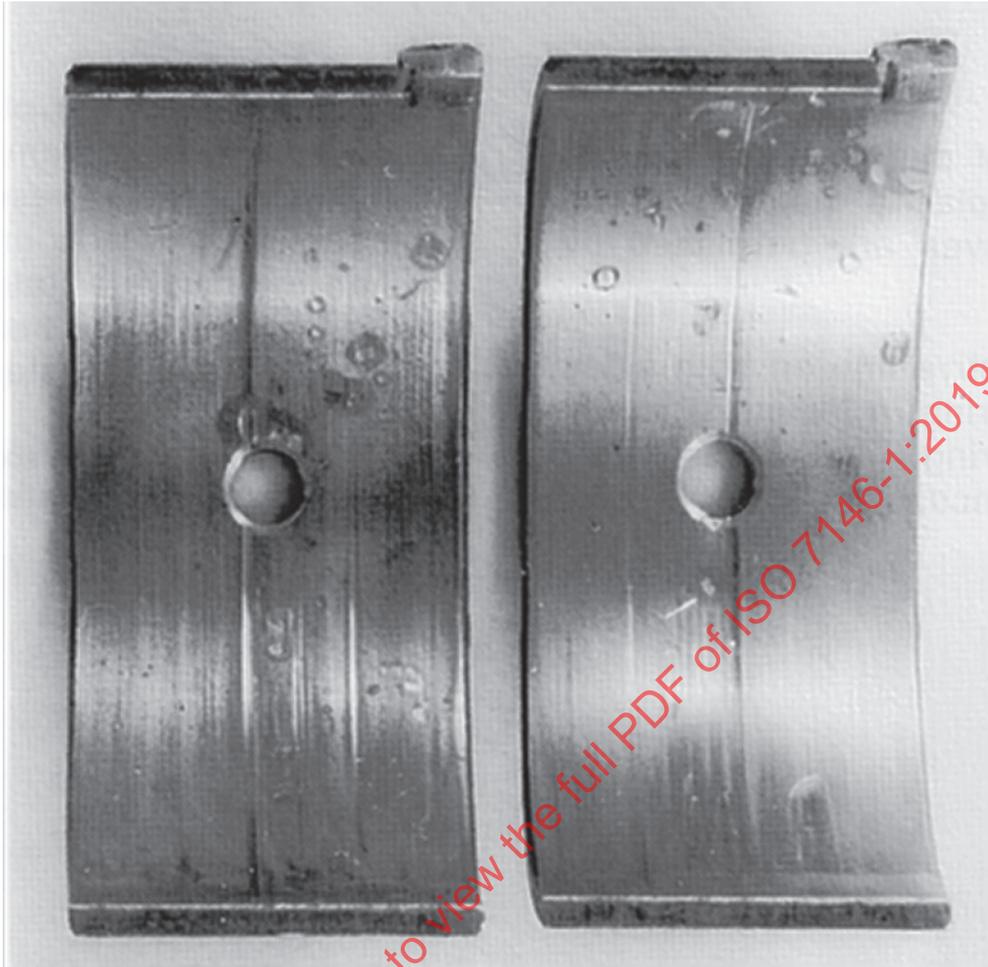
**Figure 29 — Embedding of particles, characteristic of embedding and migration tracks
(material: steel/AlSn)**

- Embedded particles.
- Scoring (see [Figure 31](#)).
- Particle-migration tracks (see [Figures 29, 32, 33](#) and [34](#)).

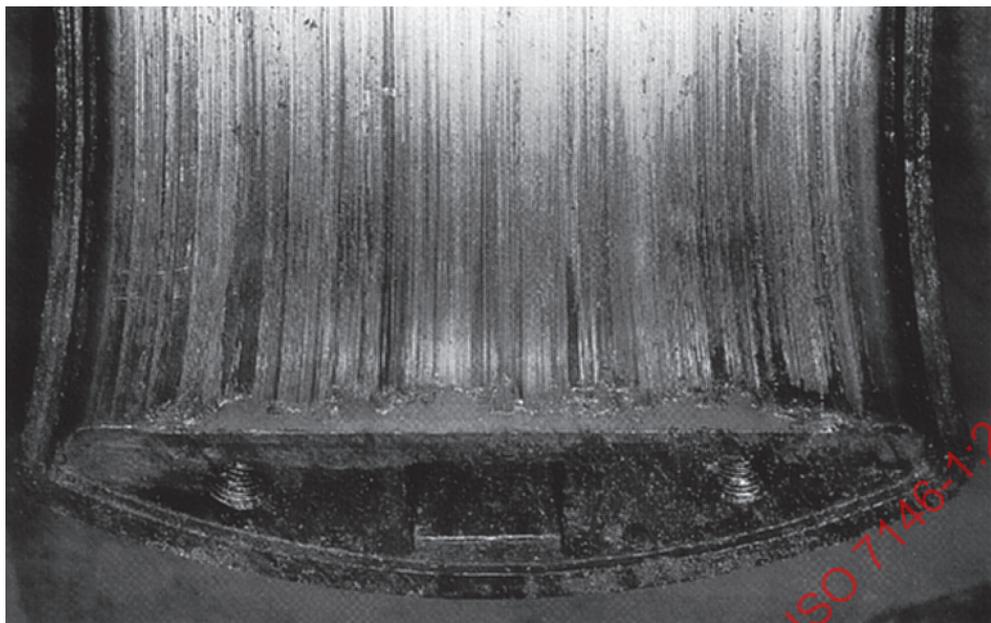
NOTE Particle-migration tracks are visible.

**Figure 32 — Cement mill bearing with contamination by cement particles entrained by the oil as a result of damaged seals
(material: steel/tin-based white metal)**

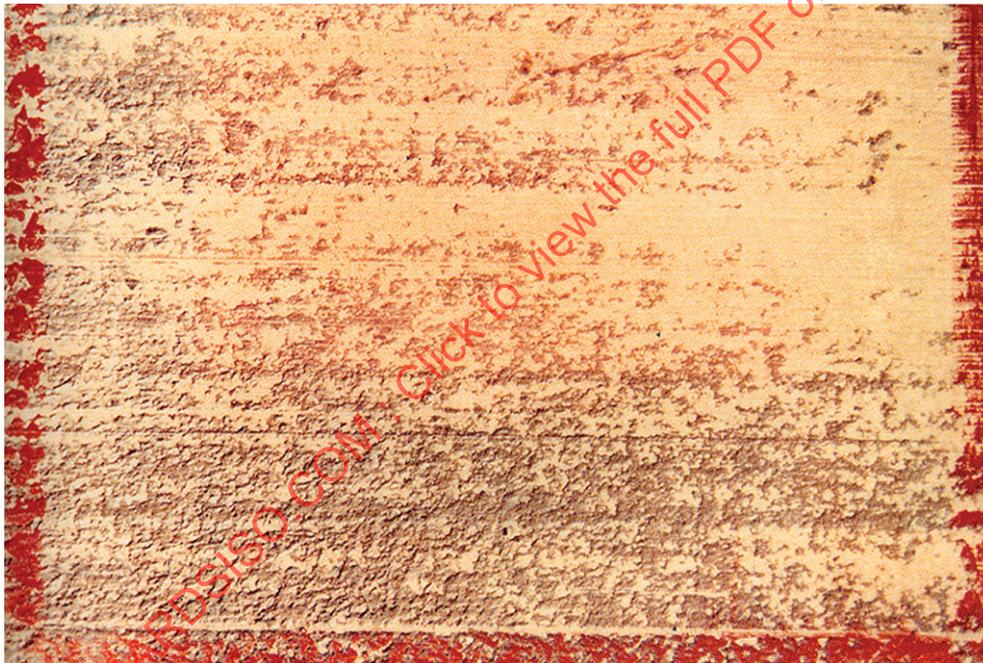
a)

b) Section from the marked area of [Figure 38 a\)](#) at increased magnification

Figure 38 — Corrosive detachment of the overlay in the area of the oil hole and selective corrosive detachment on the right-hand side of the bearing lining (material: steel/lead bronze/electroplated overlay)

See [Figures 37](#) to [42](#).

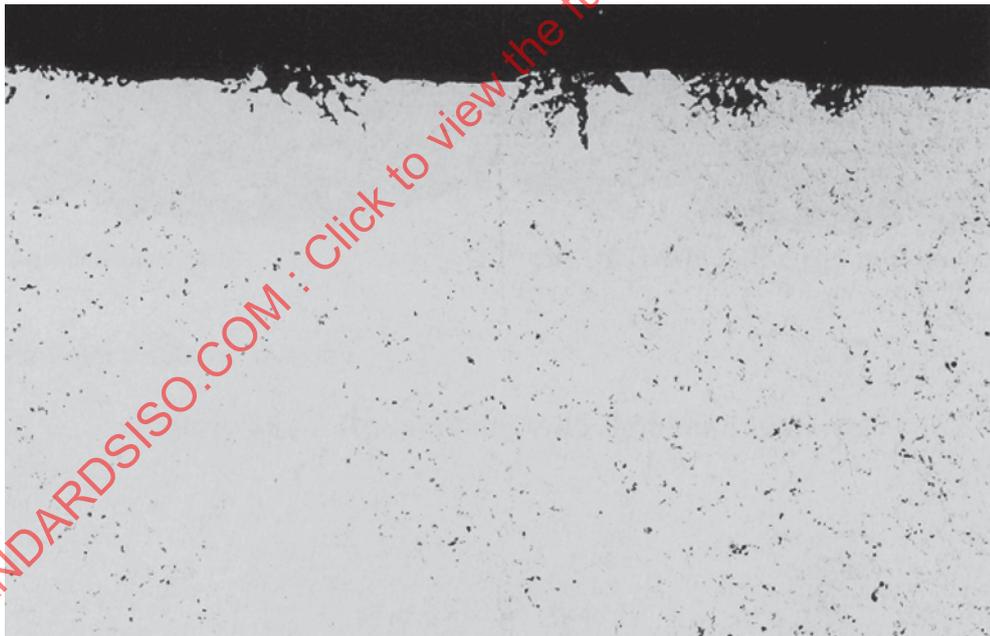
Figure 40 — Corrosion of the surface layer with selective attack on copper and lead in a tin-based material, unetched (material: steel/tin-based white metal)

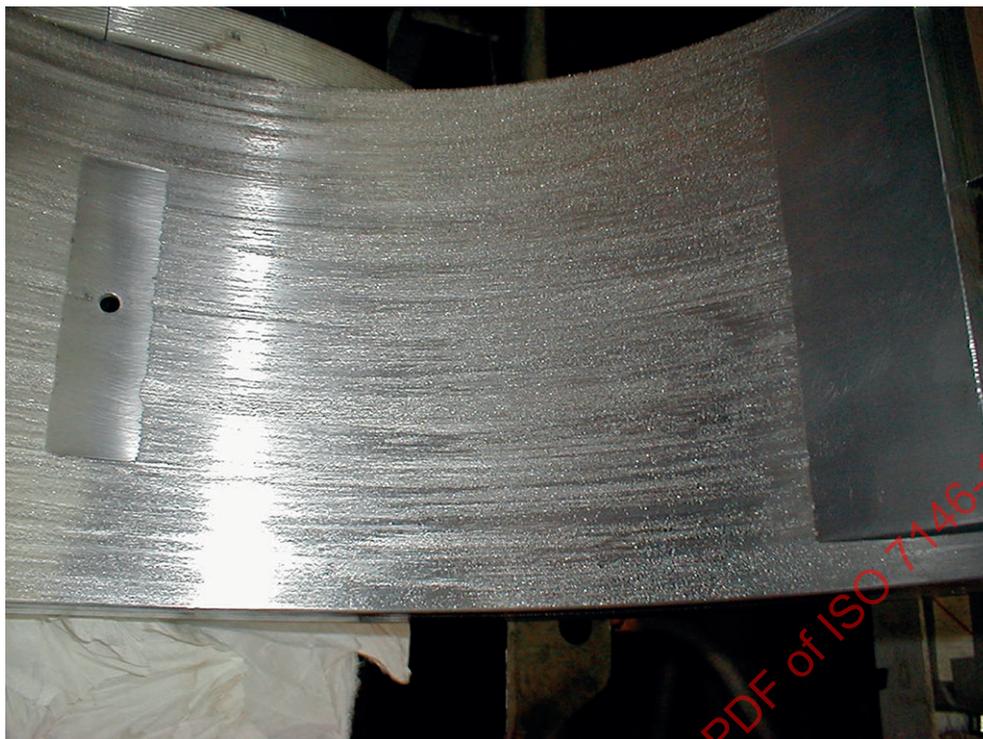
Figure 46 — Formation of electric arc craters

See [Figures 45](#) to [47](#).
