Issued 1978-03
Reaffirmed 2005-04
Revised 2013-02
Superseding AIR1243B

Anti Blow-By Design Practice for Cap Seals

This SAE Aerospace Information Report (AIR) provides information on anti blow-by design practice for cap seals. Suggestions for piston cap seal sidewall notch design and other anti blow-by design details are also described. It also includes information on two key investigations based on the XC-142 as part of the text and as Appendix A.

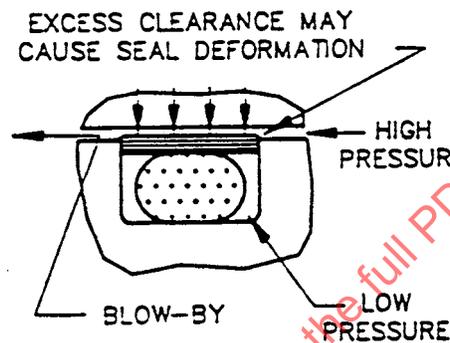
FIGURE 1 - EFFECT OF EXCESSIVE CLEARANCE OF PISTON IN CYLINDER BORE

The mechanism of blow-by (see Figure 1) was described in an Air Force report in December 1965 which was issued following an XC-142 accident. This report has been updated and is attached (see Appendix A). Tests conducted by Vought Aeronautics Division, LTV Aerospace Corporation established that blow-by was a contributing factor to the accident.

4. CONTROL OF DIAMETER CLEARANCE (SEE FIGURE 1)

Excessive diametral clearance may cause deformation (feathering into the extrusion gap) of the cap seal. This deformation may close off the seal side wall clearance, hence reduce the rate of pressure response of the seal assembly during rapid increase in hydraulic pressure. Diametral clearance per ARP1233 and AS4716 will serve to reduce the relative cap-strip seal deformation but will not in itself prevent blow-by.

The effective life of side wall notches can be extended by incorporating chamfers in the cap seal that reduce the tendency of the notches to close off with seal use. The chamfers may be local at each notch on the outside diameter of the cap seal (see Figure 4) or circumferential chamfers may be used along the outside corners of the seals (see Figure 5). Circumferential chamfers are also effective in reducing the cap seal deformation shown in Figures 1 and 5. Testing is recommended.

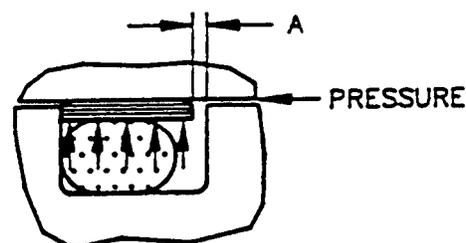
FIGURE 2 - CAP SEAL SIDEWALL CLEARANCE

5. USE OF CAP-STRIP SEALS WITH ADEQUATE SIDE WALL CLEARANCE (SEE FIGURE 2)

The difference between the maximum axial length of the cap seal and the minimum length of the groove should not be less than shown in Table 1 to ensure rapid pressure response.

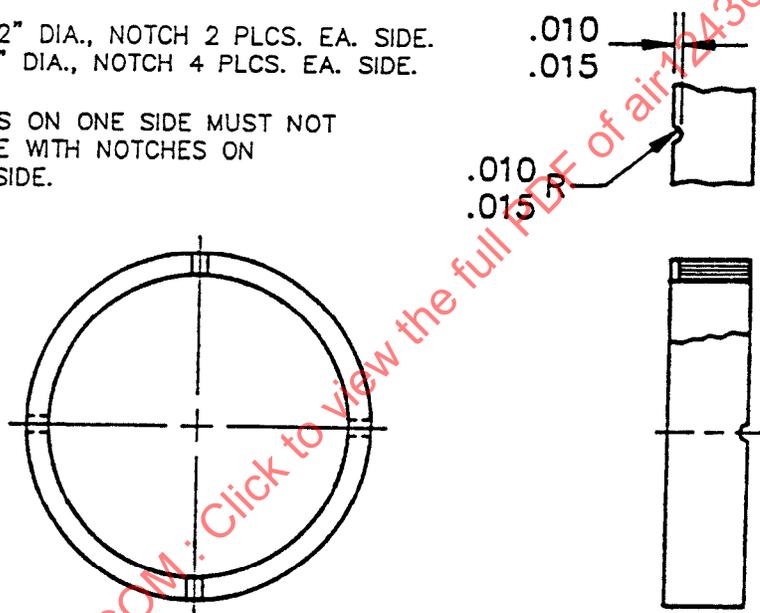
UP TO 2" DIA., NOTCH 2 PLCS. EA. SIDE.
OVER 2" DIA., NOTCH 4 PLCS. EA. SIDE.

NOTCHES ON ONE SIDE MUST NOT
COINCIDE WITH NOTCHES ON
OTHER SIDE.

FIGURE 3 - RECOMMENDATIONS FOR SIDEWALL NOTCHES IN PISTON CAP SEAL

6. USE OF SIDE WALL NOTCHES ON PISTON (OD) CAP-STRIP SEALS (SEE FIGURES 3 AND 4)

In addition to the recommended diametral clearance and side wall clearance, notches in the seal side walls should be used to provide rapid pressure response and prevent blow-by. Recommended notch detail is shown in Figure 3.

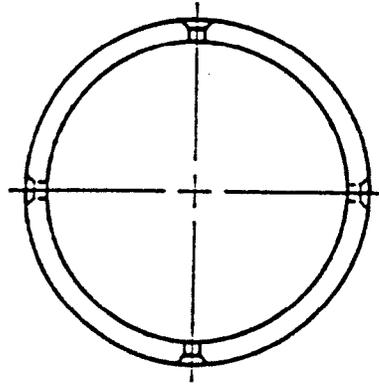
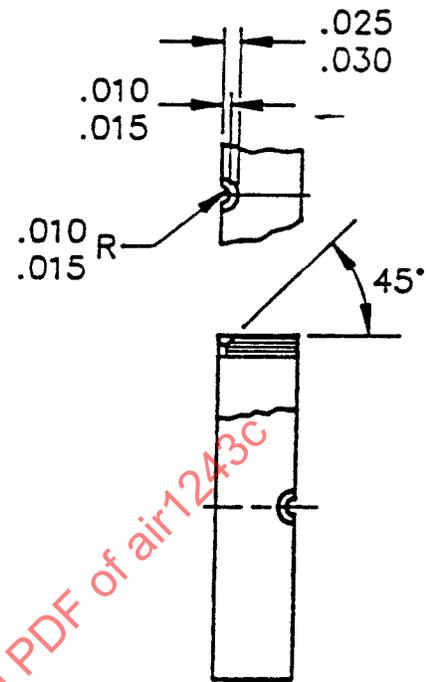
UP TO 2" DIA., NOTCH 2 PLCS. EA. SIDE.
OVER 2" DIA., NOTCH 4 PLCS. EA. SIDE.

NOTCHES ON ONE SIDE MUST NOT
COINCIDE WITH NOTCHES ON
OTHER SIDE.

FIGURE 4 - CAP SEAL WITH CHAMFERED NOTCH

7. USE OF CHAMFERS ON PISTON (OD) CAP SEALS (SEE FIGURES 4 AND 5)

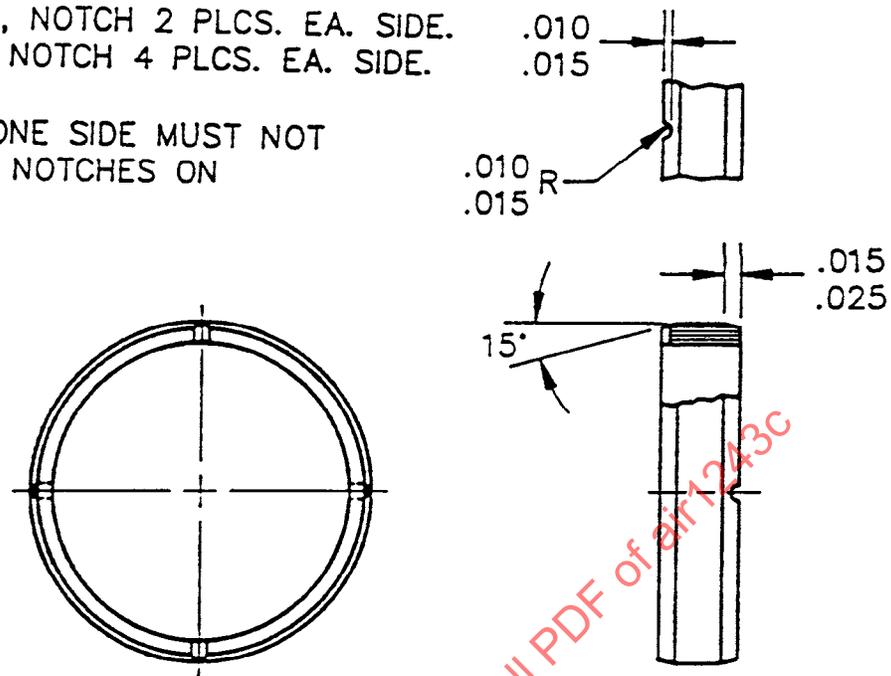
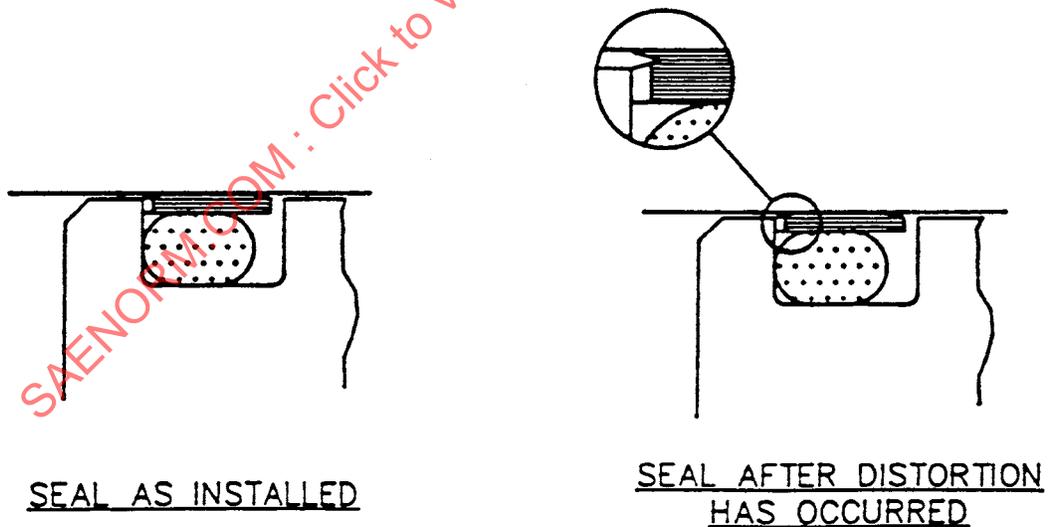
UP TO 2" DIA., NOTCH 2 PLCS. EA. SIDE.
OVER 2" DIA., NOTCH 4 PLCS. EA. SIDE.

NOTCHES ON ONE SIDE MUST NOT
COINCIDE WITH NOTCHES ON
OTHER SIDE.

CAP SEAL WITH NOTCH AND CIRCUMFERENTIAL CHAMFER

CHAMFER ENSURES RAPID PRESSURE RESPONSE
EVEN IN THE PRESENCE OF DISTORTION.

FIGURE 5 - RECOMMENDATIONS FOR SIDEWALL NOTCHES IN PISTON CAP SEAL WITH CHAMFERED EDGES

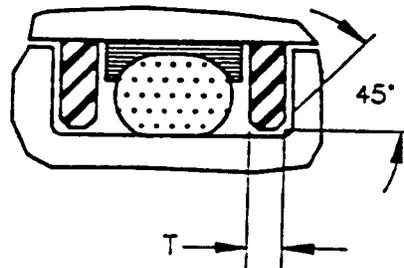
FIGURE 6 - ARRANGEMENT OF PISTON CAP SEAL WITH HIGH MODULUS BACKUP RINGS

8. USE OF HIGH MODULUS MATERIAL BACKUP RINGS WITH PISTON (OD) CAP SEALS (SEE FIGURE 6)

Backup rings made from high modulus material such as polyamide (note temperature limitations), polyimide, polyetheretherketone (PEEK) or filled PTFE compatible with system operating parameters, may be located in the groove adjacent to the cap seal to protect the seal against extrusion. Adequate side wall clearance (0.010 in (0.25 mm) min) will ensure rapid pressure response of the cap seal. Notches in the backup rings on the radial surface facing the groove side wall can also be used advantageously to increase the fluid pressure response. Notches should be on both sides of backup ring to prevent misassembly.

CAUTION 1: The O-ring can be damaged in the gap below the high modulus backup ring. This can be minimized by 45 degrees x T/4 chamfers on the backup ring at both the edge that contacts the O-ring and the edge which tends to ride up on the groove radius (not necessary for filled PTFE backup rings). A PTFE or filled PTFE ring next to the O-ring with a higher modulus ring outboard will also provide the necessary O-ring protection. Testing is recommended.

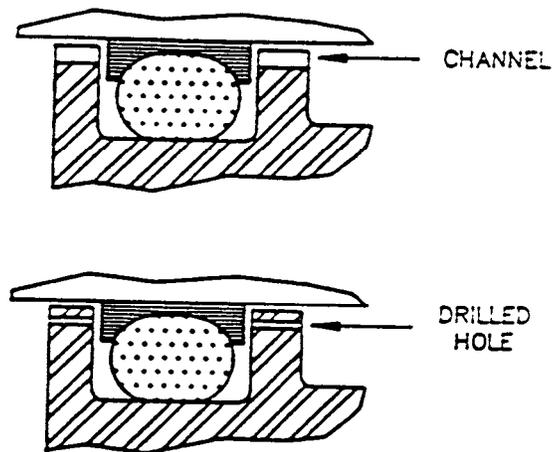
FIGURE 7 - PISTON CAP SEAL INSTALLED WITH CHANNELS AND DRILLED HOLES IN PISTON

9. USE OF PISTON HEAD CHANNELS AND DRILLED HOLES (SEE FIGURE 7)

Channels in the piston head which admit fluid pressure into the seal groove will ensure rapid pressure response. A 0.010 in (0.25 mm) wide channel is effective. Channel depth should not exceed the minimum side wall height of the cap seal to avoid extrusion of the elastomer into the channel. Two to four channels are recommended on each side of the seal groove. Testing is recommended.

Drilled holes through the piston head can be used as an alternative to the piston head channel. Holes must be located in the seal groove so that the cap seal prevents O-ring extrusion into the hole. The number of holes and hole size will vary depending upon design requirements and limitations.
