AEROSPACE INFORMATION REPORT

AIR 764A

SKID CONTROL SYSTEM VIBRATION SURVEY

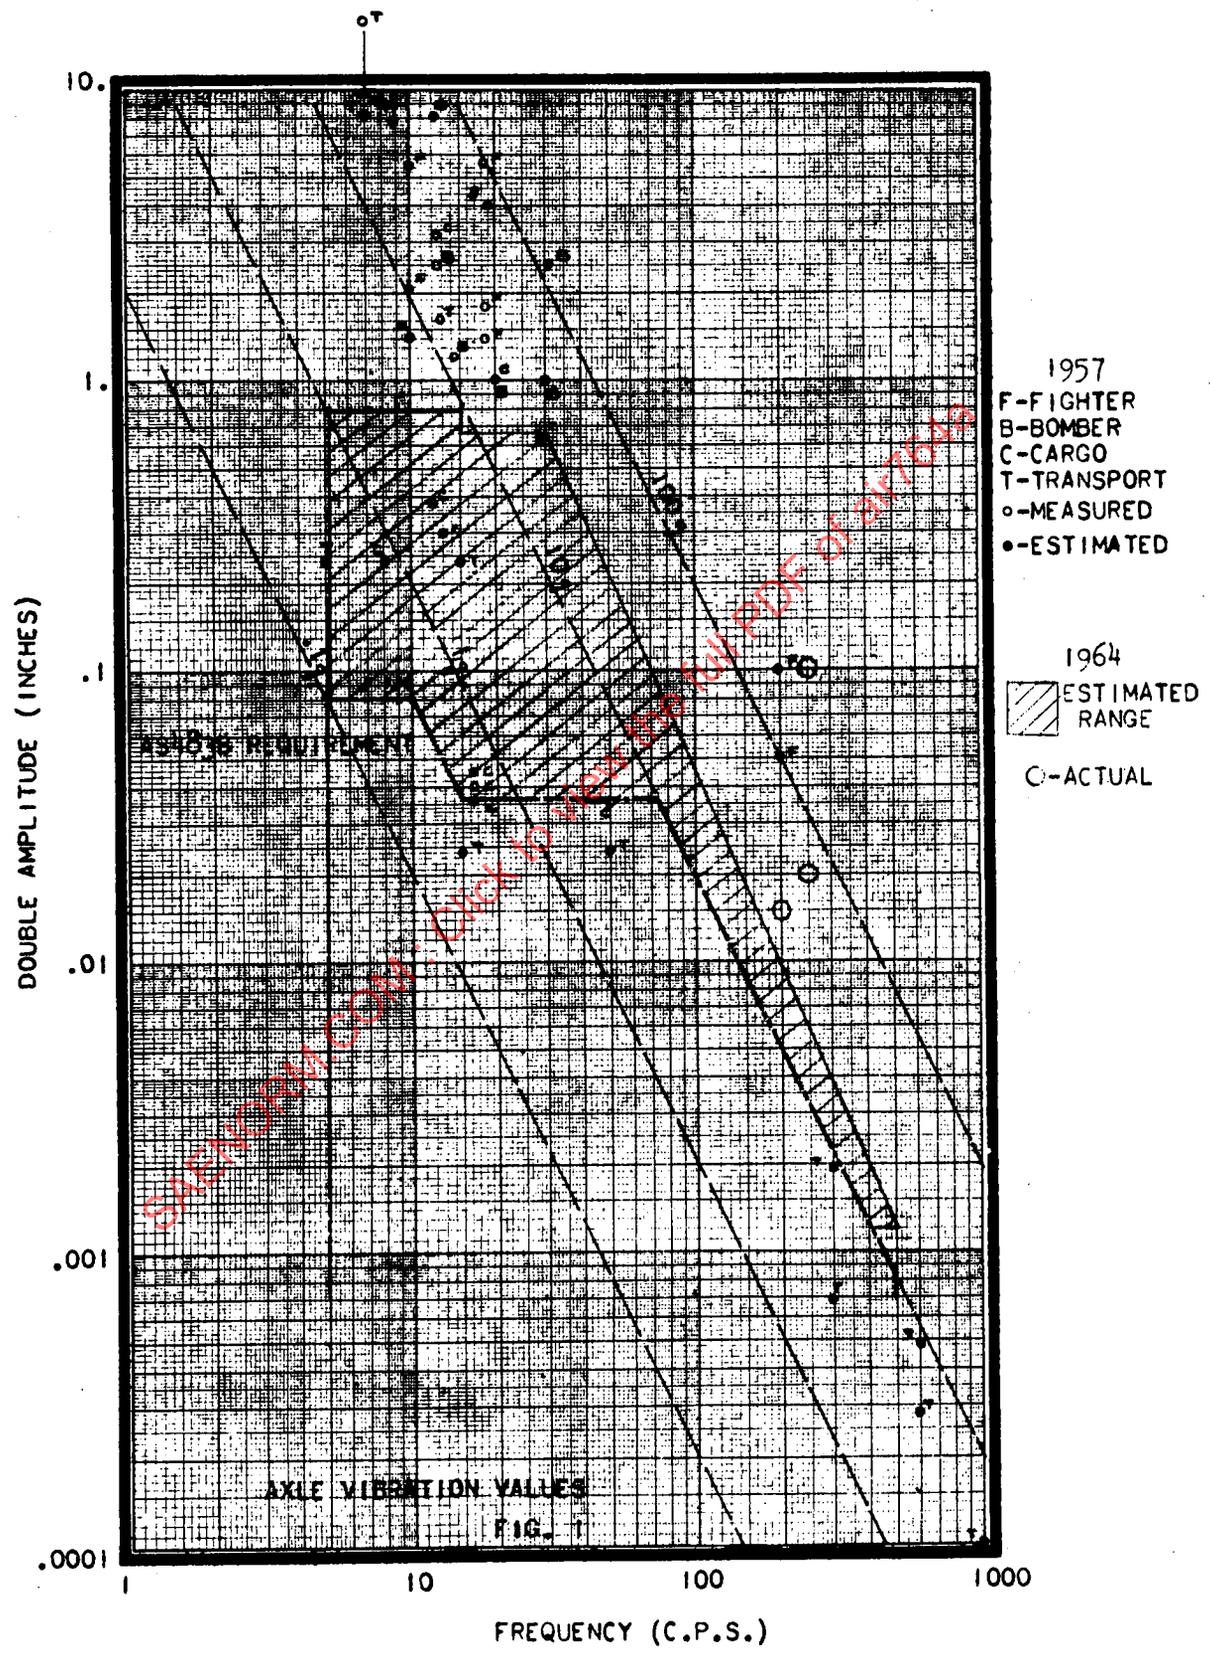
The reported values are plotted on Figures 1 and 2 showing the comparison of these values with the AS 483B vibration requirements.

Study of the figures shows that vibration may occur at the control box location with values varying from .03 g to 10 g and from 5 cps to 1,000 cps. Axle vibration values vary from .3 g to 200 g and 5 cps to 1,000 cps.

This information has been added to Figures 1 and 2 as noted in the figure margins.
