SURFACE VEHICLE INFORMATION REPORT	J810™	MAR2025
	Issued 1956-04 Reaffirmed 1987-03 Revised 2025-03	
Superseding J810 MAR1996		
(R) Classification of Common Imperfections in Sheet Steel

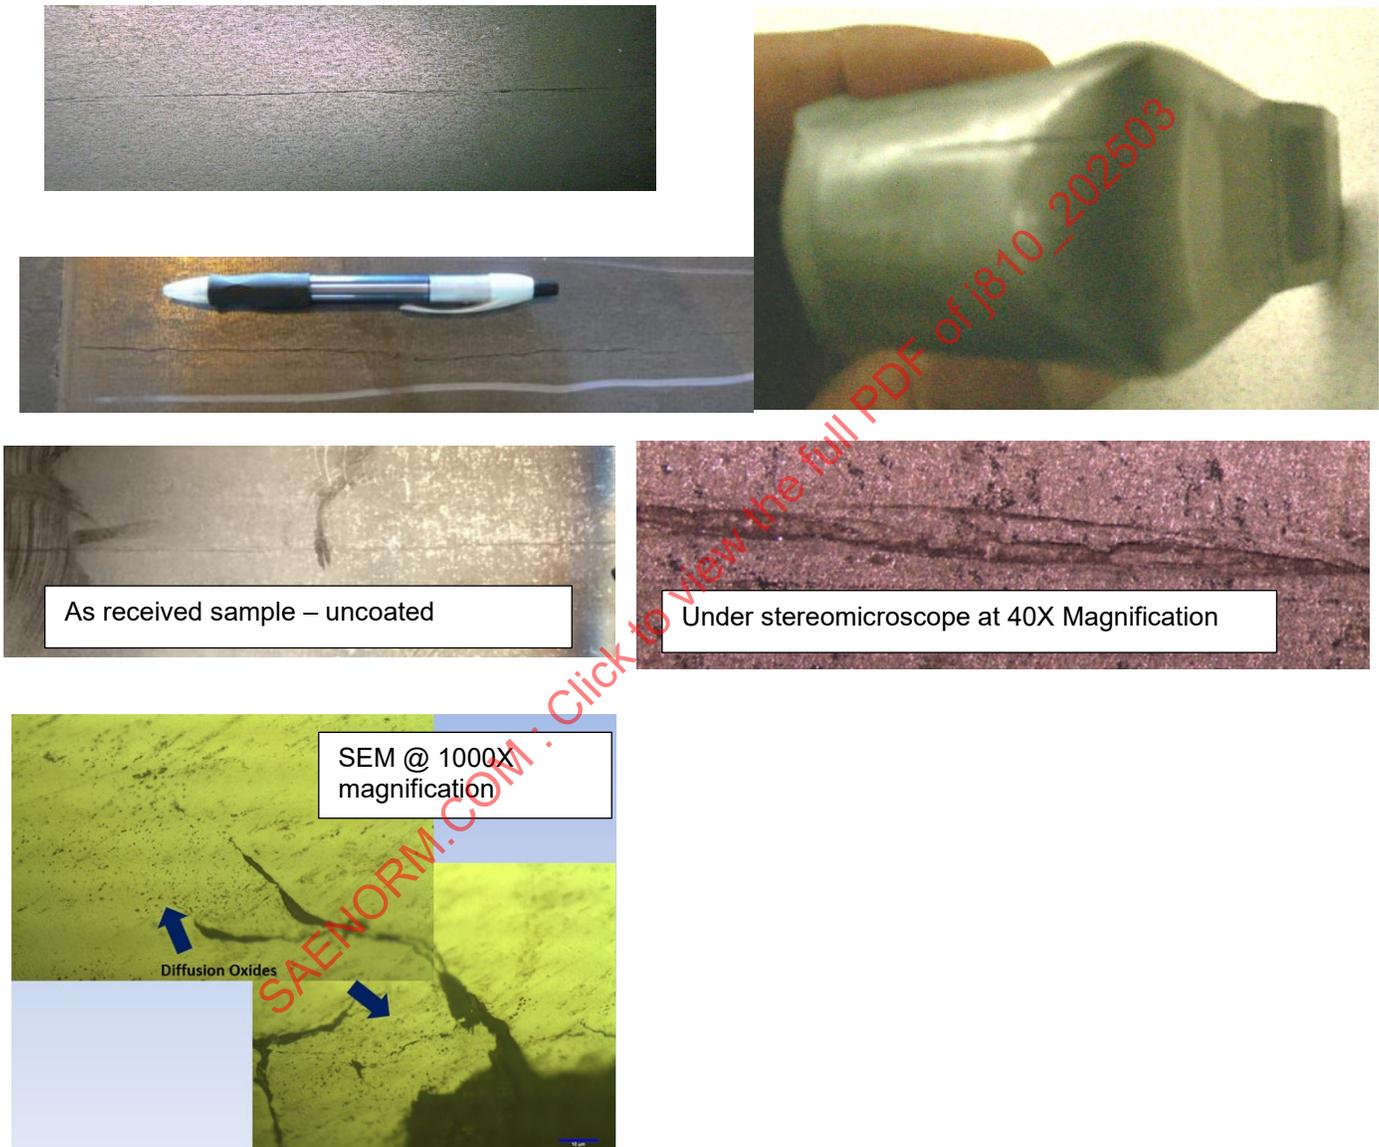
Figure 1

4.1 Caster Cracks

Description:	Caster cracks are formed as a tear in the surface as the slab solidifies. They look like a deep scratch in the surface of the strip. They run in the rolling direction and may be continuous or fade and reappear throughout a coil.
Cause:	Caster cracks are caused by uneven cooling across the width of the slab as it solidifies and are influenced by chemistry and caster practices relative to mold flux, cooling rates, and/or mold taper.
Product Affected:	All products.
Similar Imperfection:	Caster Fold; Seam; Longitudinal Crack.

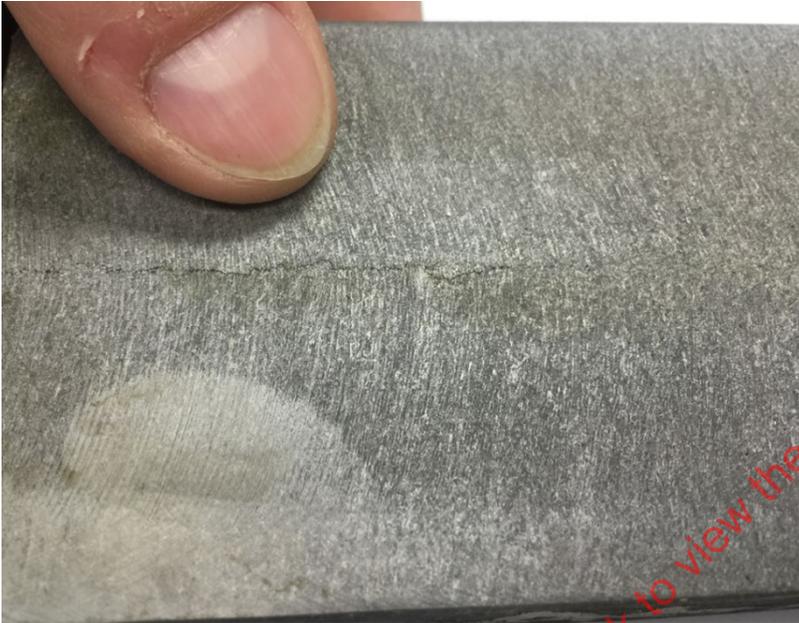
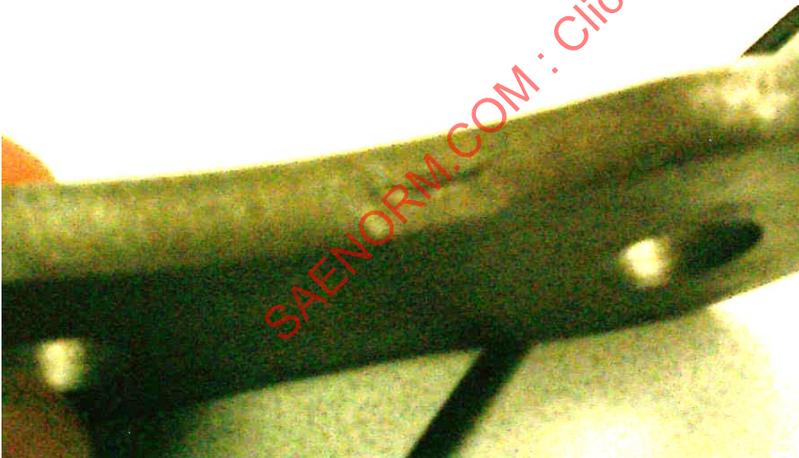
Figure 2

4.2 Centerline Cracks

Description:	An opening along the centerline of the as-cast slab that is oxidized during cooling and does not close on subsequent rolling. This subsurface tear may be continuous or interrupted. This defect may be exposed during shearing, cutting, or punching of the strip.
Cause:	Centerline cracking originates with the normal shrinkage of the steel at the center of the slab as it solidifies relative to the subsequent deformation of the strand during casting and can be caused by segregation, poor cooling condition during casting, and misalignment of caster segments.
Product Affected:	All products.
Similar Imperfection:	Pipe Lamination; Center Lamination; Radial Crack.

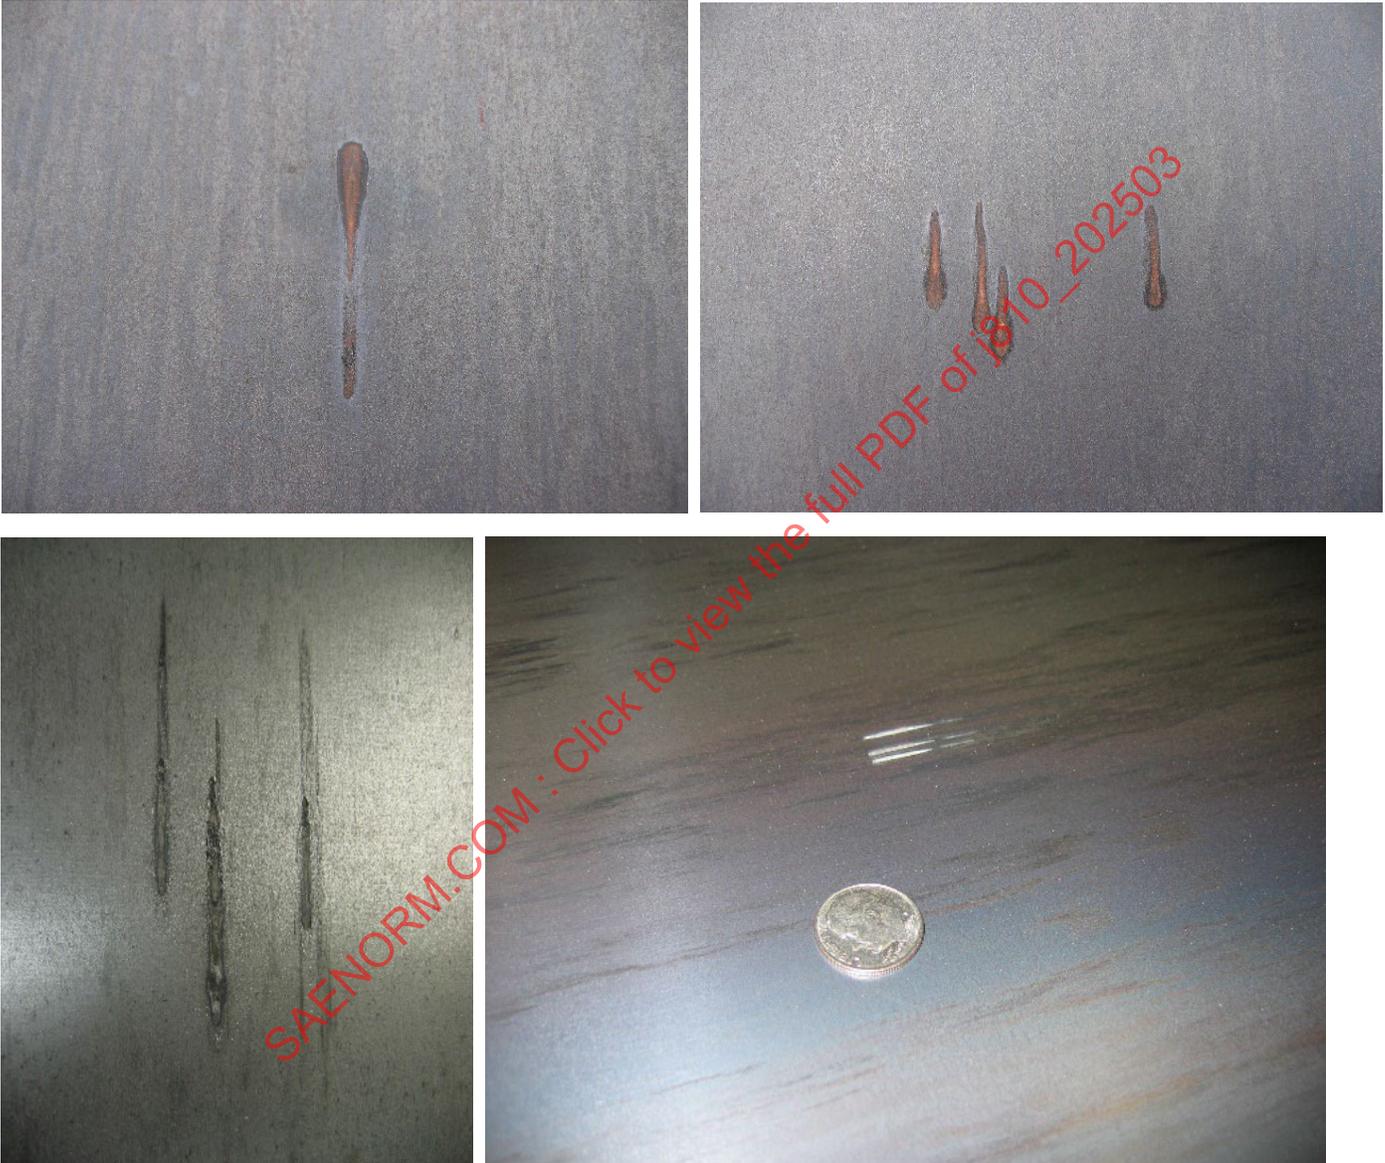
Figure 3

4.3 Entrapped Mold Powder

Description:	Mold powder is used to lubricate the sides of the caster mold so that the steel solidifies and slides freely out of the bottom of the mold. The powder is specially designed to burn off, but occasionally, it will get entrapped in the steel and create a defect.
Cause:	Entrapment during turbulent liquid metal flow during casting.
Product Affected:	All products.
Similar Imperfection:	None.

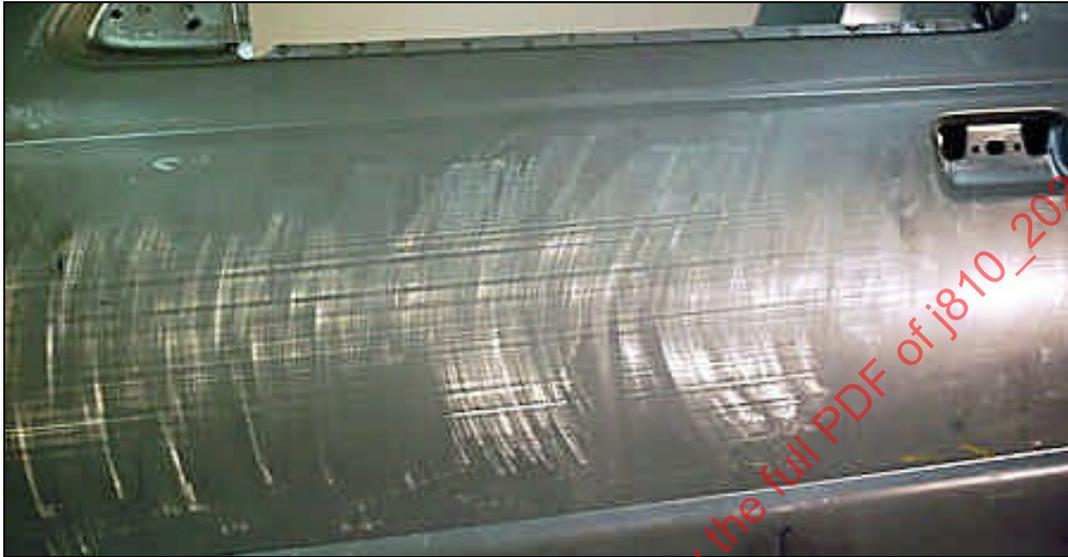
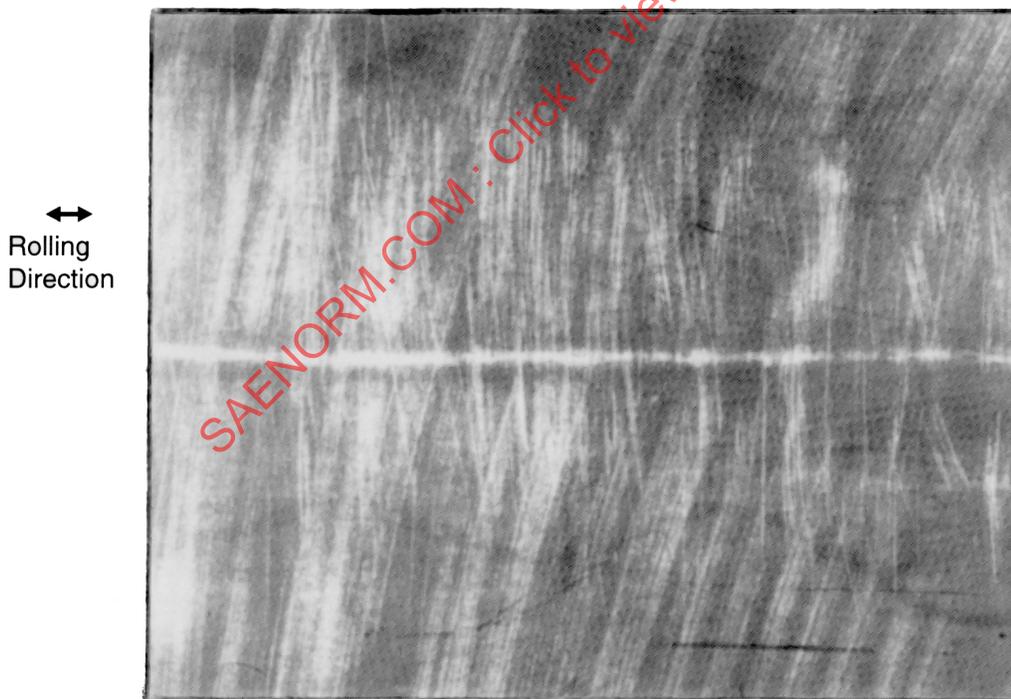
Figure 4

4.4 Ghost Lines

Description:	Ghost lines typically are not visible until after the sheet is stamped into a formed panel, although stoning brings out the ghost lines in unformed sheet steel. Ghost lines run parallel to the rolling direction.
Cause:	Ghost lines are caused by improper caster alignment and deoxidation practices. Ghost lines can also be caused by rolled-in alumina or phosphorus segregation.
Product Affected:	All products.
Similar Imperfection:	Surface Scratches; Striations; Chatter Lines (except chatter is perpendicular to the rolling direction).

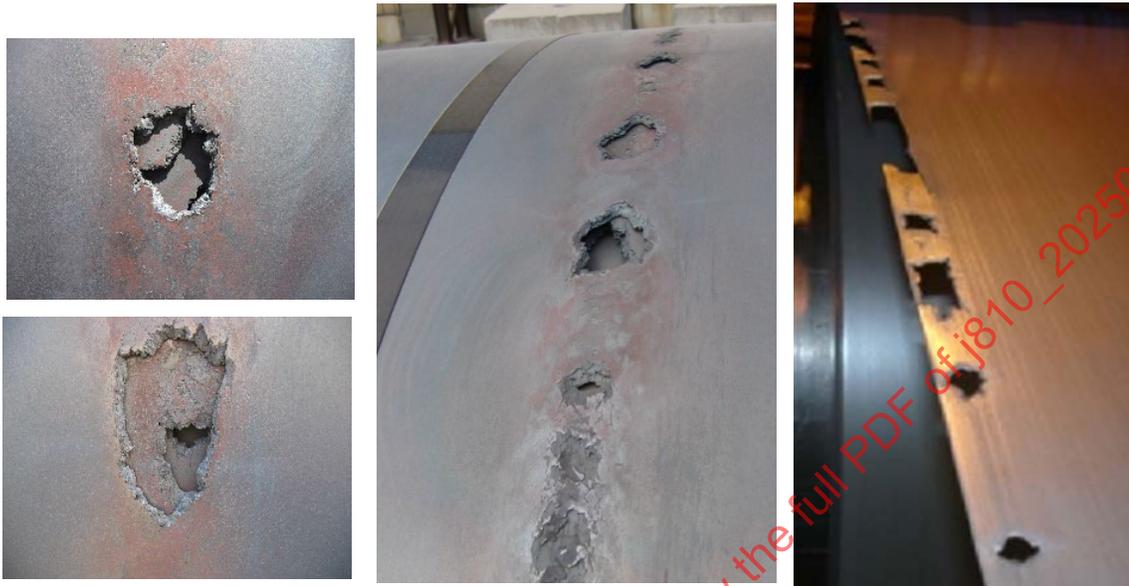
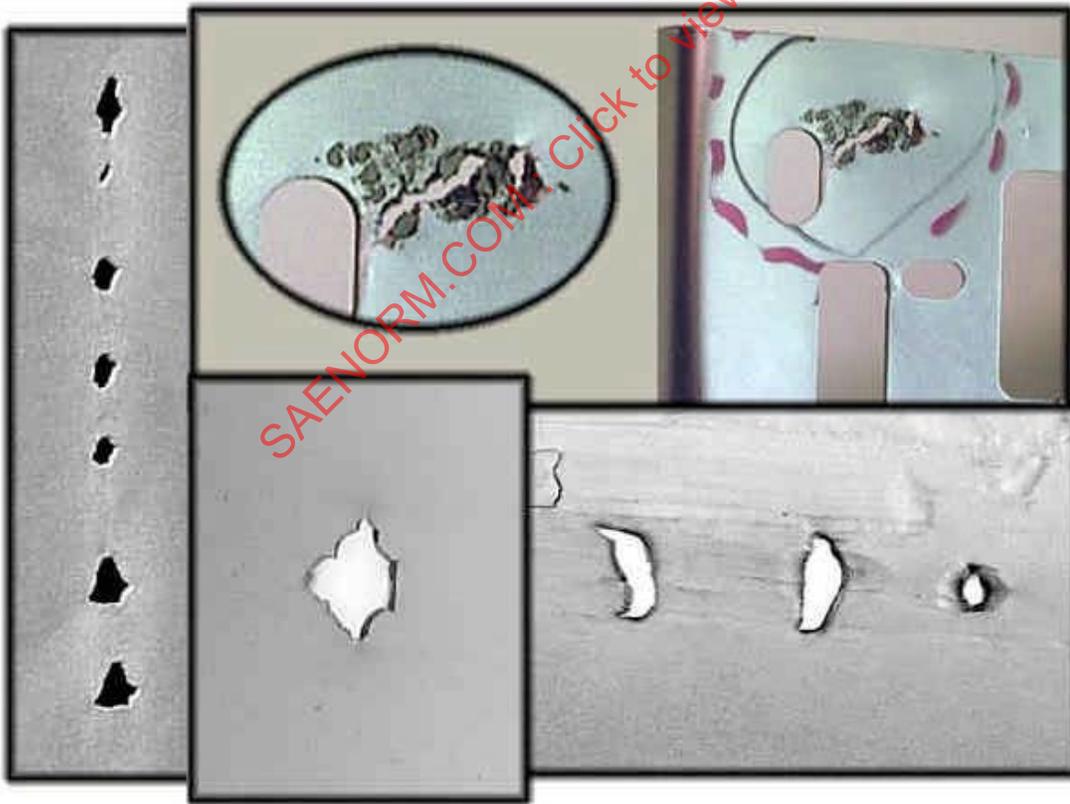
Figure 5

4.5 Holes

Description:	Holes are voids in the sheet.
Cause:	Holes result from the presence of laminations, pipe laminations, inclusions, scabs, or rolled-in foreign material which open during rolling.
Product Affected:	All products.
Similar Imperfection:	Perforations; Edge Holes.

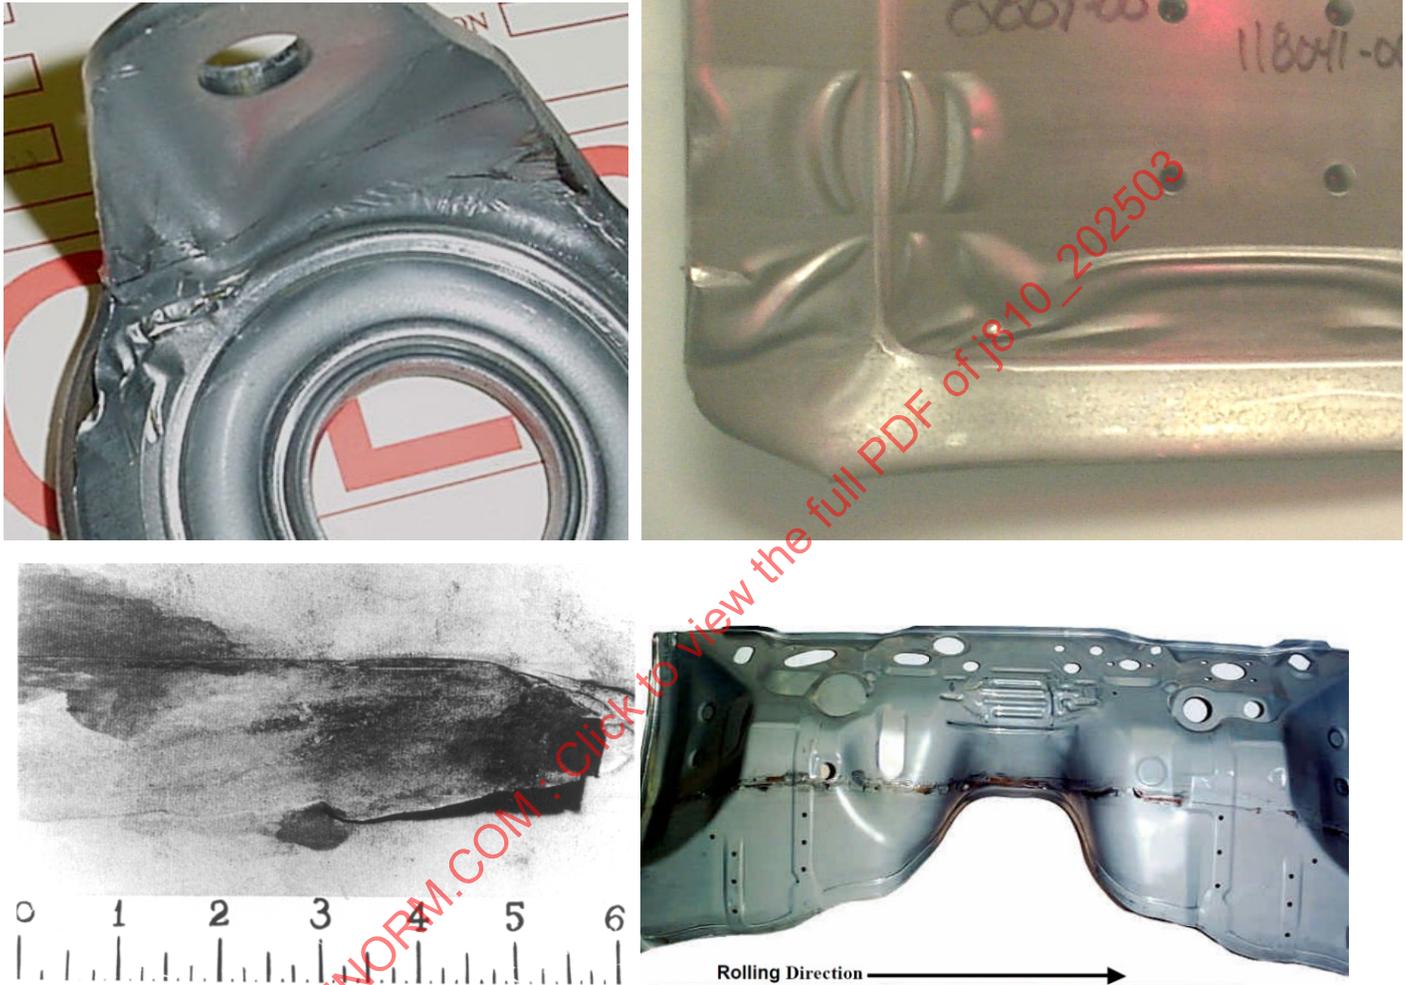
Figure 6

4.6 Lamination

Description:	Lamination is a subsurface separation which usually results in a visible surface rupture.
Cause:	Lamination is usually caused by the presence of nonmetallic inclusions or entrapped steelmaking refractory or other contaminant often resulting in delamination or fractures during forming or stamping.
Product Affected:	All products.
Similar Imperfection:	Sliver; Skin Lamination; Edge Lamination; Heavy Lamination; Pipe Lamination; Subsurface Lamination.

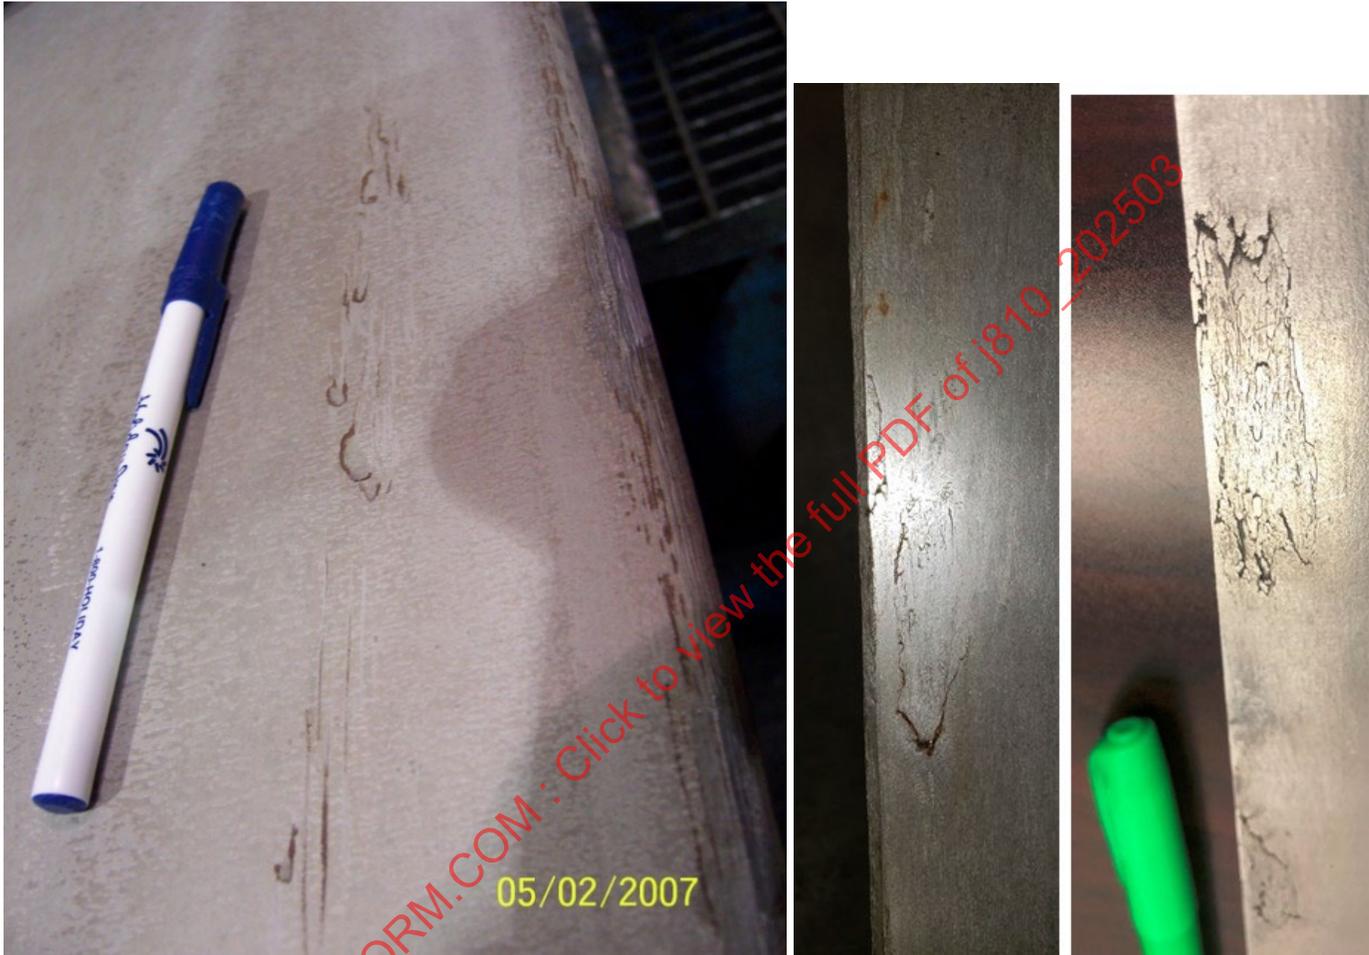
Figure 7

4.7 Lamination: Edge Lamination

Description:	Edge laminations are tears in the steel, particularly at the edges where the slab is colder.
Cause:	Edge laminations are microsegregations on grain boundaries causing them to slide instead of pancaking during deformation at certain temperatures depending on the steel composition.
Product Affected:	All products containing the original hot mill edge.
Similar Imperfection:	Rough Edges; Slab Cracks.

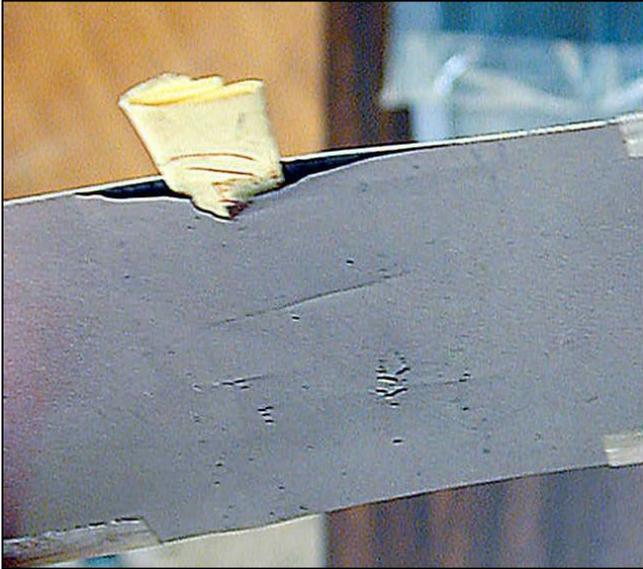
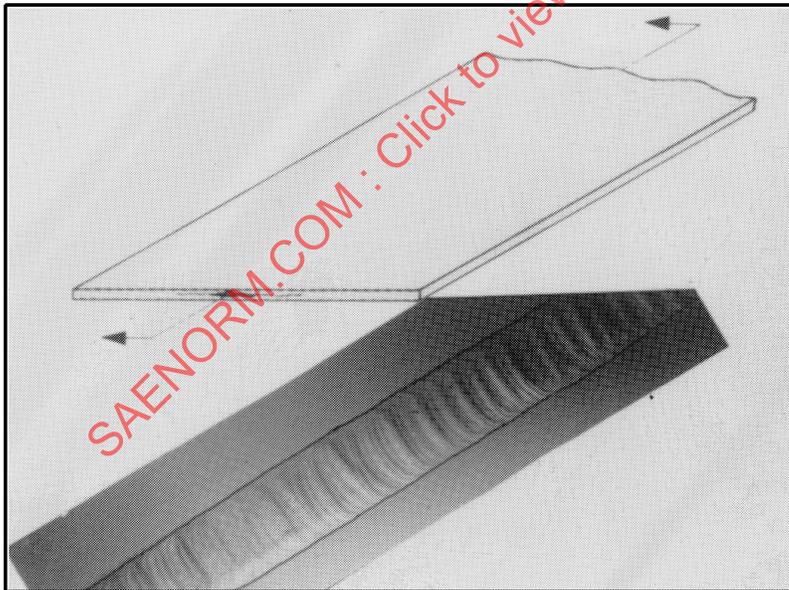
Figure 8

4.8 Lamination: Pipe Lamination

Description:	Pipe lamination is an internal imperfection running parallel to the rolling direction. It appears as a separation midway between the surfaces.
Cause:	Pipe lamination results from centerline segregation and the presence of oxide inclusions.
Product Affected:	All products.
Similar imperfection:	Center Lamination; Blister Lamination; Radial Crack.

→
Rolling
Direction

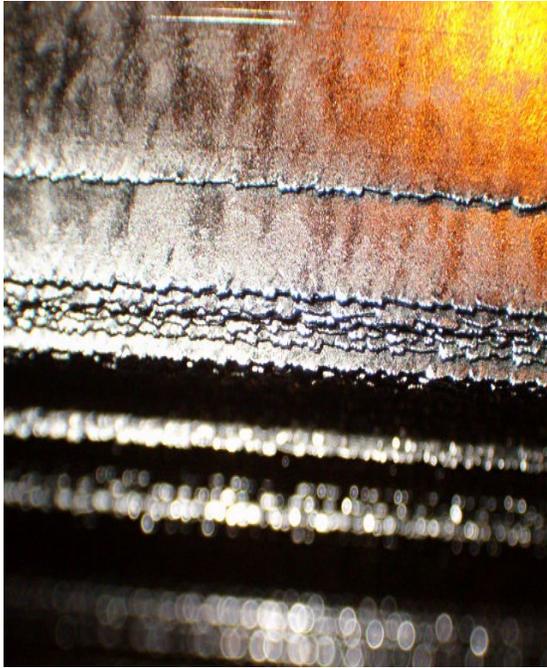
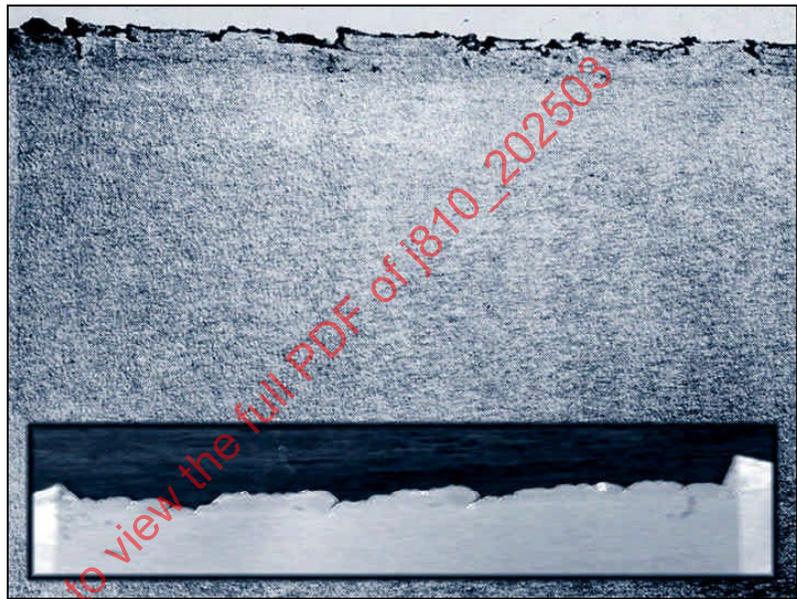
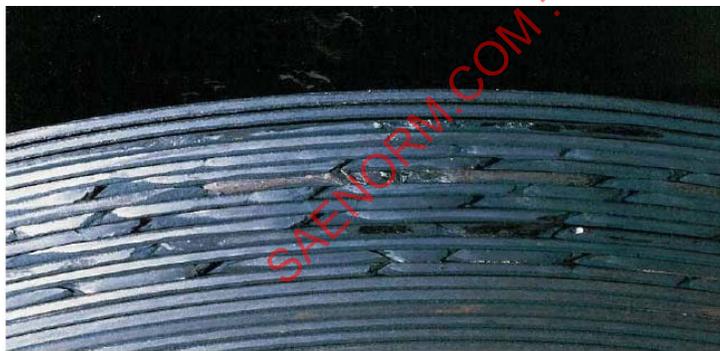
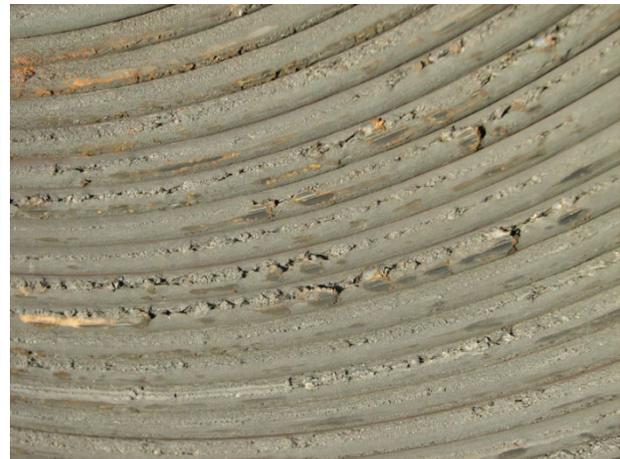
Figure 9

4.9 Ragged Edge

Description:	Appears as a rough, broken-away mill edge or as splitting on the coil edge. Cracks generally run perpendicular to the rolling direction. Ragged edge is a serrated edge that has been work hardened and subsequently fractured or deformed during the rolling operation.
Cause:	Ragged edges can be caused by: <ul style="list-style-type: none">- Bad heating practices- Poor slitting or edge trimming- Damage during annealing
Product Affected:	All products.
Similar Imperfection:	Damaged Edge; Sawtooth Edge; Cracked Edge; Serrated Edge; Chipped Slitter Knife.

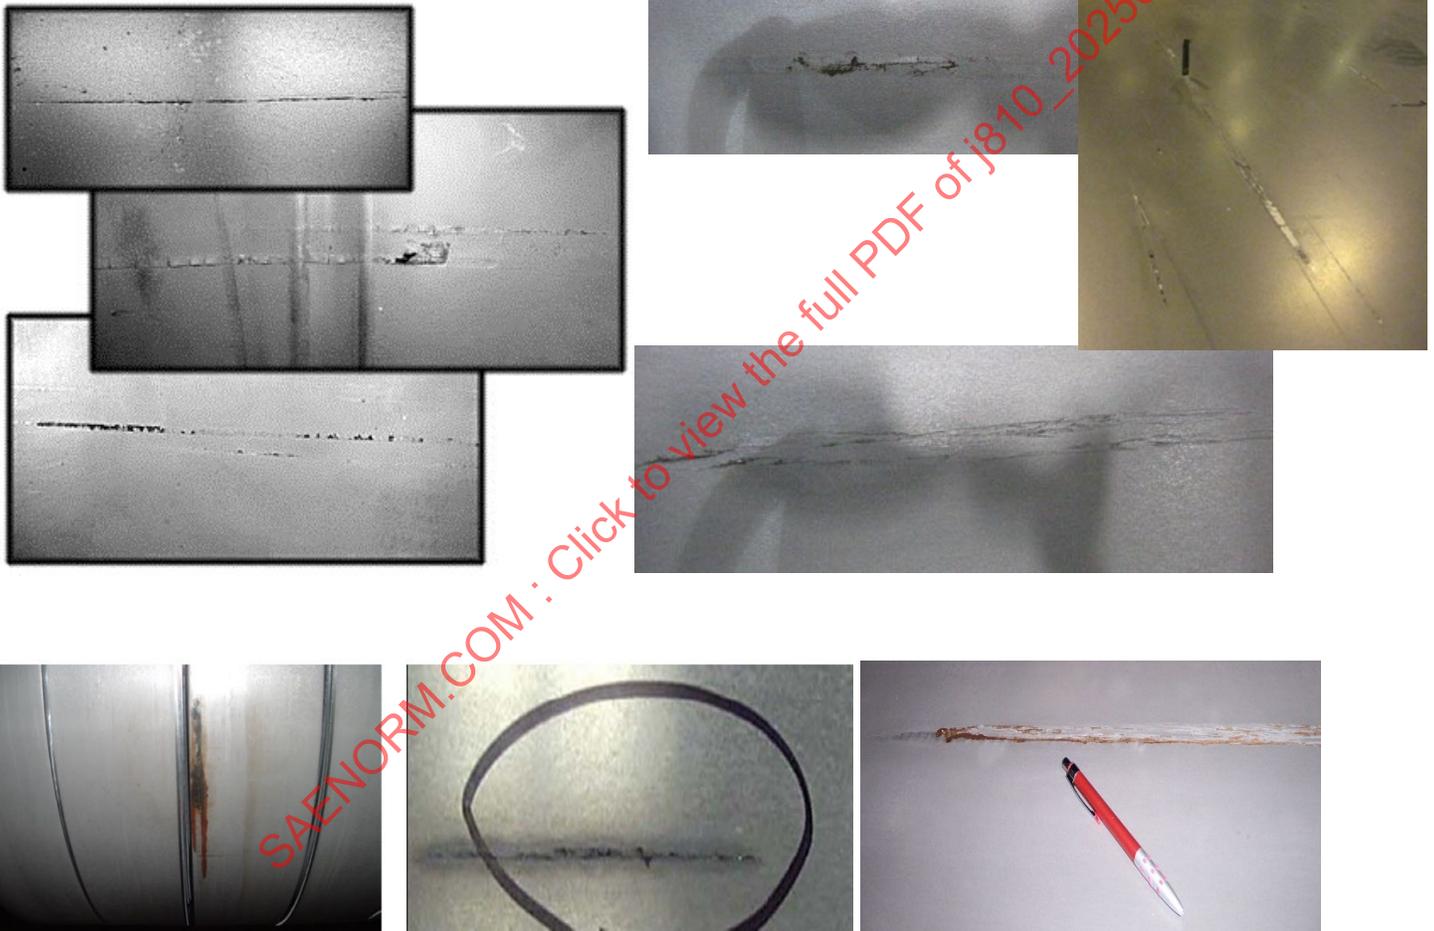
Figure 10

4.10 Slivers

Description:	Jagged tapered slivers of metal attached at one end. Usually an isolated defect. Slivers are small open surface laminations which are the result of any subsurface inclusion or steelmaking refractory entrapped in the liquid steel which comes to the surface during the rolling process.
Cause:	Slivers can be generated mechanically, or caused by: <ul style="list-style-type: none">- Improper casting conditions- Improper composition (over oxidized, high sulfur)- Inadequate slab conditioning- Improper heating (overheating)- Tearing of corners in early stages of rolling- Entrapped mold flux- Transverse corner crack in slab
Product Affected:	Hot rolled.
Similar Imperfection:	Scab; Seam; Skin Lamination; Lamination.

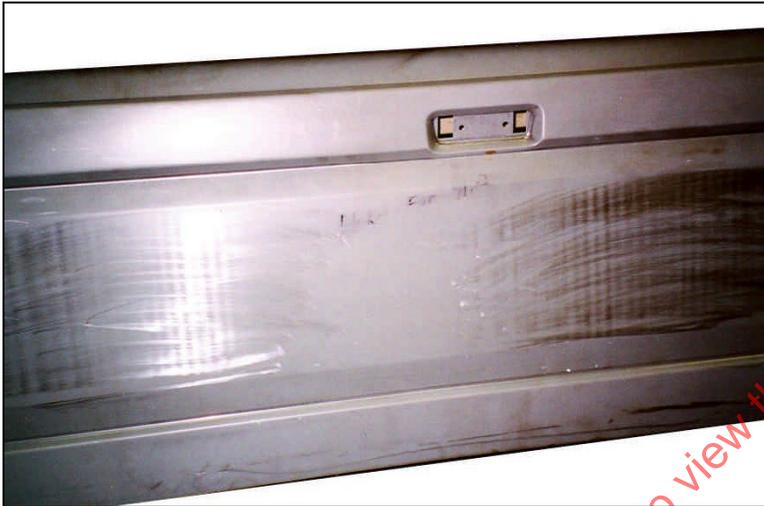
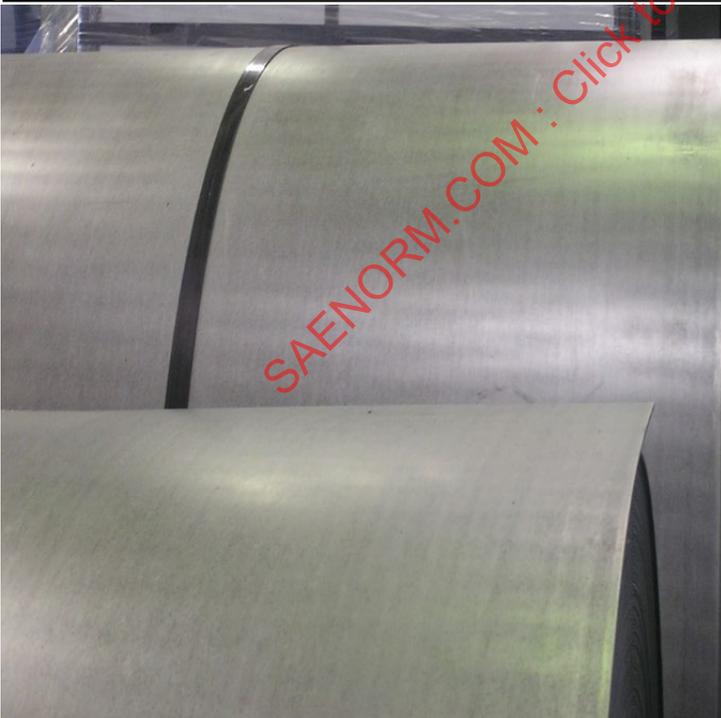
Figure 11

5.1 Chatter Marks

Description:	Chatter is an intermittent surface distortion, perpendicular to the rolling direction (across the width). They may or may not be perceptible to the touch. They may appear as alternate bright and dull streaks. They can be highlighted by stoning.
Cause:	Chatter marks can be caused by: <ul style="list-style-type: none">- Vibration during rolling- Vibration during leveling- Vibration of tools used to grind rolls- Lubricant failure causing fluctuation in the coefficient of friction between the roll face and the sheet surface- Improper tension between stands during rolling
Product Affected:	All products.
Similar Imperfection:	Chatter.

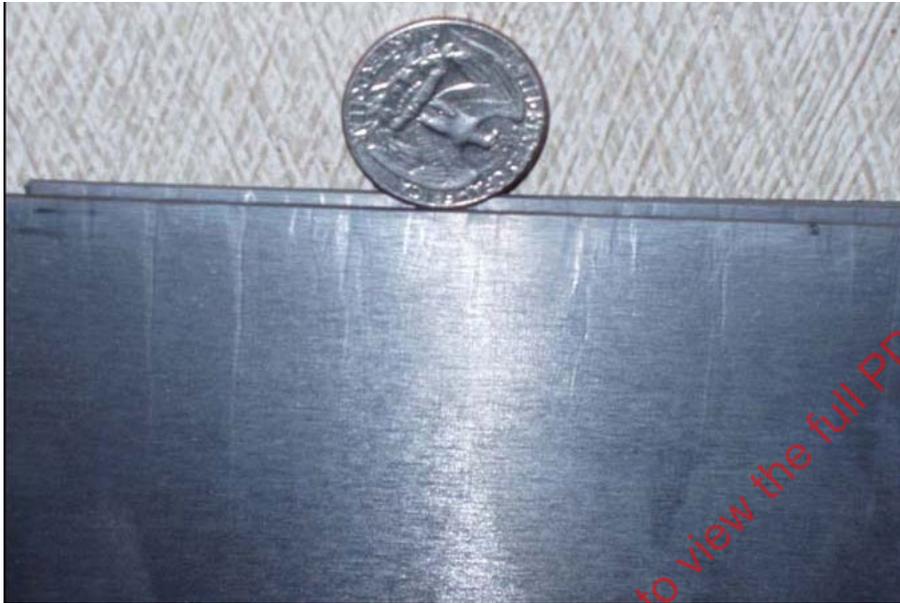
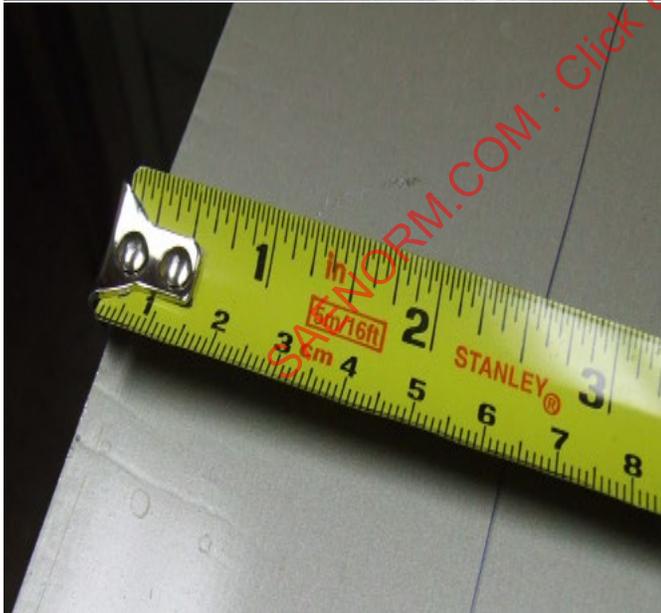
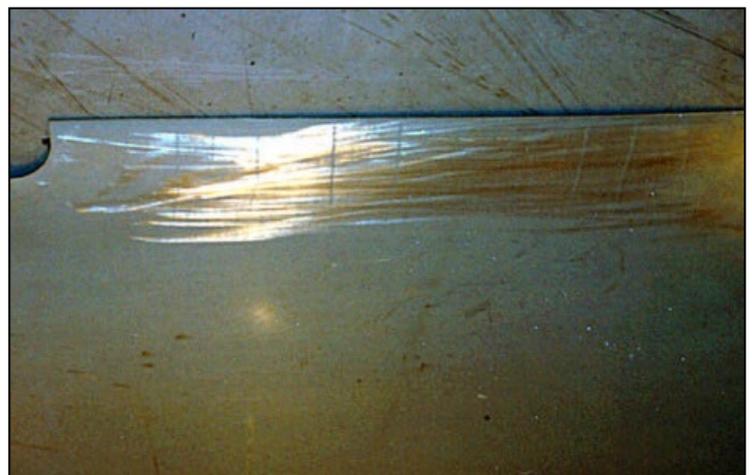
Figure 12

5.2 Edge Breaks

Description:	Edge breaks are short creases which extend in from the edge of the sheet and appear as “branch like” transverse stretch lines that originate at the edge of the material. Edge breaks usually appear on both top and bottom surfaces.
Cause:	Edge breaks are caused by insufficient tempering and yield point elongation. Edge breaks occur in steel when the edges are substantially thinner than the rest of the sheet and do not receive sufficient temper reduction to minimize or eliminate yield point elongation.
Product Affected:	All products.
Similar Imperfection:	Lüders Lines; Yield Point Elongation (YPE); Edge Strain; Stretcher Marks; Sticker Breaks.

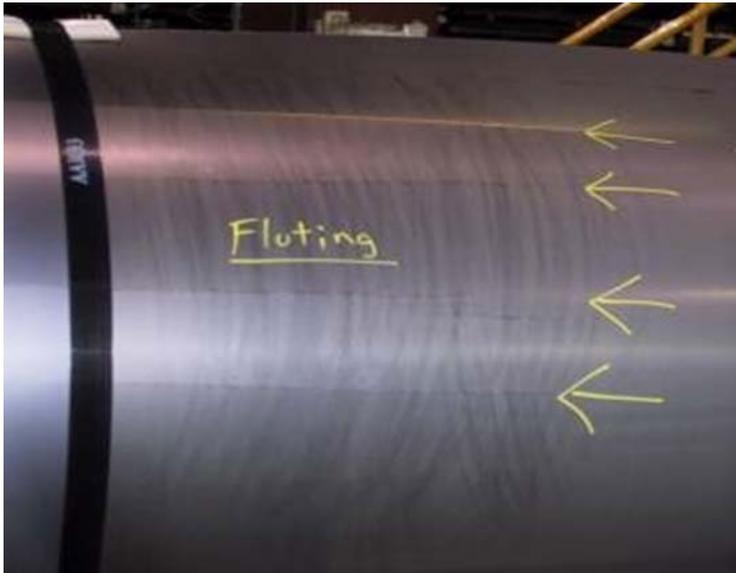
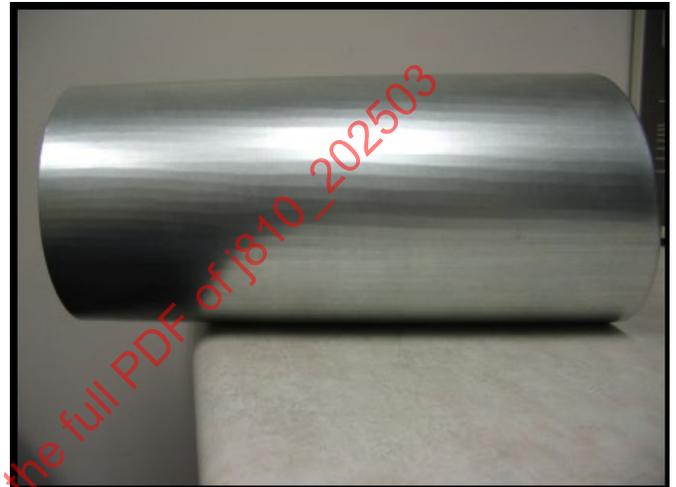
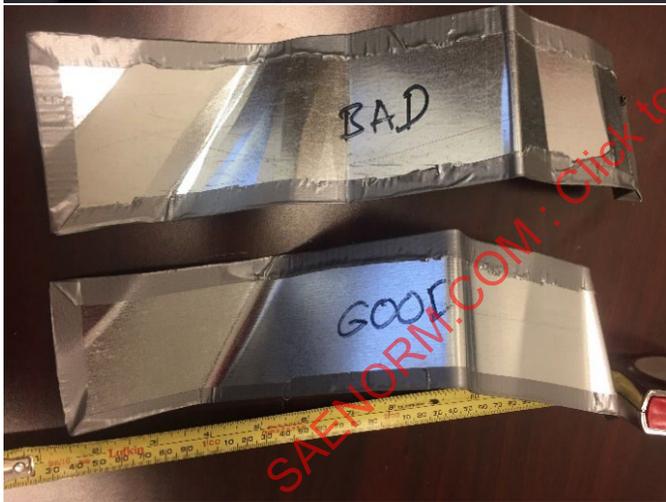
Figure 13

5.3 Fluting

Description:	Appearance will be similar to a reel kink. Severity can vary by material grade and application.
Cause:	Fluting typically occurs during roll forming to small diameters or stretching during stamping resulting from the presence of yield point elongation (YPE).
Product Affected:	Roll formed products.
Similar Imperfection:	Reel Kink; Coil Breaks; Lüders Lines.

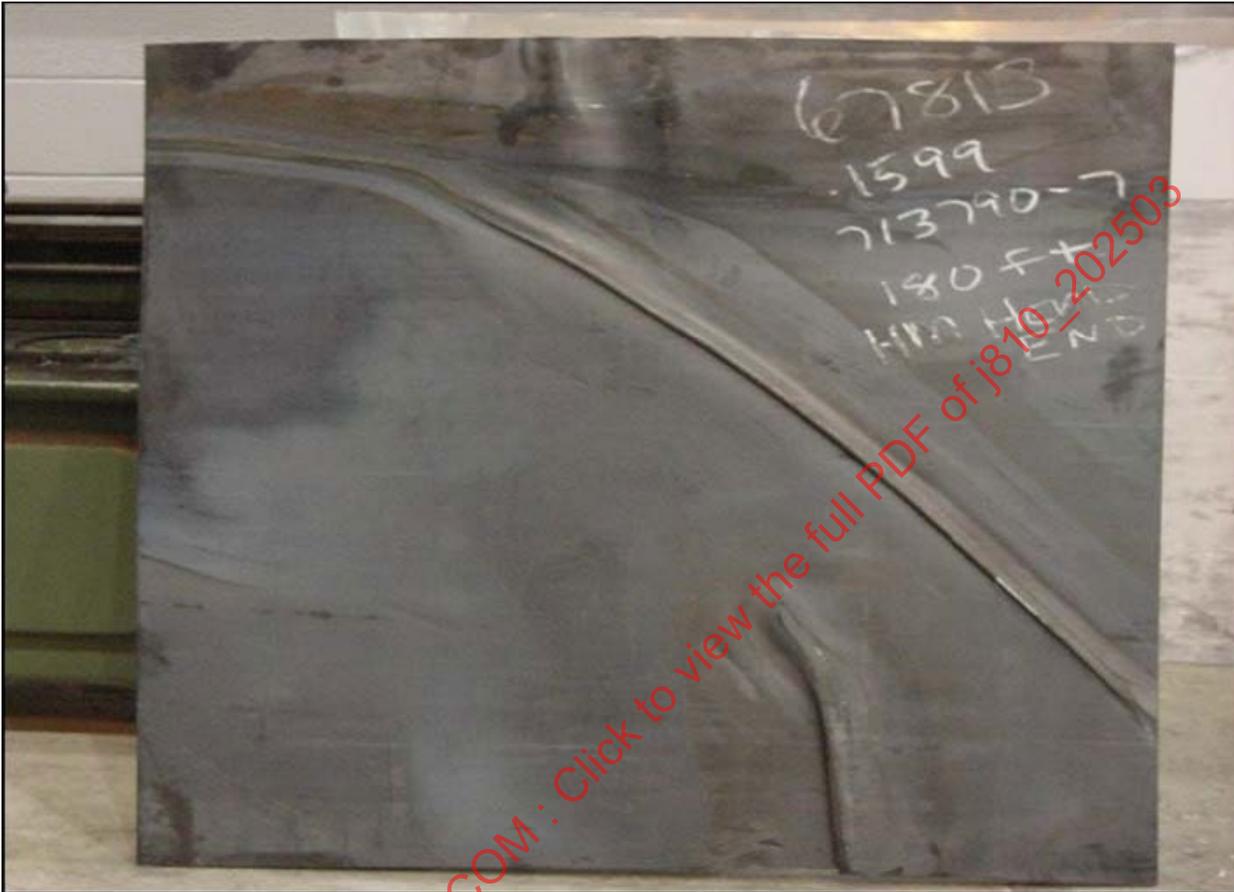
Figure 14

5.4 Fold Over

Description:	Fold over appears as random surface folds or whip-like marks.
Cause:	Fold over is caused by poor shape or tension control during rolling.
Product Affected:	All products.
Similar Imperfection:	Whip Marks; Crimp; Flopper; Creases.

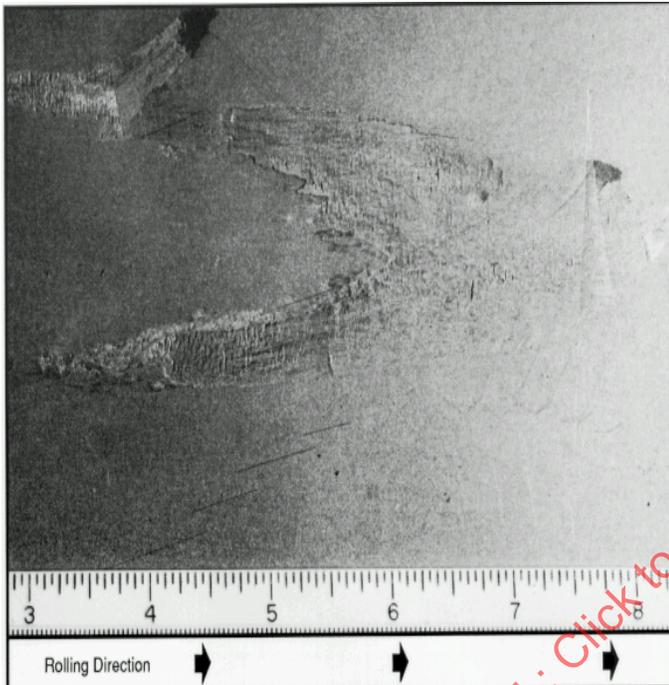
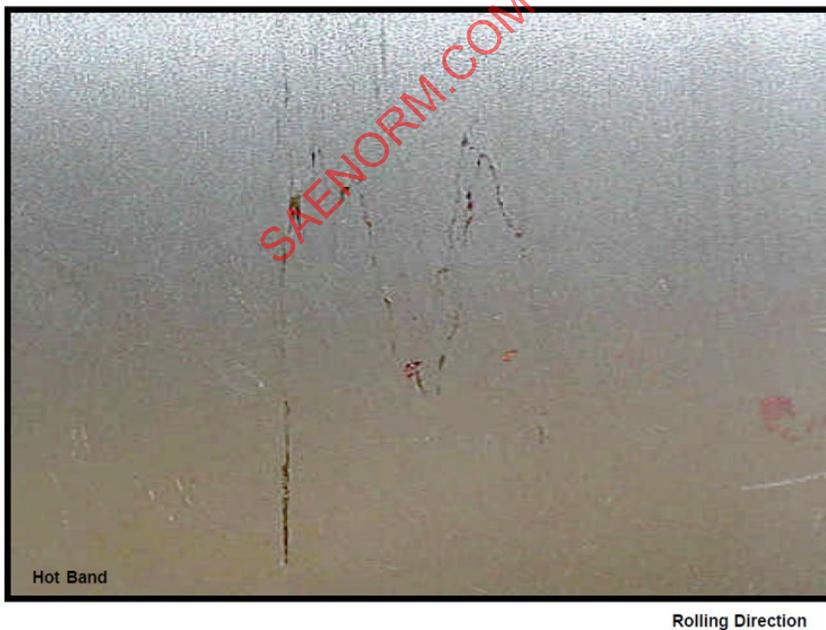
Figure 15

5.5 Lightning Bolt

Description:	Lightning bolts are breaks or tears in the surface of the strip and are located on the bottom surface at the hot strip mill.
Cause:	Lightning bolts are caused by: <ul style="list-style-type: none">- Wear and deterioration of skids in a reheat furnace- A surface rupture in the hot mill reheat furnace- Slab conveyor condition- Slab handling procedures
Product Affected:	All products.
Similar Imperfection:	Skin Lamination; Furnace Tear.

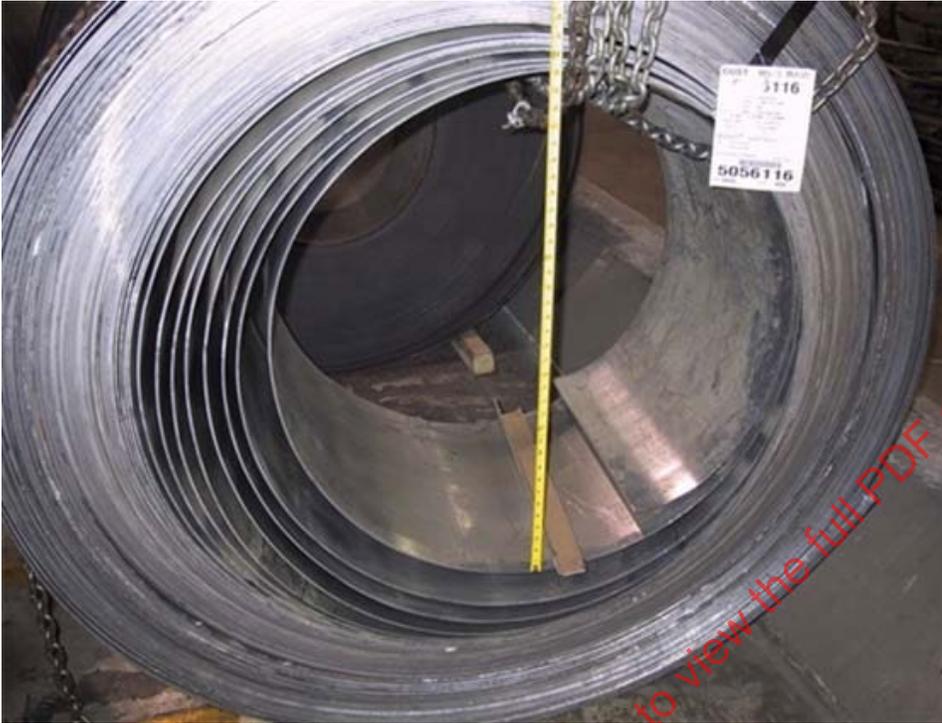
Figure 16

5.6 Loose Winding

Description:	Loose laps typically near the ID (inside diameter) of a coil.
Cause:	Insufficient tension during winding.
Product Affected:	All products.
Similar Imperfection:	Soft Coils; Telescoping; Clocksprung Coil.

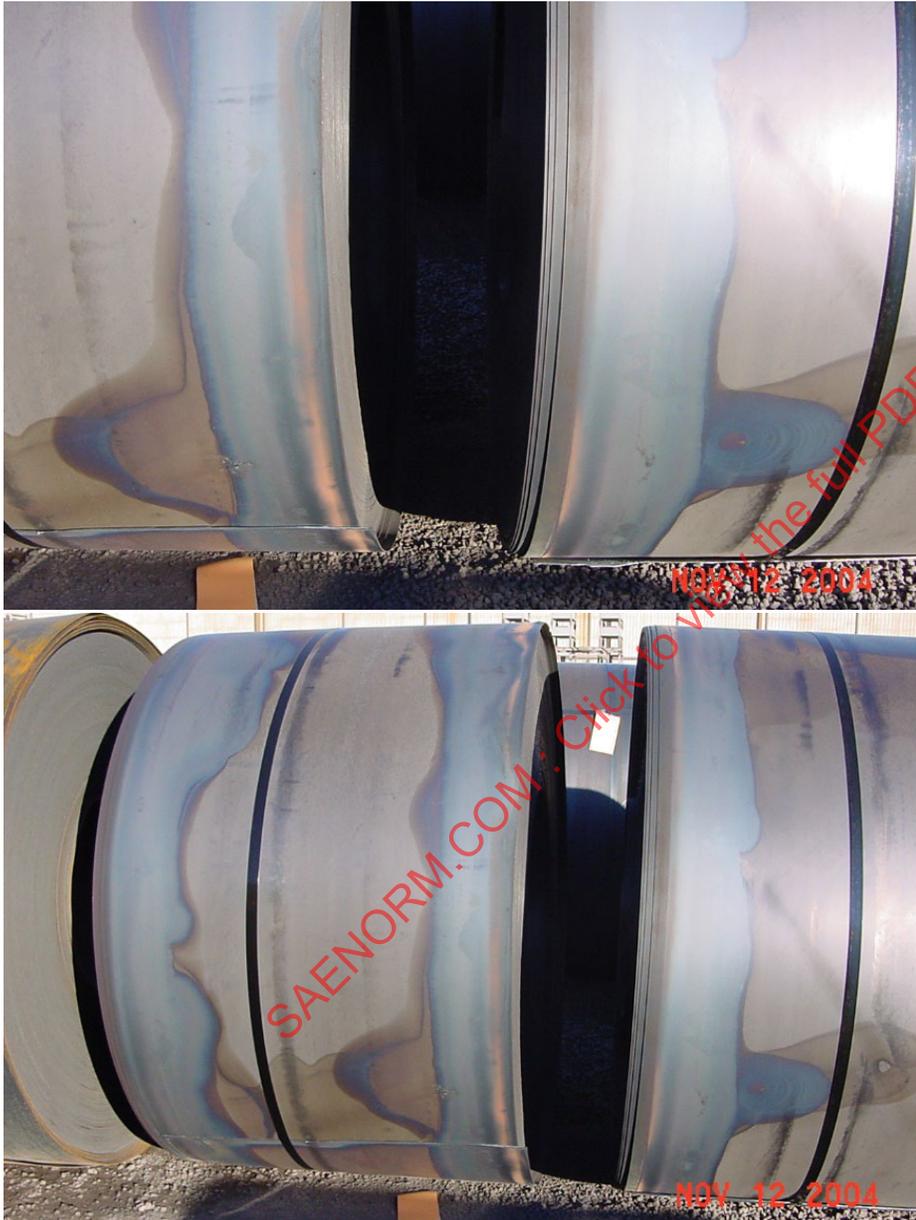
Figure 17

5.7 Oxide Edges

Description:	Oxide edges are discolored edges on hot band coils and appear as a wavy pattern located near an edge. Oxide edges can be multiple shades of blue, gray, and black.
Cause:	Different types of scale forming from the edge leading to discoloration. Additionally, heat from the surrounding coils leads to various scale formation.
Product Affected:	Hot rolled steel.
Similar Imperfection:	Anneal Blue; Annealing Burn.
