SURFACE VEHICLE INFORMATION REPORT	J810™	MAR2025
	Issued 1956-04 Reaffirmed 1987-03 Revised 2025-03	
Superseding J810 MAR1996		
(R) Classification of Common Imperfections in Sheet Steel

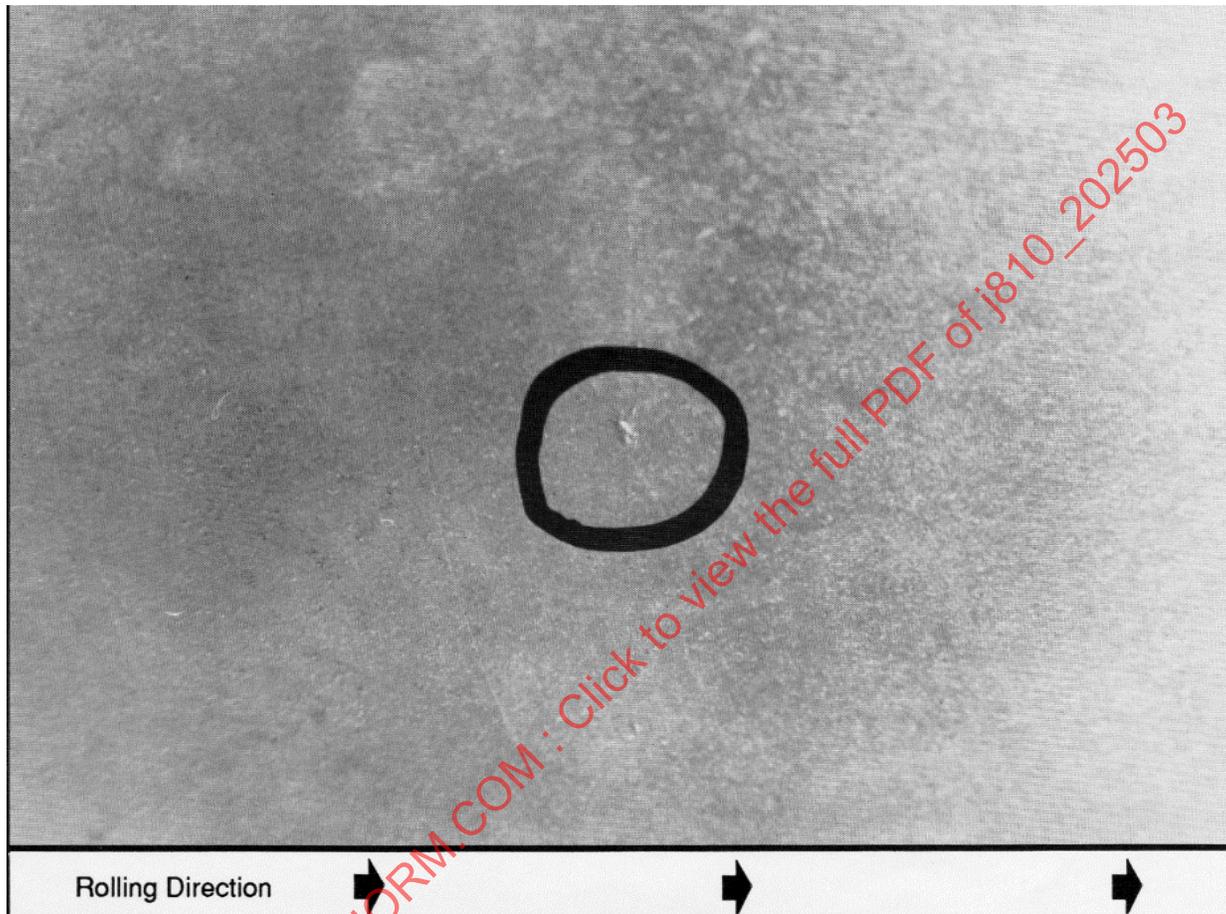
Figure 18

5.8 Pick-Up

Description:	Pick-up is a series of repetitive depressions, dents, or scratches on a sheet.
Cause:	Pick-up is caused when metallic or nonmetallic debris adhere to work rolls or other rolls. These particles could be the base metal or the galvanized coating if it occurs at that stage of processing. Pinch roll pick-up, also called stickers, occurs when metal sticks to the hot mill coiler pinch roll and leaves a repeating impression on the strip.
Product Affected:	All products.
Similar Imperfection:	Roll Pick-Up; Punch Roll Pick-Up; Pits.

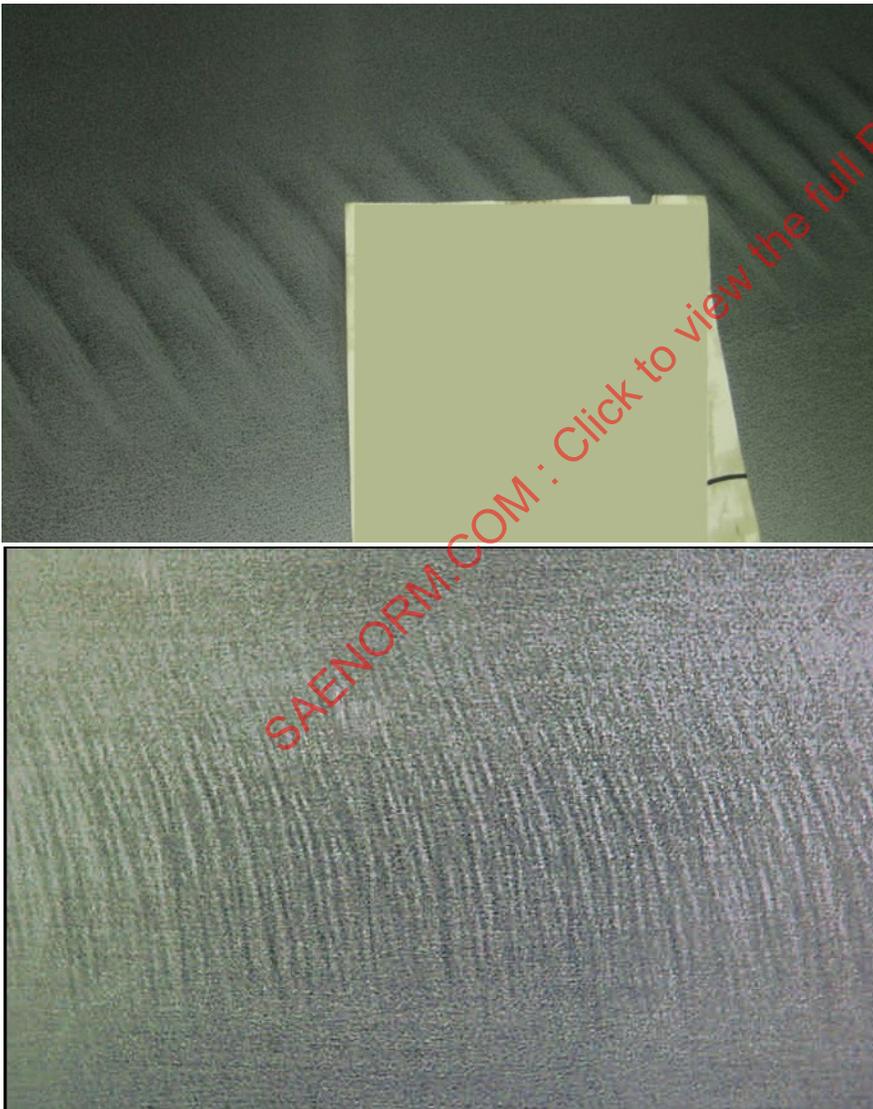
Figure 19

5.9 Pinchers

Description:	<p>Pinchers occur during rolling. They can be observed with the naked eye and usually run diagonal to the direction of rolling. Pinchers may occur locally or across the width of the sheet.</p> <p>The strip may slip sideways after it leaves the last mill stand and is more prone to occur at lighter gauges and on strips with camber. This sideways slip may produce an area of pinched up metal at the downcoiler.</p> <p>Floppers are a type of pincher, usually from an edge wave that bunches up in a roll bite.</p> <p>Stickers are different than pinchers. Pinchers are more mechanical, occurring when metal bunches up in roll bite. Stickers have a heat component.</p> <p>Pinch marks are sometimes described using the term "pinchers." Pinch marks are caused by roll marks left behind when a tail end pinches or rips going through the last mill stand. These pinch marks are usually very large repeating areas of discolored steel but can rarely be felt.</p>

Cause:	Pinchers are caused when the profile of the incoming strip does not coincide with that of the "roll gap" during temper rolling to produce, for example, a wavy strip.
Product Affected:	Cold rolled.
Similar Imperfection:	Feathering; Cross Hatch; Pinch Marks; Stickers; Sticker Breaks; Floppers.

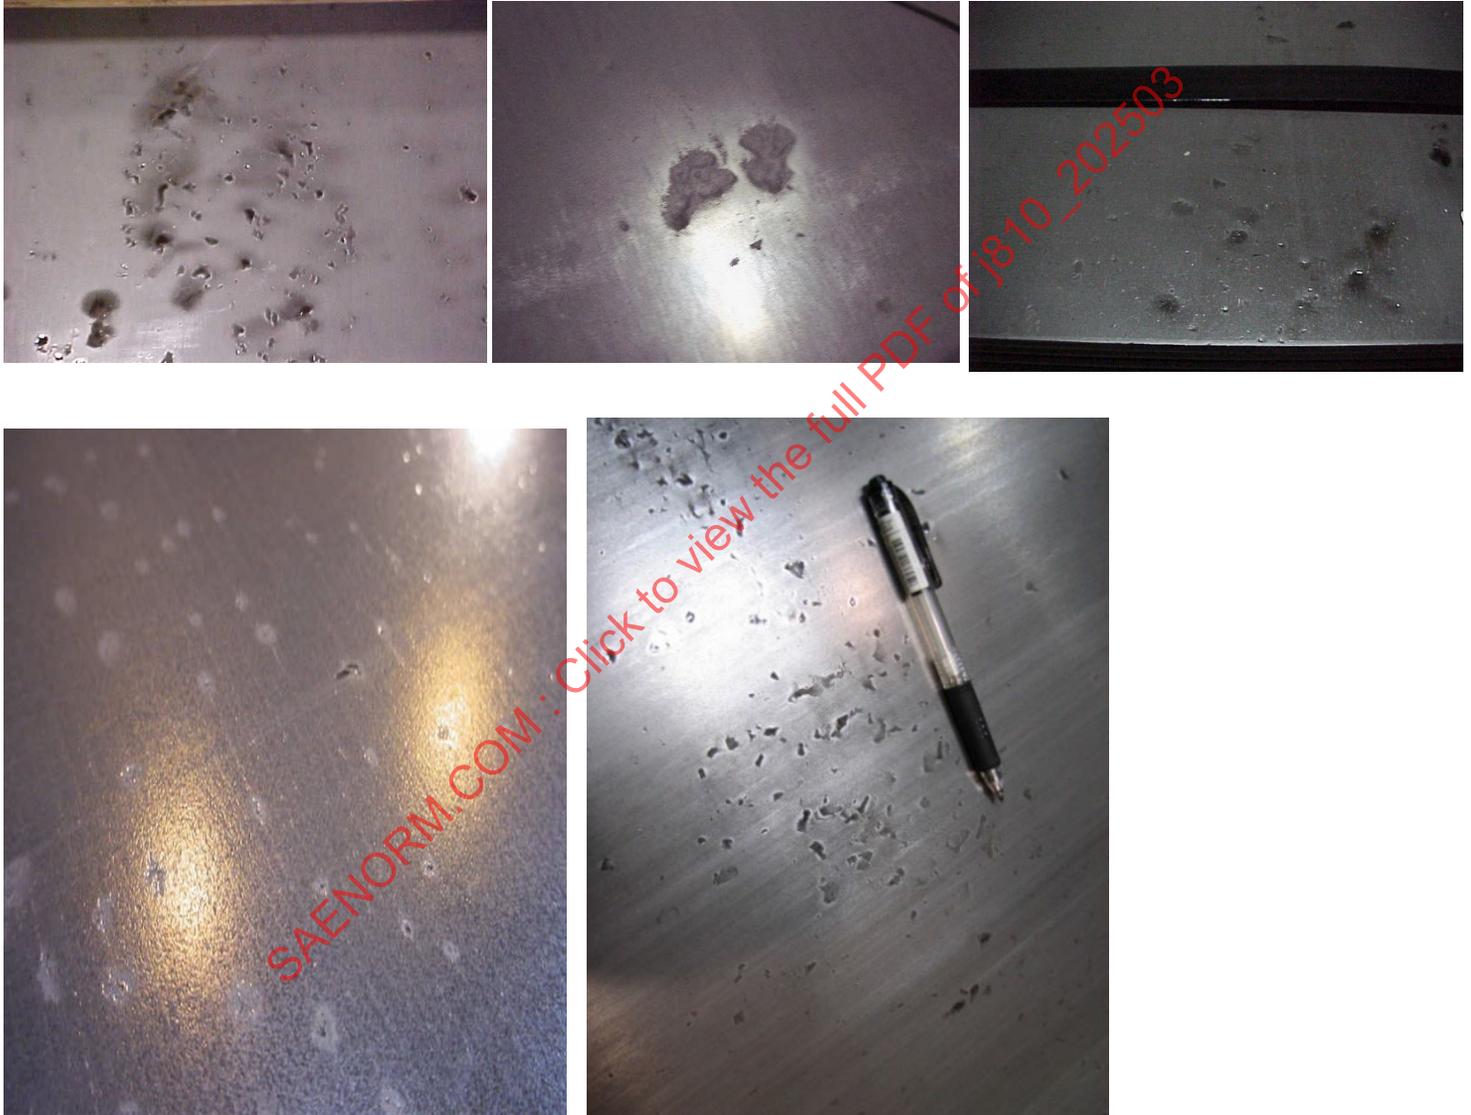
Figure 20

5.10 Pits

Description:	Pits are small cavities in the surface of the steel characterized by randomly distributed indentations.
Cause:	Pits can be caused by: <ul style="list-style-type: none">- Debris on temper mill rolls- Foreign particles or metal flakes rolled into and subsequently fall out of the steel coil surface- Rolled-in scale which has been removed by pickling Pits can form when coils have been set on rocks or debris which then are pressed into the surface.
Product Affected	All products.
Similar Imperfection:	Pick-Up; Rolled-In Dirt; Rolled-In Scale; Corrosion Pits; Scale Pits; Grease Pits; Slug Pits; Scale Pits.

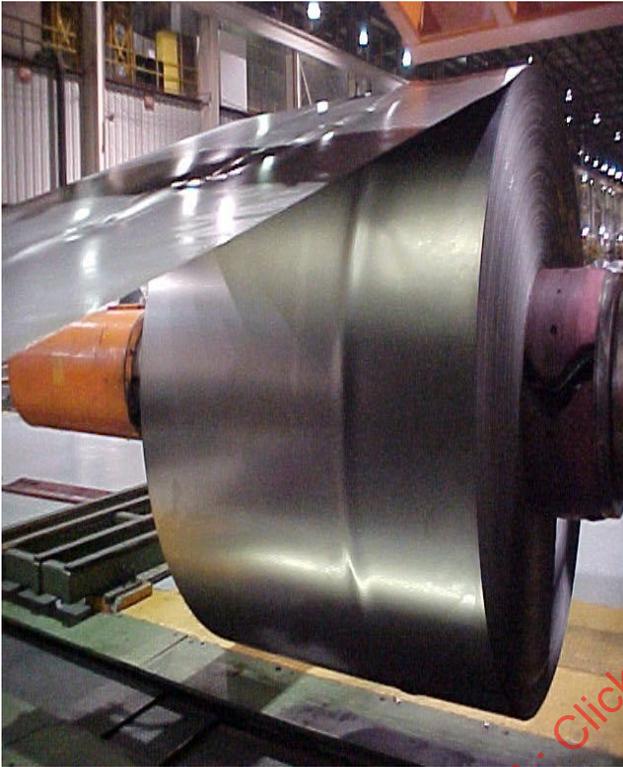
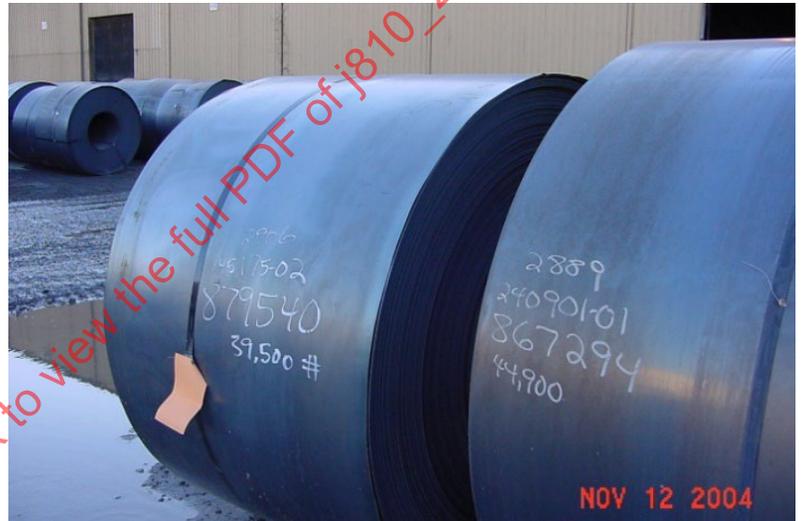
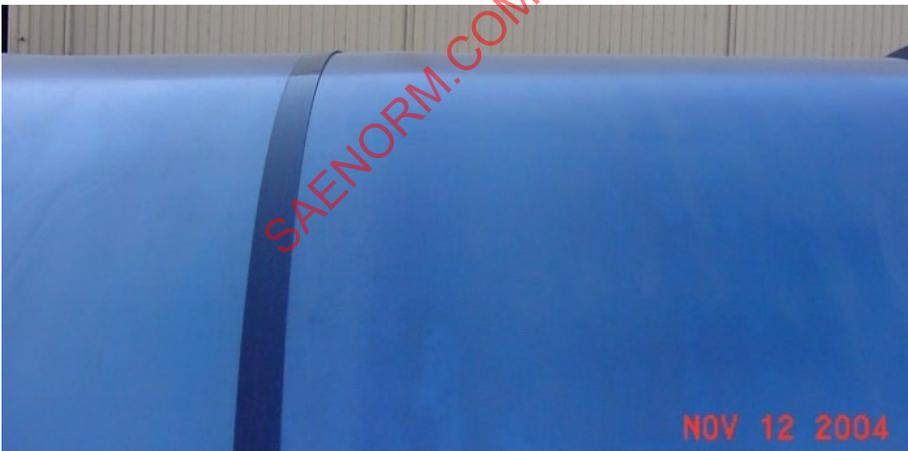
Figure 22

5.12 Ridge

Description:	A ridge is a localized linear difference in the strip contour or thickness that runs parallel to the rolling direction.
Cause:	Ridges can be caused by localized excess coating or strip thickness. Ridges can also be caused by improper work roll cooling during hot rolling.
Product Affected:	All products.
Similar Imperfection:	Build-Up; Burnish Mark; Crease.

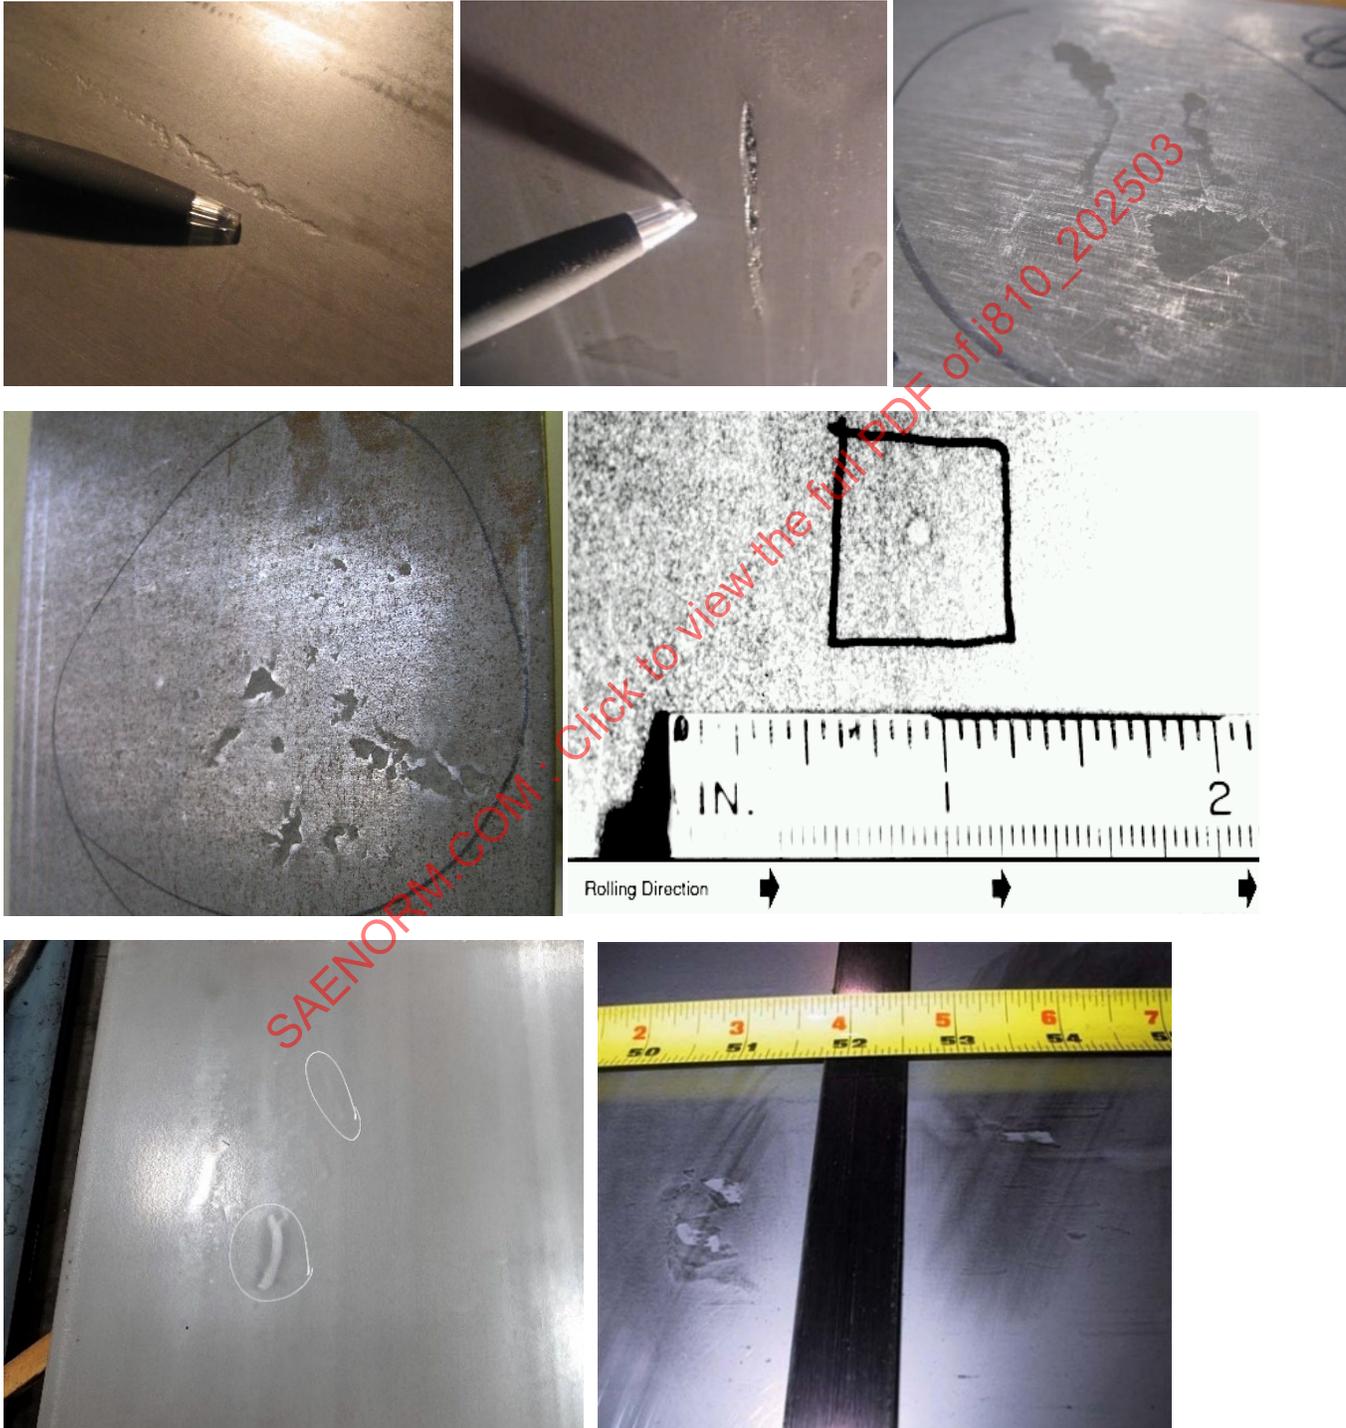
Figure 23

5.13 Roll Marks

Description:	Roll marks appear as indentations in the material surface and are usually irregularly shaped. Roll marks repeat at regular intervals, with the repeat distance matching the circumference of the roll that caused the imperfection (distance may be elongated by subsequent rolling).
Cause:	Roll marks are caused by damaged roll(s) or debris on roll(s).
Product Affected:	All products.
Similar Imperfection:	Bruise; Mill Mark; Repeat Mark; Pick-Up; Dents; Pits.

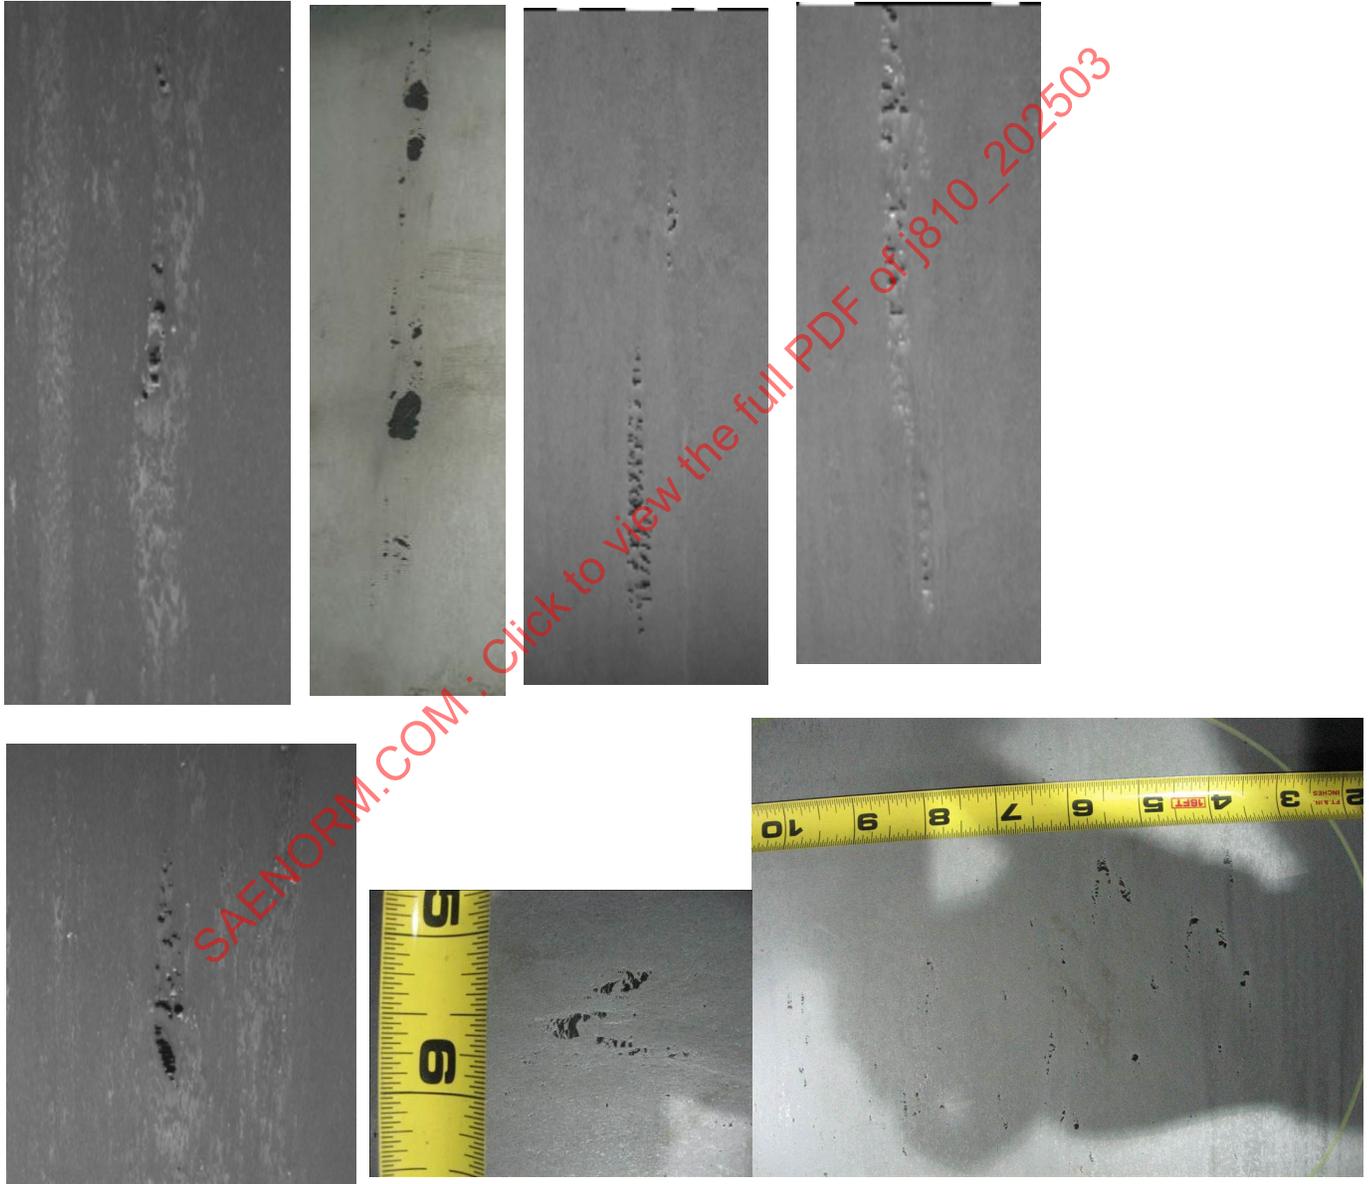
Figure 24

5.14 Scale: Primary Scale

Description:	Primary scale forms on the slab in the reheat or tunnel furnace by reaction between the surface of the steel with combustion gasses that include excess air, water vapor, and carbon dioxide. If this primary scale is not removed by the descaling process prior to hot rolling, it becomes pressed into the surface of the steel and leaves an impression that often contains residual portions of this scale after pickling.
Cause:	Primary scale can be caused by extended time in the reheat or tunnel furnace and abnormally thick scale layers not easily removed prior to rolling through the roughing mill or finishing mill.
Product Affected:	Hot rolled.
Similar Imperfection:	Furnace Scale; Fleck Scale; Spot Scale; Secondary Scale.

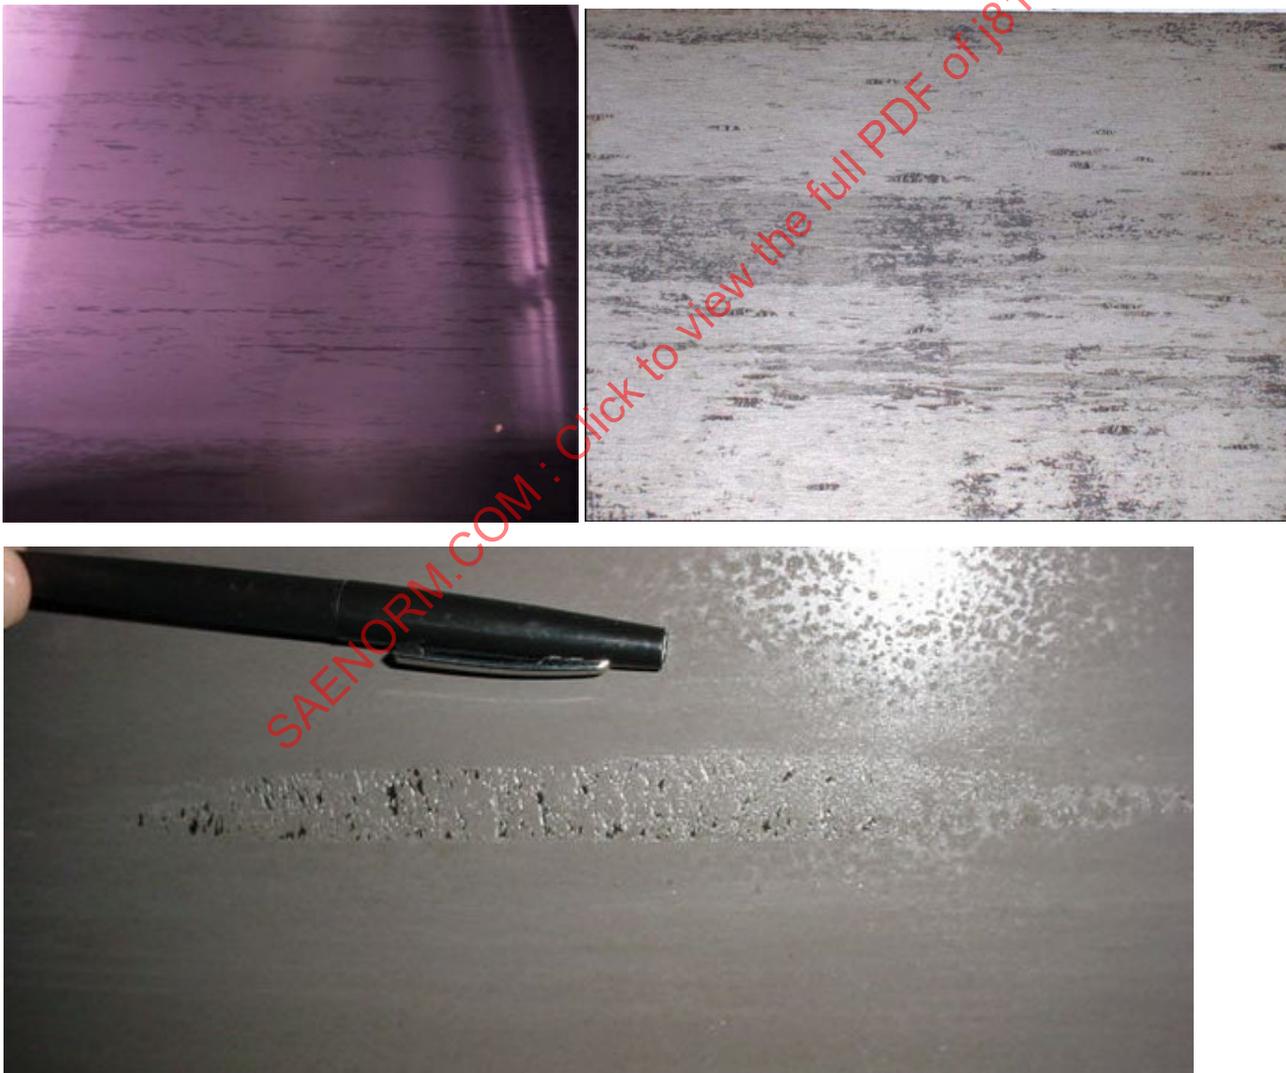
Figure 25

Description:	<p>Rolled-in scale appears as dark streaks or spots in the rolling direction which are small particles loosely attached or embedded in the surface of the metal. May be elongated in the rolling direction. May appear as pit marks if the scale has been pickled out.</p> <p>When a slab reaches the hot strip mill, the surface scale must be completely removed prior to rolling. Reasons for incomplete removal of scale include a clogged water-jet nozzle, a chunk of scale ricocheting through the nozzles (rebound scale), or tight adherence to the steel. Scale is mechanically harder but more brittle than base metal, so when it is rolled into the steel, it leaves a deep impression and breaks apart as it is elongated.</p>
Cause:	<p>Rolled-in scale results when scale that has accumulated on the work roll surface is partially rolled into the surface of the sheet. This condition can cause holes in certain products.</p> <p>The scale sometimes forms in pits and is rolled into the steel and is often described as “pepper” scale. Sometimes, the effect is an elongated streak of black scale similar to primary scale, but much lighter and thinner.</p> <p>Rolled-in scale can also result from insufficient pickling of deeply pitted surfaces during hot rolling.</p>

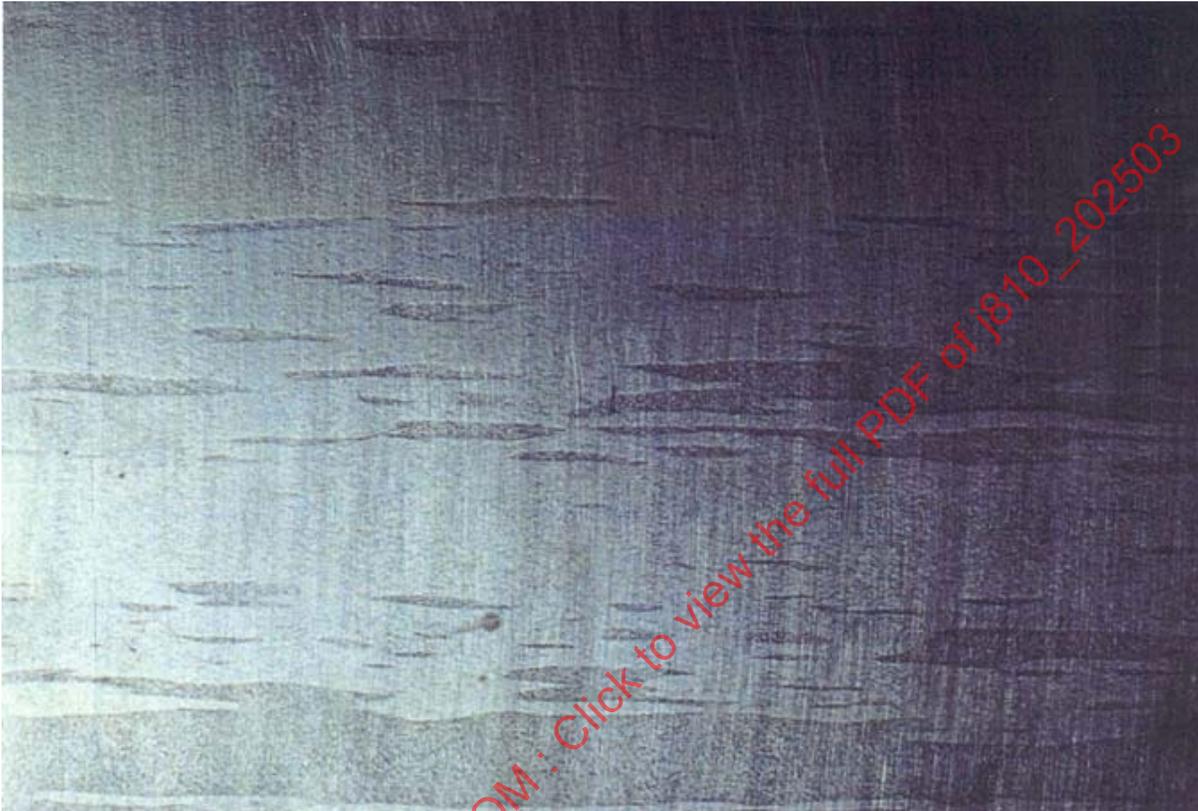
Figure 26

5.16 Scale: Silicon Streaks

Description:	Silicon streaks appear as closely packed tapered streaks lightly impressed or imprinted in the surface. The color is usually slightly darker than the pickled strip.
Cause:	Silicon streaks are caused by the formation of a difficult to remove silicon-rich scale, called fayalite, which becomes elongated during hot rolling.
Product Affected:	Hot rolled, cold rolled.
Similar Imperfection:	Tiger Stripes.

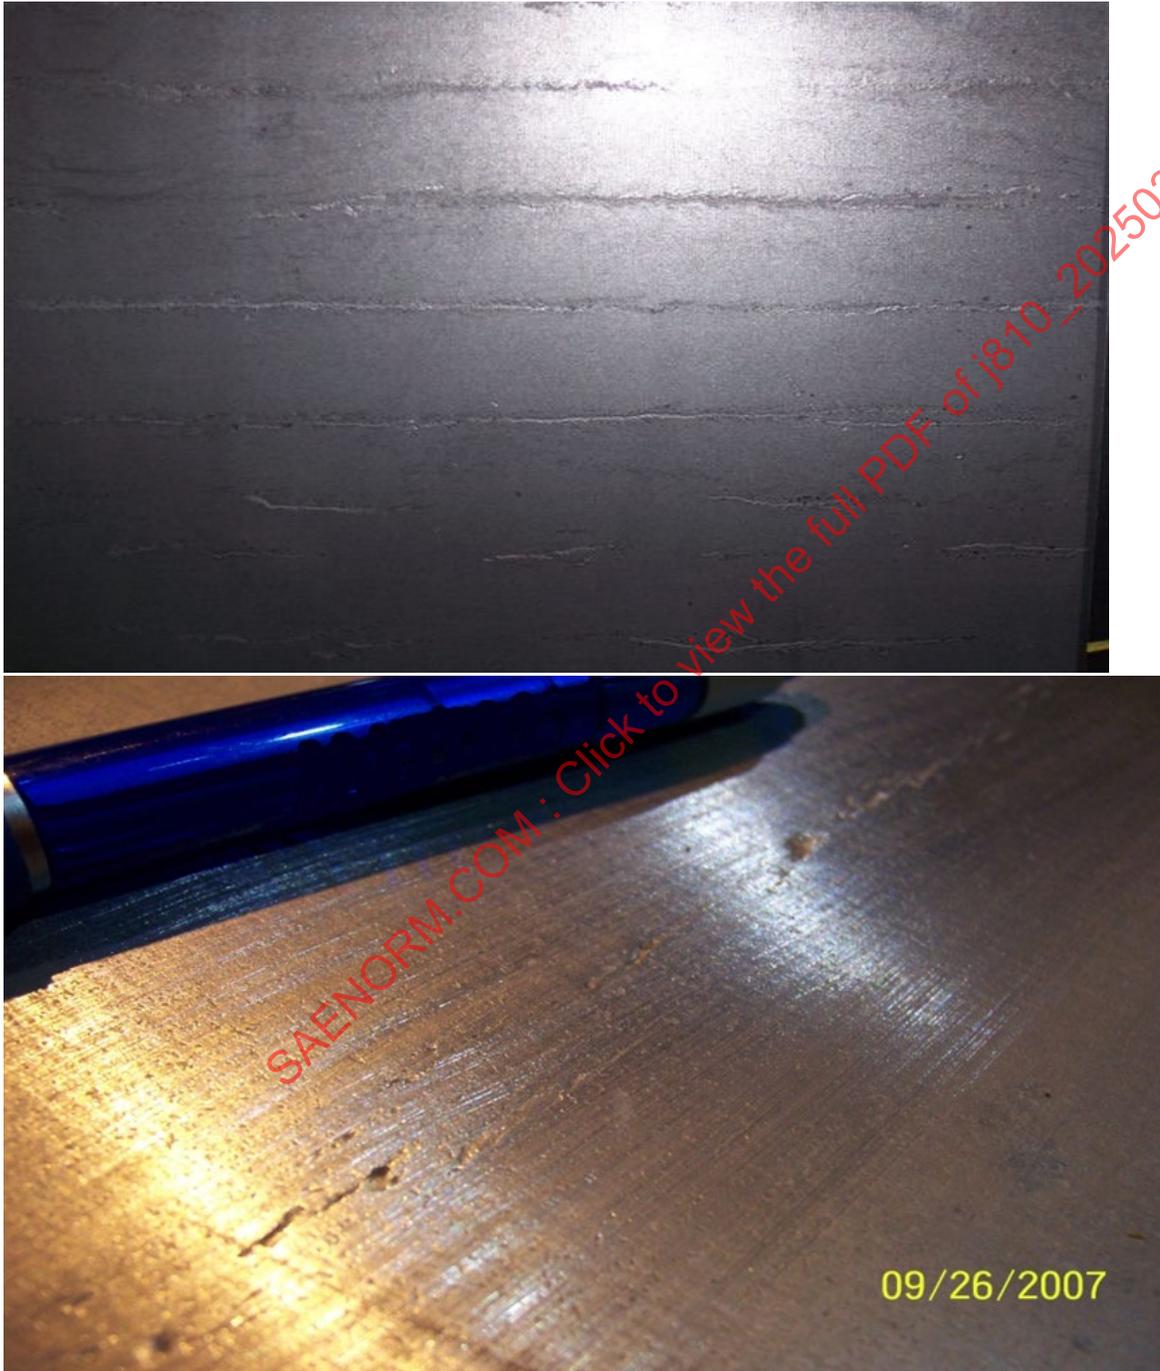
Figure 27

5.17 Scale: Streak Scale

Description:	Streak scale appears as dark streaks in the rolling direction.
Cause:	Streak scale results when scale is partially rolled into the surface of the sheet.
Product Affected:	All products.
Similar Imperfection:	Black Streak; Pits; Rolled-In Dirt.

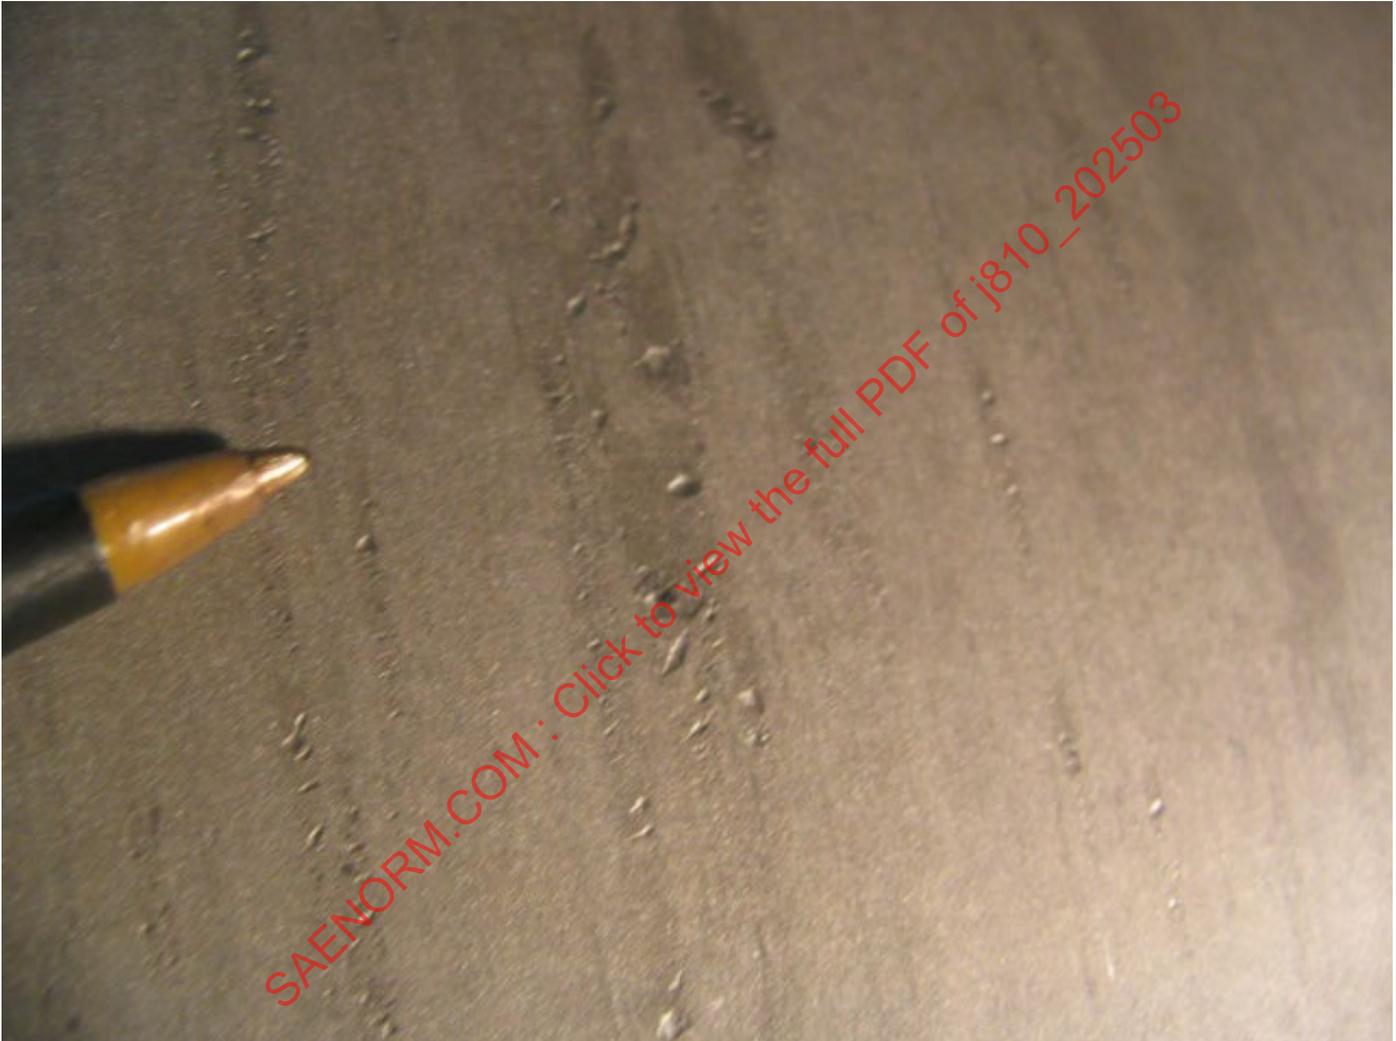
Figure 28

5.18 Scale: Worn Roll Scale

Description:	Worn roll scale looks like patches or streaks of pits. Sometimes, black scale is present in the pits.
Cause:	Worn roll scale is produced when scale (oxidized steel) forms in the rough area left behind when peeled hot strip mill work rolls scour the surface of the steel during rolling. The scale usually grows in the earlier mill stands where a combination of high temperature, heavy workload, and time between stands is ideal for scale growth.
Product Affected:	All products.
Similar Imperfection:	Pepper Scale; Streak Scale.

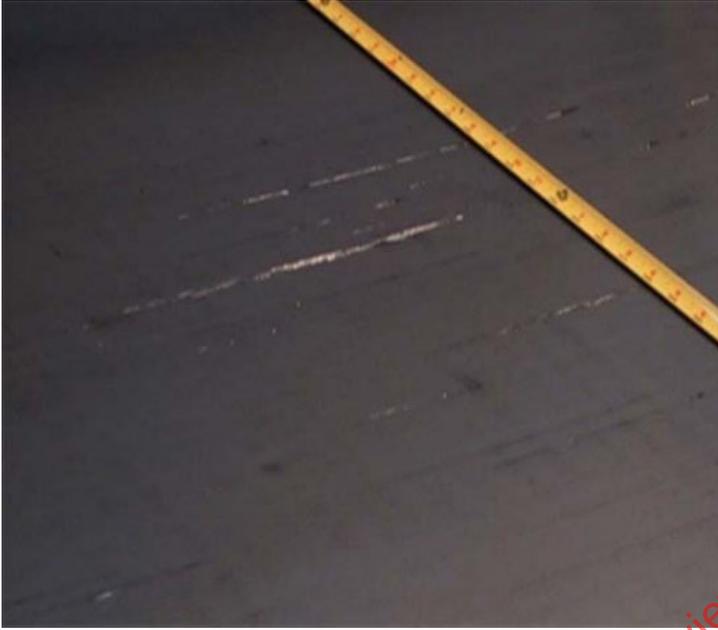
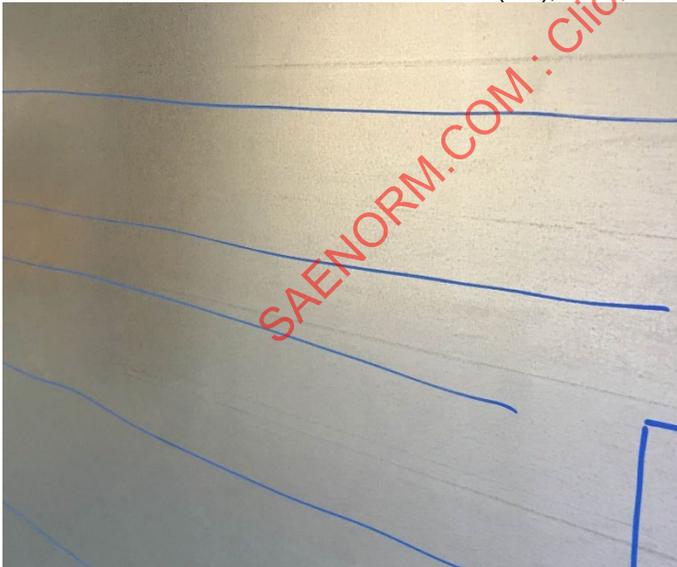
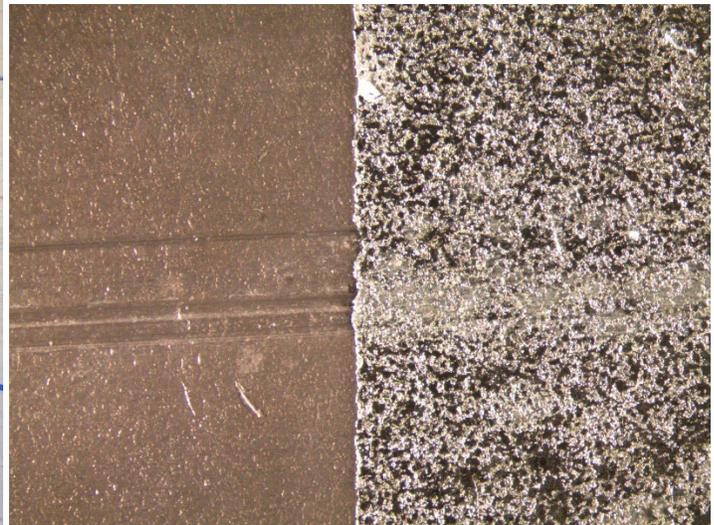
Figure 29

5.19 Scratch

Description:	Scratches appear as a linear scoring of the material surface and can be continuous or intermittent.
Cause:	Scratches are typically caused by an object rubbing against the material surface. Scratches can come from a variety of sources.
Product Affected:	All products.
Similar Imperfection:	Healed-Over Scratch; Friction Digs.

Galvanized scratches (left); Galvanized scratches under 50X magnification (right)

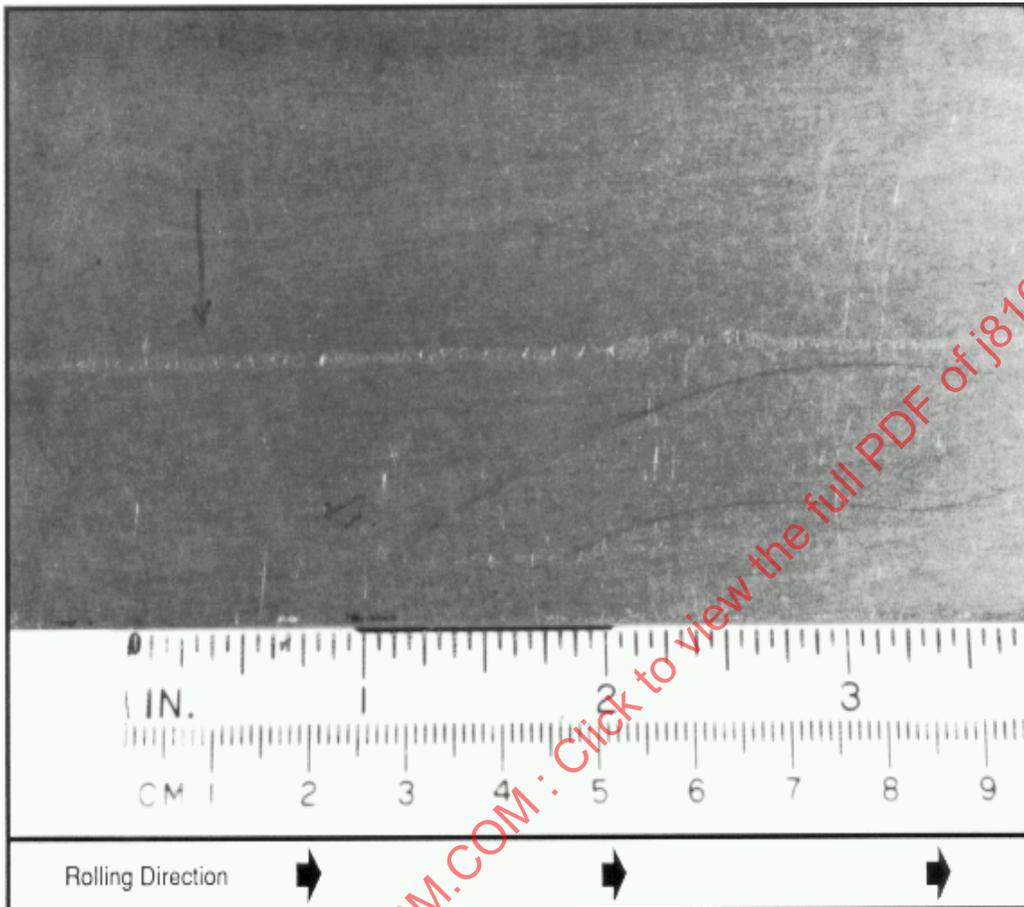
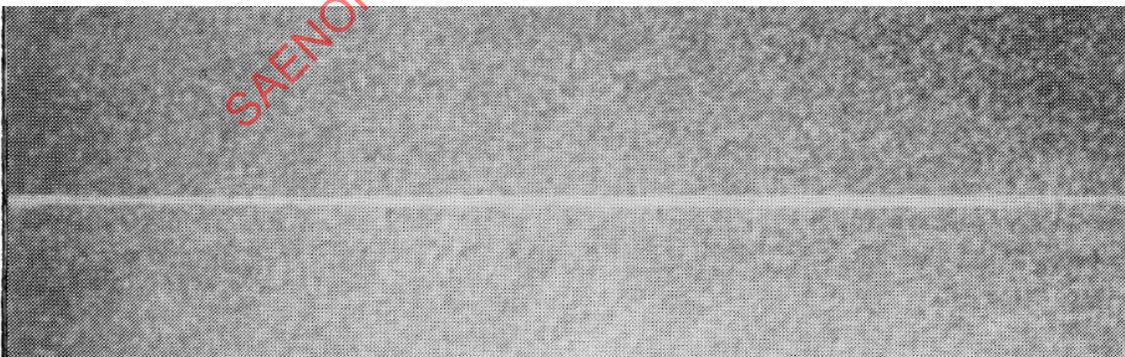
Figure 30

5.20 Scratch: Healed-Over Scratch

Description:	A healed-over scratch is one that has been rolled hot or cold that may open during rolling or forming.
Cause:	A healed-over scratch is one that originated in one mill operation and is partially or completely masked in subsequent rolling.
Product Affected:	All products.
Similar Imperfection:	Rolled-Over Scratch; Scratch.

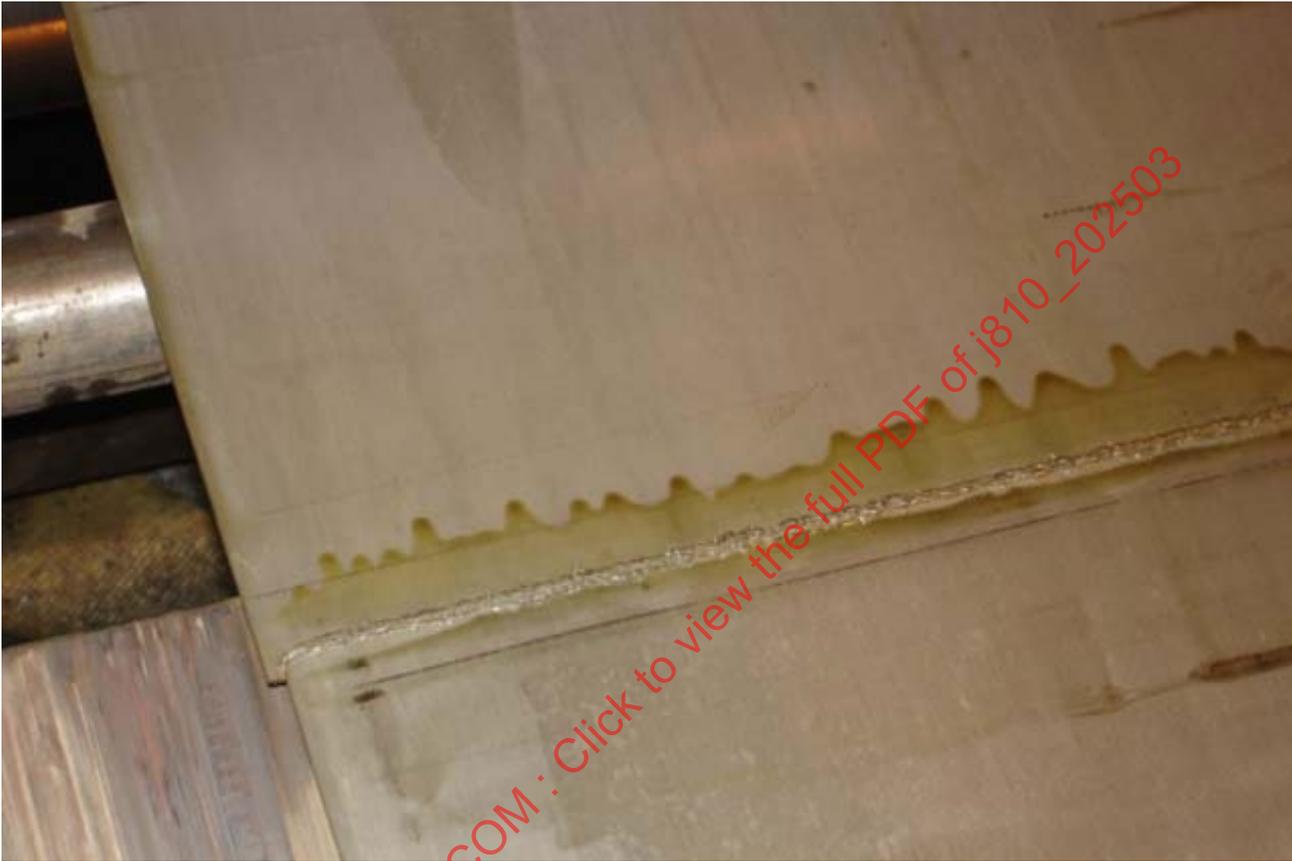
Figure 31

5.21 Seams

Description:	Seams may appear as a shiny or gray line across the width of the material. The gauge of the material will usually be heavier at the weld point.
Cause:	Two sections of coil being joined together.
Product Affected:	All products.
Similar Imperfection:	Welds; Fold-Over; Creases.

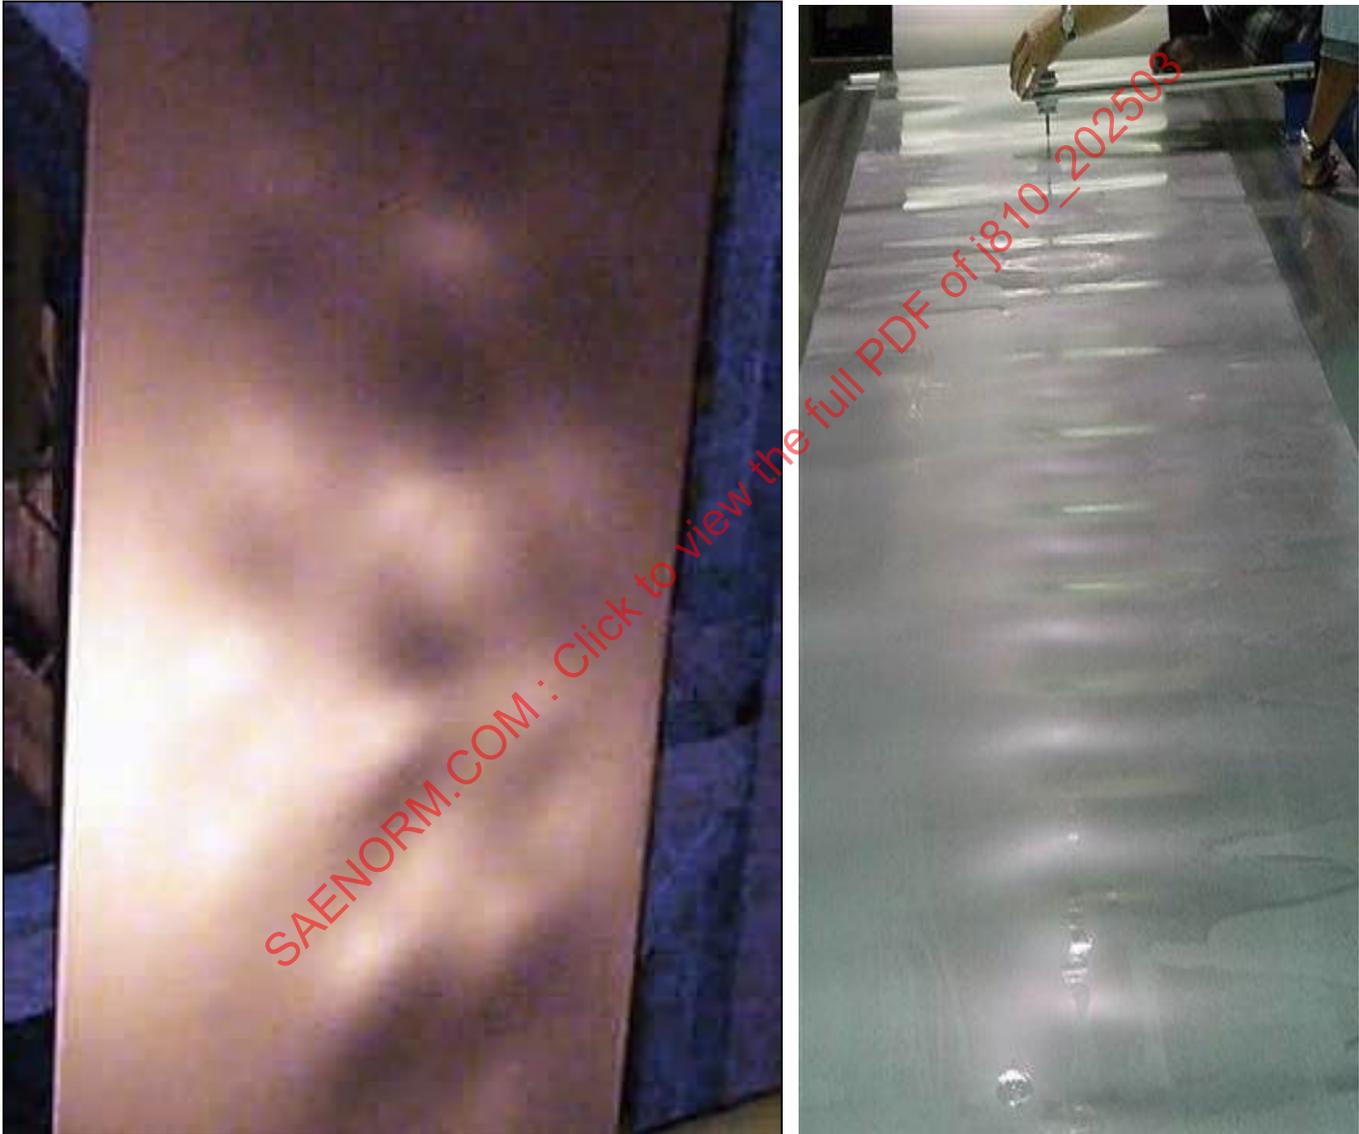
Figure 32

5.22 Shape: Buckles

Description:	Buckles are a series of waves transverse to the direction of rolling and vary in frequency and can be located along the centerline of the sheet or off center. The imperfection is called center buckle when it is located in the middle of the sheet, or side buckle (also called quarter buckle), when it is located near, but off-center.
Cause:	Buckles are caused by hardness variations of hot rolled sheet due to uneven cooling of the steel or mill rolls, build-up, or poor rolling practice.
Product Affected:	All products.
Similar Imperfection:	Edge Wave; Oil Canning; Ridge Buckle; Center Buckle; Full Center.

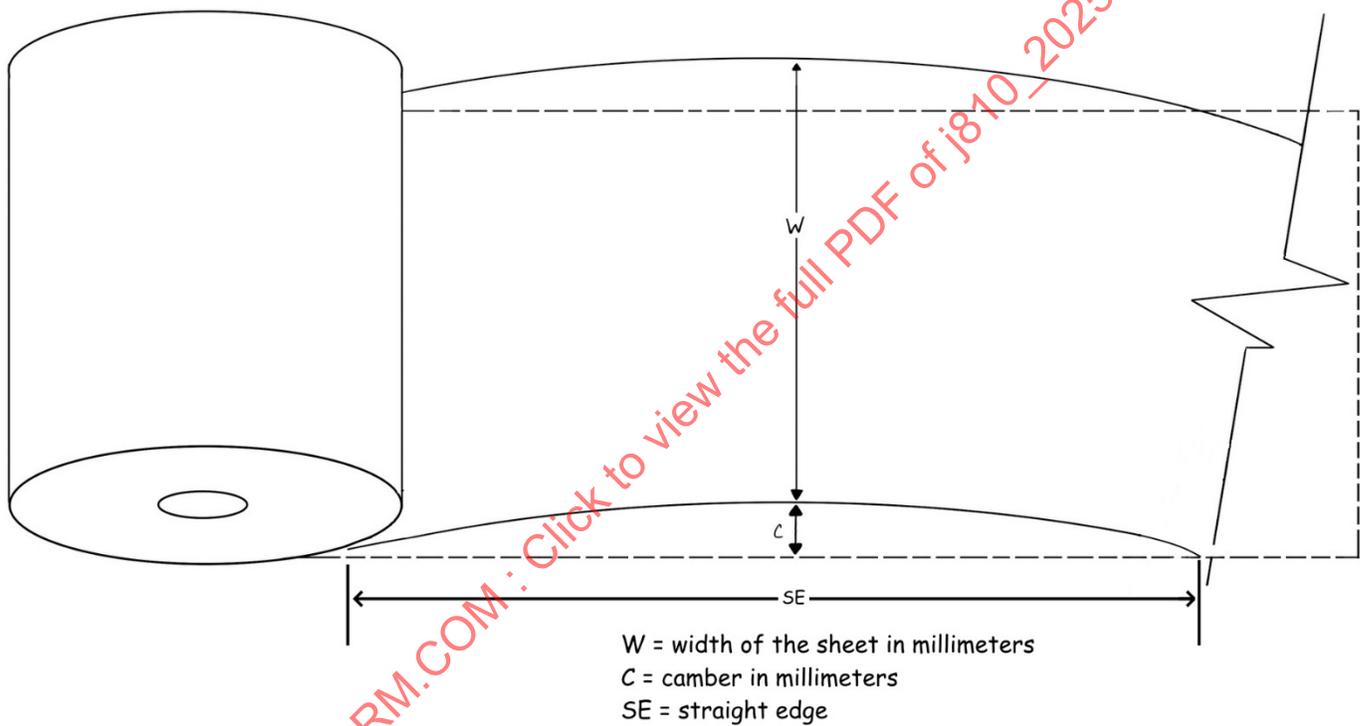
Figure 33

5.23 Shape: Camber

Description:	Camber is the deviation of the edge of a sheet from a straight line. It is measured as the greatest deviation of the concave edge of the sheet from a straight line.
Cause:	Camber is the result of improper slitting or is caused when the mill is off-level when the sheet is rolled. Camber can also be caused by edge wave and center buckle.
Product Affected:	All products.
Similar Imperfection:	Hook Ends; Snake.
