SURFACE VEHICLE INFORMATION REPORT	J810™	MAR2025
	Issued 1956-04 Reaffirmed 1987-03 Revised 2025-03	
Superseding J810 MAR1996		
(R) Classification of Common Imperfections in Sheet Steel

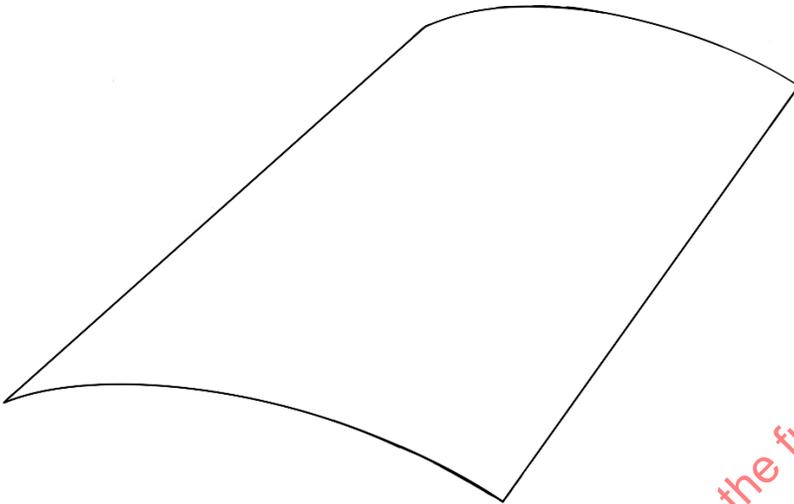
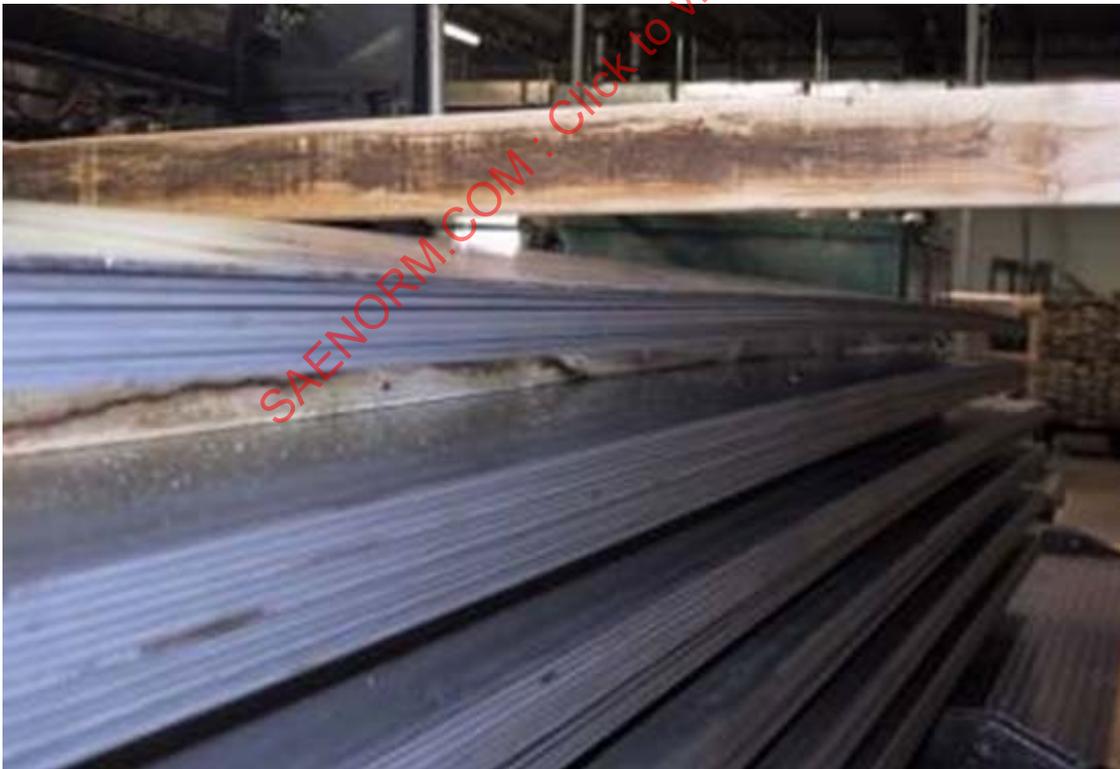
Figure 34

5.24 Shape: Cross-Bow

Description:	A concave curvature with the center of the width being the high point and the edge being the low point. Reverse cross-bow is where the curvature condition is in the opposite direction to cross-bow.
Cause:	Cross-bow is typically found with steel sheet supplied in coil form resulting from coil set. Cross-bow can be caused by improper rolling and tension control and can be minimized with proper post-flattening or leveling operations.
Product Affected:	All products.
Similar Imperfection:	Coil Set; Off-Flatness; Hog Back; Canoe.

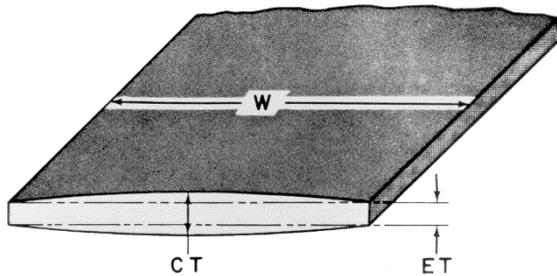
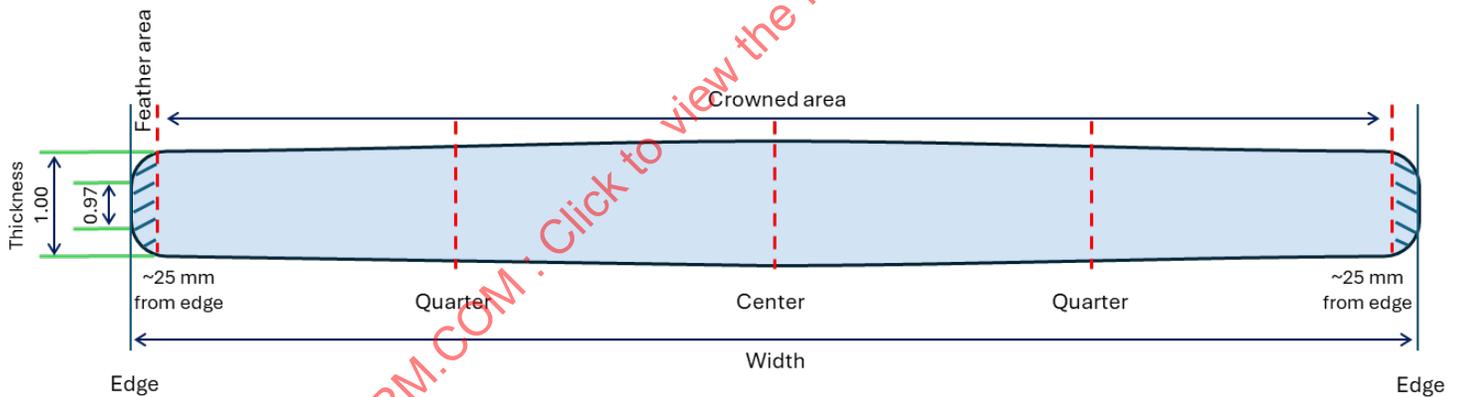
Figure 35

5.25 Shape: Crown

Description:	Crown is a typical condition that exists with flat rolled products where the thickness at the centerline is greater than the thickness at a defined distance from the edge. Crown is inherent on all products.
Cause:	Crown is controlled by rolling practice.
Product Affected:	All products.
Similar Imperfection:	Heavy Gauge/Light Gauge; Feathered Edge; Wedge.

W = WIDTH OF SHEET

ET = EDGE THICKNESS OF THE SHEET

CT = CENTER THICKNESS OF THE SHEET

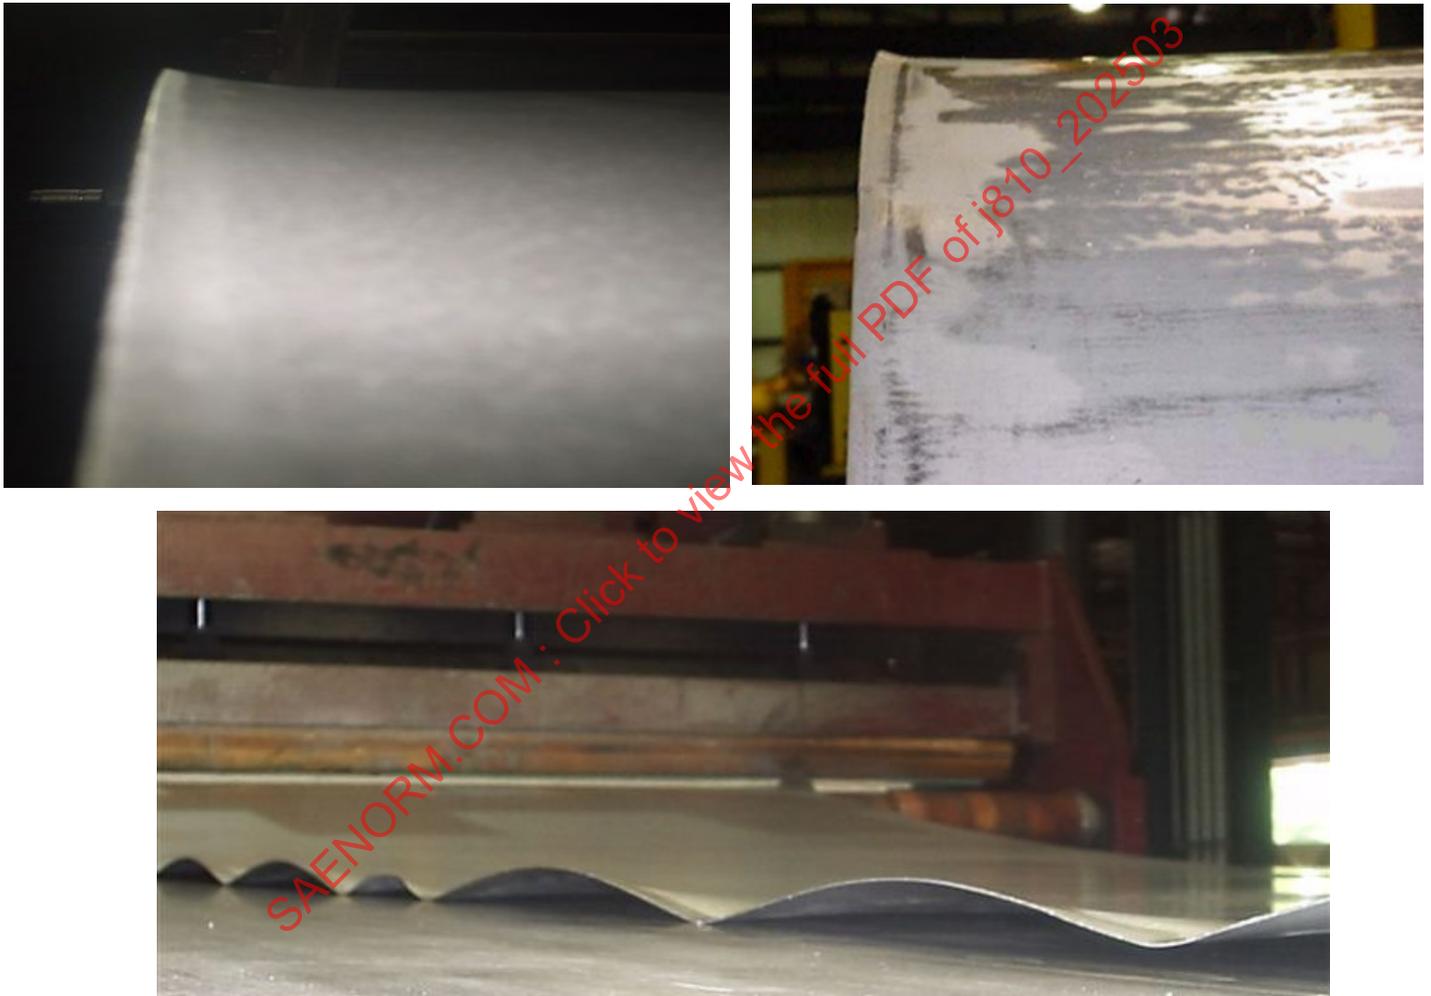
**Figure 36**

5.26 Shape: Edge Build-Up

Description:	Edge build-up appears as an up turned edge, usually on one side of the coil, but can affect both. Occurs during coiling when one edge flares up, giving the coil a trumpet shape.
Cause:	Edge build-up can be caused by: <ul style="list-style-type: none">- Long edge- Rippled edge- Heavy coating on the edge- Material rubbing on separator disk during slitting- Excessive burr
Product Affected:	All products.
Similar Imperfection:	Flared Edge; Pie Crust Edge; Spooling.

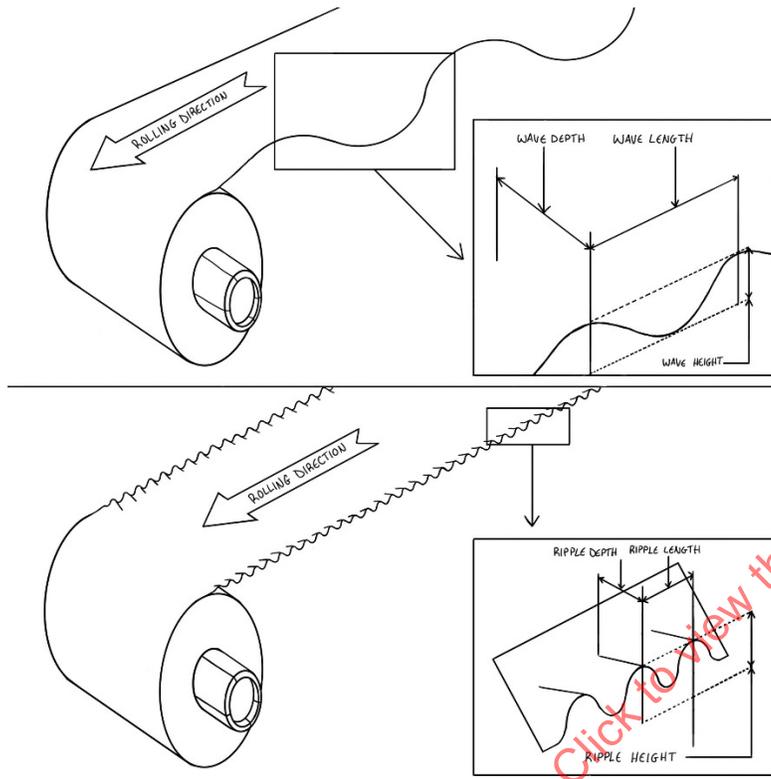
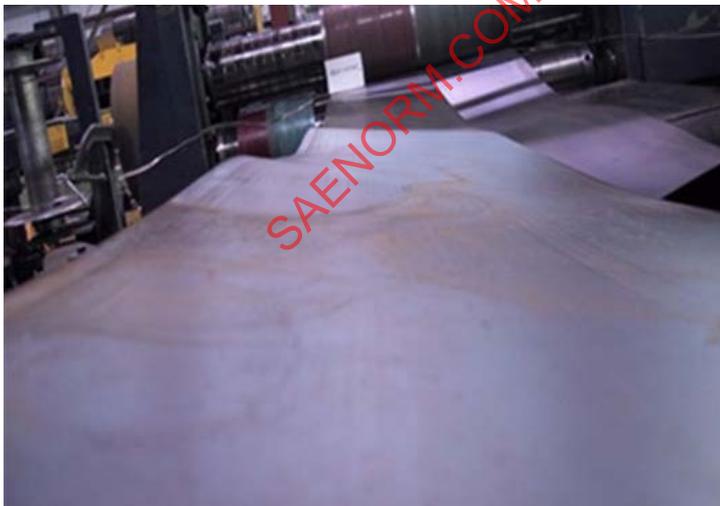
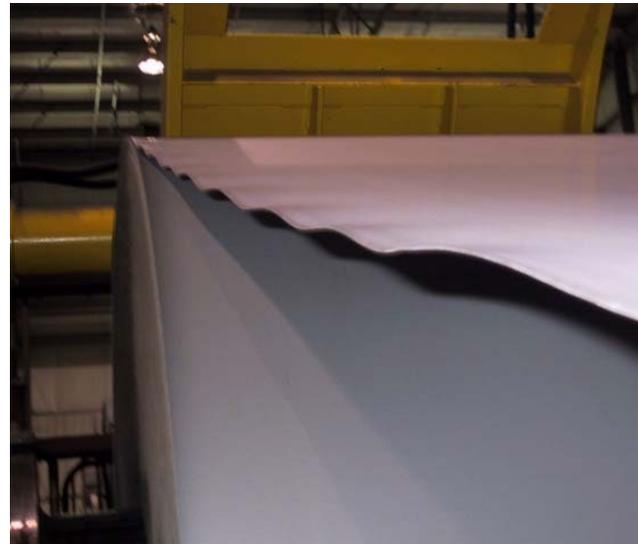
Figure 37

5.27 Shape: Edge Wave

Description:	Edge wave appears as a rise and fall of the edge on one or both sides of the strip.
Cause:	Edge wave occurs when the material along the edge of the strip is longer than the center. Edge wave can be caused by worn work rolls and uneven coolant flow during rolling.
Product Affected:	All products.
Similar Imperfection:	Wavy Edge; Pie-Crust Edge; Rippled Edge (if there is a short peak-to-peak distance).

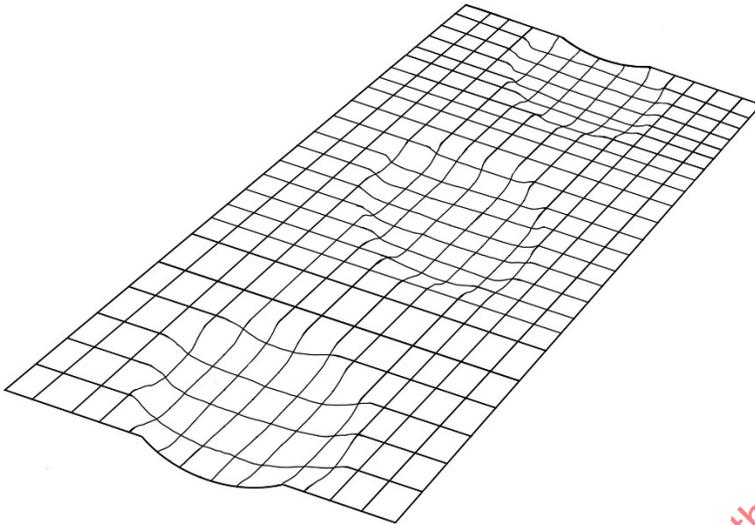
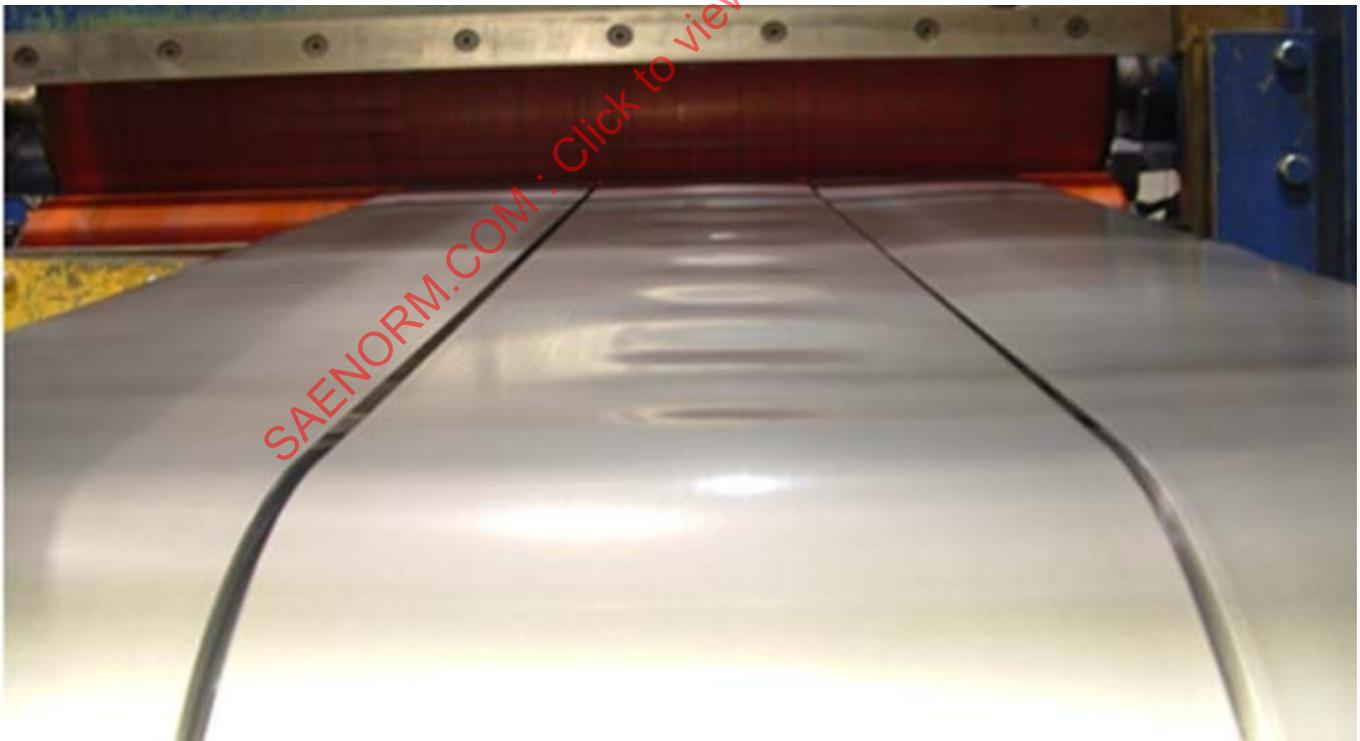
Figure 38

5.28 Shape: Full Center

Description:	Appears as trapped buckles near the center of the master coil width. When slit, the center mullets will be longer in length
Cause:	Occurs when the center of the strip receives more roll force than the rest from either too much roll crown, roll wear, inadequate roll bending, or too much crown or ridge in the incoming material. May also be caused by uneven coolant flow during rolling.
Product Affected:	All products.
Similar Imperfection:	Oil Can; Edge Wave; Center Buckle.

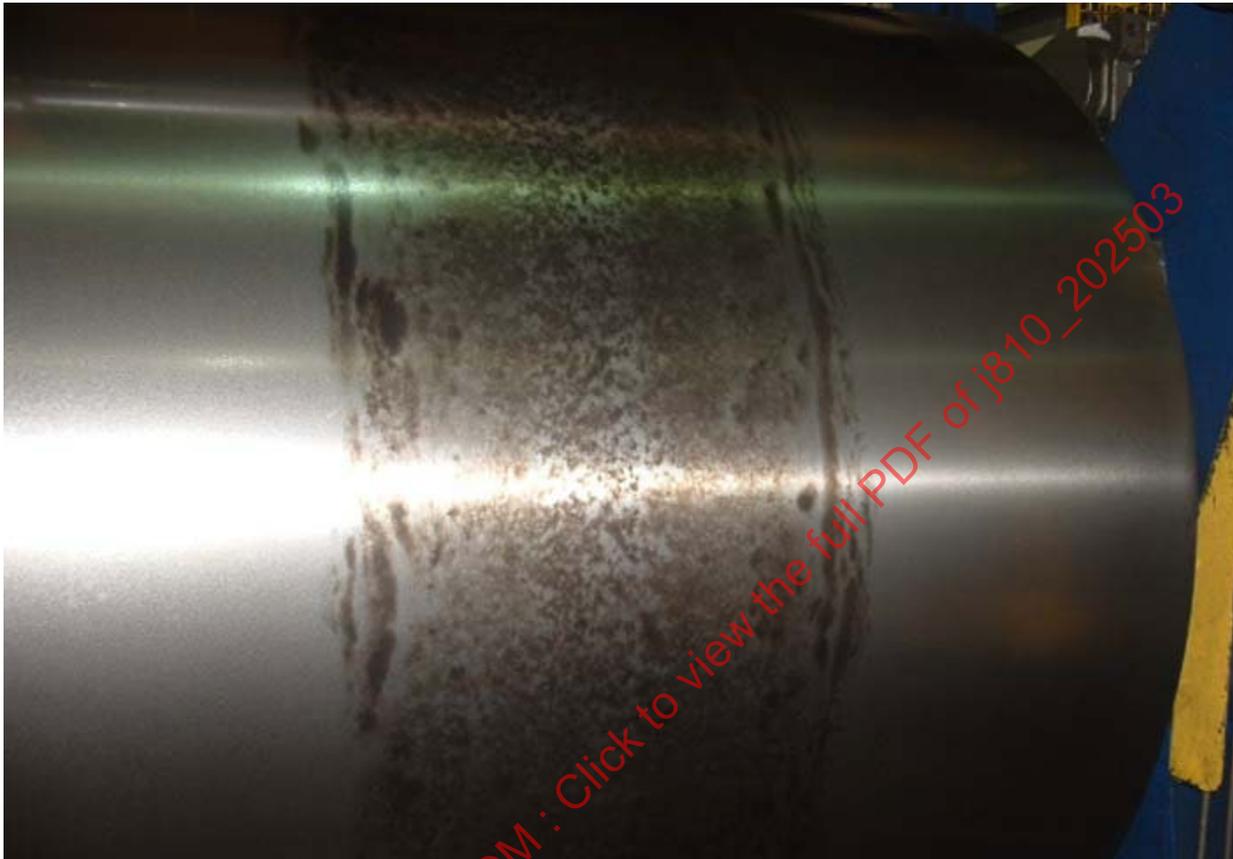
Figure 39

5.29 Solution Stain

Description:	An unsightly black stain that has poor paintability.
Cause:	Poor rinsing in cold rolling mill/poor bath maintenance. Poor blow off when rolling with solution.
Product Affected:	Cold rolled steels.
Similar Imperfection:	Cold Rolled Detergent Stain; Pickle Stain; Annealing Stain; Emulsion Stain.

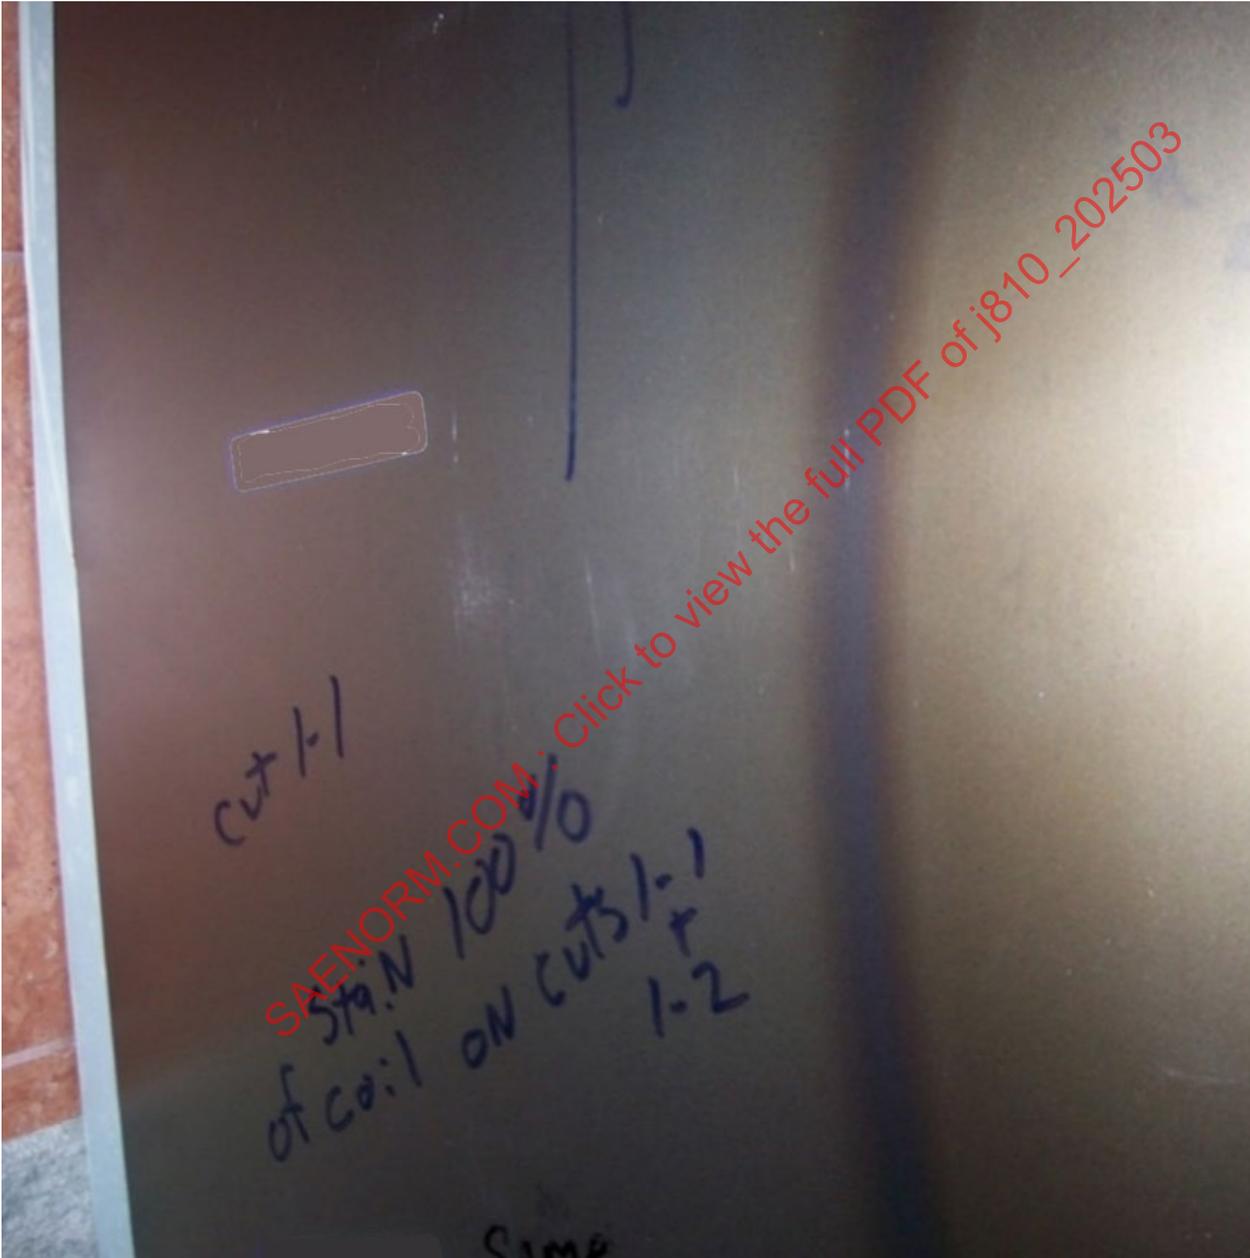
Figure 40

6.1 Anneal Border

Description:	Anneal border is a thin, tightly adhering oxidized layer which extends in from the edge of the coil or sheet. The color may range from straw yellow to blue and can be removed by pickling or re-deoxidizing.
Cause:	Anneal border is caused by air coming into contact with hot steel via leaks in the anneal furnace cover or by removing the anneal furnace cover at too high a temperature.
Product Affected:	Cold rolled.
Similar Imperfection:	Oxidized Surface; Straw Color; Anneal Stain; Blue Steel; Carbon Edge.

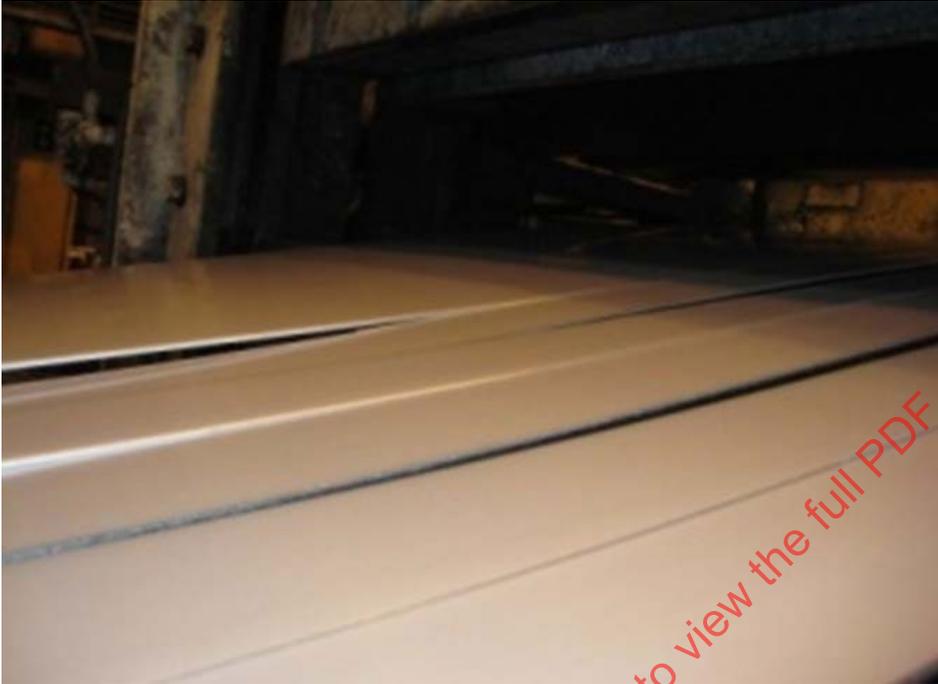
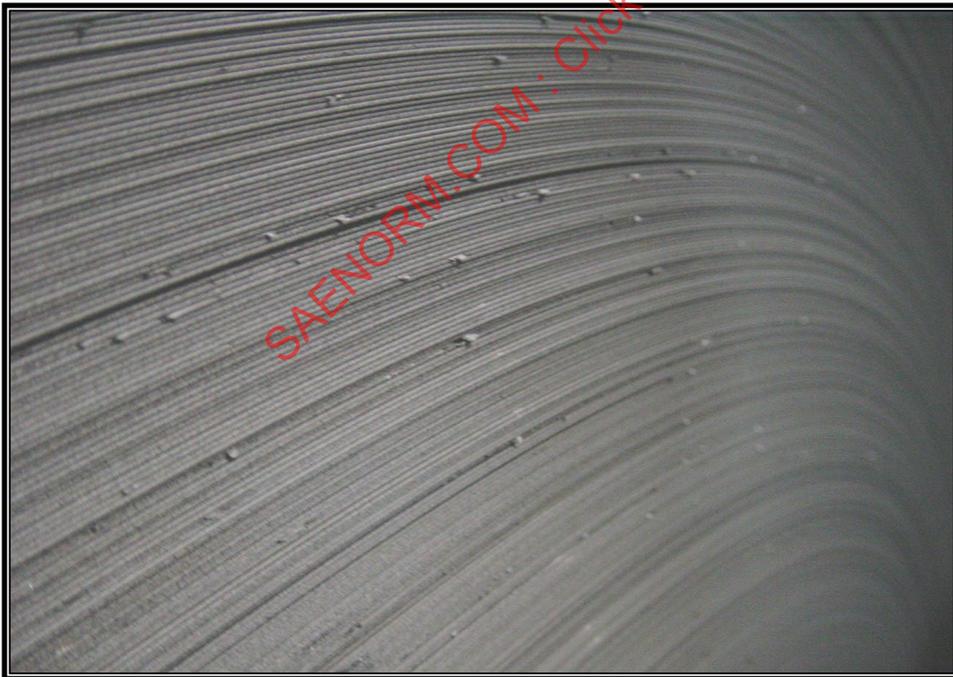
Figure 41

6.2 Burr

Description:	A burr is a sharp raised area at the edge of the material resulting from trimming, shearing, or slitting and may be continuous or intermittent.
Cause:	Poor clearance on slitter knives or shear blade. May also be caused by dull or damaged knives and blades.
Product Affected:	All products mechanically slit, sheared, or trimmed.
Similar Imperfection:	None.

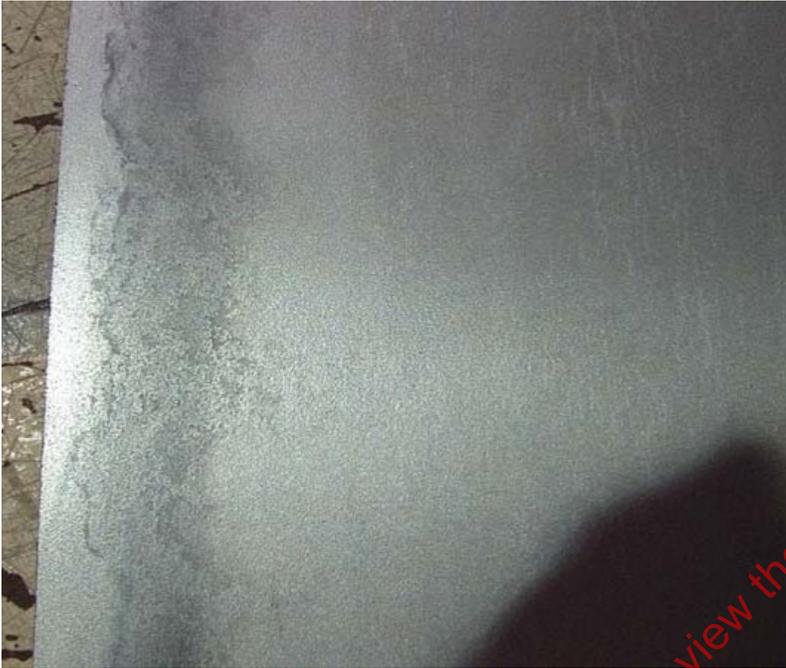
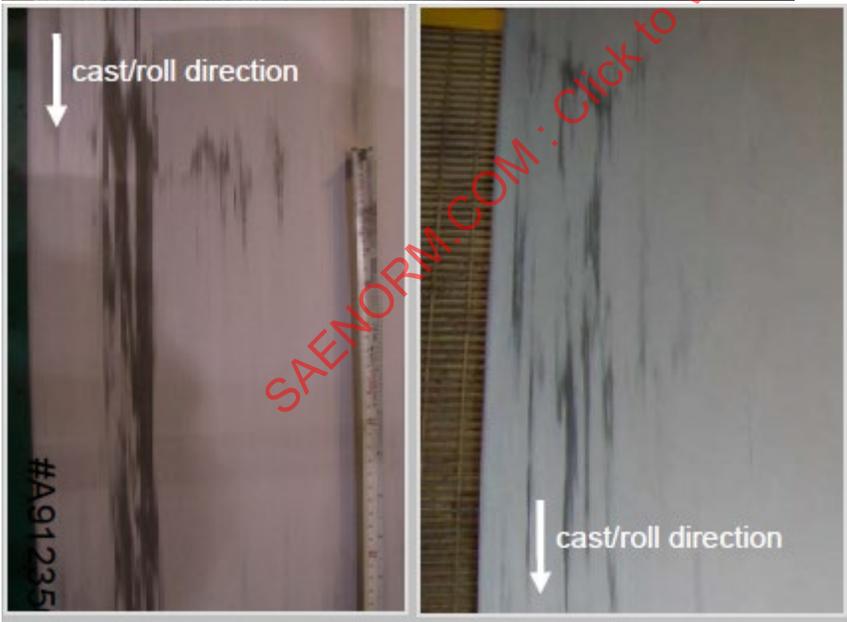
Figure 42

6.3 Carbon Stain

Description:	Carbon stain appears as smutty black or gray stains.
Cause:	Carbon stain is the result of residual rolling oils reduced in the annealing process.
Product Affected:	Cold rolled.
Similar Imperfection:	Snake Edge; Solution Stain; Carbon Border; Carbon Smut.

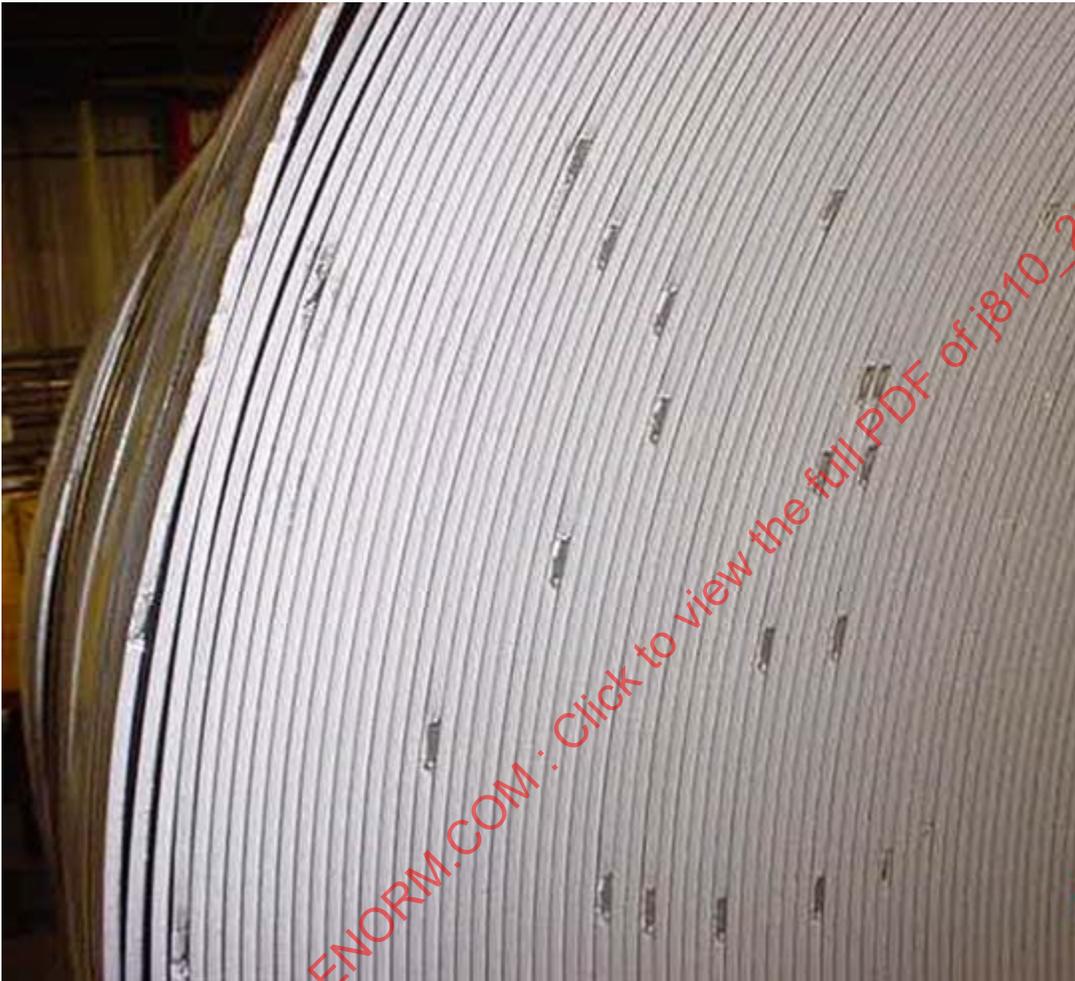
**Figure 43**

6.4 Chipped Slitter Knife

Description:	This condition will appear as a periodic variance in the slit edge. The distance of the variance will correlate to the distance between knife defects or, if only one knife, the circumference of the knife. Severity can range from a light blemish to a heavy burr.
Cause:	This condition is the result of a chipped slitter knife.
Product Affected:	Slit products.
Similar Imperfection:	Poor Slit; Knick; Burr Edge.

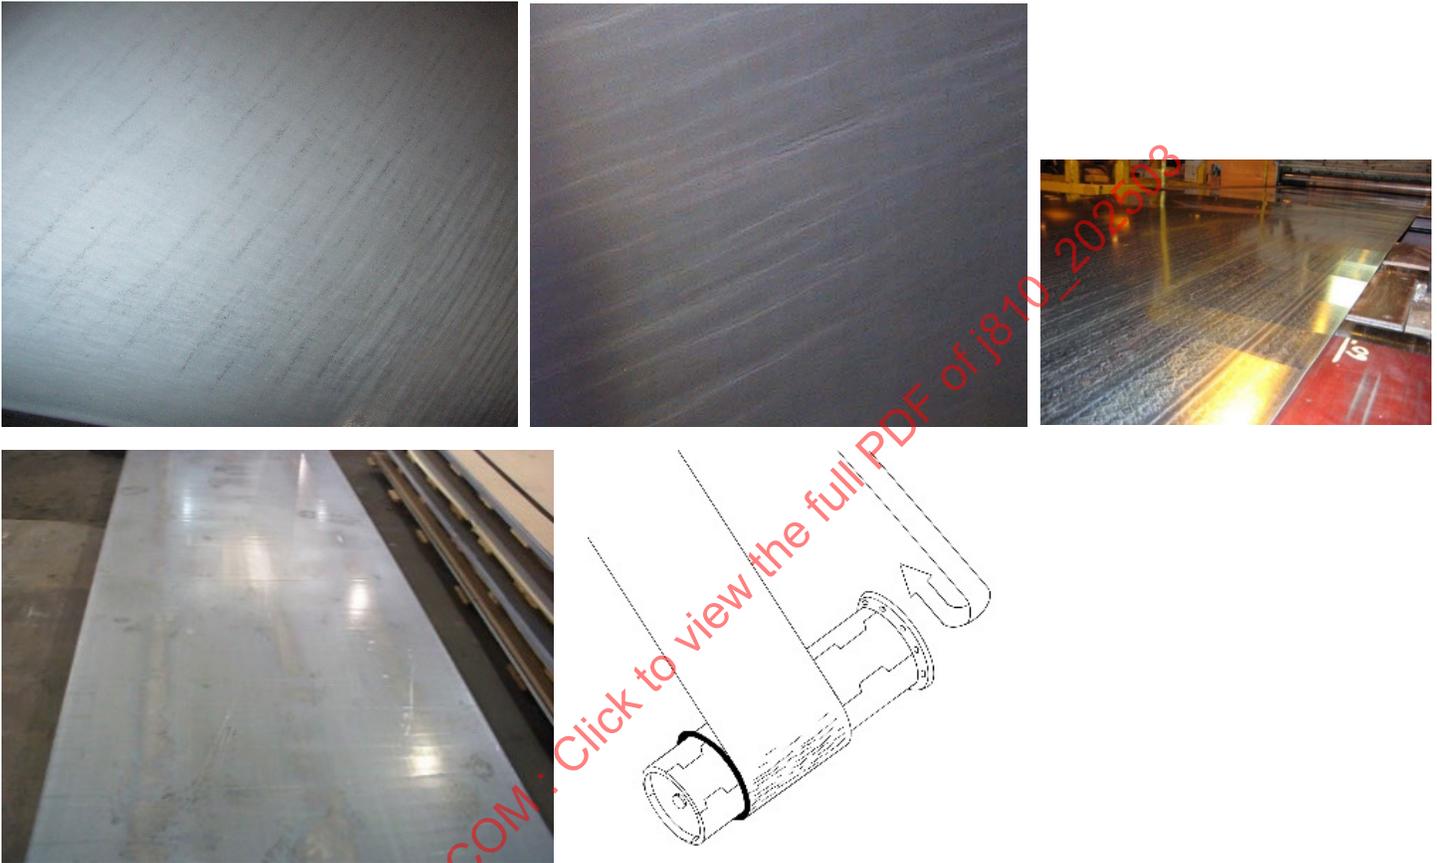
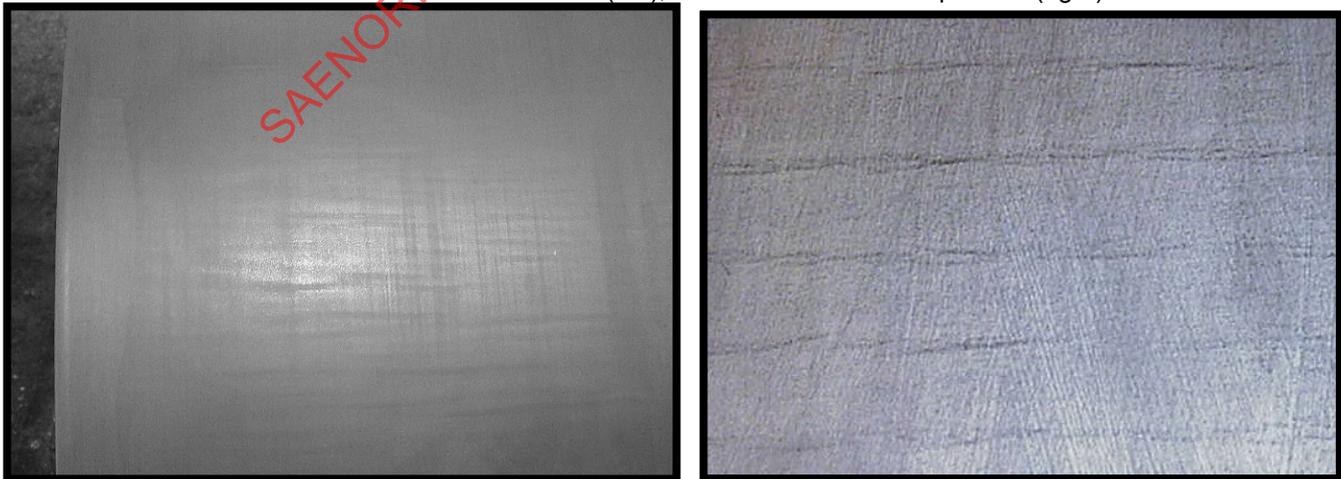
Figure 44

6.5 Coil Breaks

Description:	Coil breaks are creases or ridges which appear as parallel lines transverse to the rolling direction and may extend across the sheet width.
Cause:	Coil breaks are formed during coiling or uncoiling when the extension exceeds the elastic limit of the steel and yield point elongation is present.
Product Affected:	All products.
Similar Imperfection:	Sticker Breaks; Fluting; Break Marks: Lüders Lines.

Coil Break on Hot Band (left); Coil Break on finished product (right)

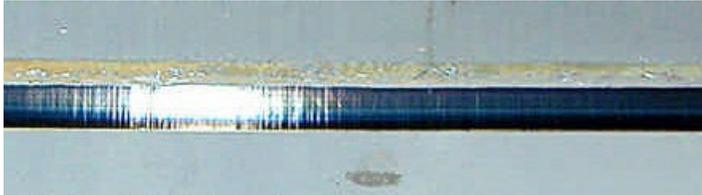
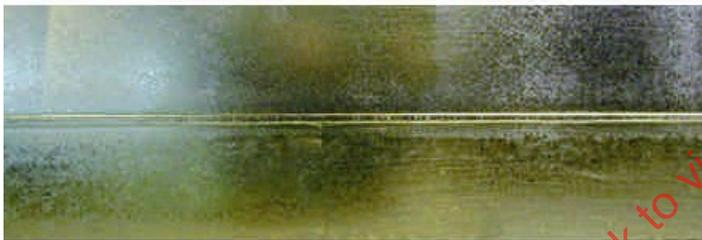
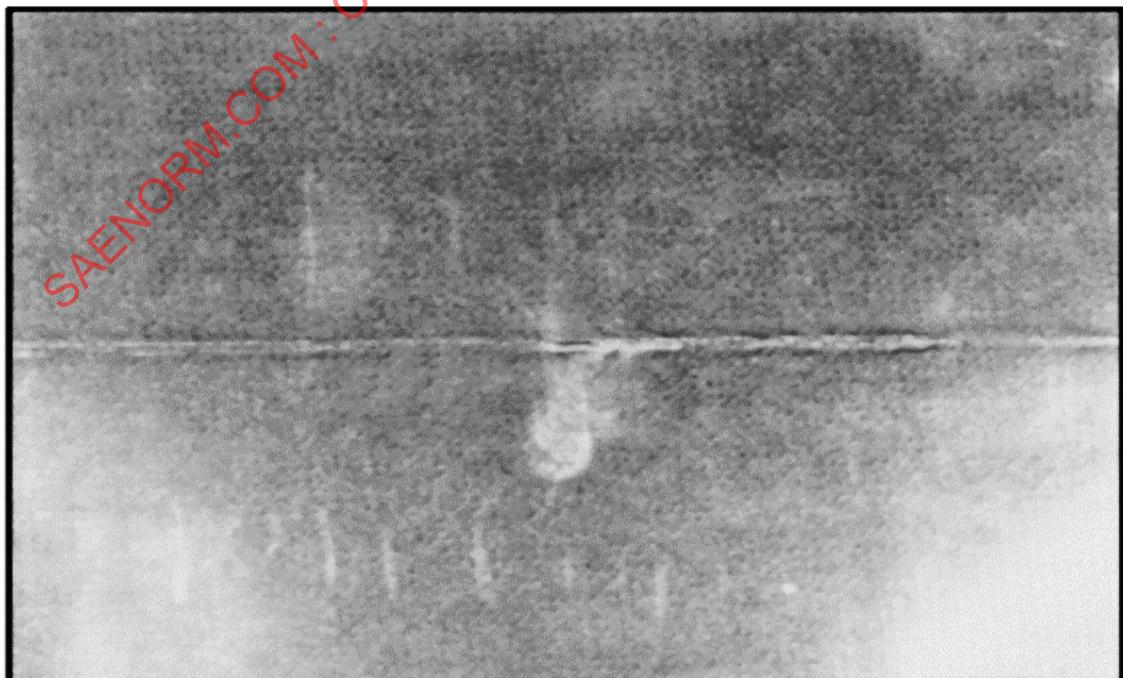
Figure 45

6.6 Coil Welds

Description:	A coil weld is the area where two coils have been joined together to go through pickling, rolling, or coating lines for continuous processing.
Cause:	Two coils are joined or fused together by heat. Cold reduced butt weld or lap welds should be undetectable in the cold rolled or coated stage.
Product Affected:	All products.
Similar Imperfection:	Weld Fusion Marks; Seam; Creases.

Pickle Weld (Butt)

EGL Weld (Butt)

HDG Weld (Lap)

↑
↓
Rolling
Direction

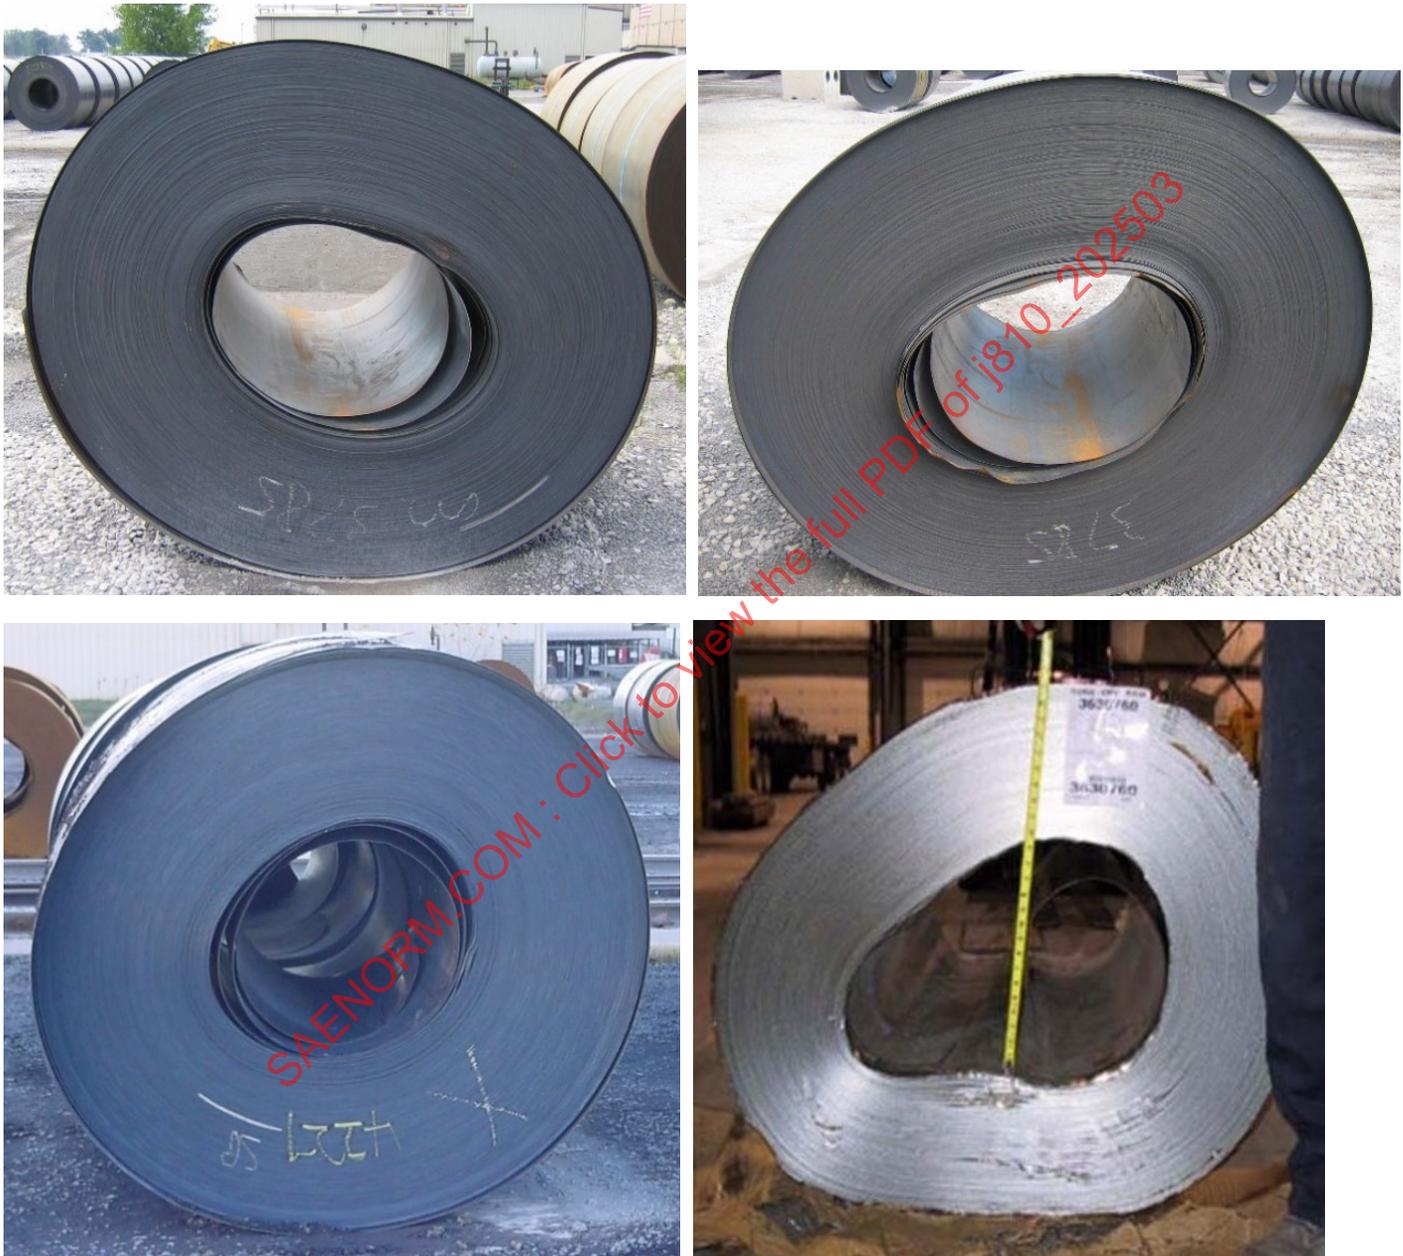
Figure 46

6.7 Collapsed ID (Inside Diameter)

Description:	A collapsed ID (inside diameter) is oblong instead of round. Severity can range from minor to almost flat.
Cause:	A collapsed ID can be caused by improper coiling or storage practices.
Product Affected:	All products.
Similar Imperfection:	Egg Shaped ID; Flat Coil; Collapsed Coil; Soft Coil; Loose Winding; Out-of-Round Eye.

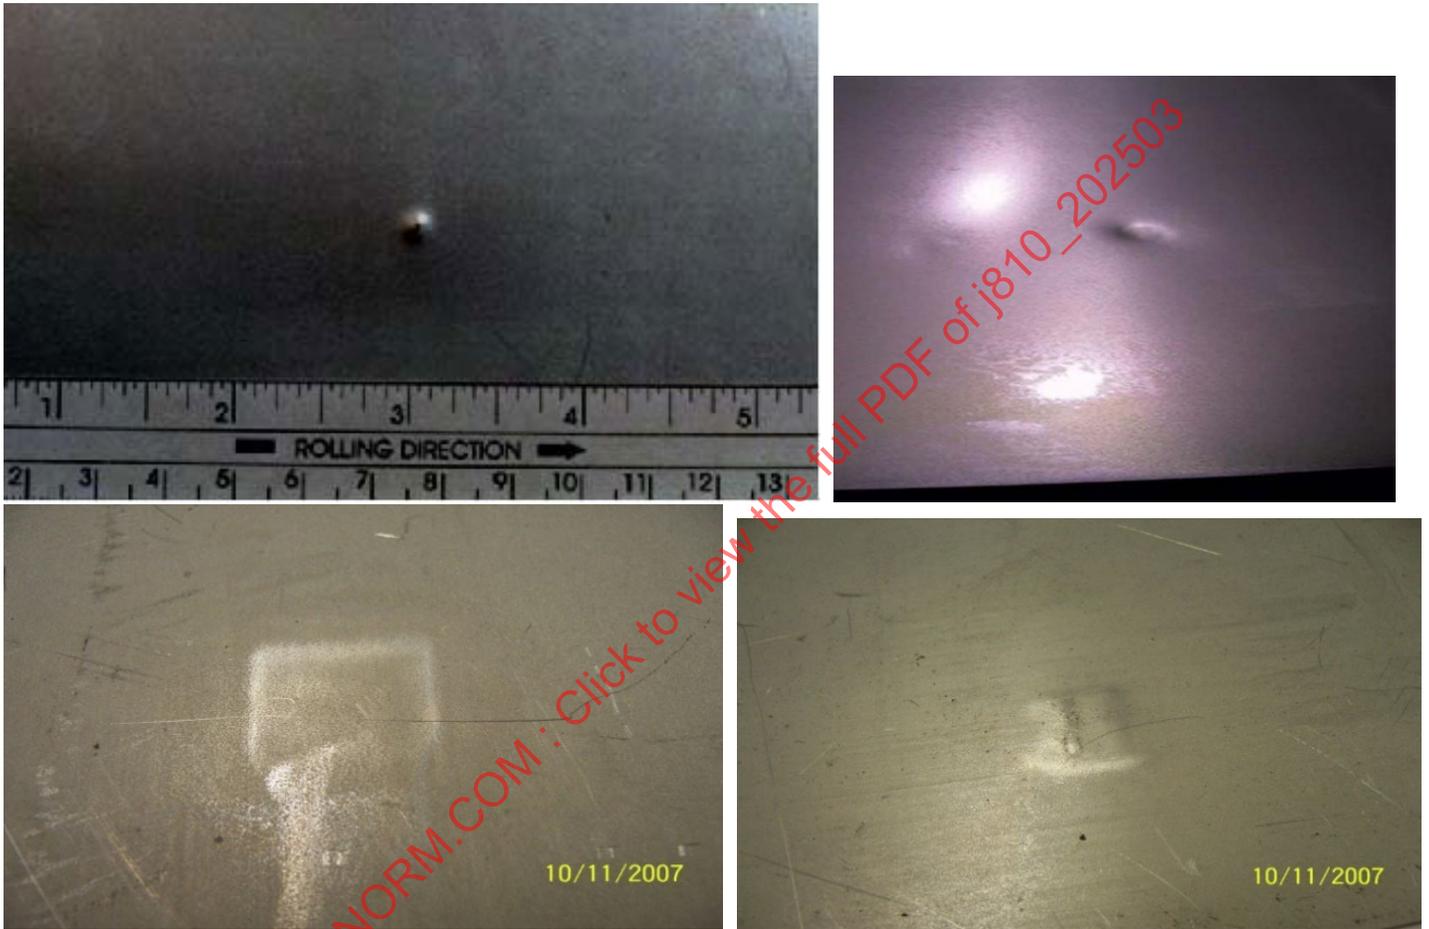
Figure 47

6.8 Dents

Description:	Dents are repetitive impressions in the sheet surface that will have an embossed area that usually is visible as an expression on the opposite side.
Cause:	Dents are caused when debris on a roll is mechanically pressed into the surface of the sheet. Common causes are foreign objects between the coil laps, coil sitting on strap clip, and ID (inside diameter) damage from a mandrel.
Product Affected:	All products.
Similar Imperfection:	Roll Marks; Impressions; Punch Marks; Indents.

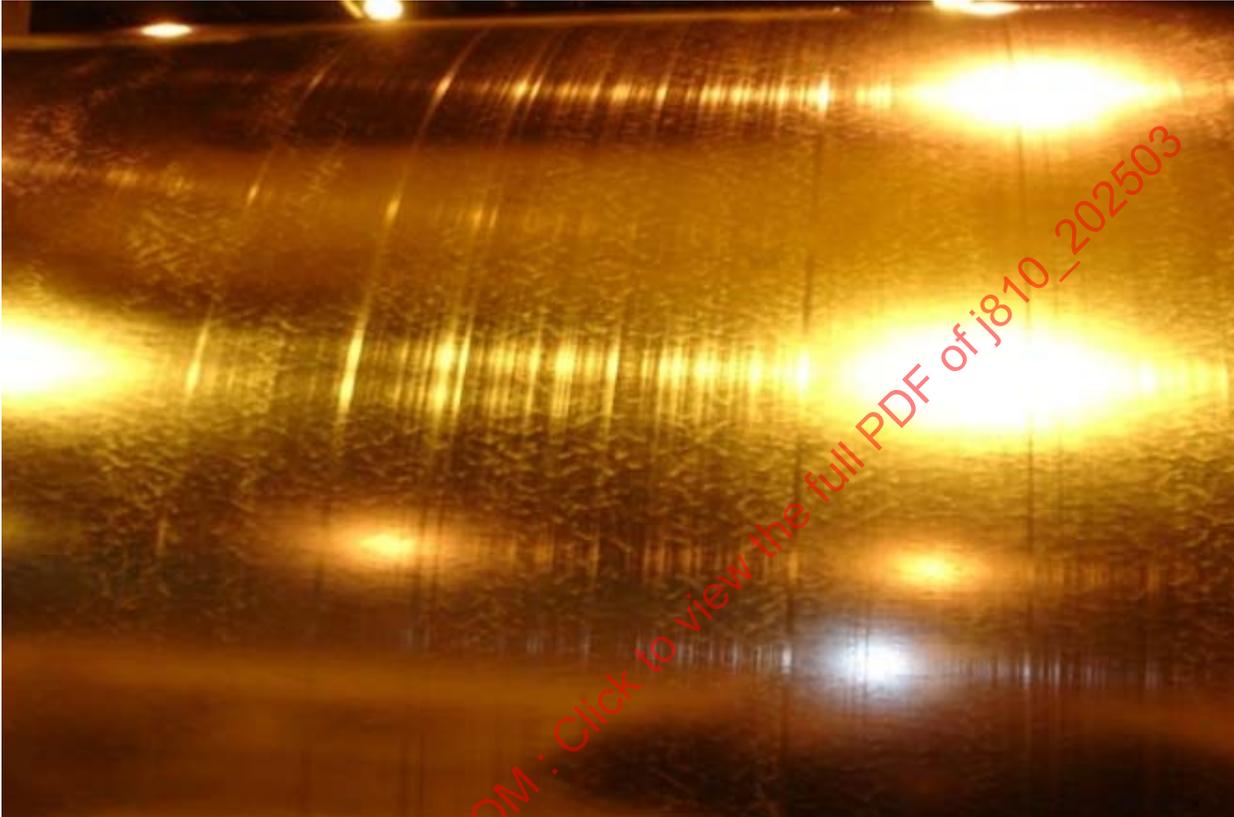
Figure 48

6.9 Drag Board Marks

Description:	Drag board marks appear as fine shiny longitudinal lines on the strip surface and may affect both top and bottom surfaces. Severity can range from a light shiny scuff mark to a distinct linear scratch that can be felt.
Cause:	Drag board marks are caused by either excess pressure or foreign material on the nip pad or other areas where a drag board may be applied. Drag board marks are a processing defect.
Product Affected:	All products.
Similar Imperfection:	Scratches; Drag Board Scuff.

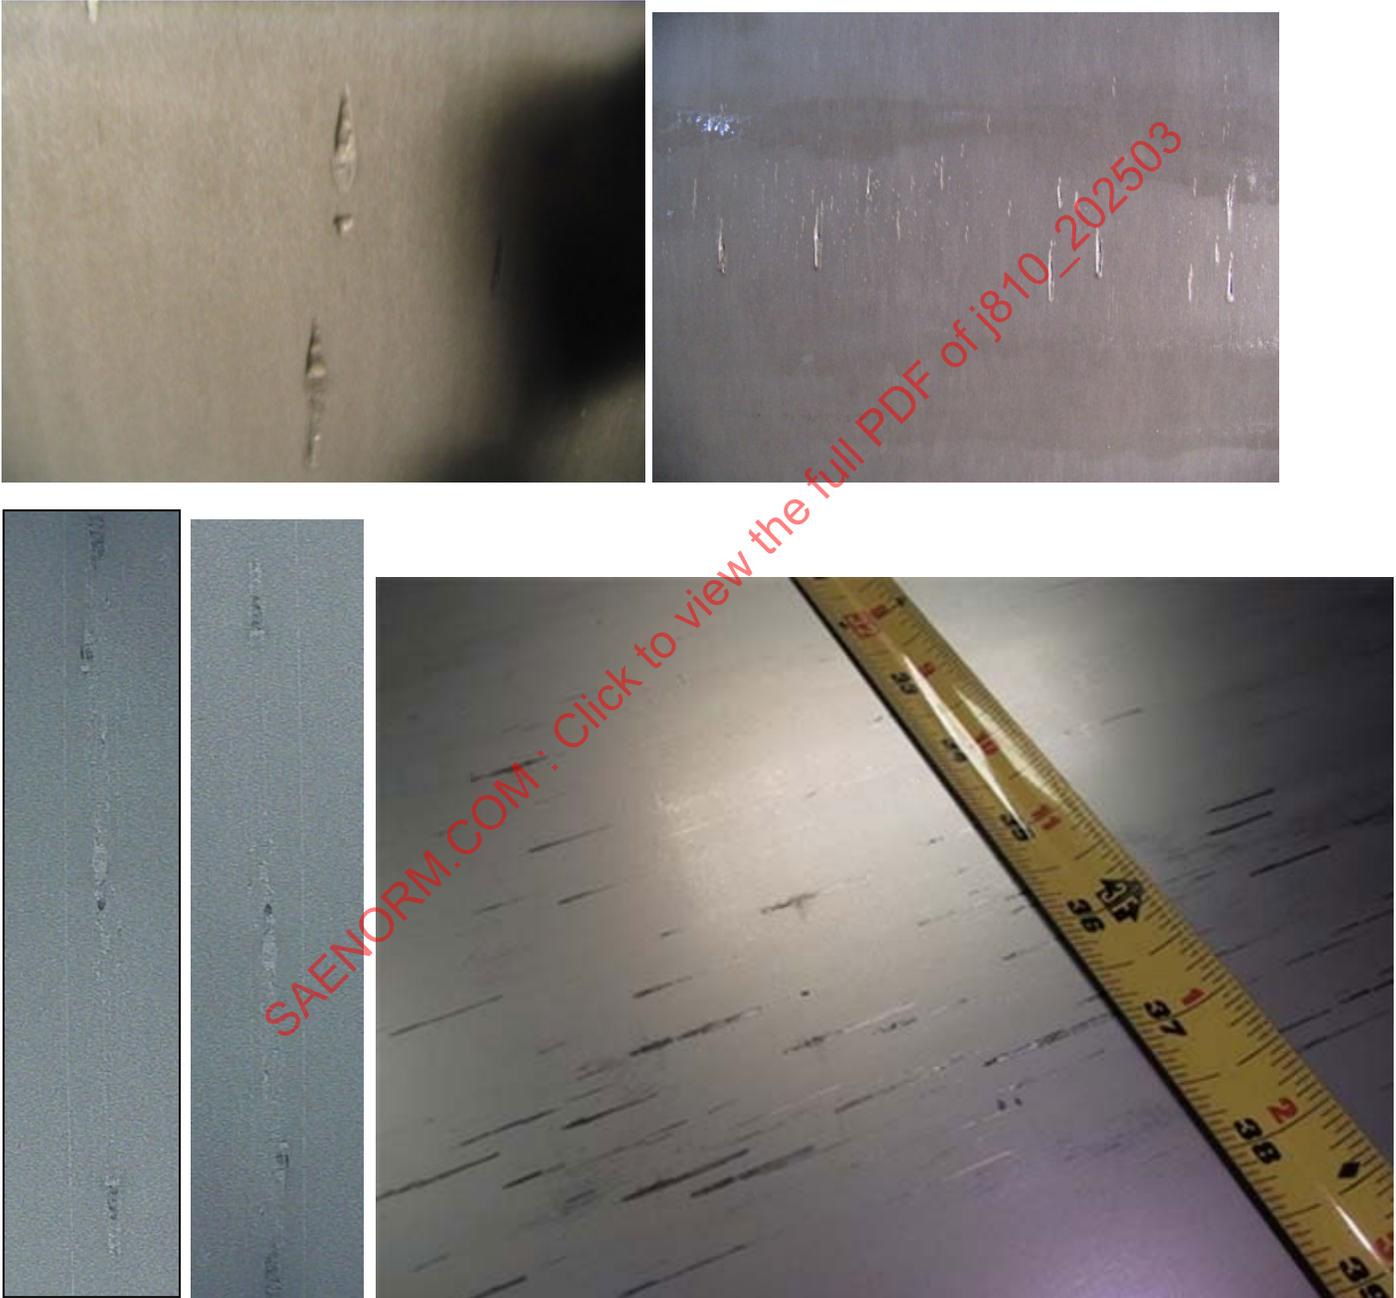
Figure 49

6.10 Friction Digs

Description:	Friction digs are short gouges running in the longitudinal, transverse, or slightly angled direction. Friction digs are usually found on mating surfaces with metal buildup at one end of the dig.
Cause:	Friction digs are caused by slippage of adjacent laps of a coil during uncoiling and coiling or in transit if a coil is inadequately wound.
Product Affected:	All products.
Similar Imperfection:	Galls; Gouges; Scratches.
