SURFACE VEHICLE INFORMATION REPORT	J810™	MAR2025
	Issued 1956-04 Reaffirmed 1987-03 Revised 2025-03	
Superseding J810 MAR1996		
(R) Classification of Common Imperfections in Sheet Steel

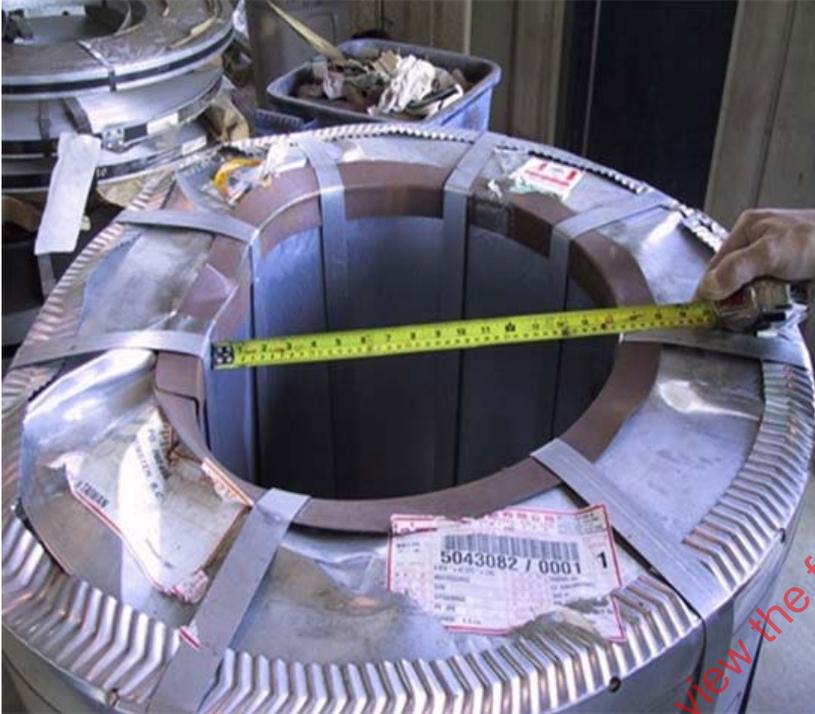
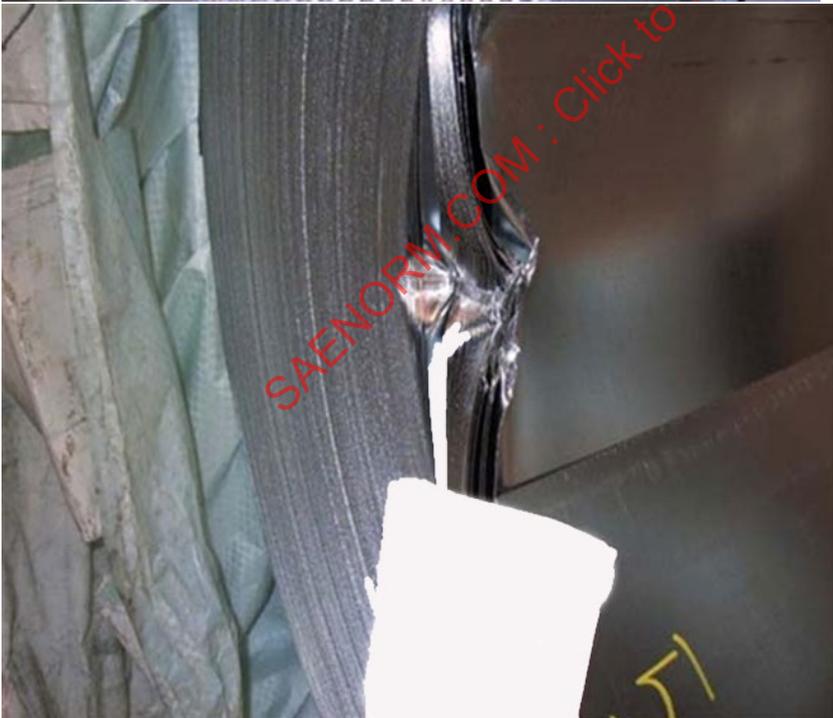
Figure 50

6.11 Handling Damage

Description:	Localized mechanically induced tear, dent, scrape, or gouge.
Cause:	Storage and/or transportation practices.
Product Affected:	All products.
Similar Imperfection:	Chain Damage; Coil Damage; Crane Damage; Floor Damage; Dropped Coil.

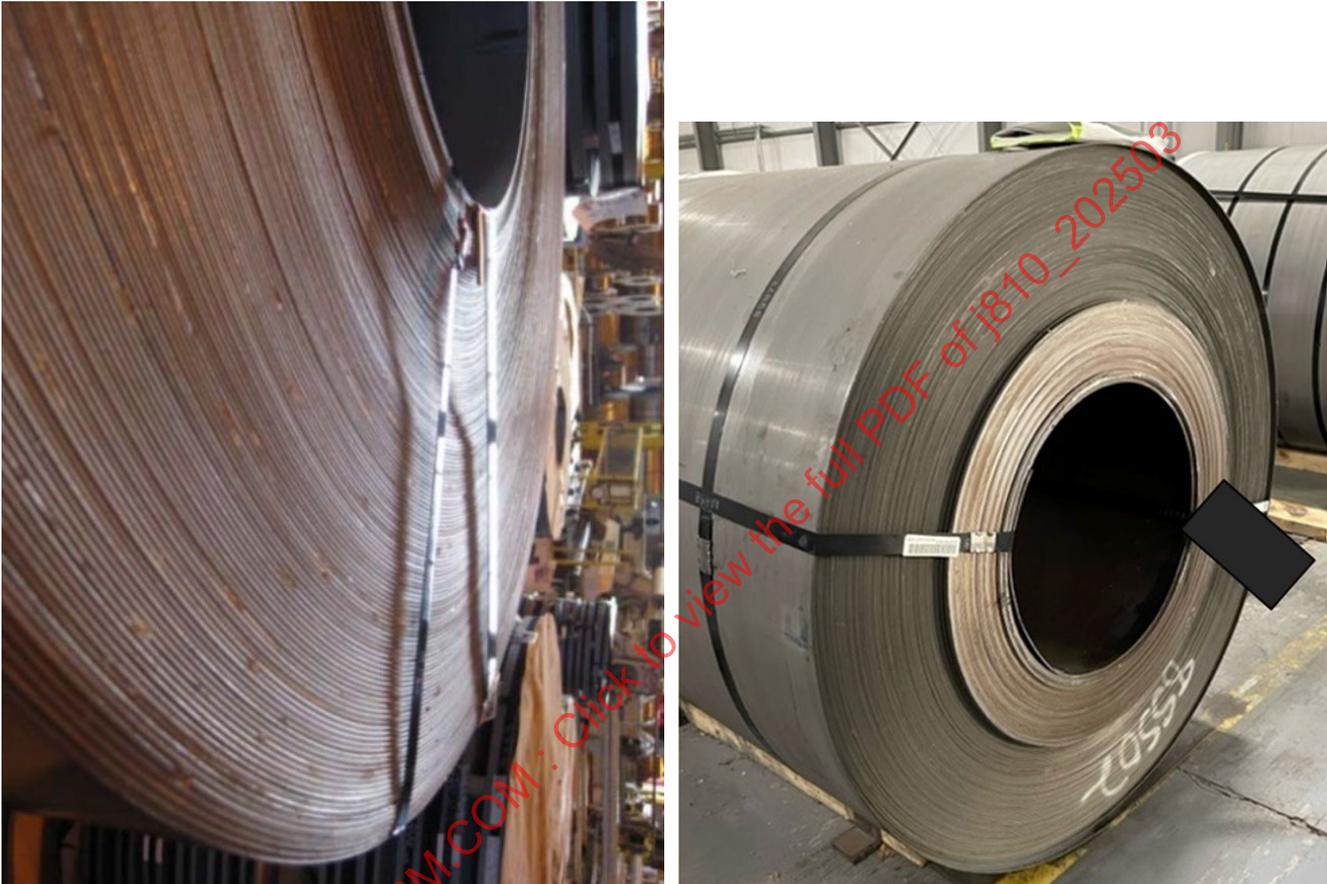
Figure 51

6.12 Lost Slit Edge

Description:	A lost slit edge appears as a duller rounded edge when compared to the brighter slit edge and can be of brief duration or for significant portions of the coil.
Cause:	The width of the master coil is insufficient to accommodate the width(s) of the slit coil(s) to be taken from it.
Product Affected:	Slit products.
Similar Imperfection:	Insufficient Trim of Mill Edge.

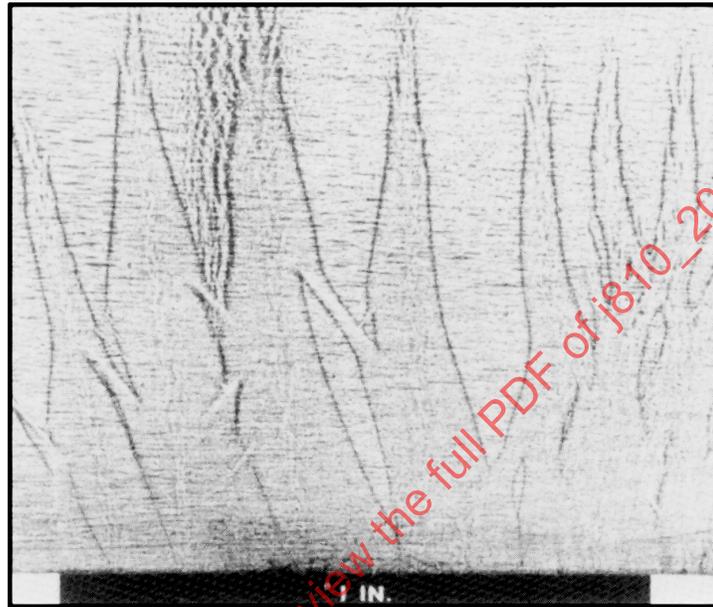
Figure 52

6.13 Lüders Lines

Description:	Lüders lines occur during forming and cause an uneven, undulating surface.
Cause:	Lüders lines are associated with yield point elongation. Just after the yield point is exceeded, nonuniform plastic deformation occurs. With increased stretching, these zones multiply and intersect each other until the entire surface is covered.
Product Affected:	All products.
Similar Imperfection:	Stretcher Strains; Lüders Strain; Yield Point Elongation.

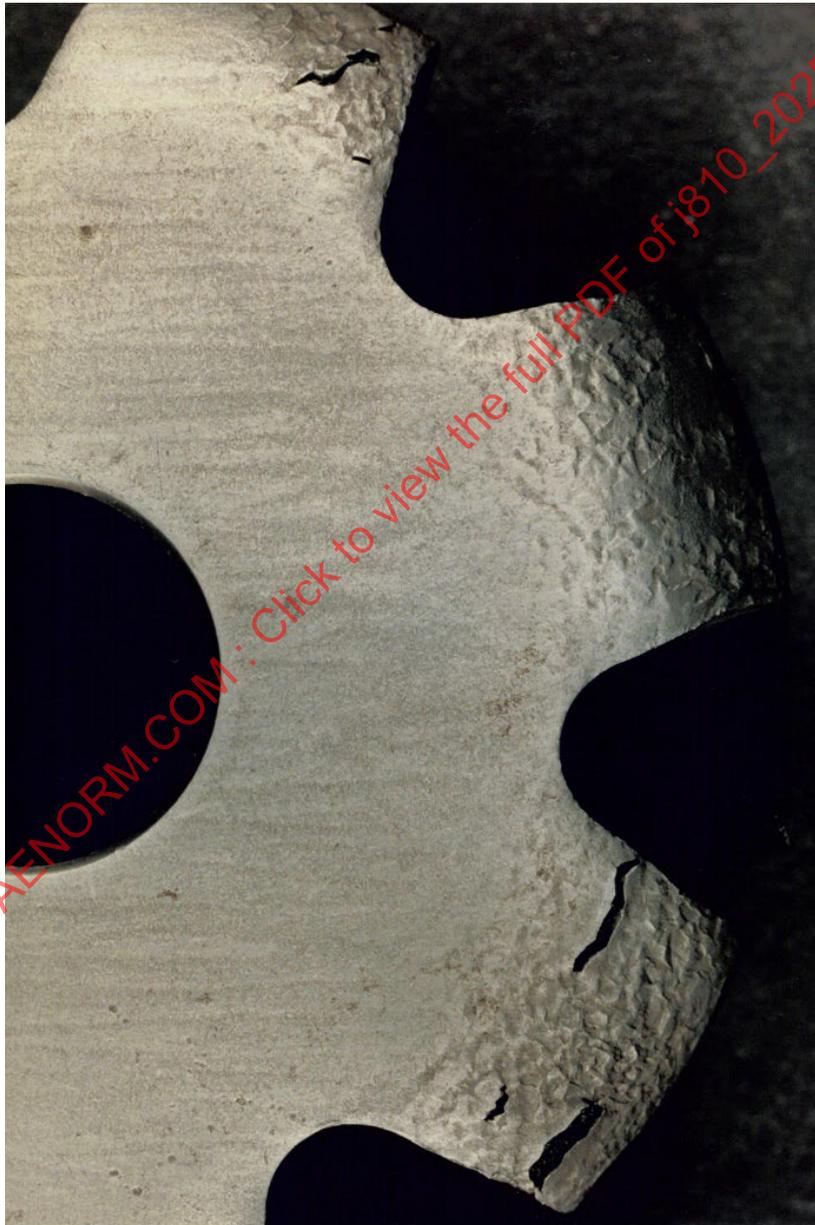
Figure 53

6.14 Onion Skin

Description:	Onion skin is a flaky layer of tightly adhering oxidized steel that can be produced with non-optimized run-out table cooling after hot rolling or during the annealing process of black (not pickled) coils. Formation during annealing is caused when the oxygen present in the furnace atmosphere combines with the carbon present in the steel while the coil is being heated. This condition only affects the surface of the steel but can sometimes be difficult to remove during pickling, even with rotating brushes. Onion skin is most common in alloy steels (e.g., SAE J404 Grade 4140 and SAE J404 Grade 6150).
Cause:	During annealing, onion skin results from the oxygen present in the furnace atmosphere combining with the carbon present in the steel while the coil is being heated. This condition only affects the surface of the steel but can sometimes be difficult to remove during pickling.
Product Affected:	Hot rolled.

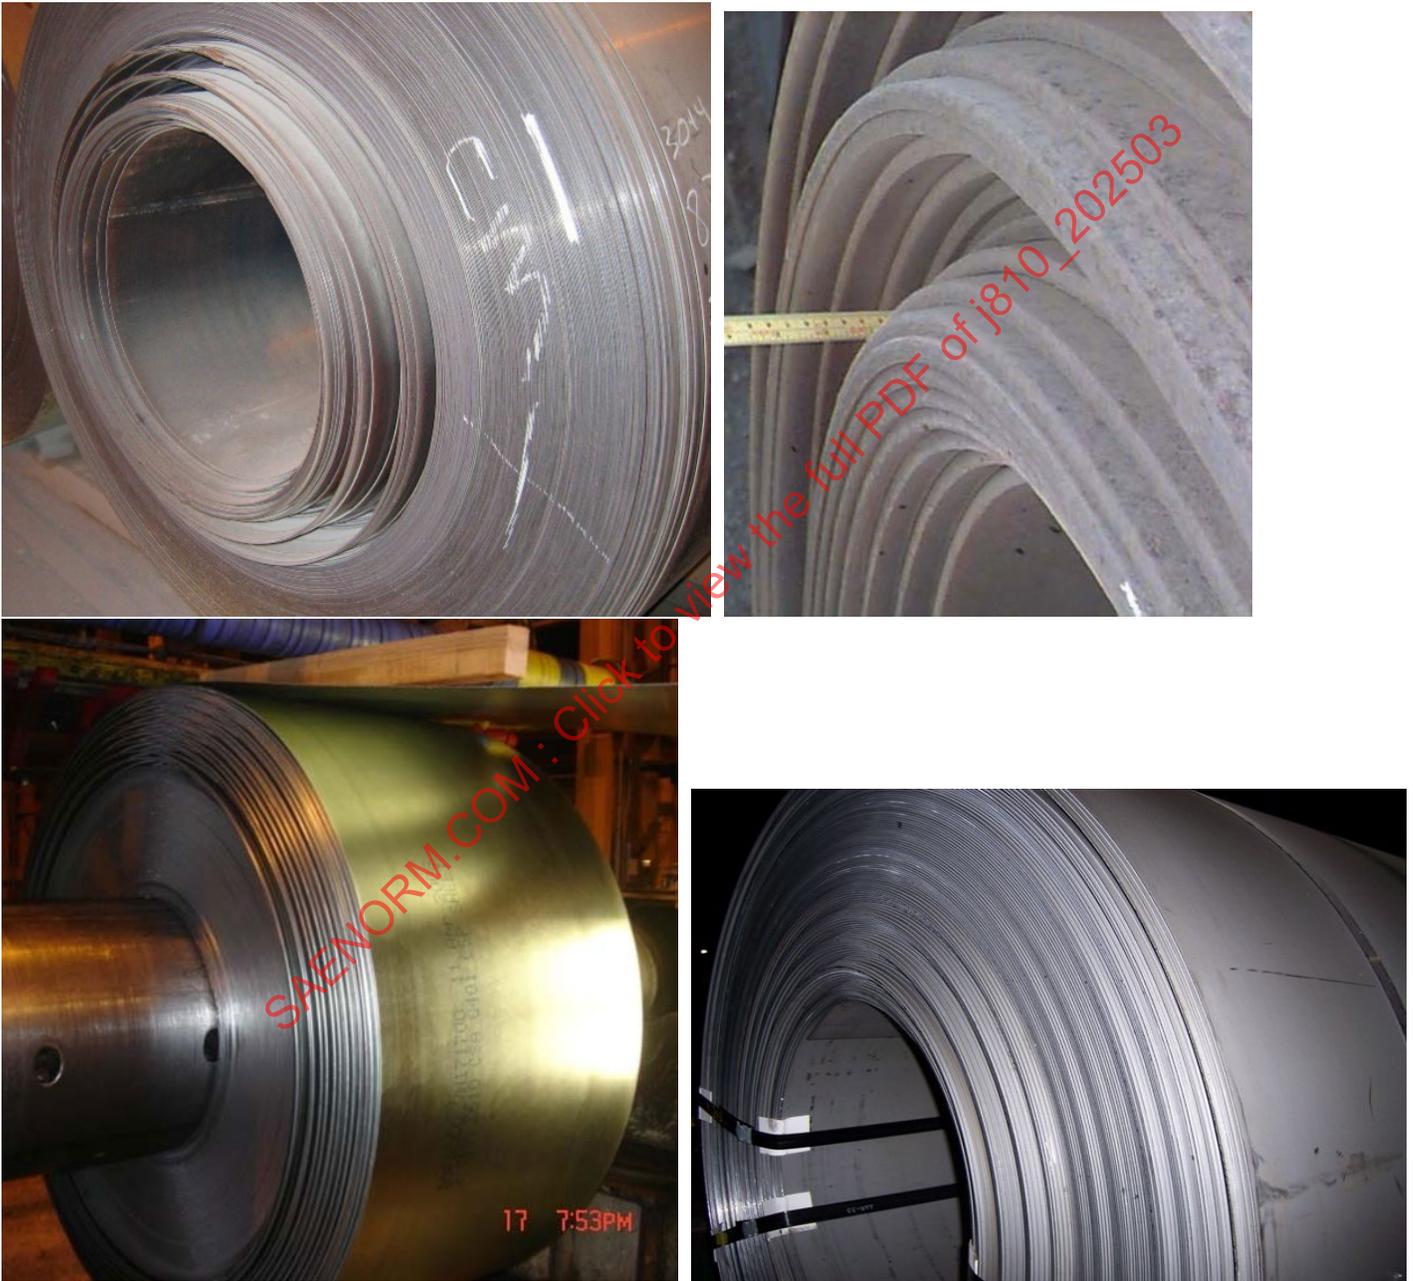
Figure 55

6.16 Oscillation

Description:	Oscillation is characterized by unevenly wound wraps resulting in an intermittent telescoping condition throughout the coil.
Cause:	Oscillation is caused by temporary loss of tension during coiling. A simple, repetitive oscillation pattern may be done intentionally by some operators. If intentional, it is referred to as staggered edges.
Product Affected:	All products.
Similar Imperfection:	Telescoping; Staggered Wind.

Oscillation	Telescoping; Staggered Wind	55
Passivation Stain	Chemical Treatment Stains; Chromate Stains	56
Pickle Stain	Rust; Water Stain; Rinse Stain; Pickle Rinse Stain	57
Rust	Speckled Rust; Water Stain; Red Rust	58
Separator Disk Damage	Knife Nicks; Edge Wave; Separator Damage	59
Slit Edge Beading	Poor Slit Edge; Sawtooth Edge; Uneven Slit Cut; Double-Break Condition	60
Solution Stain	Carry-Over; Cold Rolled Detergent Stain; Pickle Stain; Annealing Stain; Emulsion Stain	61
Solution Starve	Insufficient Oil; Work Roll Chrome Peel; Wet Temper Dry Streaks	62
Speckled Rust	Lineal Rust; Pinpoint Rust; Rust Patches; Salt and Pepper Rust	63
Stagger Sheet	Stagger-Stacked	64
Sticker Breaks	Coil Breaks; Edge Breaks; Stickers; Pinch Marks; Pick-Up	65
Strain	Lüders Lines; Stretcher Marks; Yield Point Elongation (YPE)	66
Telescoping	Oscillation; Stagger Wind; Hyphened Coil	67
Unpickled Edge	Underpickled; Black Edges	68

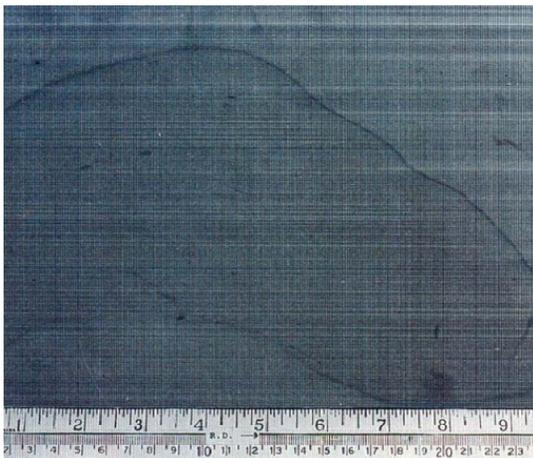
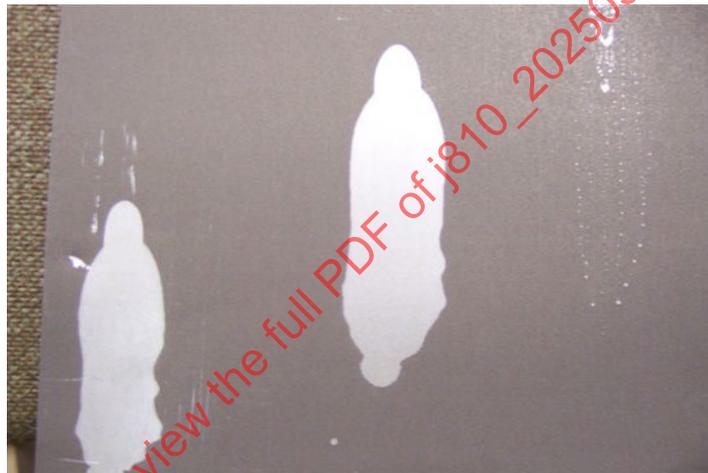
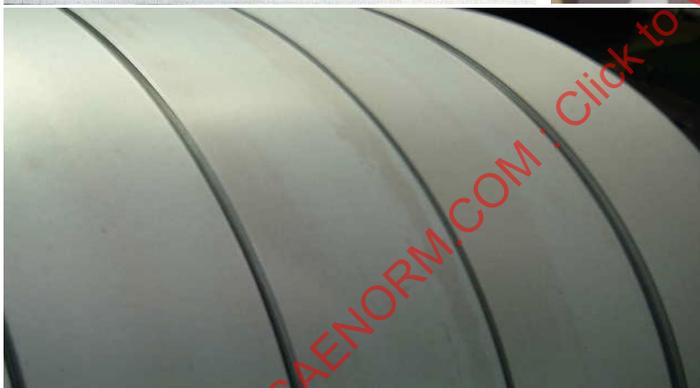
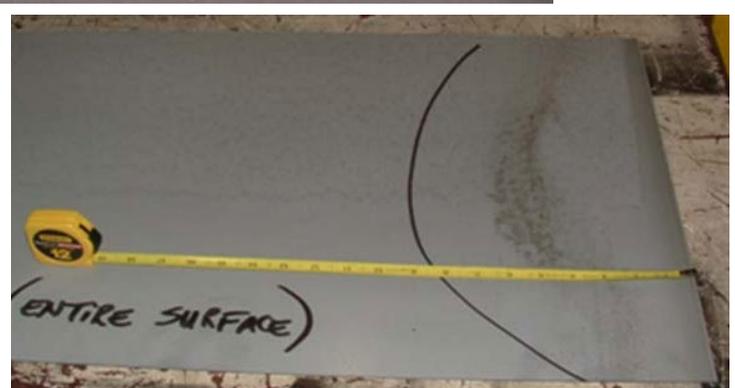
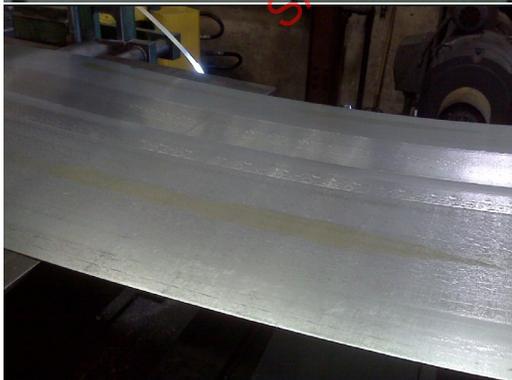
Figure 56

6.17 Passivation Stain

Description: A passivation stain appears as spots streaks or patches that are greenish or orange in color. The stains typically affect top and bottom surfaces and may affect the entire width or appear as streaks or drips anywhere along the strip in the rolling direction.

Chromate stain is a specific type of passivation stain involving a chromate conversion coating.

Cause: Passivation/chromate stain can be caused by:

- Insufficient wiping
- Worn squeegee rolls
- Inappropriate temperature
- Inappropriate concentration

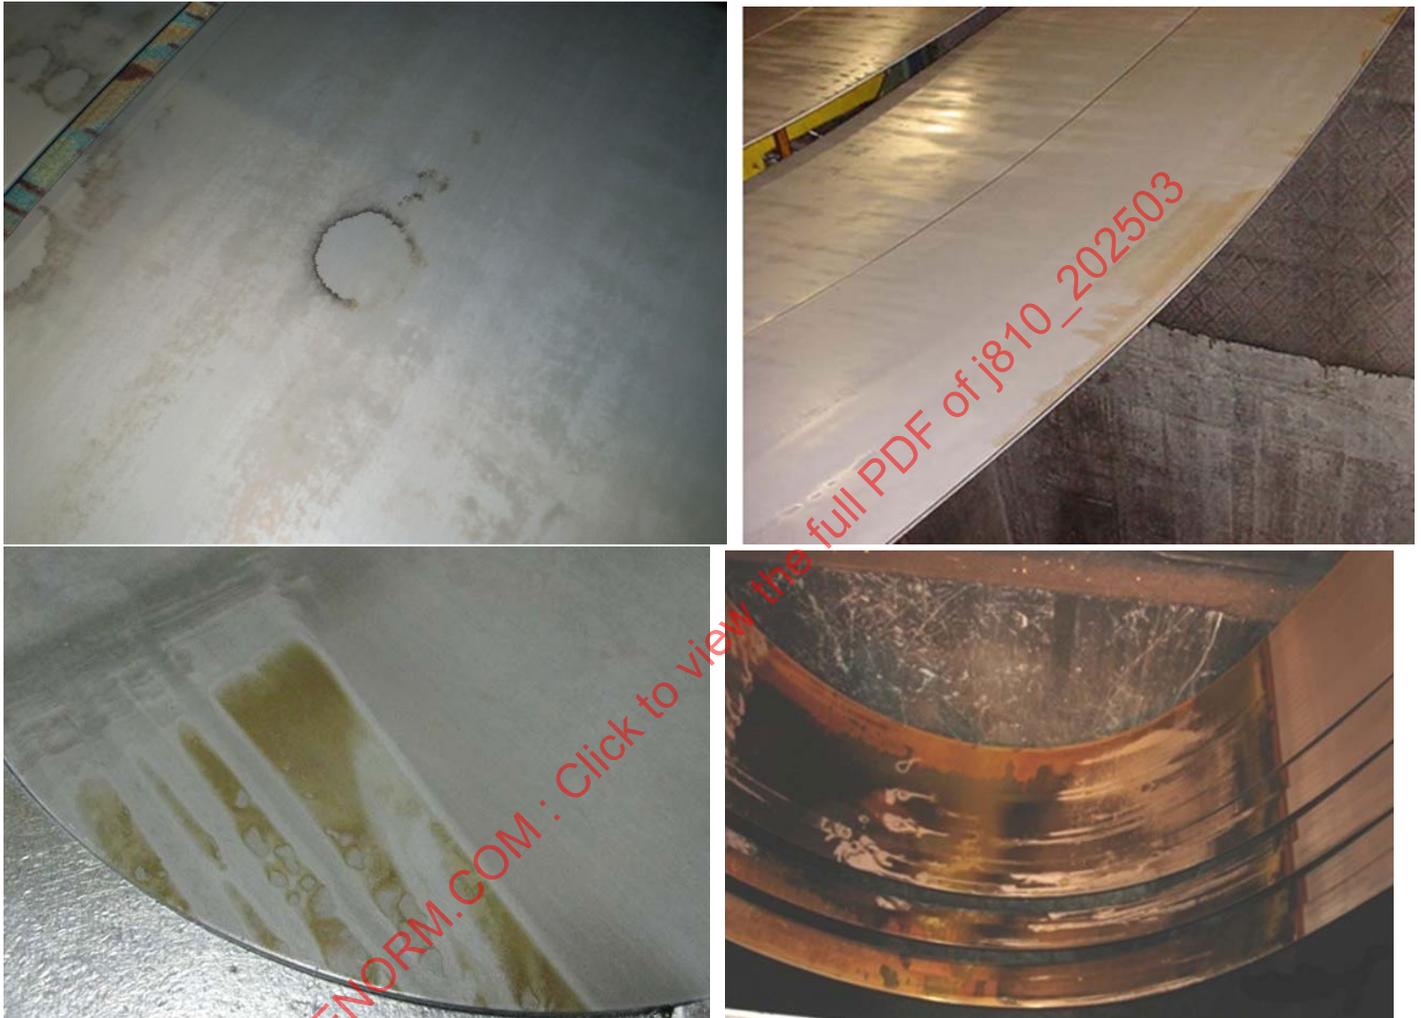
Figure 57

6.18 Pickle Stain

Description:	Pickle stain is light to dark orange and may be isolated to edges or go across the surface of the strip.
Cause:	Pickle stain can be caused by poor acid rinsing practices and line stops during the pickling process.
Product Affected:	Pickled hot roll.
Similar Imperfection:	Rust; Water Stain; Rinse Stain; Pickle Rinse Stain.

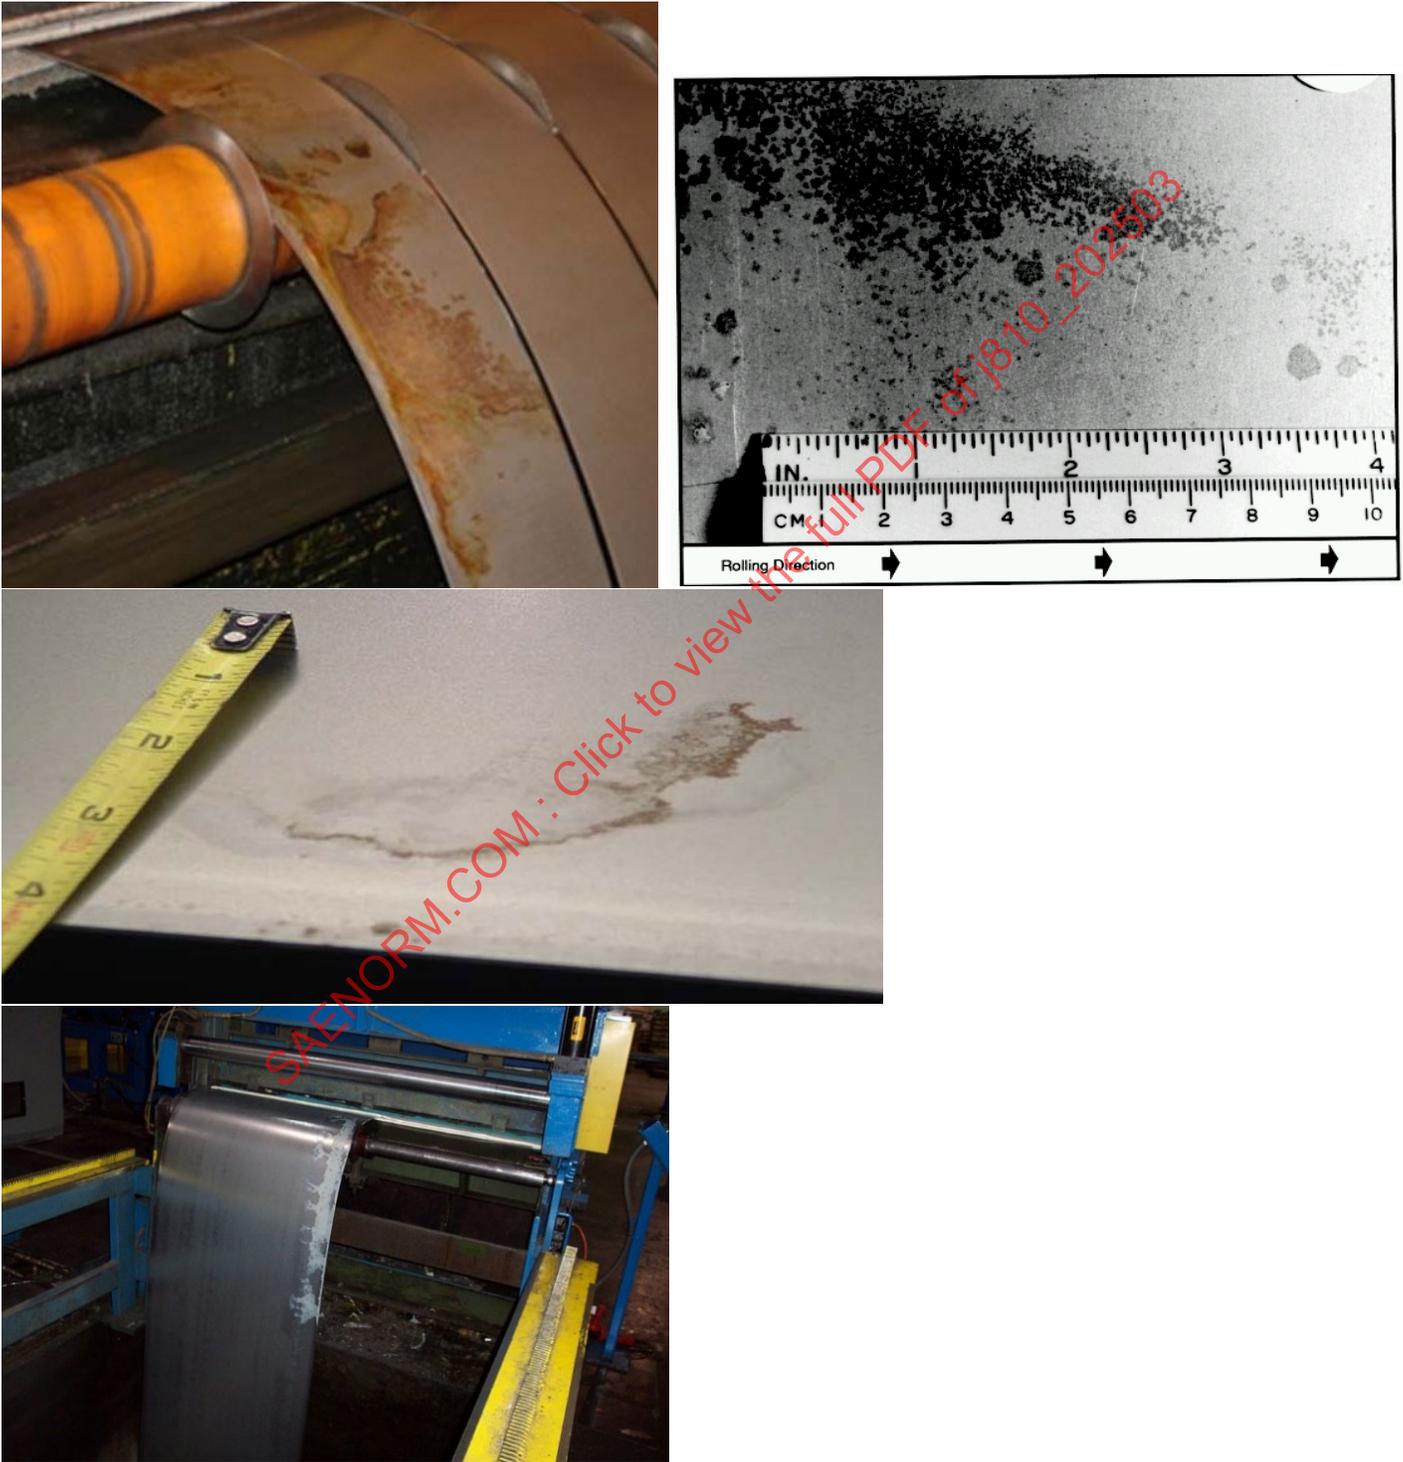
Figure 58

6.19 Rust

Description:	Rust is an oxide that forms on the surface of the sheet.
Cause:	Rust is caused when steel comes in contact with moisture.
Product Affected:	Hot rolled and cold rolled uncoated products.
Similar Imperfection:	Speckled Rust; Water Stain; Red Rust.

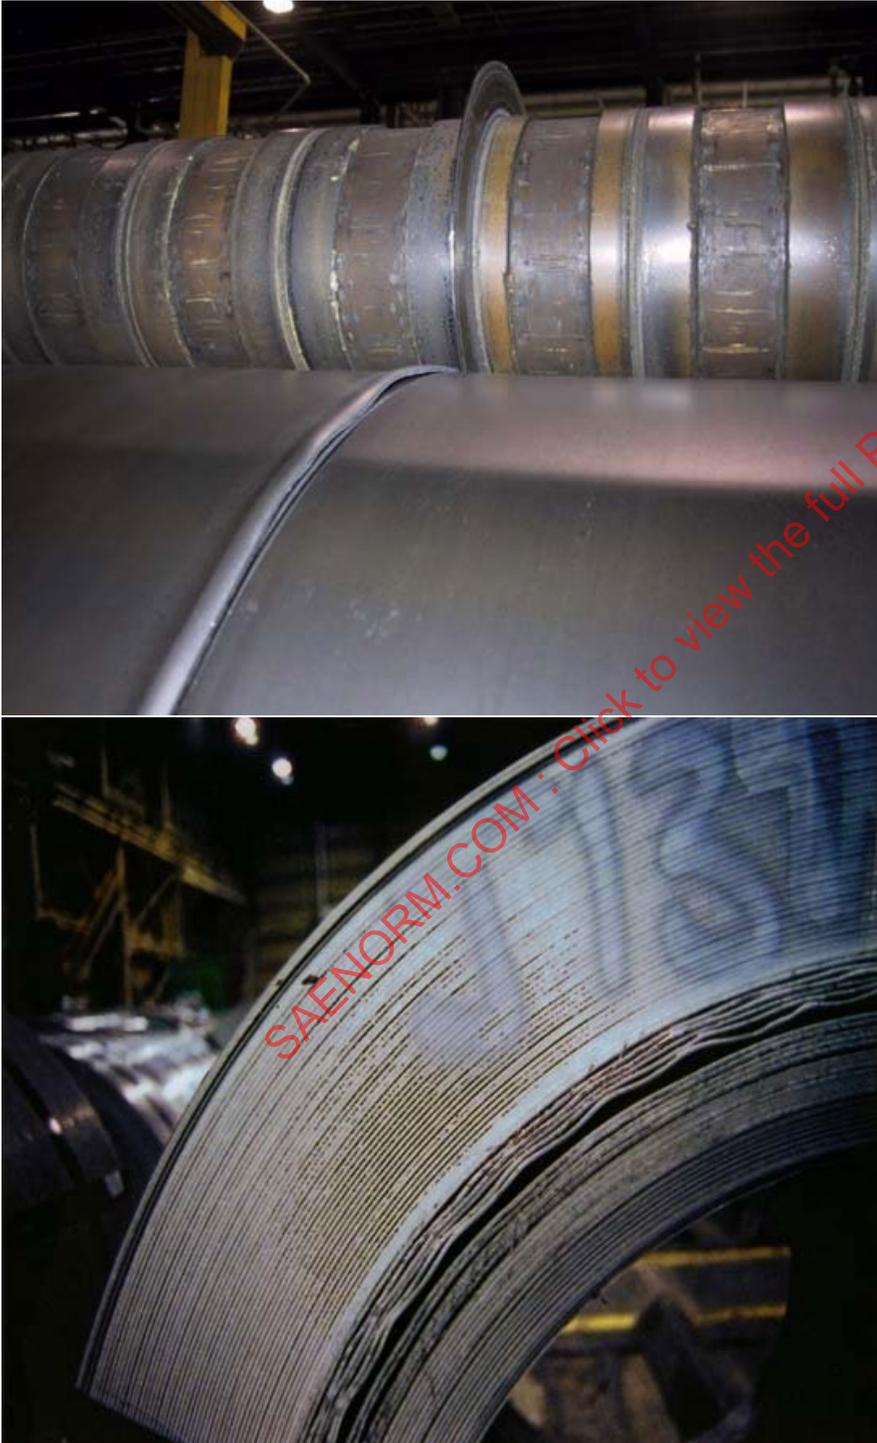
Figure 59

6.20 Separator Disk Damage

Description:	Separator disk damage typically appears as crescent shaped markings on the coil sidewall. In severe cases, it will appear as an abrasion with small filings on the sidewall.
Cause:	Separator disk damage is caused by a damaged separator disk in the trimming or slitting operation.
Product Affected:	Slit products.
Similar Imperfection:	Knife Nicks; Edge Wave; Separator Damage.

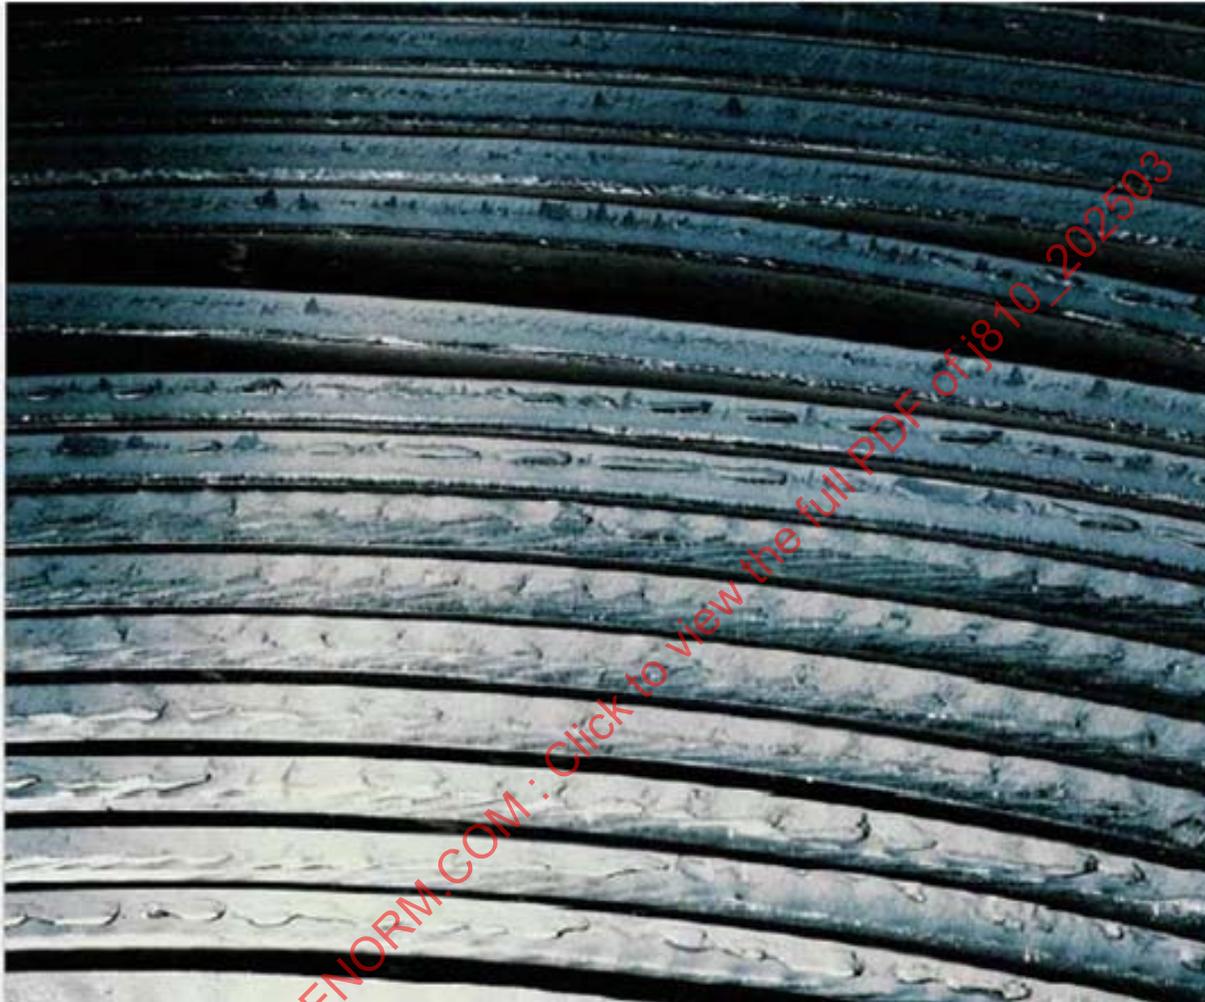
Figure 60

6.21 Slit Edge Beading

Description:	Slit edge beading appears as a rough slit edge where the material is not broken off evenly in the break portion of the cut.
Cause:	Poor slitter knife clearance.
Product Affected:	Slit products.
Similar Imperfection:	Poor Slit Edge; Sawtooth Edge; Uneven Slit Cut; Double-Break Condition.

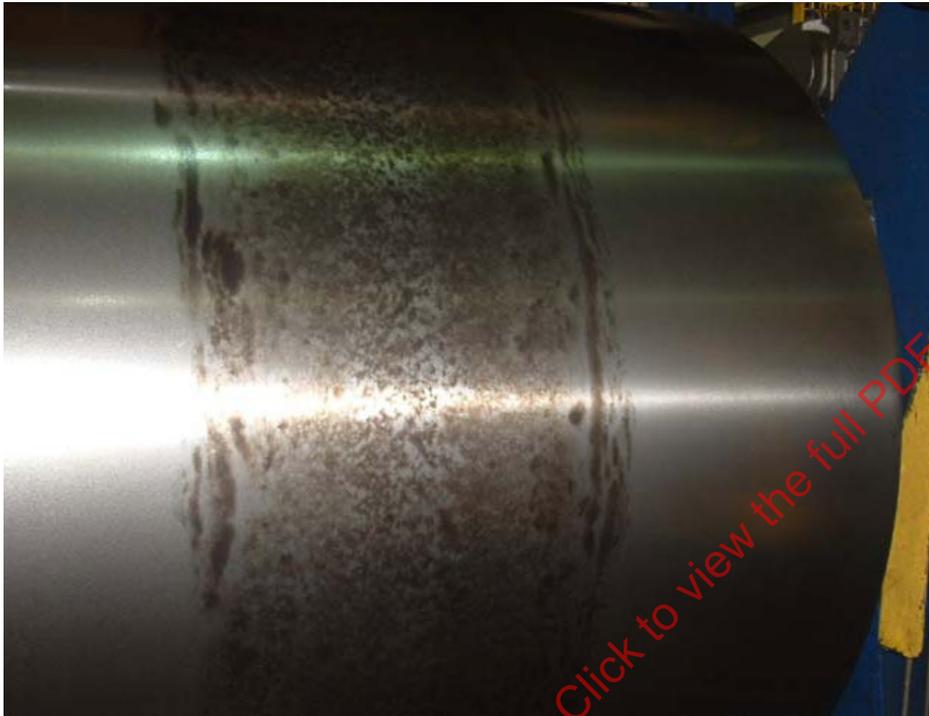
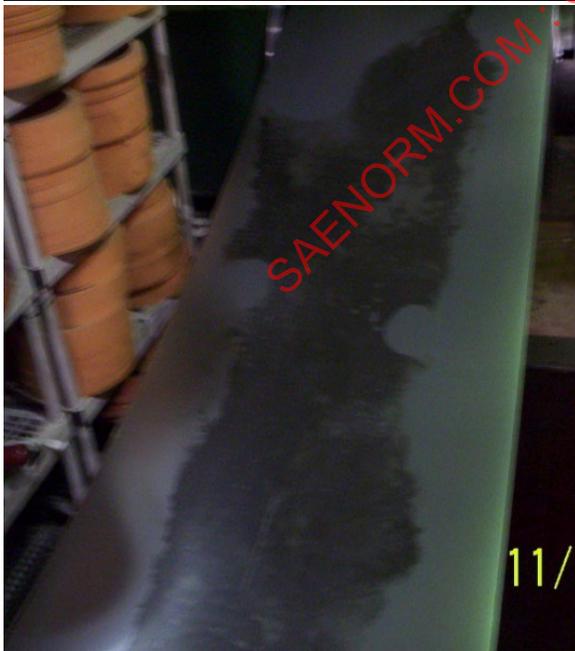
Figure 61

6.22 Solution Stain

Description:	Solution stain can vary in severity from light gray to brown or black discoloration of the steel surface and can result in poor paintability.
Cause:	Solution stain is caused by inadequate blow-off of the rolling solution used during tandem or temper mill rolling which results in a wet strip before oiling. The residue subsequently stains or etches the strip's surface.
Product Affected:	Cold rolled.
Similar Imperfection:	Carry-Over; Cold Rolled Detergent Stain; Pickle Stain; Annealing Stain; Emulsion Stain.

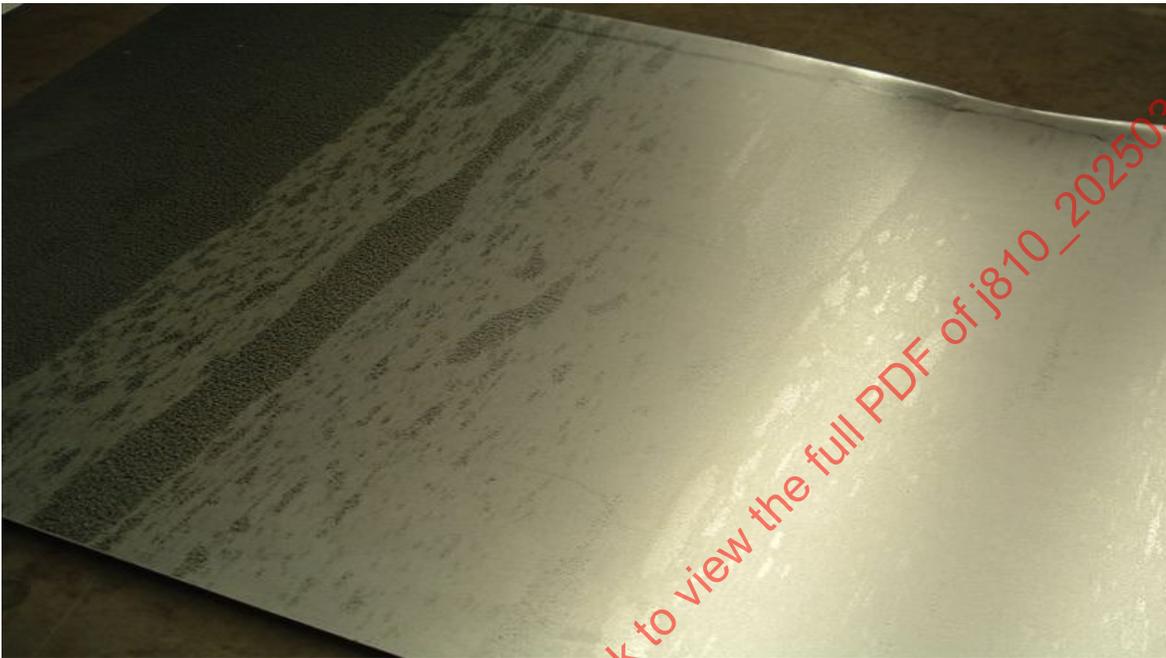
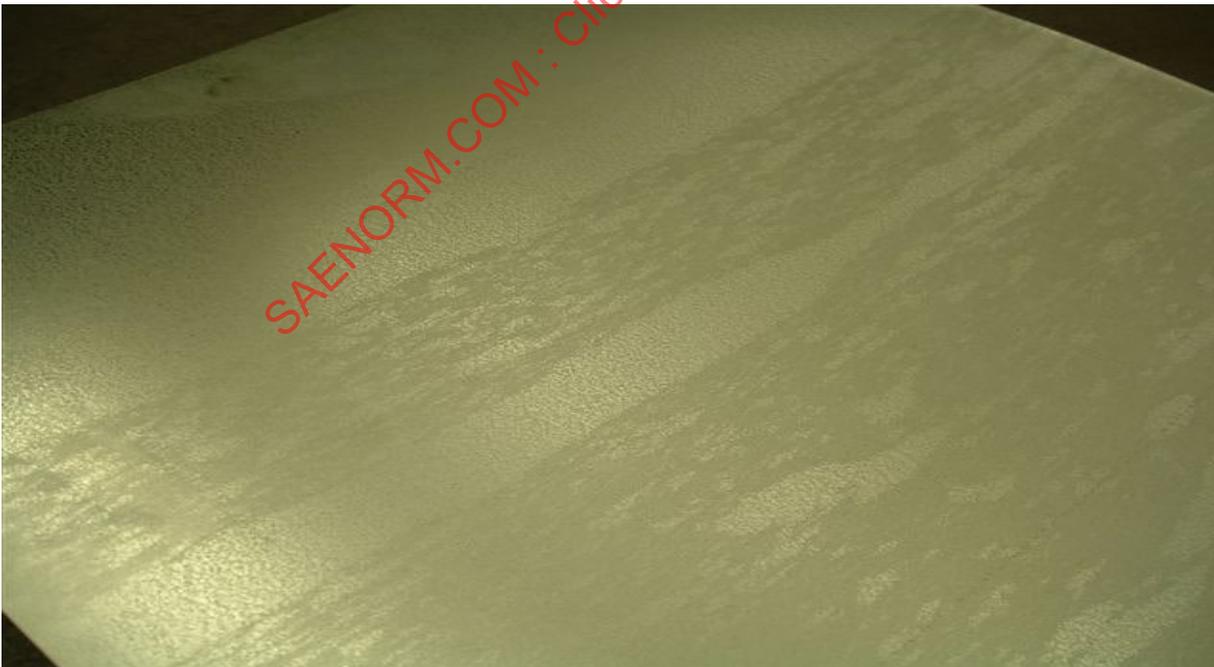
Figure 62

6.23 Solution Starve

Description:	Solution starve will appear as a difference in surface texture and may also cause poor shape in the area affected. Solution starve may be followed by pick-up or roll marks because of damage to the rolls involved.
Cause:	Solution starve is caused by insufficient flooding ahead of the roll bite in a reducing mill. Steel comes in direct contact with rolls, and the friction causes galling as the two surfaces stick, then friction weld together, and then tear apart.
Product Affected:	Cold rolled.
Similar Imperfection:	Insufficient Oil; Work Roll Chrome Peel; Wet Temper Dry Streaks.

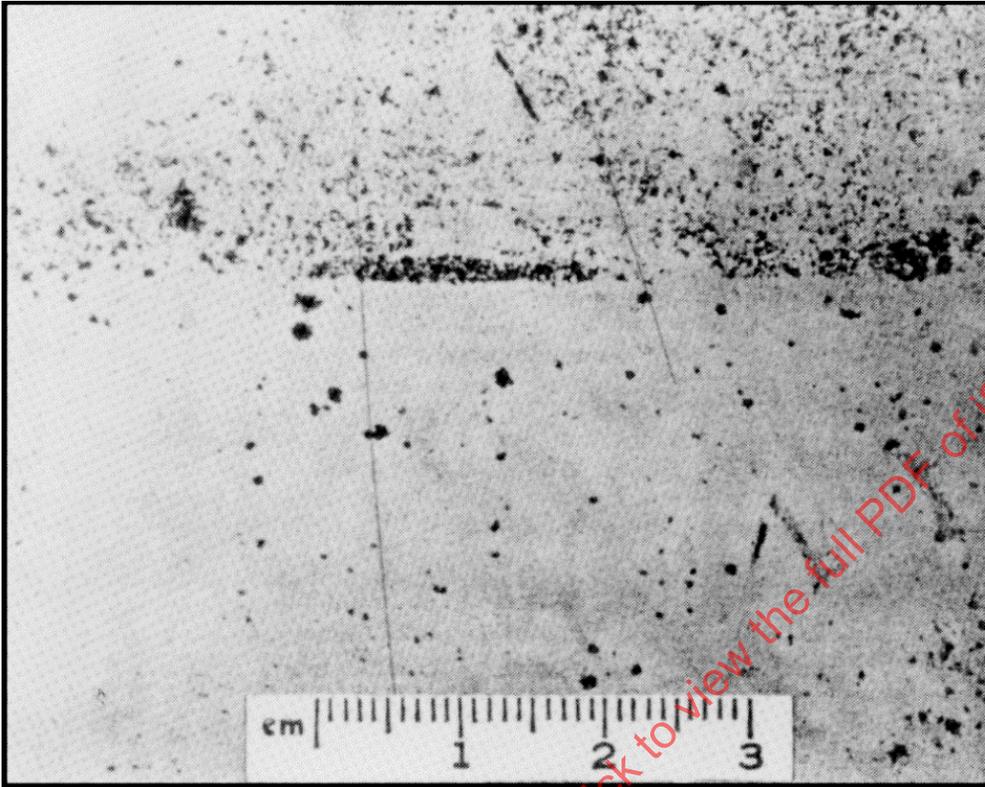
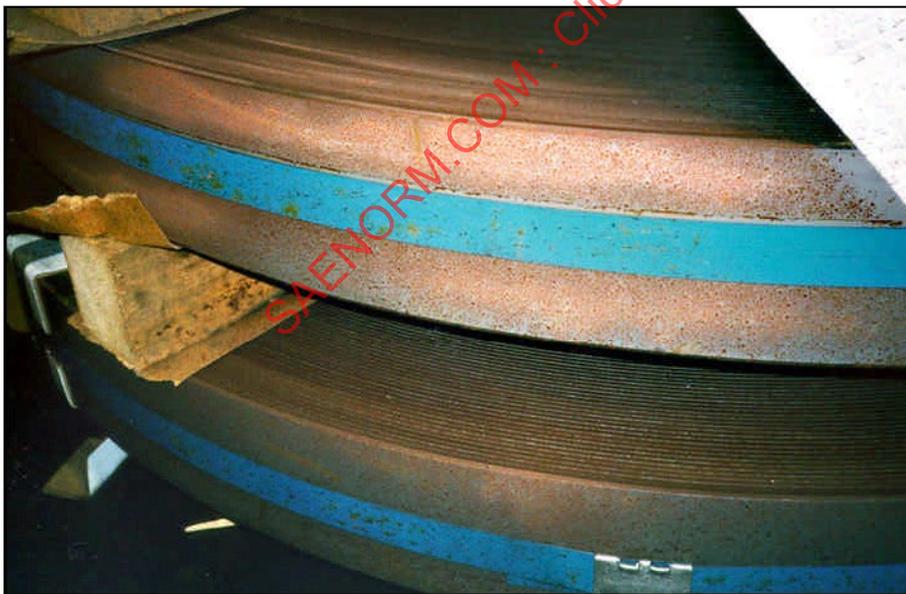
Figure 63

6.24 Speckled Rust

Description:	Speckled rust appears as round dark specks randomly distributed on the coil surface.
Cause:	Speckled rust is caused by high humidity or moisture spray.
Product Affected:	Hot rolled, cold rolled.
Similar Imperfection:	Lineal Rust; Pinpoint Rust; Rust Patches; Salt and Pepper Rust.

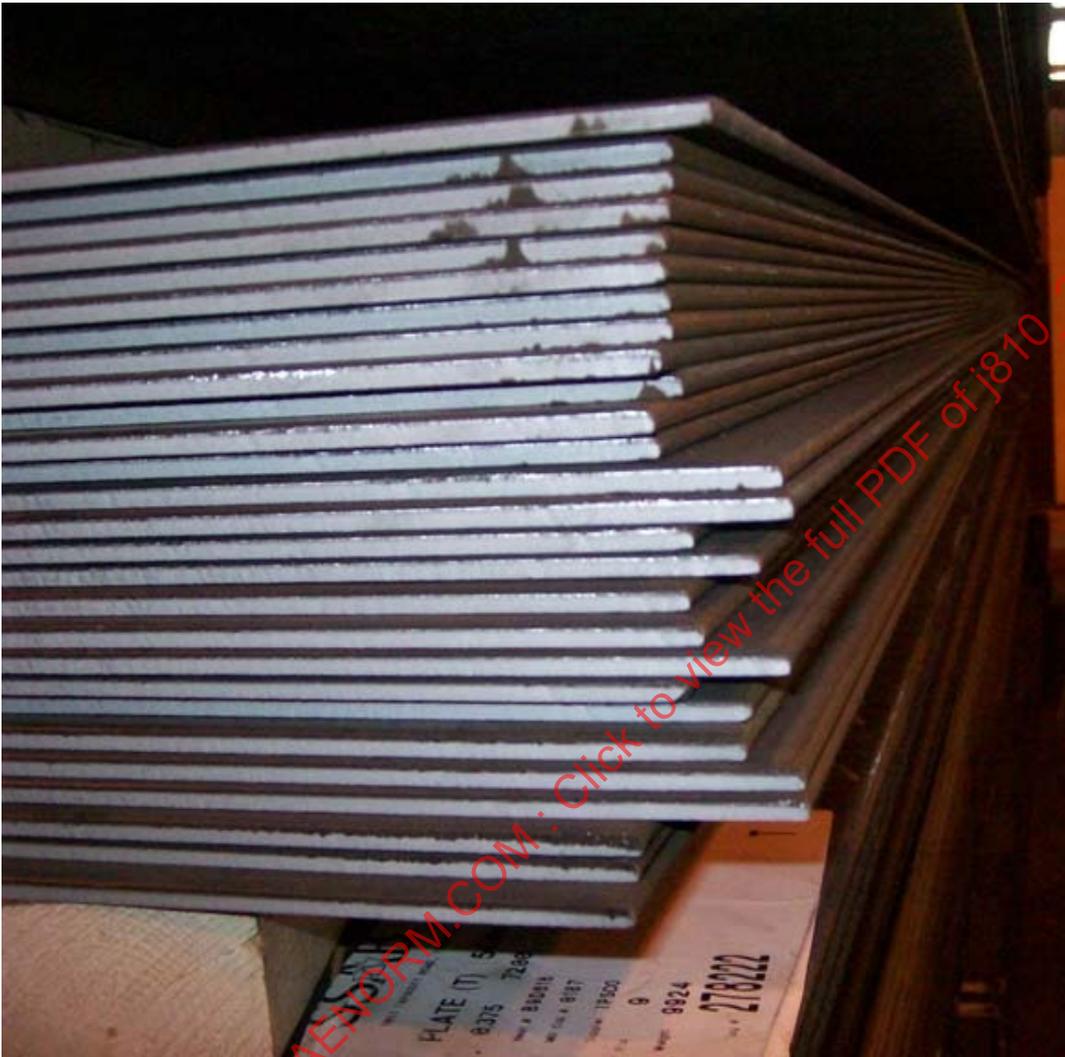
Figure 64

6.25 Stagger Sheet

Description:	Walls of the sheet or blank stacks are not straight.
Cause:	Poor placement of stacker skirts or end stops.
Product Affected:	All blanked or cut-to-length products.
Similar Imperfection:	Stagger-Stacked.

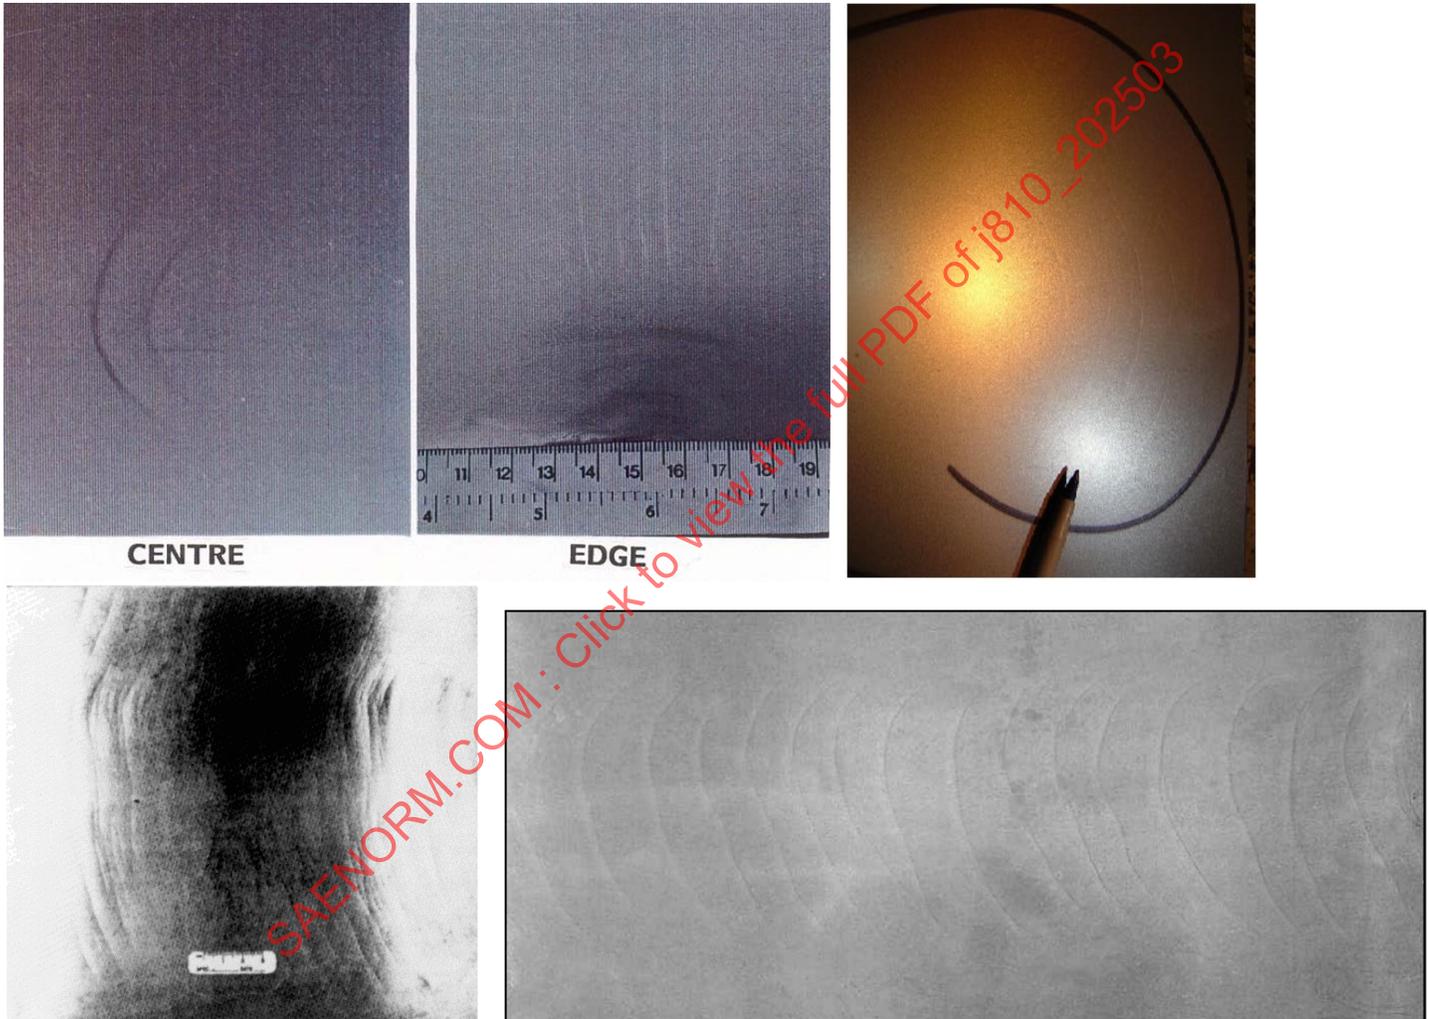
Figure 65

6.26 Sticker Breaks

Description:	Sticker breaks are creases or ridges which appear as crescent shaped lines running transverse to the rolling direction and usually near the middle of the sheet.
Cause:	Sticker breaks are formed as a result of coil laps sticking together during uncoiling which causes a raised area that is subsequently rolled during temper or skin passing because of: <ul style="list-style-type: none">- Coils being too tightly wound prior to annealing- Surface too smooth- Annealing temperature too high- Damaged coils (bumped) prior to annealing
Product Affected:	Cold rolled.
Similar Imperfection:	Coil Breaks; Edge Breaks; Stickers; Pinch Marks; Pick-Up.

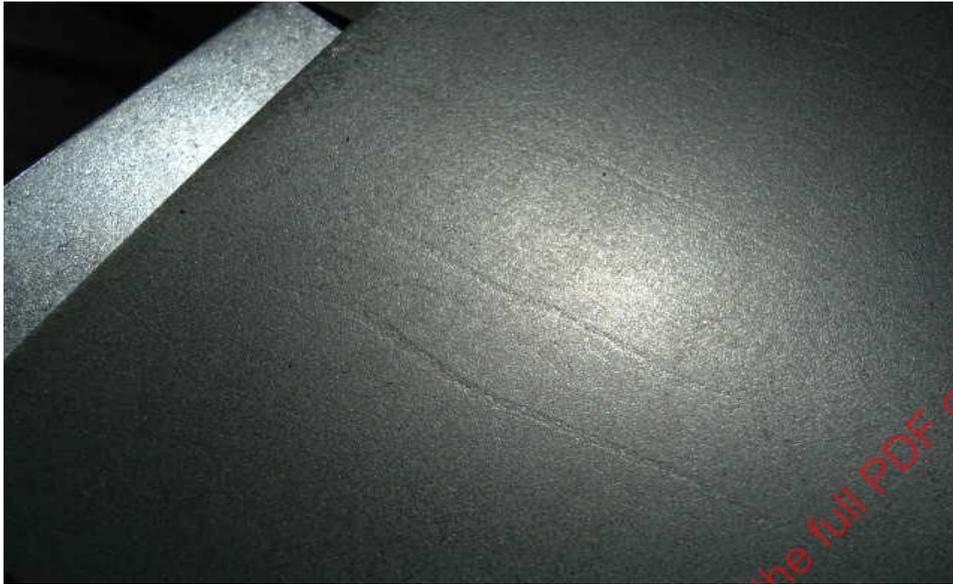
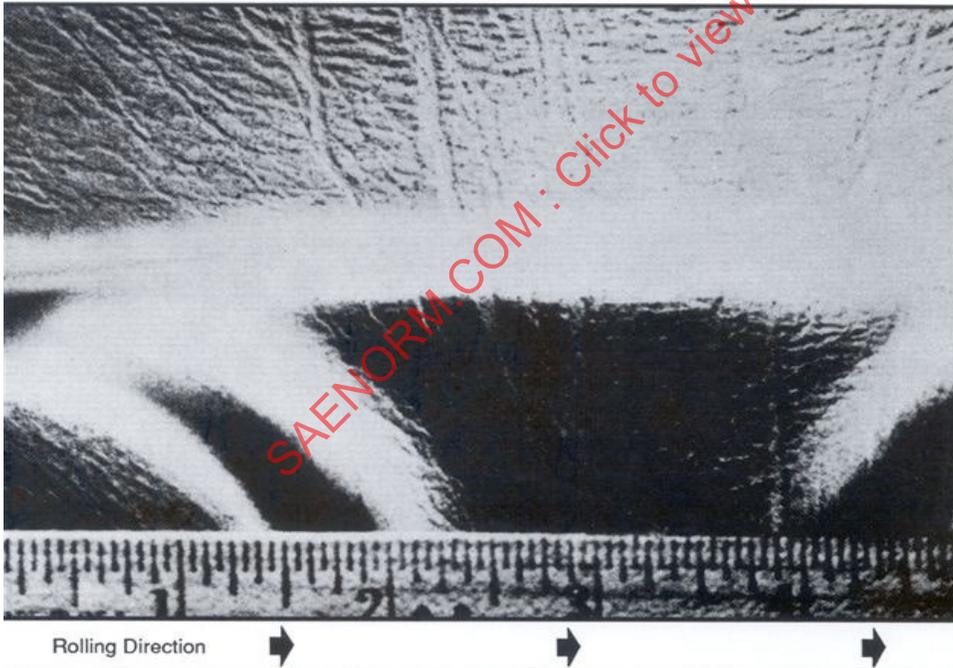
Figure 66

6.27 Strain

Description:	Strain appears as an irregular surface pattern or ridges and valleys.
Cause:	Strain is a result of yield point elongation during stretcher leveling or forming operations.
Product Affected:	All products.
Similar Imperfection:	Lüders Lines; Stretcher Marks; Yield Point Elongation (YPE).
