NFPA 909

Code for the Protection of Cultural Resource Properties — Museums, Libraries, and Places of Worship

2005 Edition

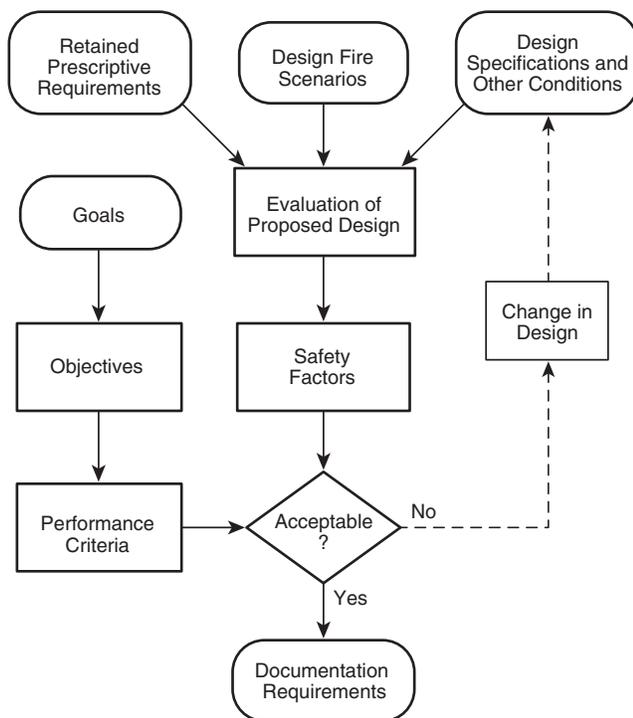
FIGURE 7.1 Process Flow Chart. (See Sections 4.2, 4.3, and 9.2 through 9.8.)

7.1* General. The process by which this code shall be applied is shown in Figure 7.1.

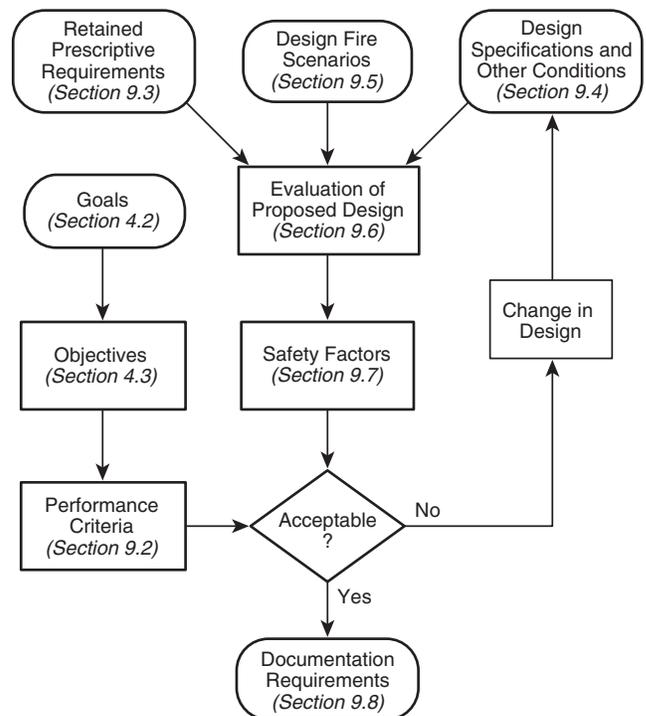
FIGURE A.9.1 Performance-Based Fire Safety Code Compliance Process.

A.9.1 Chapter 9 of this code provides requirements for the evaluation of a performance-based life safety and fire protection design. The evaluation process is summarized in Figure A.9.1.

On the left side of Figure A.9.1 is input from the code. The life safety and cultural resource property preservation goals are stated in Section 4.2. The objectives necessary to achieve those goals are stated in Section 4.3. Section 9.2, Performance Criteria, specifies the measures that are to be used to determine whether the objectives have been met.

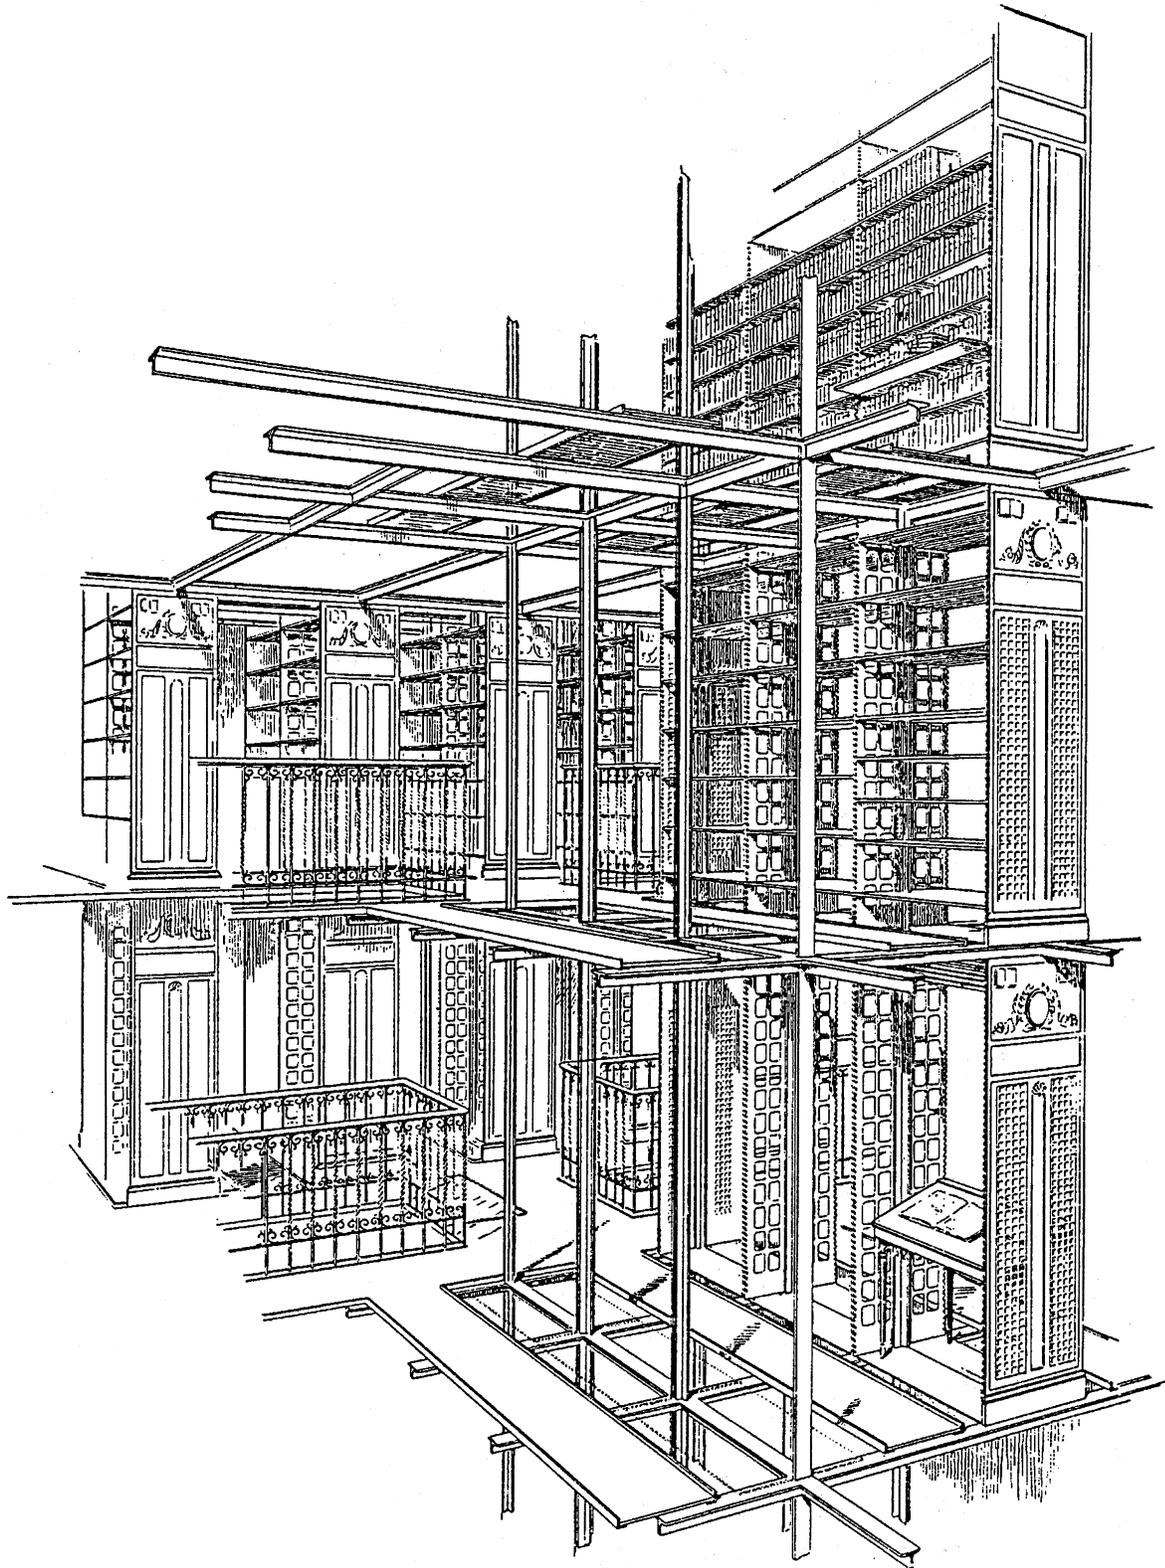
FIGURE A.16.4.10.3(a) Perspective View of Multitier Book Stack.

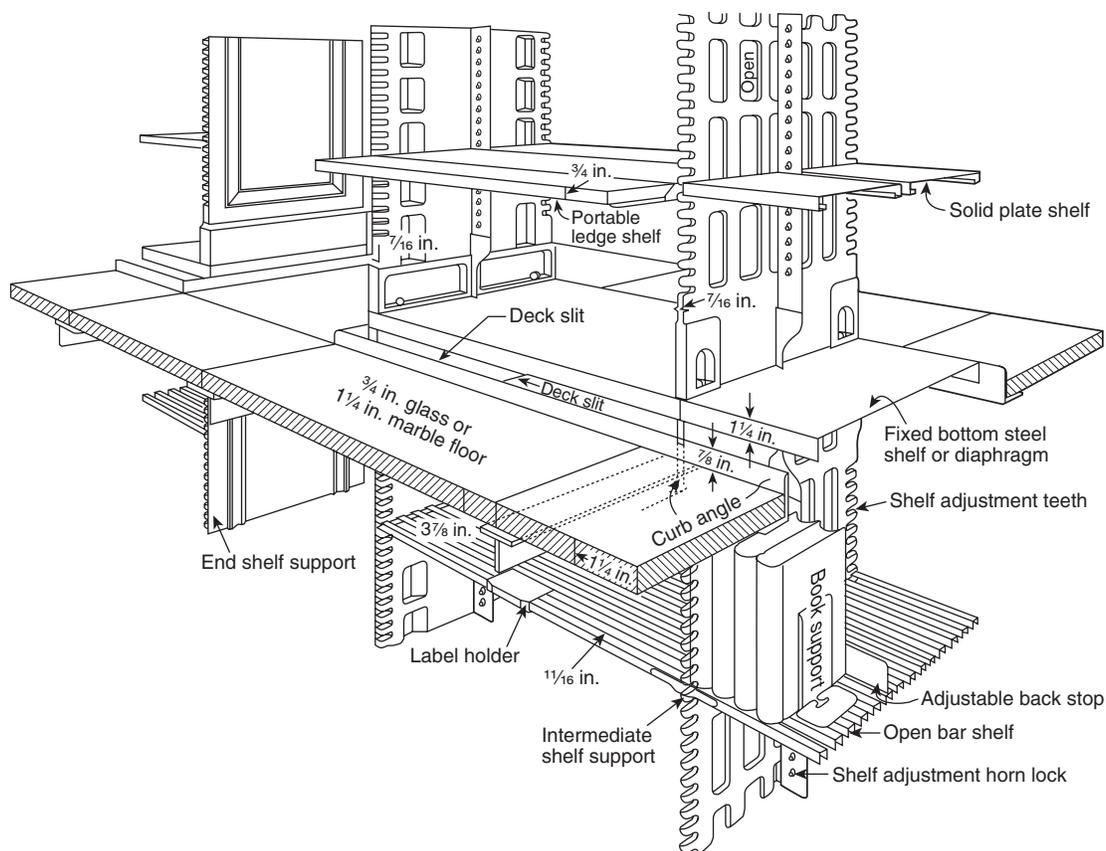
FIGURE A.16.4.10.3(b) Perspective Detail of Multitier Book Stack Showing Section Through Deck Flooring, Fixed Bottom Shelf, and Adjustable Shelves. (Note: For SI units, 1 in. = 25.4 mm.)

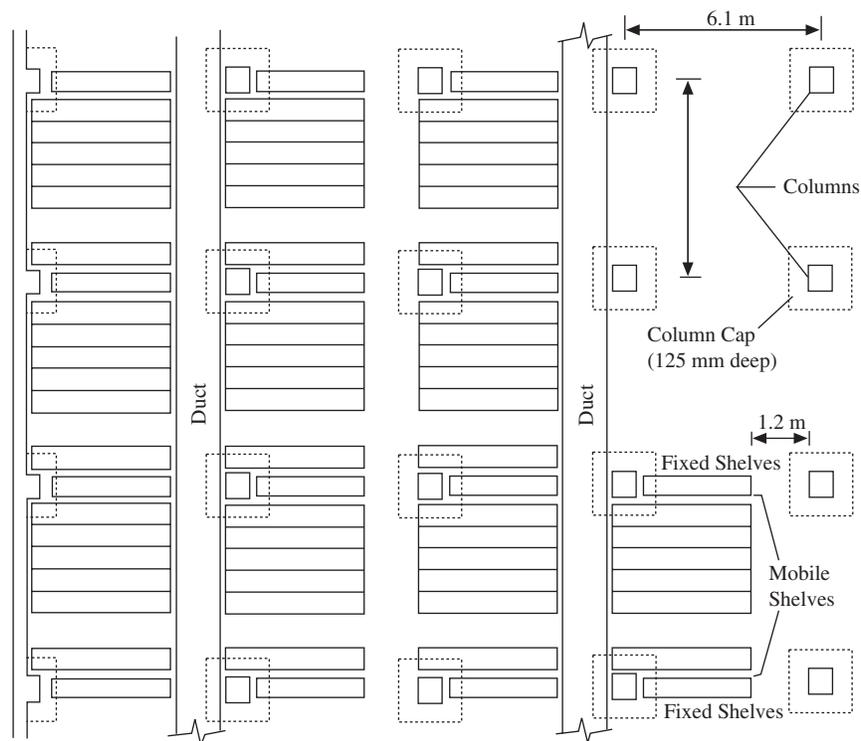
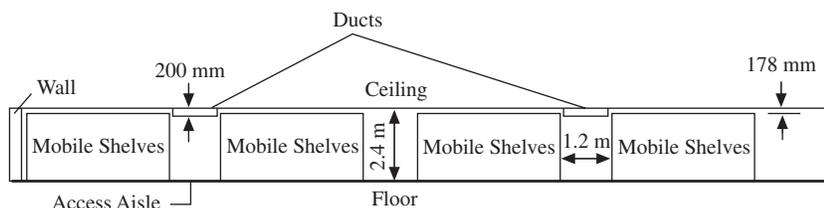
FIGURE H.2 End View of Mobile Shelving Unit

The cardboard document boxes, which were 210 mm wide by 387 mm long and 254 mm high (see Figure H.2), were packed side-by-side with four boxes on each shelf section and up to 240 boxes on each mobile unit. For the most part, they were partially filled with an average weight of 6.8 kg, including the box. The total fuel load on each mobile unit was thus approximately 1,650 kg. For a typical shelving area consisting of two fixed shelves and five mobile shelves, the fuel load density was approximately 375 kg/m² averaged over the shelving area.

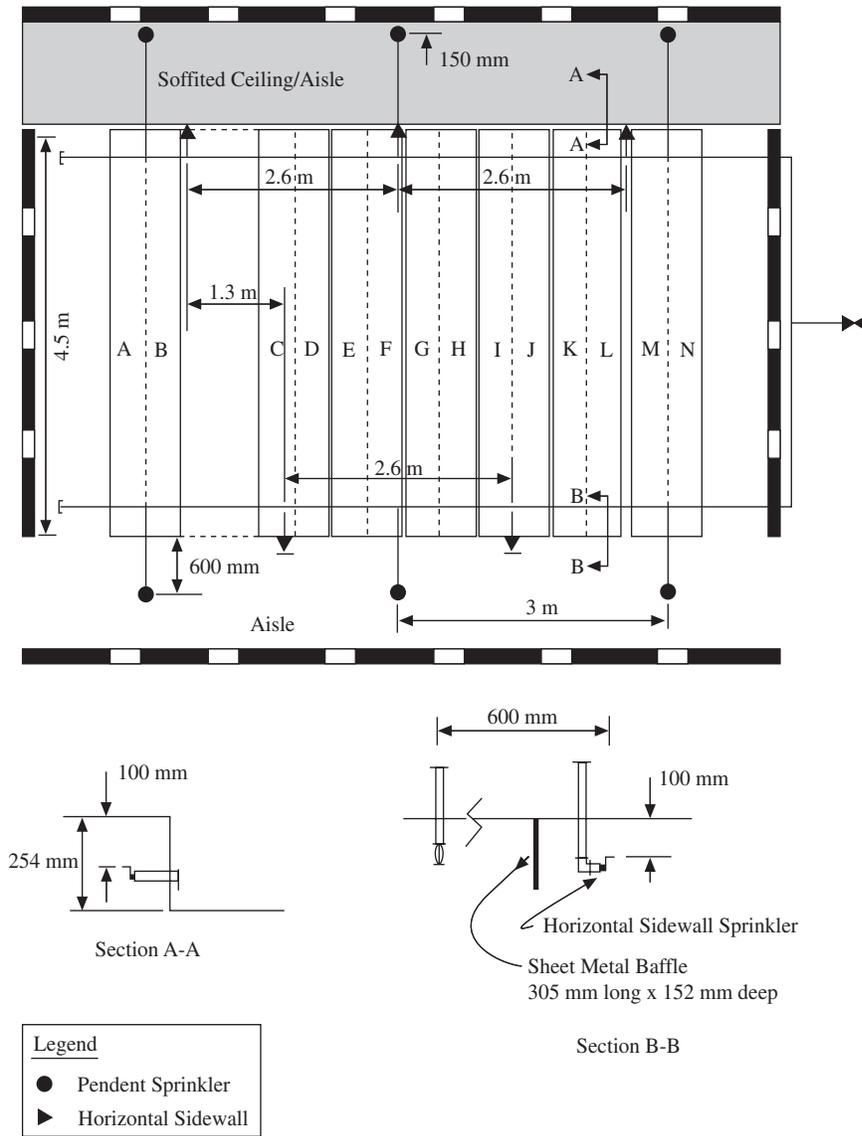
FIGURE H.5 Horizontal Sidewall and Pendent Sprinkler Layout.

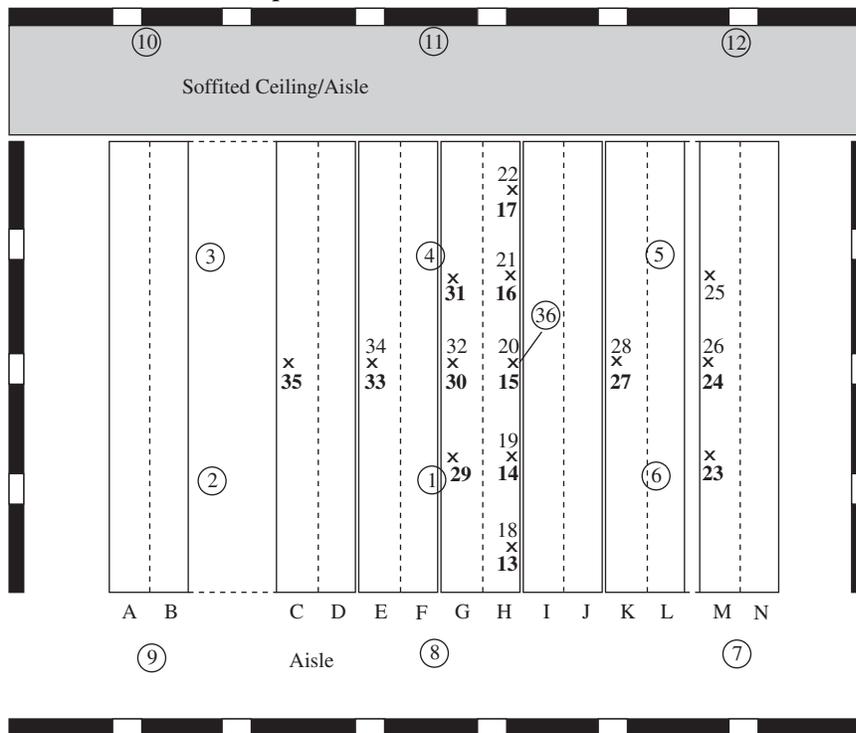
FIGURE H.6 Thermocouple Locations for Tests 1 and 2.

Thermocouples at Lower Level
 13, 14, 15, 16, 17, 23, 24,
 25, 27, 29, 30, 31, 33, 35

Thermocouples at Mid Level
 18, 19, 20, 21, 22
 26, 28, 32, 34

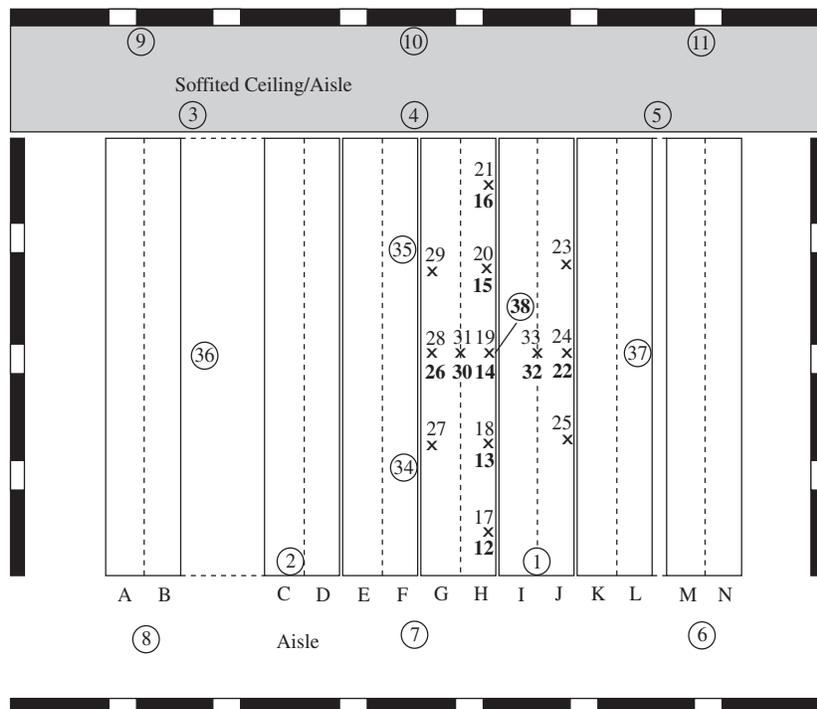
FIGURE H.7 Thermocouple Locations for Tests 3, 4, and 5.

Thermocouples on Barrier

Mid-level 30, 32
 Upper level 31, 33

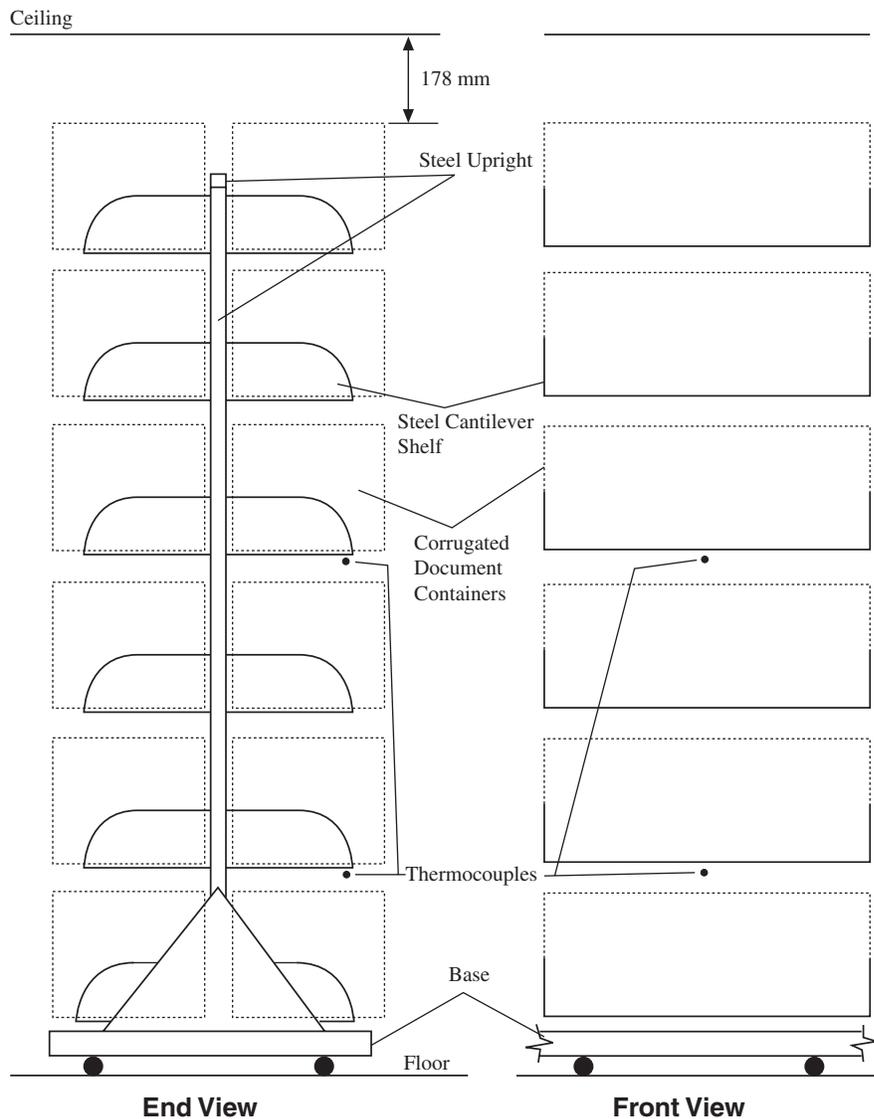
FIGURE H.8 Thermocouple Locations on Mobile Units.

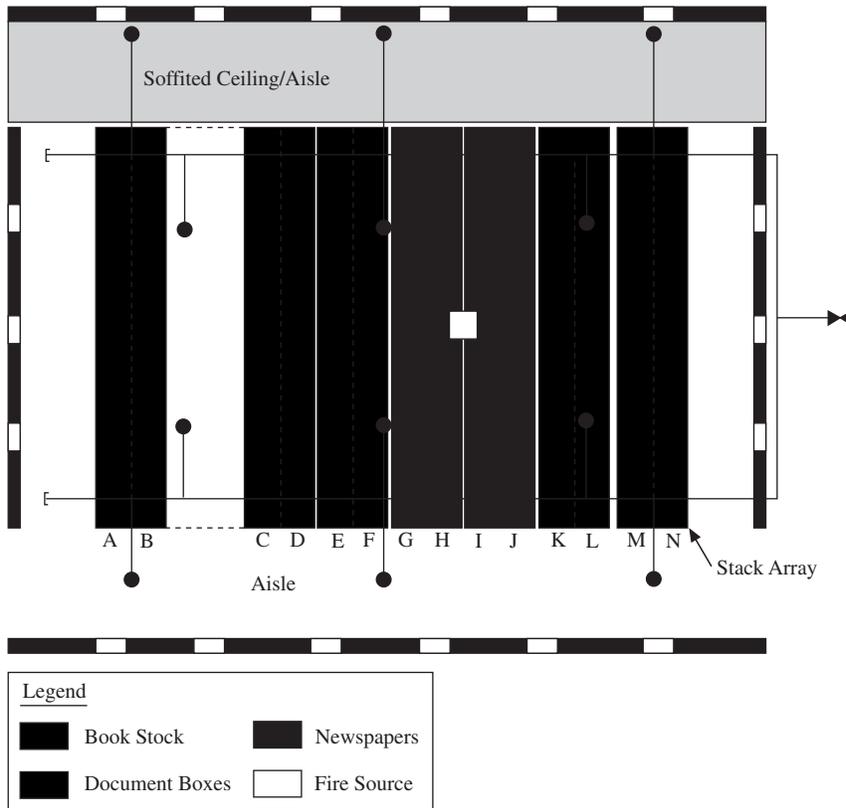
FIGURE H.9 Fire Scenario for Test 1.

As indicated previously, the analysis of the hazard in the library indicated that folded newspapers stored in periodical boxes could result in the most rapid fire spread and, thus, the most challenging fire scenario for the sprinklers. For the initial test, the mobile shelving units on either side of the fire source were completely filled with newspapers (Rows G, H, I, and J in Figure H.9). The remaining shelving rows were filled with partially filled document boxes. The alcohol pan ignition source was located at the center of the closed units between Rows H and I.

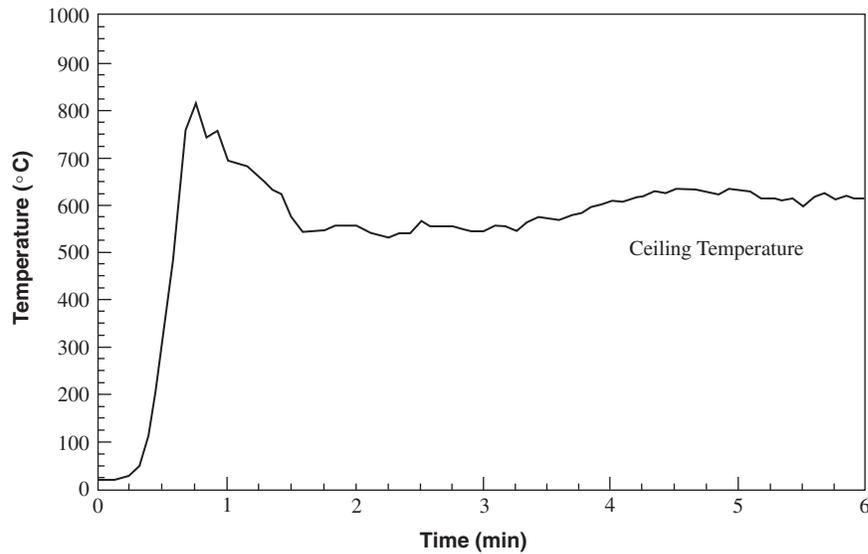
FIGURE H.10 Ceiling Temperature in Test 1.

As expected, the fire involvement of the open, folded newspapers was rapid and sustained, despite early sprinkler activation and the use of relatively high sprinkler flow rates. The high percentage of exposed surfaces of combustibles throughout the stacks resulted in very rapid fire spread along the row of fire origin and to adjacent shelving units.

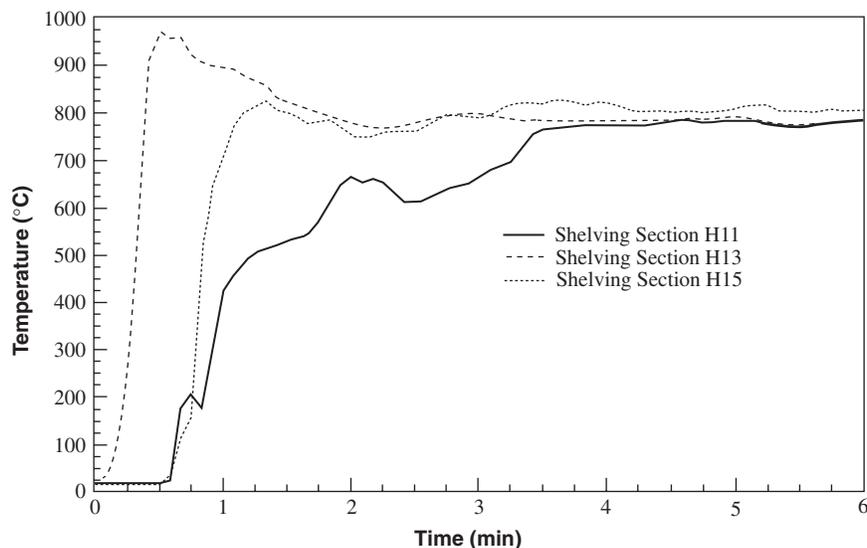
FIGURE H.11 Shelving Section H Temperatures in Test 1.

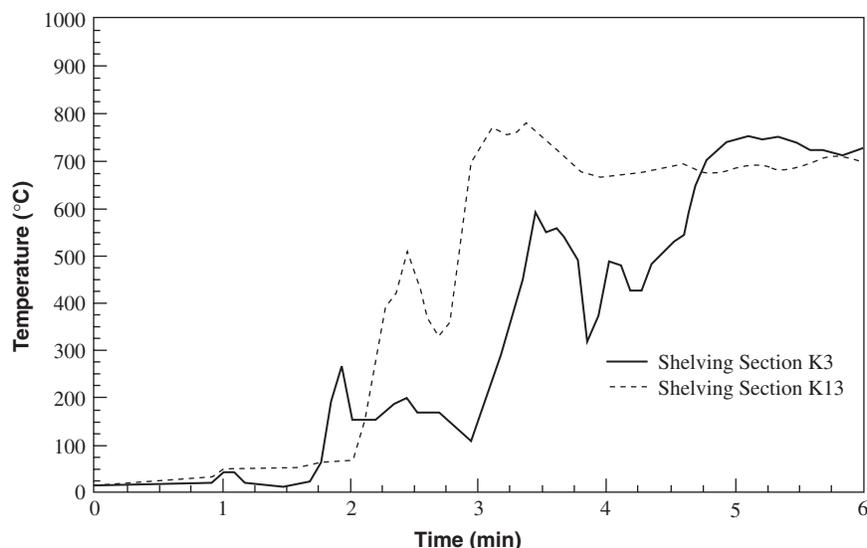
FIGURE H.12 Shelving Section K Temperatures in Test 1.

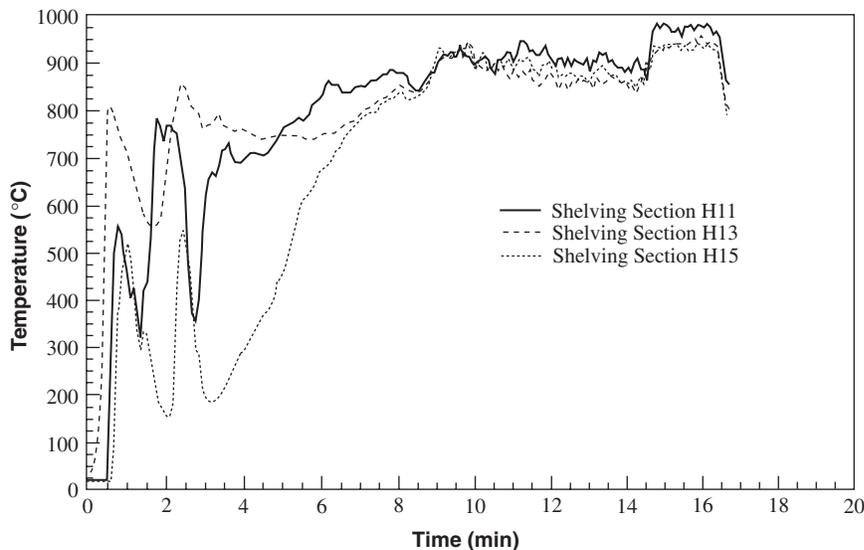
FIGURE H.13 Shelving Section H Temperatures in Test 2.

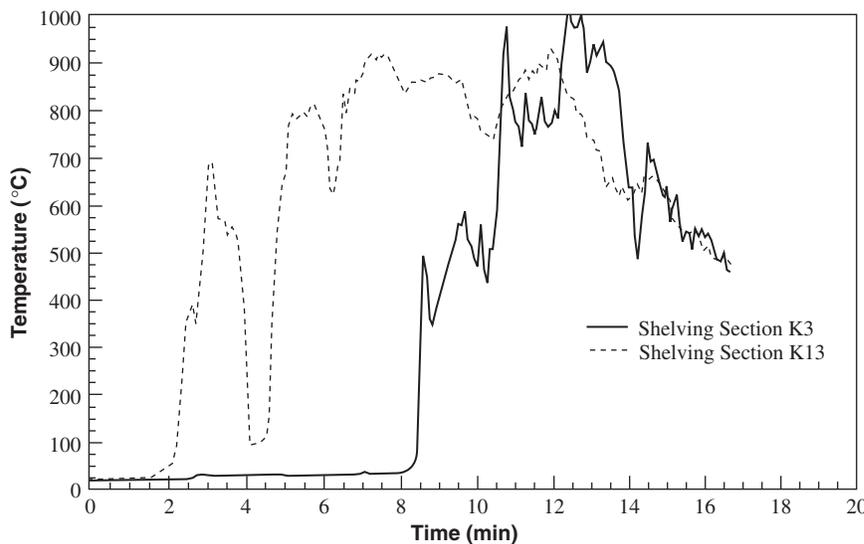
FIGURE H.14 Shelving Section K Temperatures in Test 2.

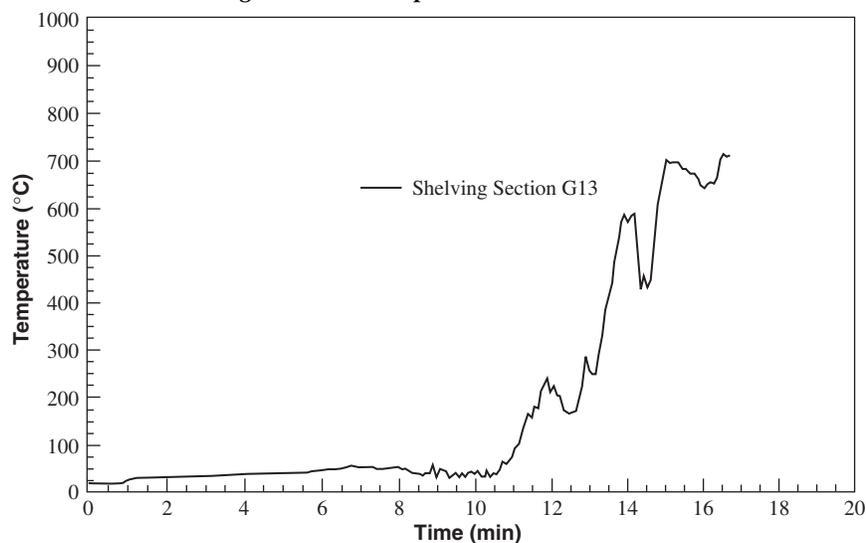
FIGURE H.15 Shelving Section G Temperatures in Test 2.

The fire barrier between Rows G and H delayed the fire spread to Row G. Figure H.15 indicates that the barrier was penetrated at approximately 10 minutes, with sustained burning after 12 minutes.

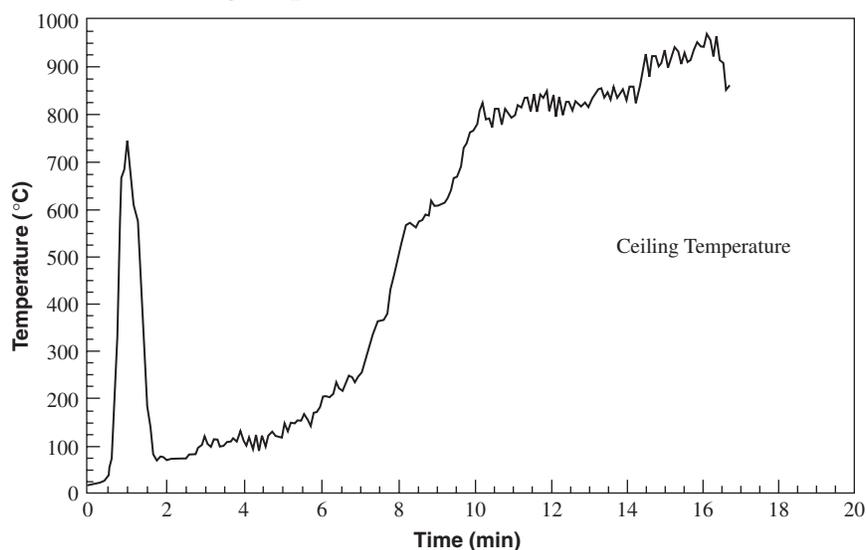
FIGURE H.16 Ceiling Temperature in Test 2.

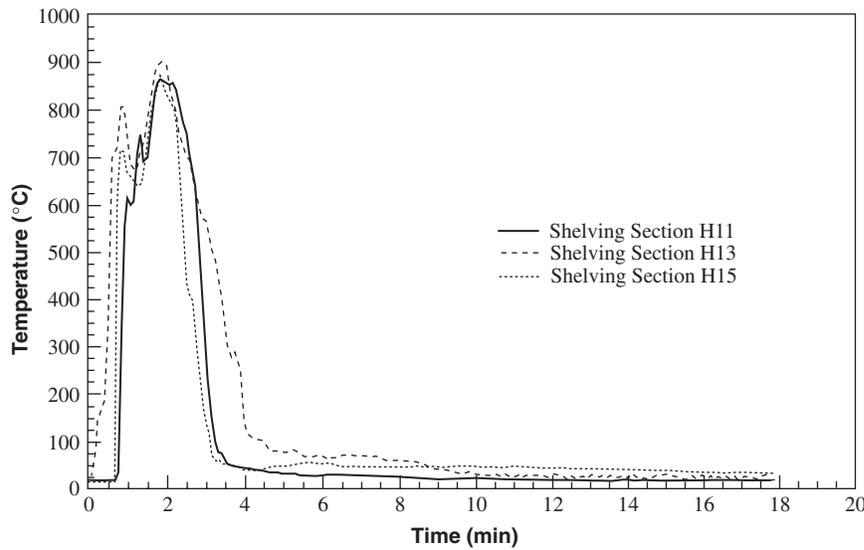
FIGURE H.17 Shelving Section H Temperatures in Test 3.

The horizontal sidewall sprinklers, in combination with the fire barriers and the 26 mm gap between the mobile units, allowed for effective cooling and extinguishment in the initial area involved in the fire. Further, the high spray density, combined with the favorable water spray projection pattern, provided cooling at the ceiling and prevented the operation of an excessive number of sprinklers.

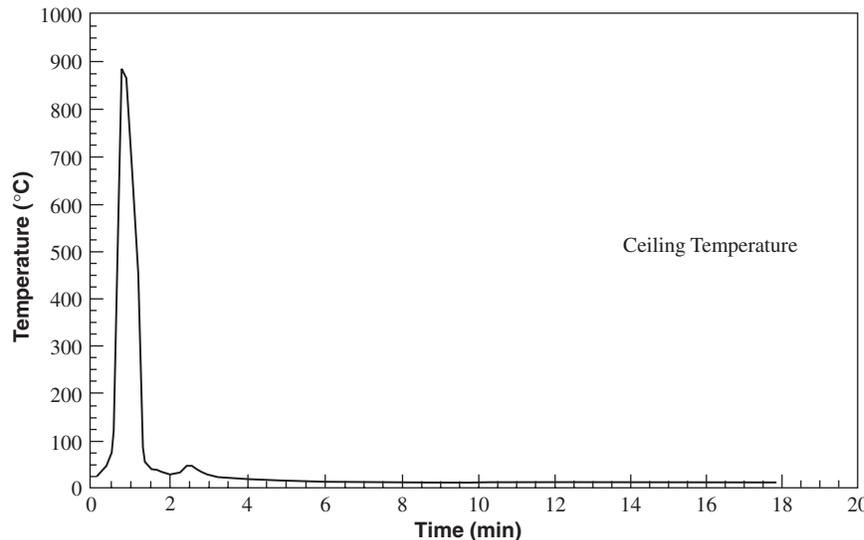
FIGURE H.18 Ceiling Temperature in Test 3.

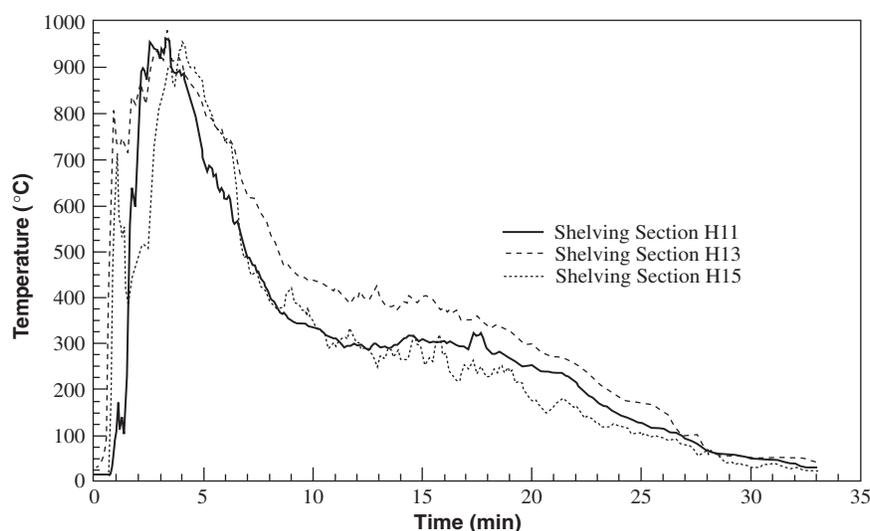
FIGURE H.19 Shelving Section H Temperatures in Test 4.

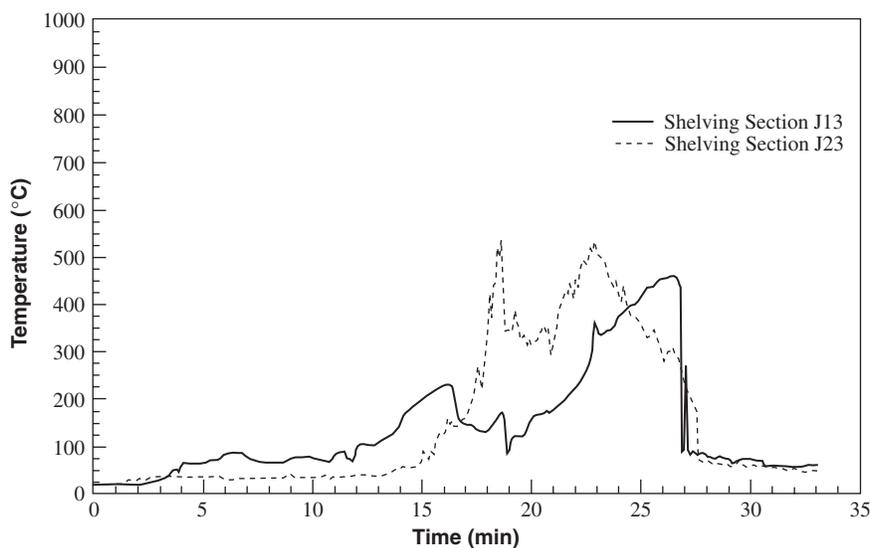
FIGURE H.20 Shelving Section J Temperatures in Test 4.

At 25 minutes, the water flow rate was increased to 24.6 (L/min)/m². With the increased flow rate, the fire was extinguished within 5 minutes.

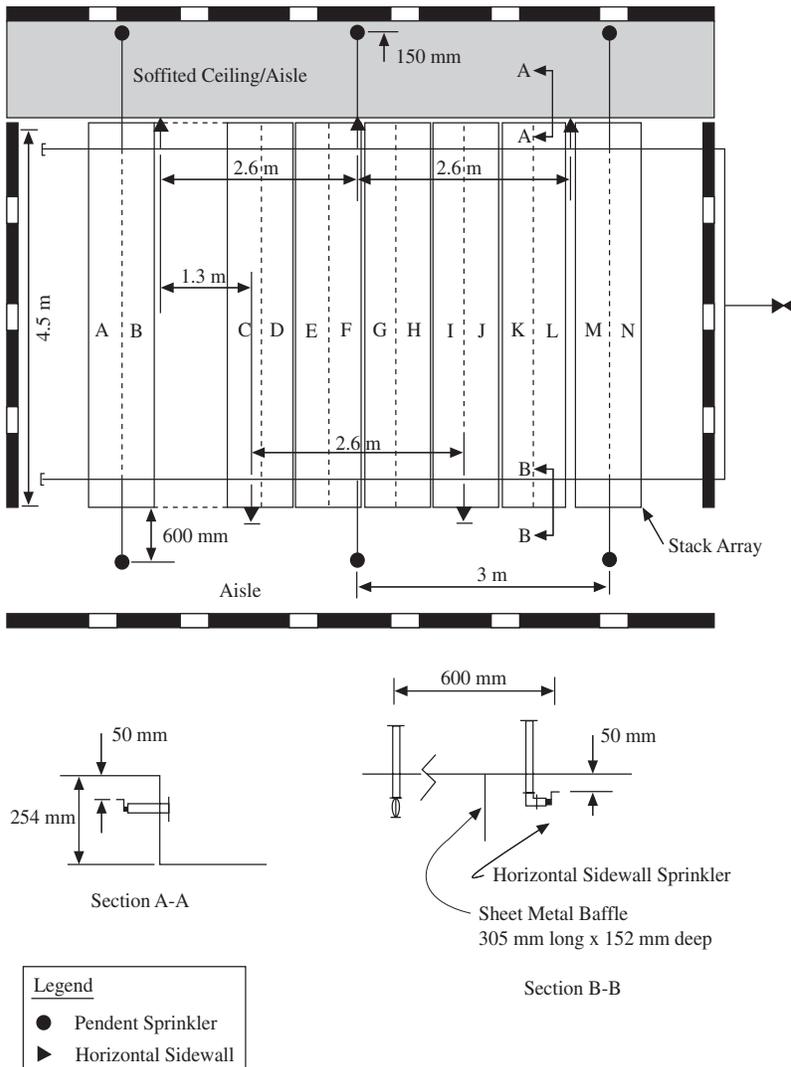
FIGURE H.21 Horizontal Sidewall and Pendent Sprinkler Layout for Test 5.

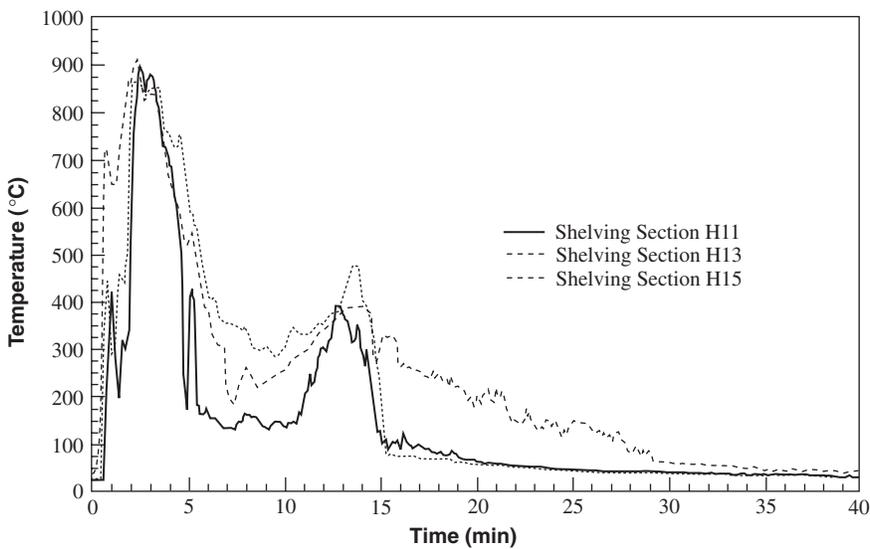
FIGURE H.22 Shelving Section H Temperatures in Test 5.

As is shown in Figures H.22 and H.23, the fire was able to regain some momentum approximately 8 minutes into the test, with high temperatures, measured in shelving Row H and at the ceiling. Once Sprinkler 4 activated at 9 minutes, the sprinklers were able to control and extinguish the fire. The 15 minutes required for the sprinklers to control the fire provided the fire with enough time to break through the fire barrier separating Rows G and H. However, the ability of the sprinkler system to regain control of the fire indicates that there is an inherent safety margin in the protection system.

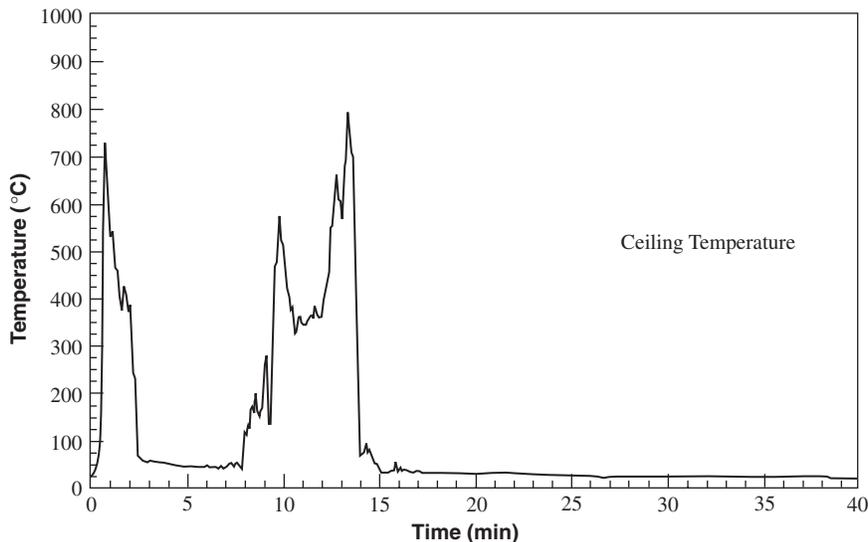
FIGURE H.23 Ceiling Temperature in Test 5.

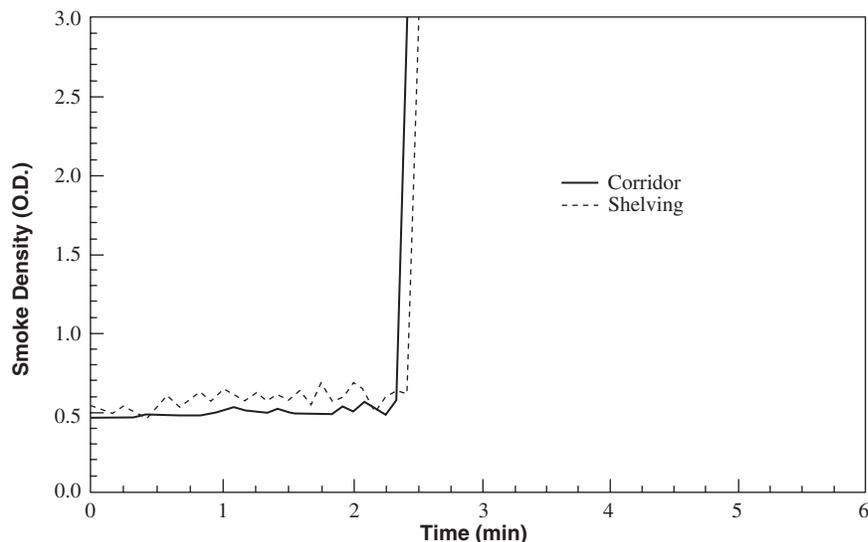
FIGURE H.24 Smoke Obscuration at 1.5 m Level in Test 1.

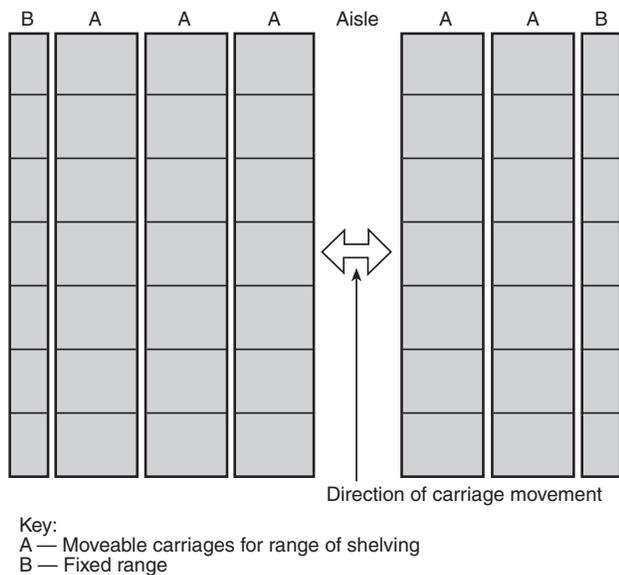
FIGURE I.1 Moving Aisle Storage.

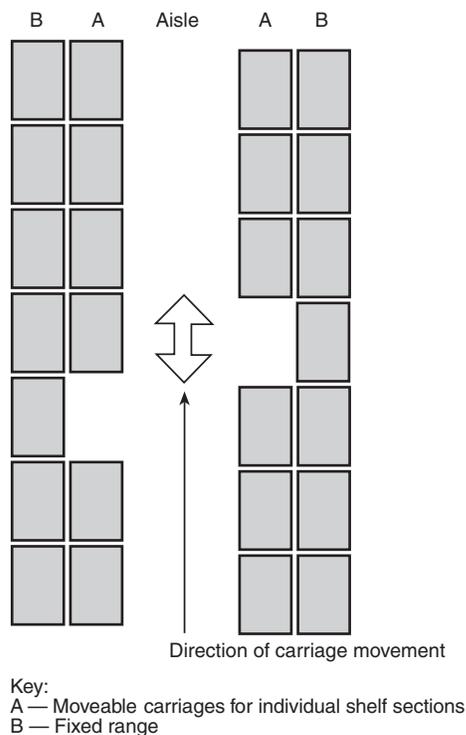
**FIGURE I.2 Moving Shelf Storage.**

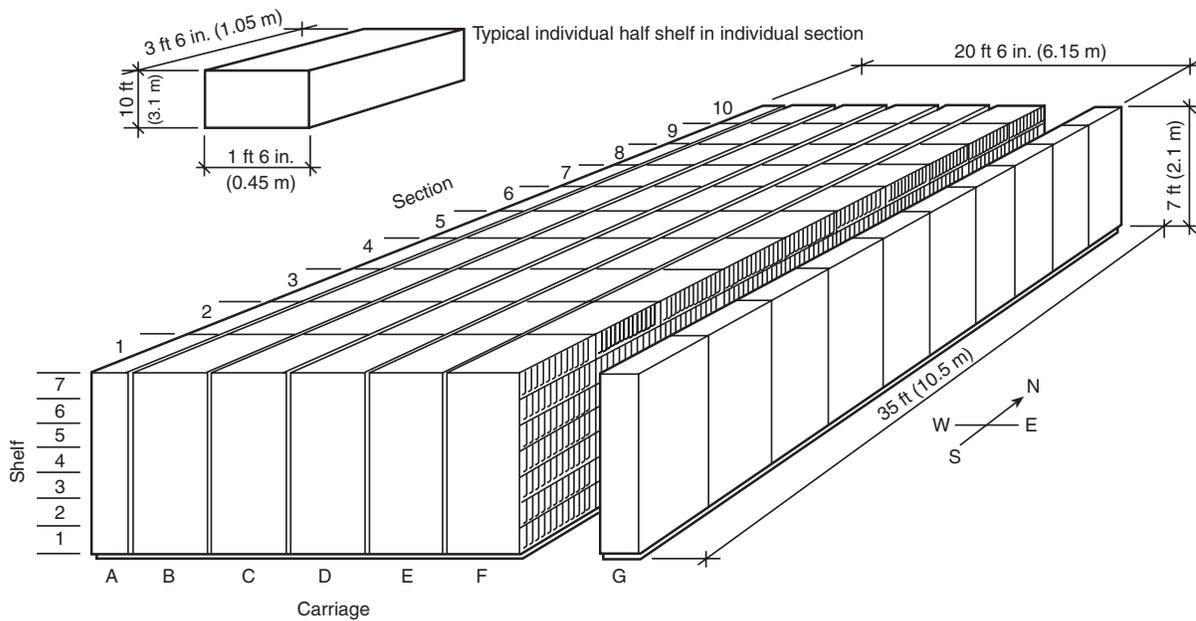
FIGURE I.3 Mobile Shelving Array Terminology and Dimensions.

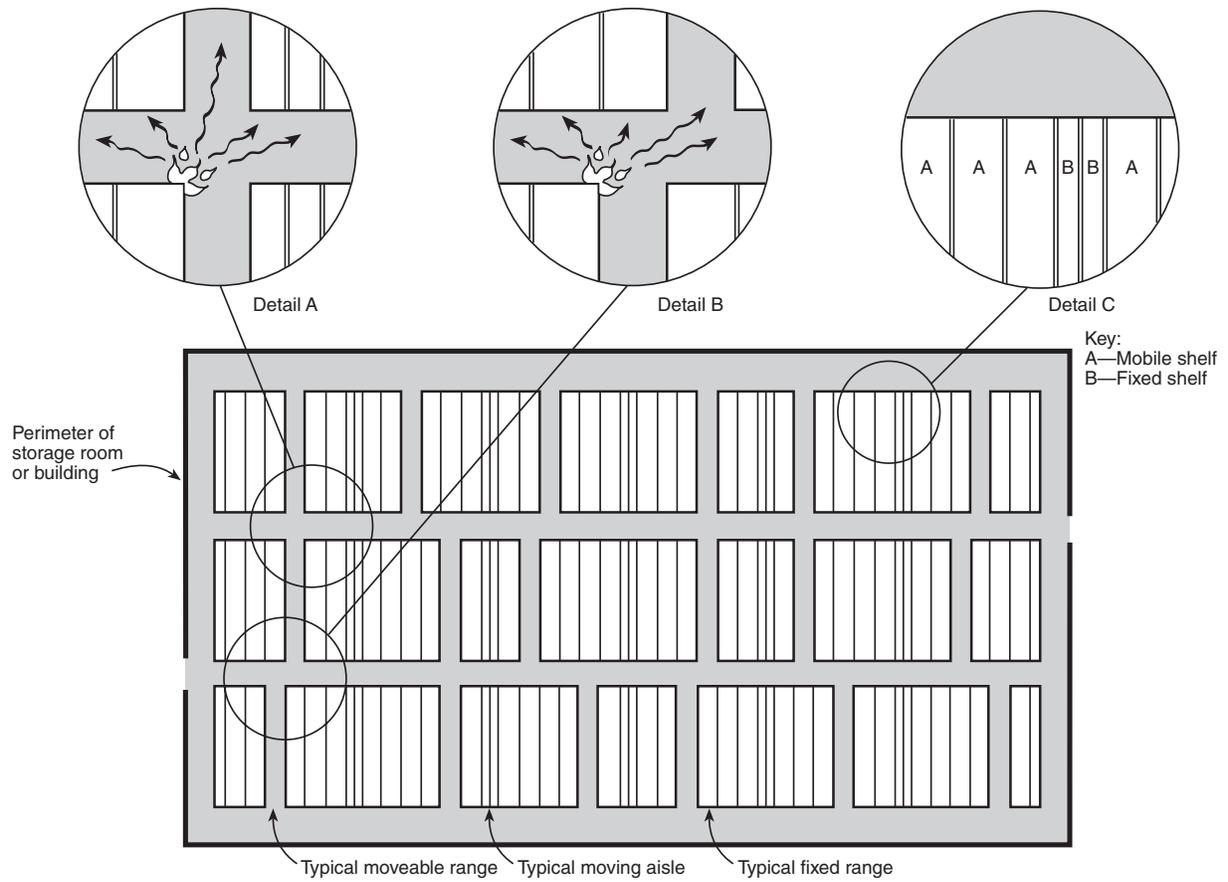
FIGURE I.4 Multiple Module Storage.

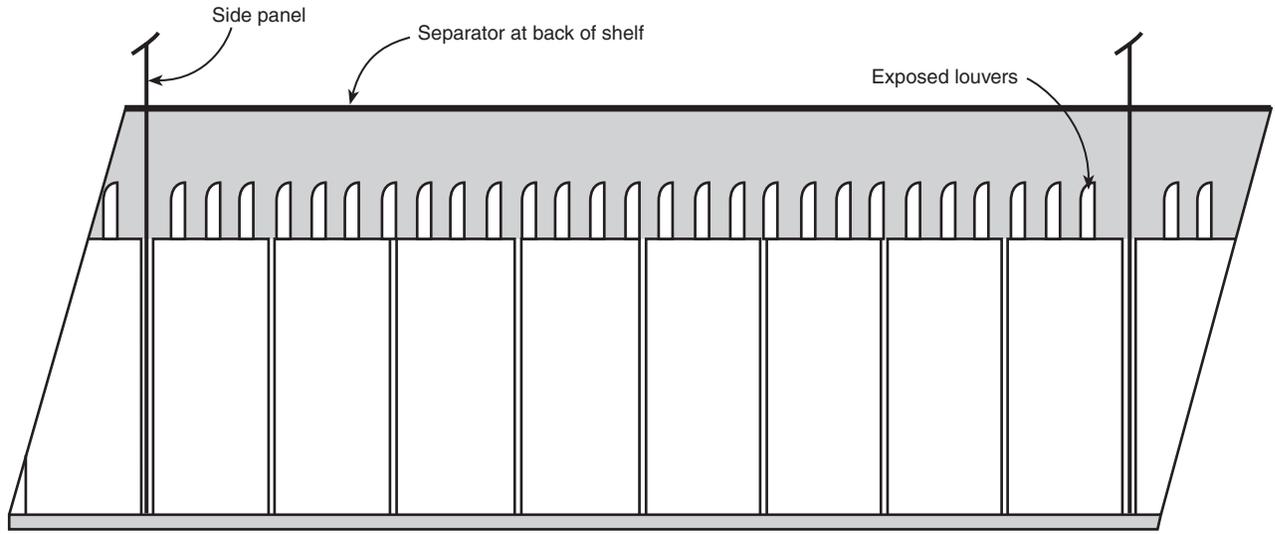
FIGURE I.5 Potential Improvement in Vertical Openness.

Plan view—archival boxes, 100% packing density

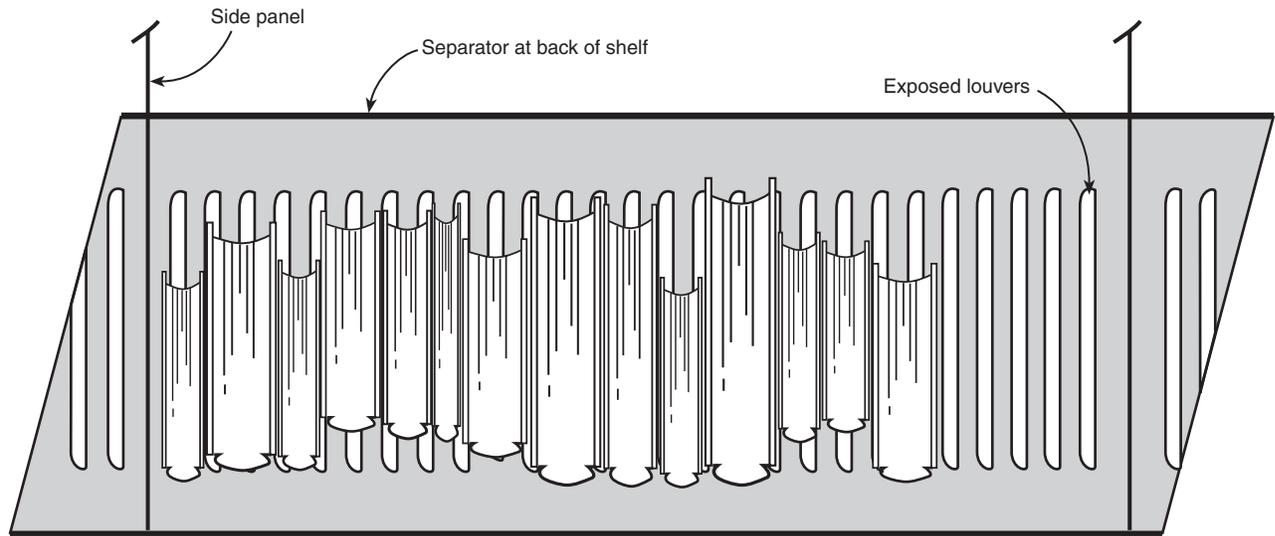
Plan view—library books, 80% packing density

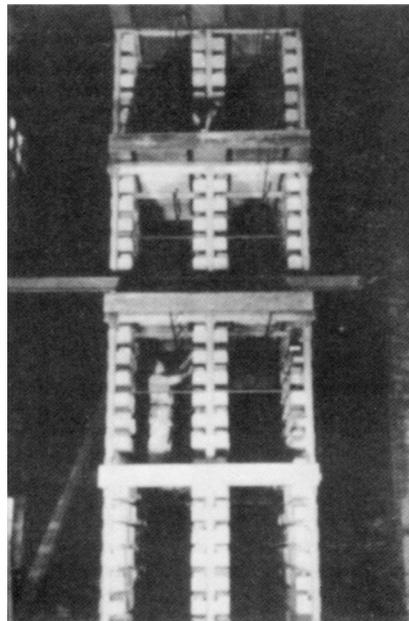
FIGURE M.1 General View of Four-Tier Book Stack Loaded With 11,200 Books.

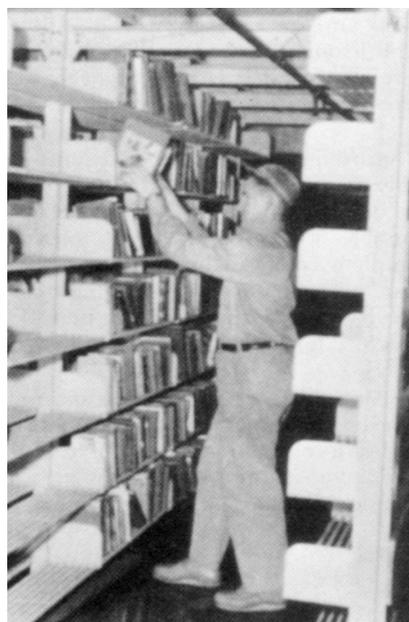
FIGURE M.2 Illustration of Structural Elements of Stack; Note One Sprinkler Position.

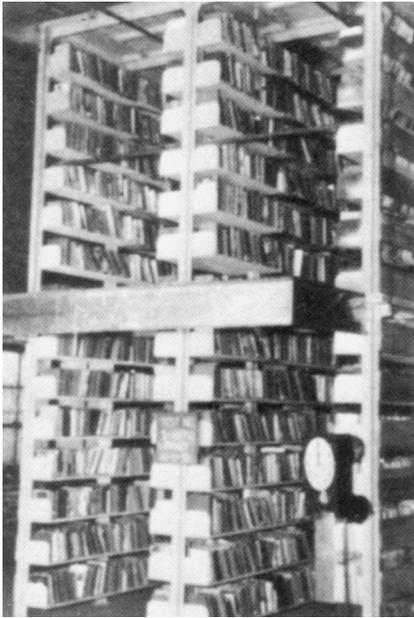
FIGURE M.3 General View of Books in the First and Second Tiers Before Tests.

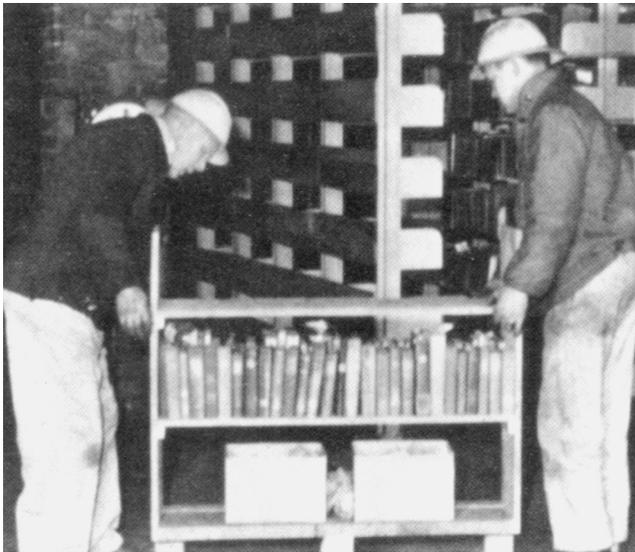
FIGURE M.4 Wood Book Cart Before Being Placed in Aisle of First Tier. (After placement, books were put on top shelf of book cart. The fire was started with an ordinary match by igniting the crumpled piece of paper between the two cartons on the bottom shelf of the cart.)

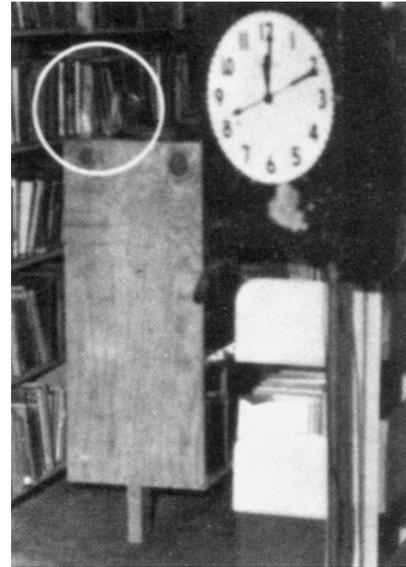
FIGURE M.5 One Minute, 10 Seconds; Flame Showing Above Book Cart; Sprinklers Not Yet Operating.

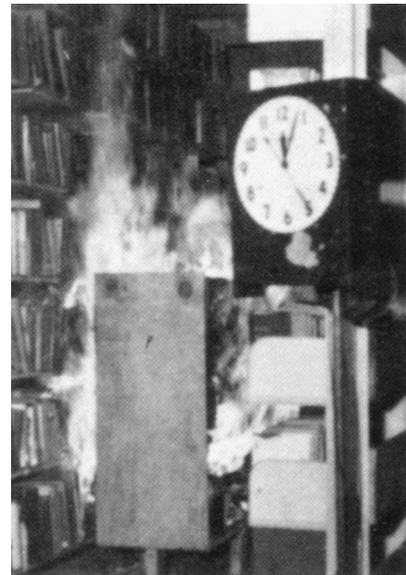
FIGURE M.6 Three Minutes, 25 Seconds; Active Burning in First Tier; Sprinklers Not Yet Operating.

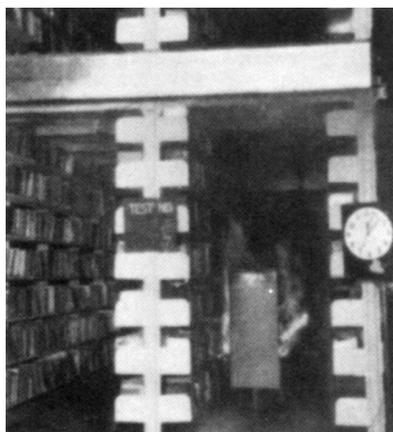
FIGURE M.7 Eight Minutes, 3 Seconds; Two Sprinklers Operating; Fire in Stack Under Control.
