NFPA 909

Code for the Protection of Cultural Resource Properties — Museums, Libraries, and Places of Worship

2005 Edition

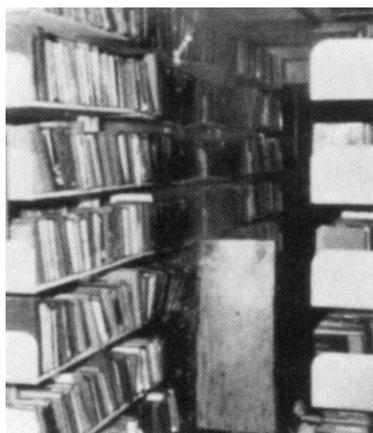
FIGURE M.8 After Fire Extinguishment by Sprinklers; Fire Damage to Books in Only 10 Percent of Space.

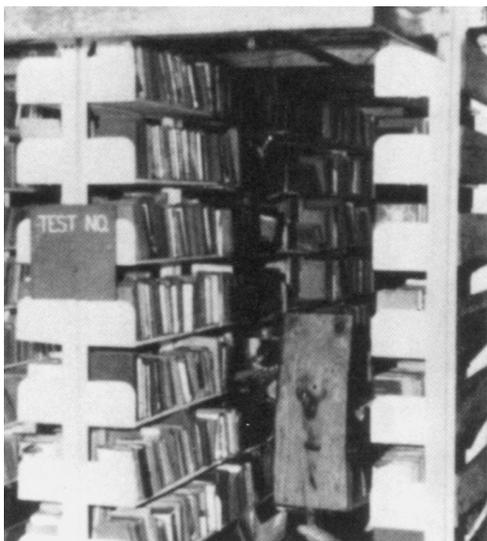
FIGURE M.9 Close-up of Extent of Fire Damage After Test 1 with Automatic Sprinklers. (Note limited area of fire damage.)

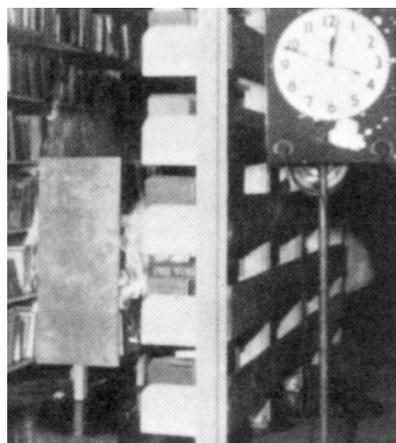
FIGURE M.10 One Minute, 48 Seconds; Books in Stack Ignited; No Sprinklers.

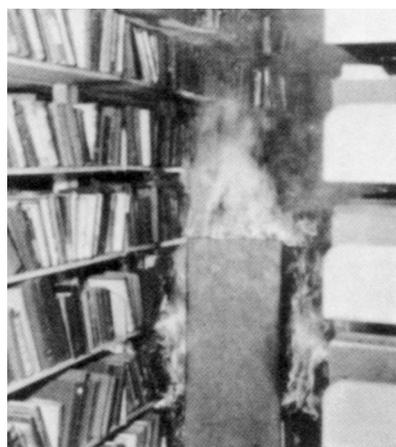
FIGURE M.11 After Approximately 3 Minutes; Active Burning in First Tier; No Sprinklers.

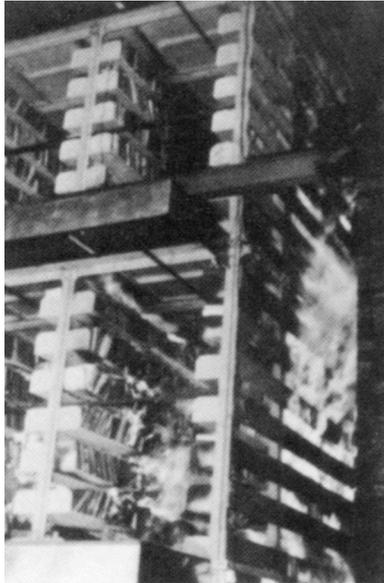
FIGURE M.12 After Approximately 7¹/₂ Minutes, Fire Involved Second and Third Tiers.

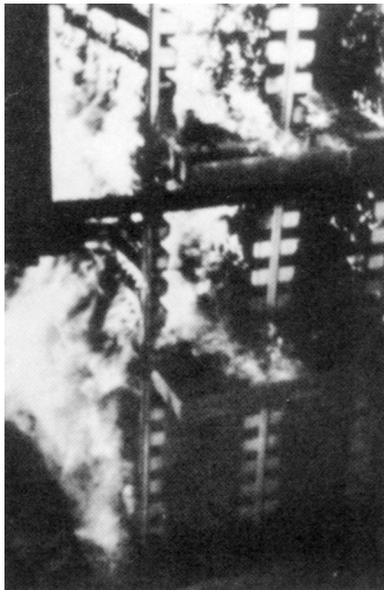
FIGURE M.13 After About 9¹/₂ Minutes, Flame Spread to Top Tier and Across Aisles on Lower Tiers.

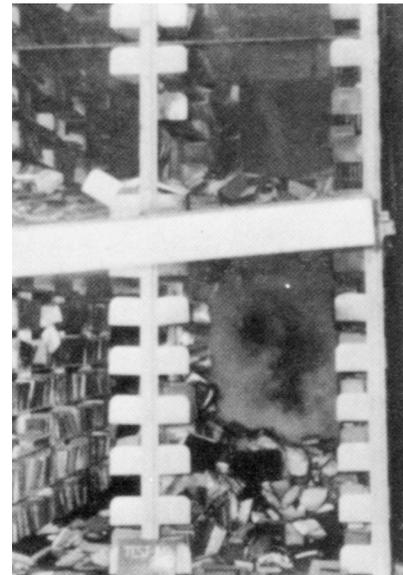
FIGURE M.14 General View of First and Second Tiers After Test 2; No Sprinklers.

Some indication of the extent of the damage to the books and stacks is given by the photographs in Figures M.14 through M.16. Quantitatively, 89 percent of the books were charred deeply or completely destroyed, 2¹/₂ percent were scorched, and the remaining 8¹/₂ percent were soaked.

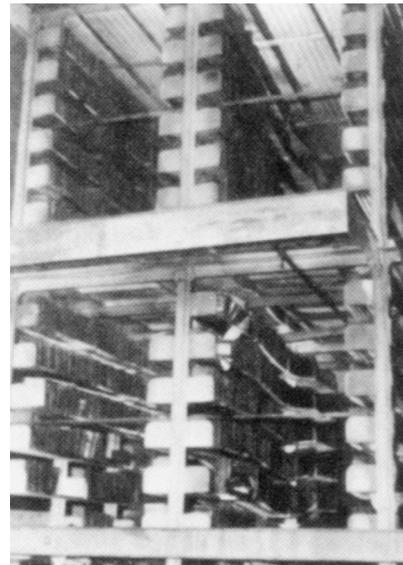
FIGURE M.15 General View of Third and Fourth Tiers; All Exposed Book Surfaces Charred.

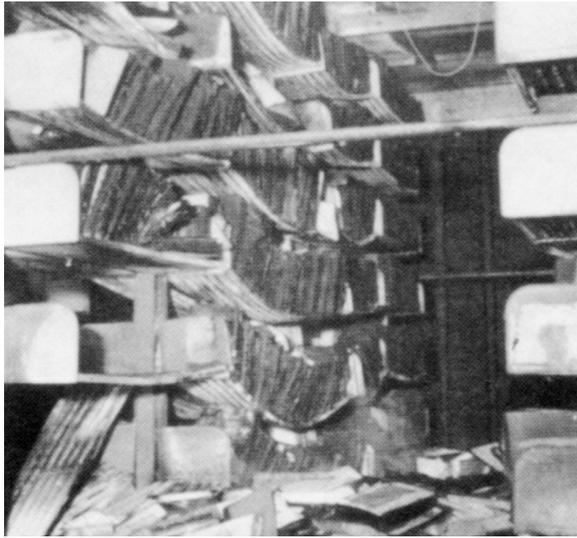
FIGURE M.16 Extent of Damage to Shelving After Test 2 on Second Tier, Right Aisle; No Sprinklers. (Note severe charring of books and collapse of shelving.)

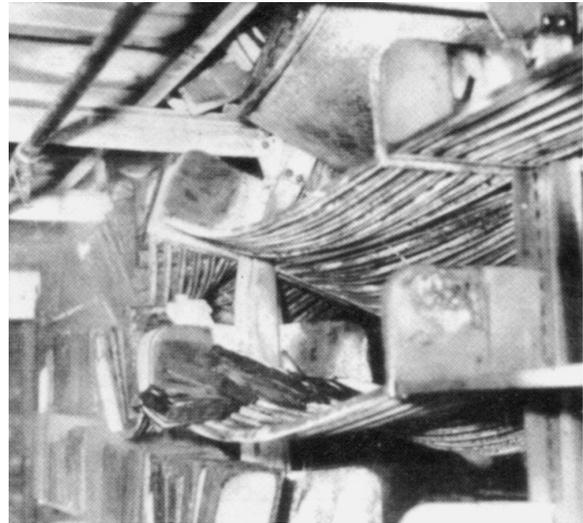
FIGURE M.17 View of First Tier, Left Aisle After Test 2; No Sprinklers. [The temperatures reached 1500°F (780°C) in each recorded location, whereas in Test 1 (with sprinklers) temperatures did not go above 500°F (260°C). Note failure of column (center of photo).]

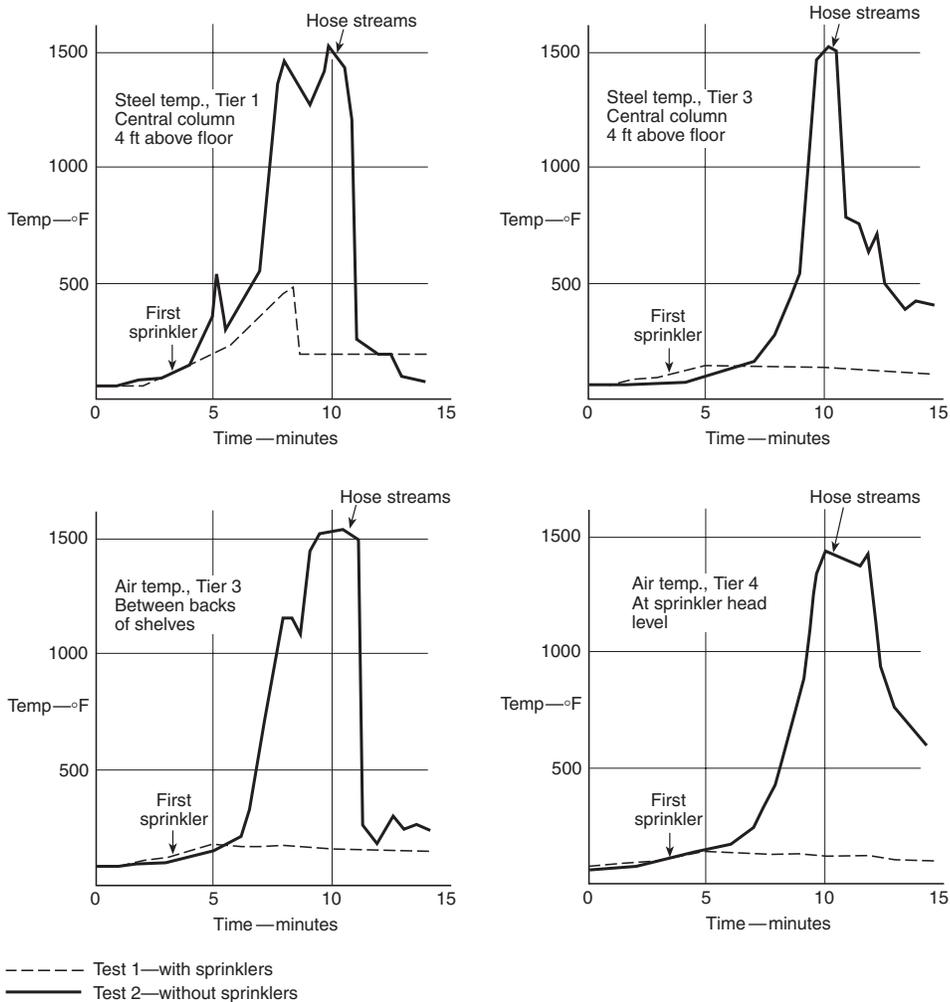
FIGURE M.18 Temperatures at Various Locations in Book Stacks.

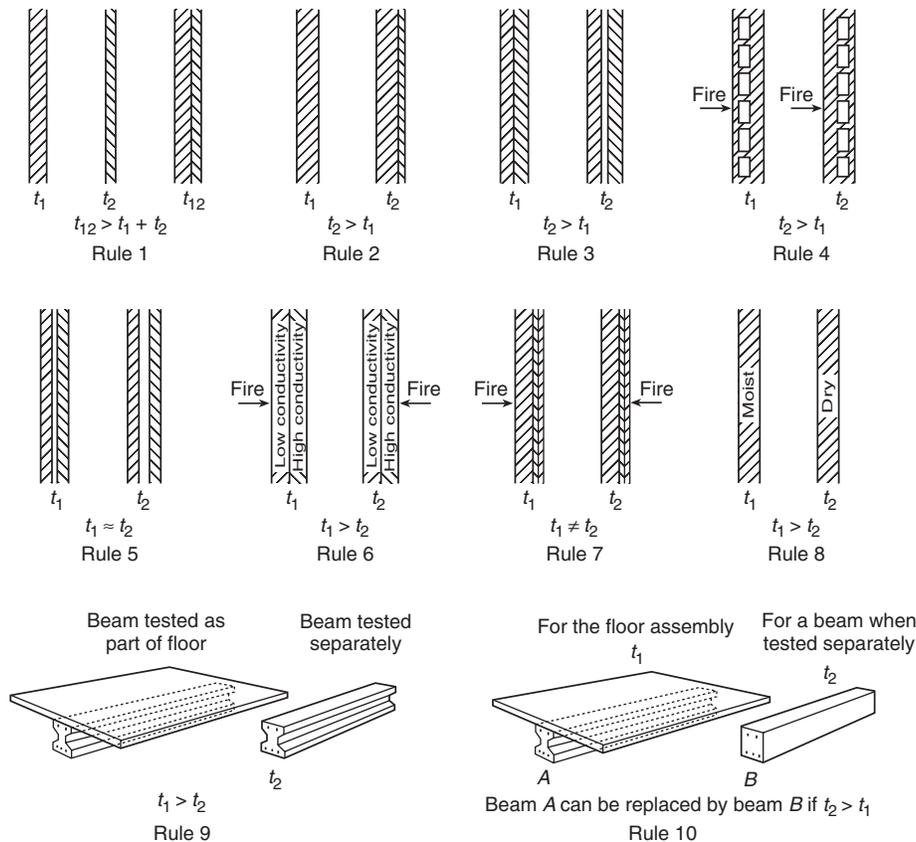
FIGURE O.3.3 Diagrammatic Illustration of 10 Rules (t = Fire Endurance).

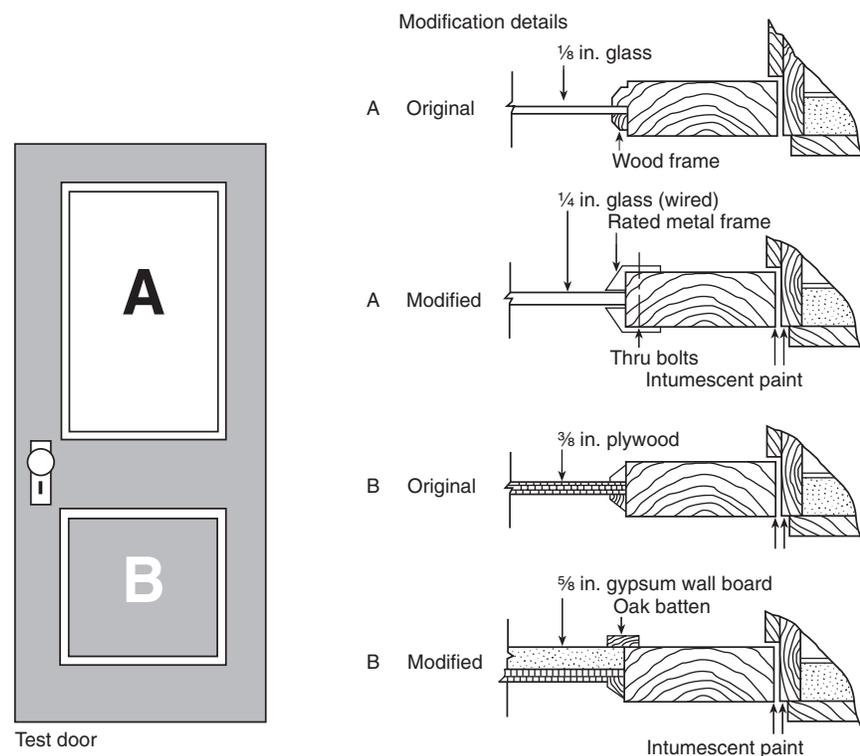
FIGURE O.3.5 Modifications to Existing Door to Increase Fire Protection Performance.

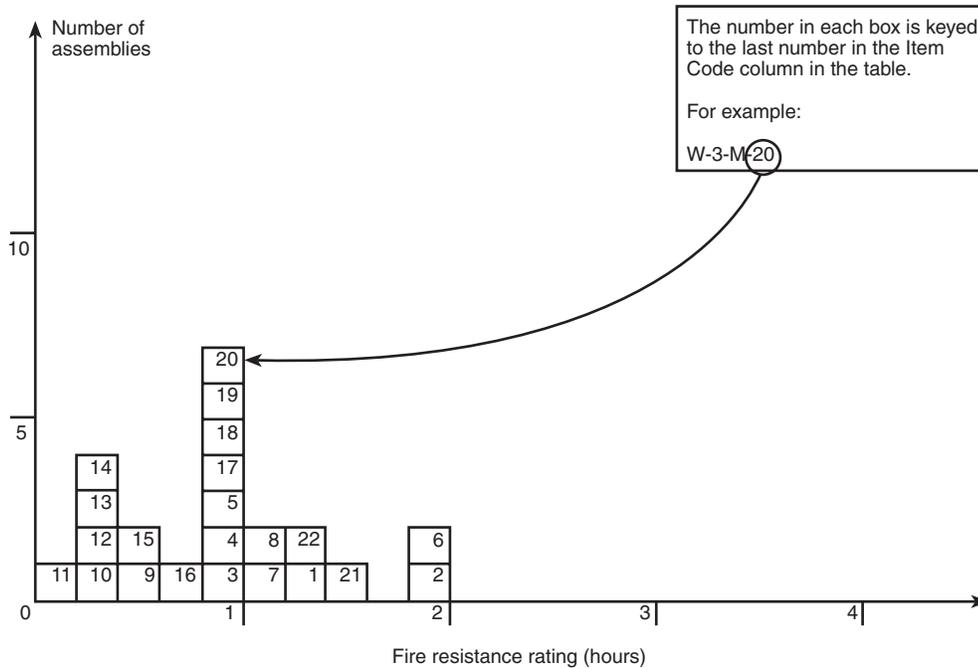
FIGURE O.4.5.1 Masonry Walls 0 in. (0 mm) to Less Than 4 in. (100 mm) Thick.

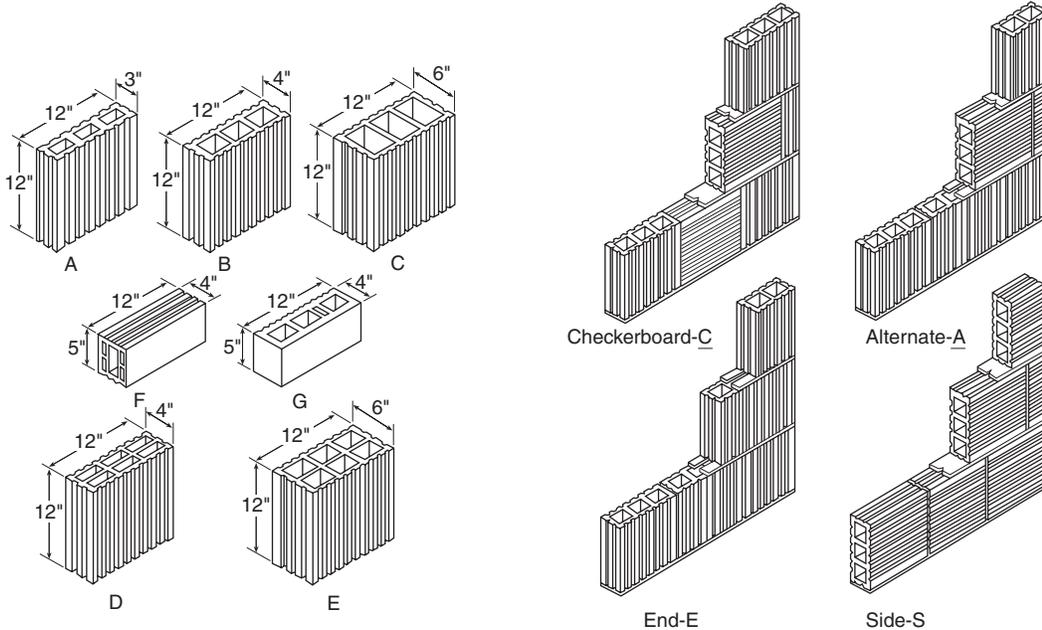
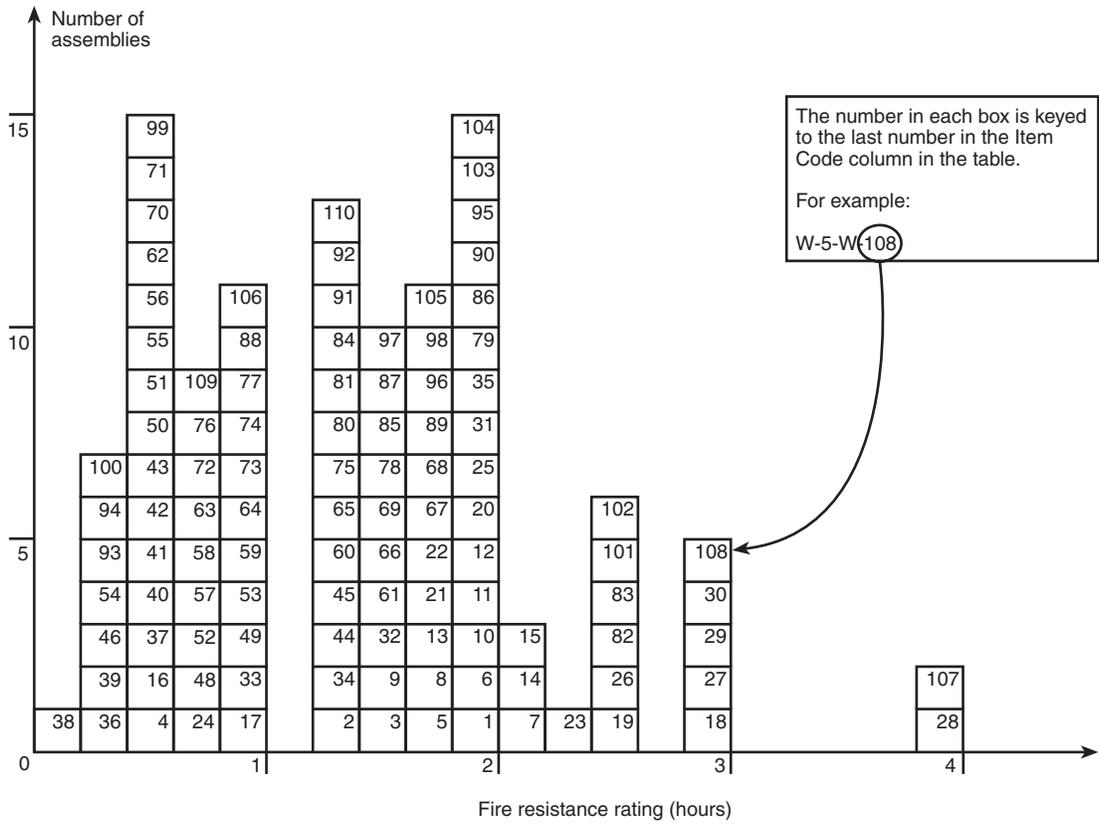
FIGURE O.4.5.2 Masonry Walls 4 in. (100 mm) to Less Than 6 in. (150 mm) Thick.

Designs of tiles used in fire-test partitions.

The four types of construction used in fire-test partitions.

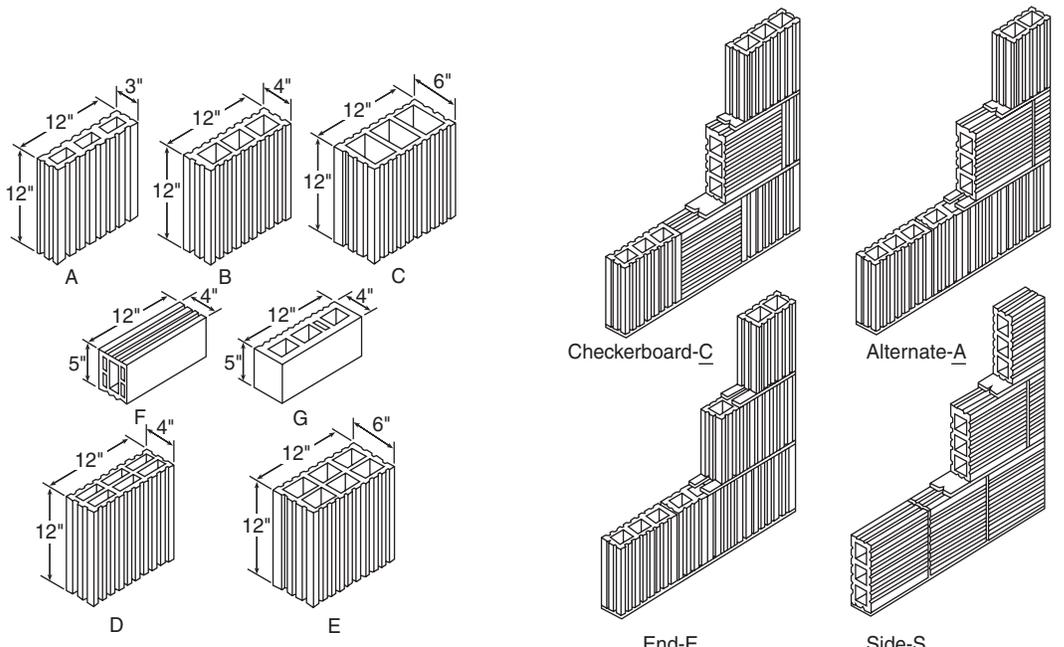
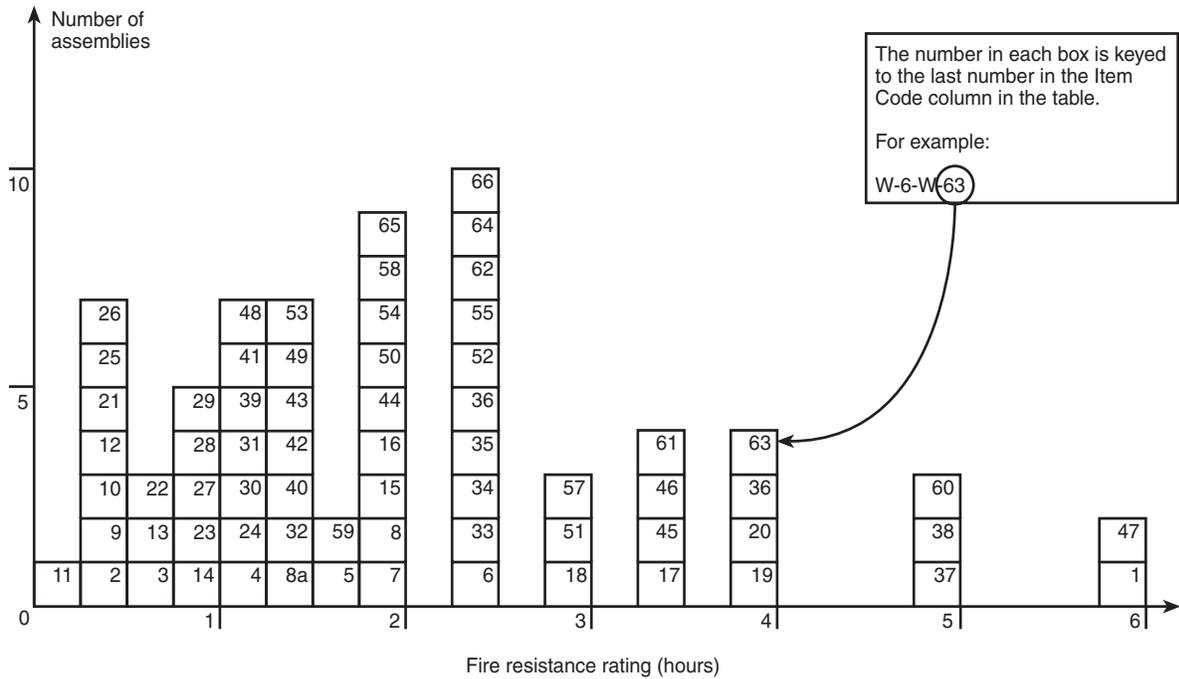
FIGURE O.4.5.3 Masonry Walls 6 in. (150 mm) to Less Than 8 in. (200 mm) Thick.

Designs of tiles used in fire-test partitions.

The four types of construction used in fire-test partitions.

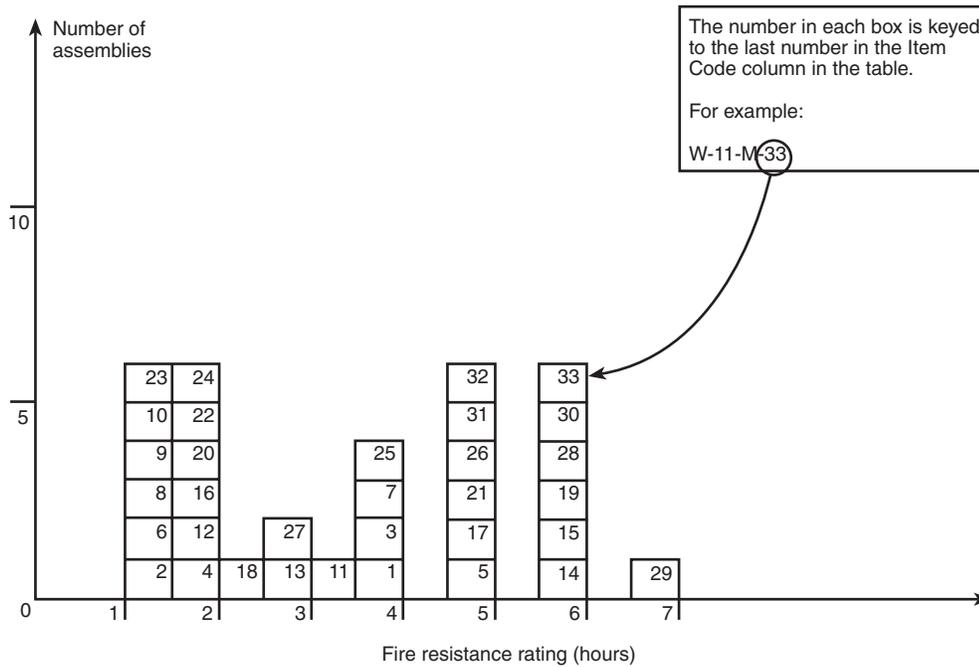
FIGURE O.4.5.5 Masonry Walls 10 in. (250 mm) to Less Than 12 in. (300 mm) Thick.

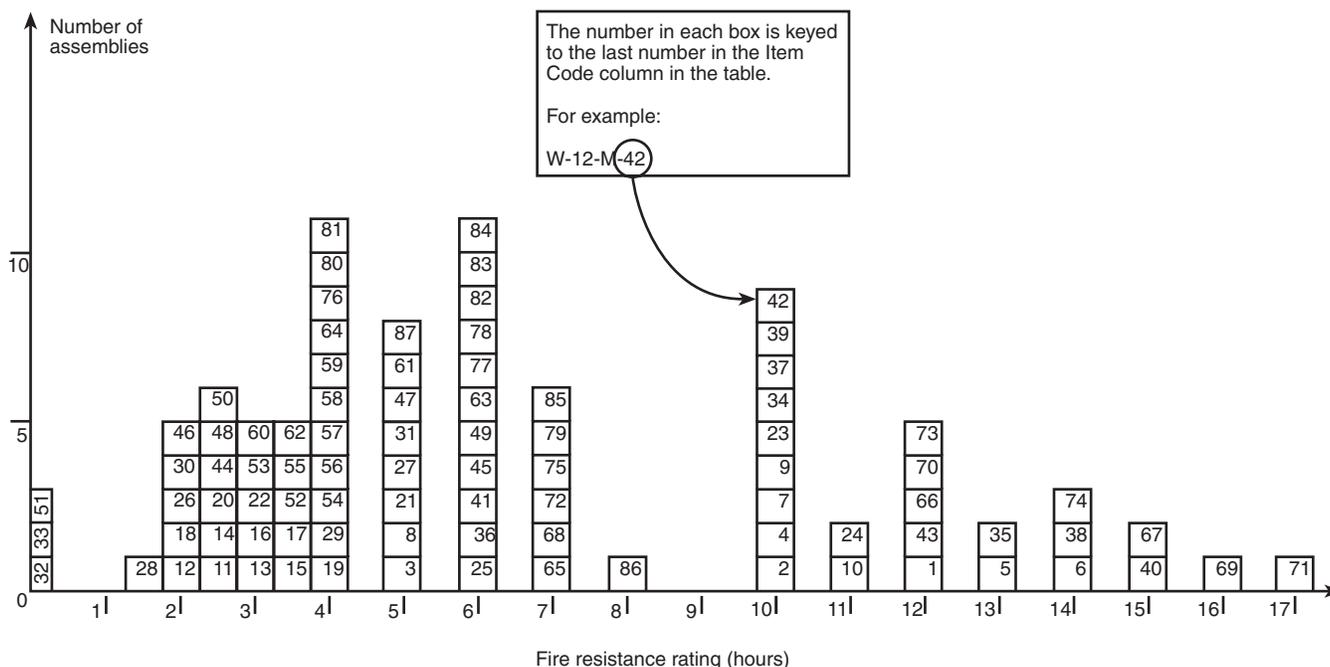
FIGURE O.4.5.6 Masonry Walls 12 in. (300 mm) to Less Than 14 in. (350 mm) Thick.

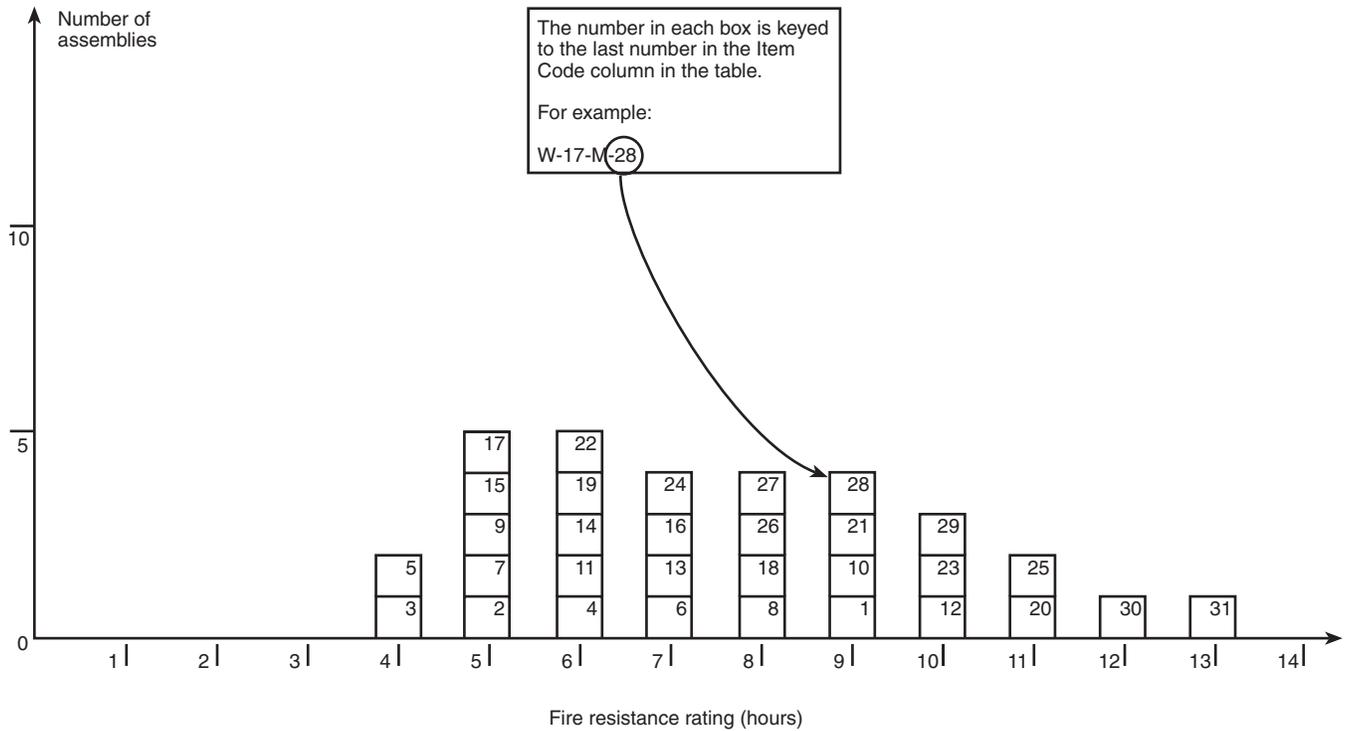
FIGURE O.4.5.7 Masonry Walls 14 in. (350 mm) or More Thick.

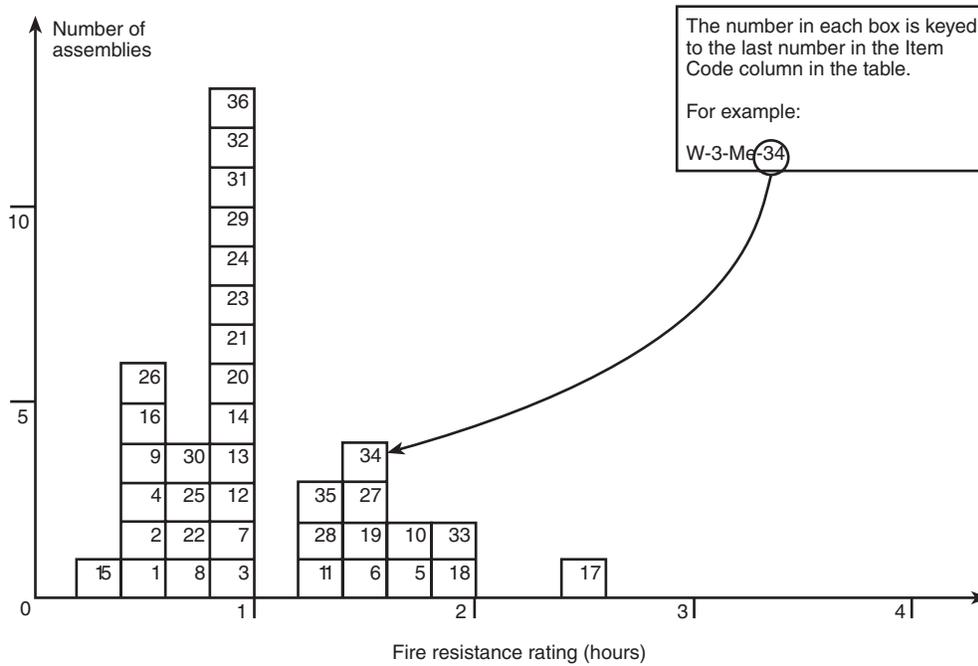
FIGURE O.4.5.8 Metal Frame Walls 0 in. (0 mm) to Less Than 4 in. (100 mm) Thick.

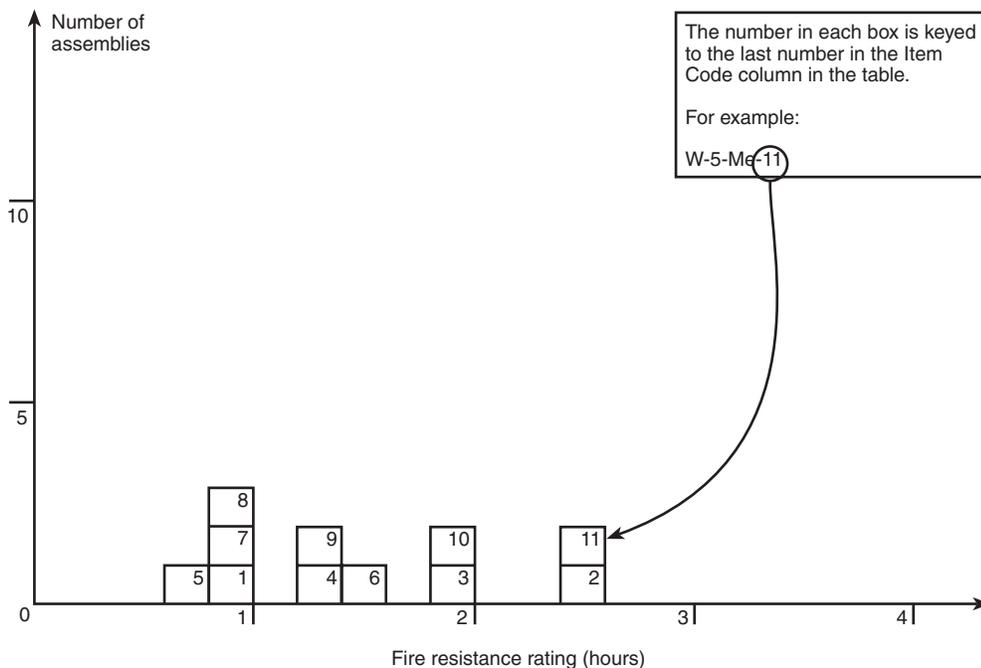
FIGURE O.4.5.9 Metal Frame Walls 4 in. (100 mm) to Less Than 6 in. (150 mm) Thick.

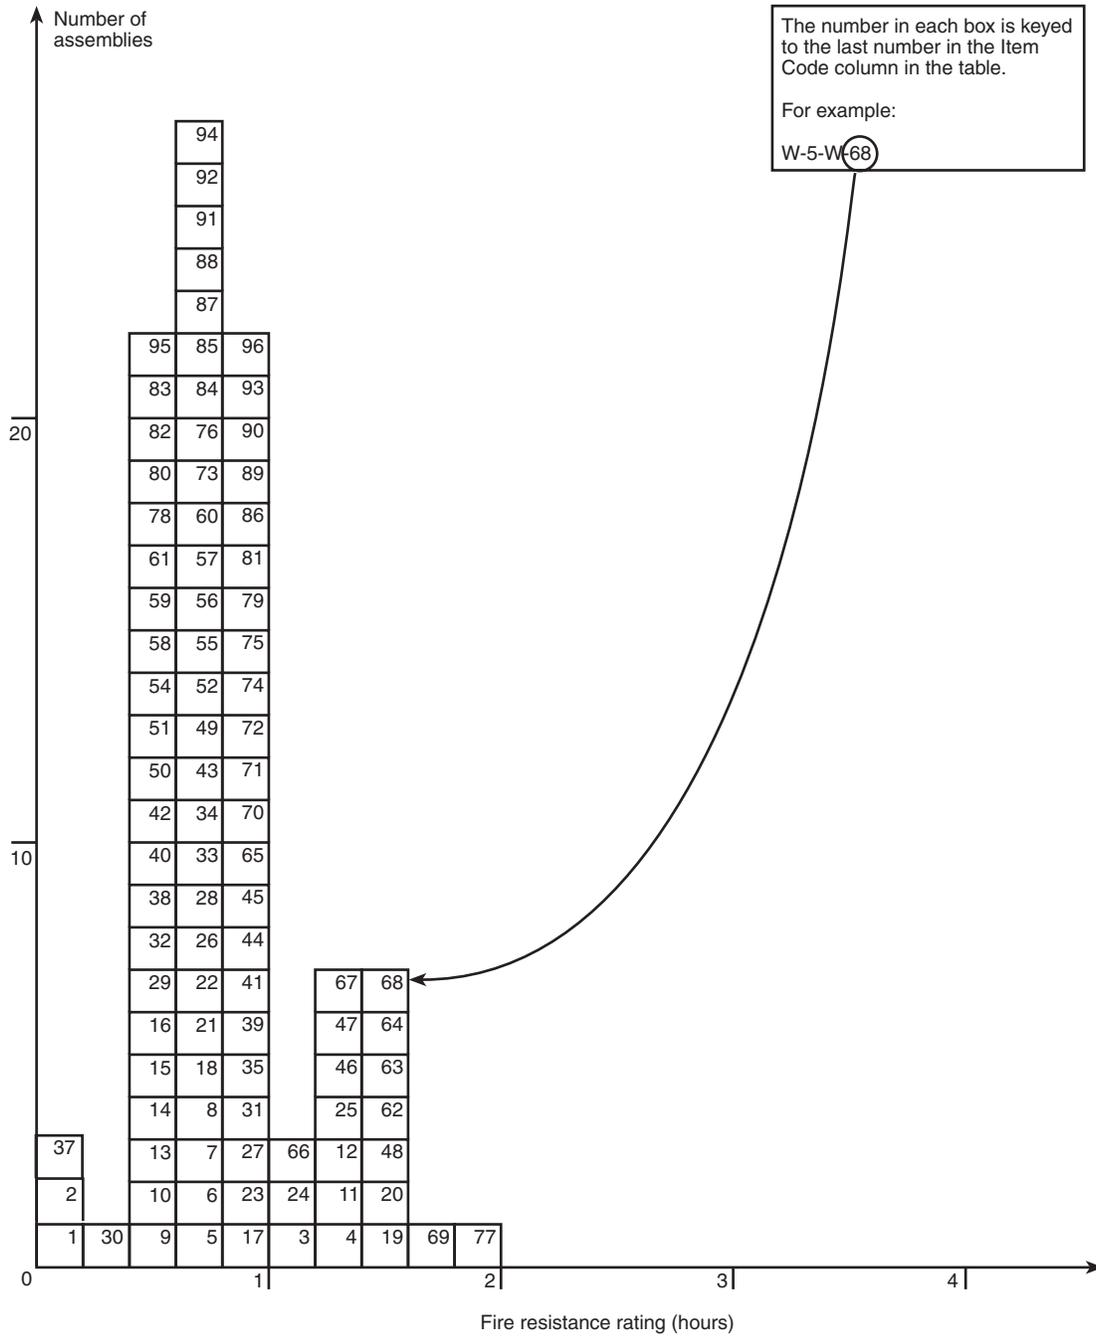
FIGURE O.4.5.13 Wood Frame Walls 4 in. (100 mm) to Less Than 6 in. (150 mm) Thick.

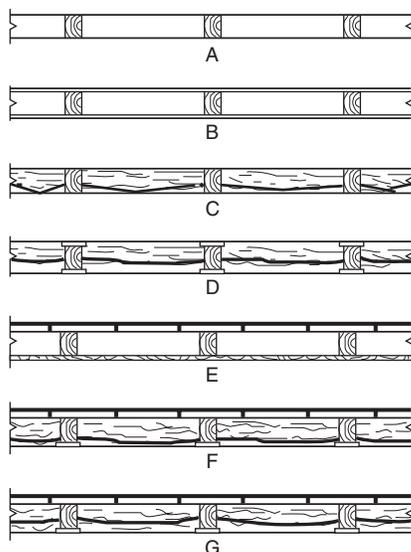
FIGURE O.4.5.13 [Diagram of] Wall Design.

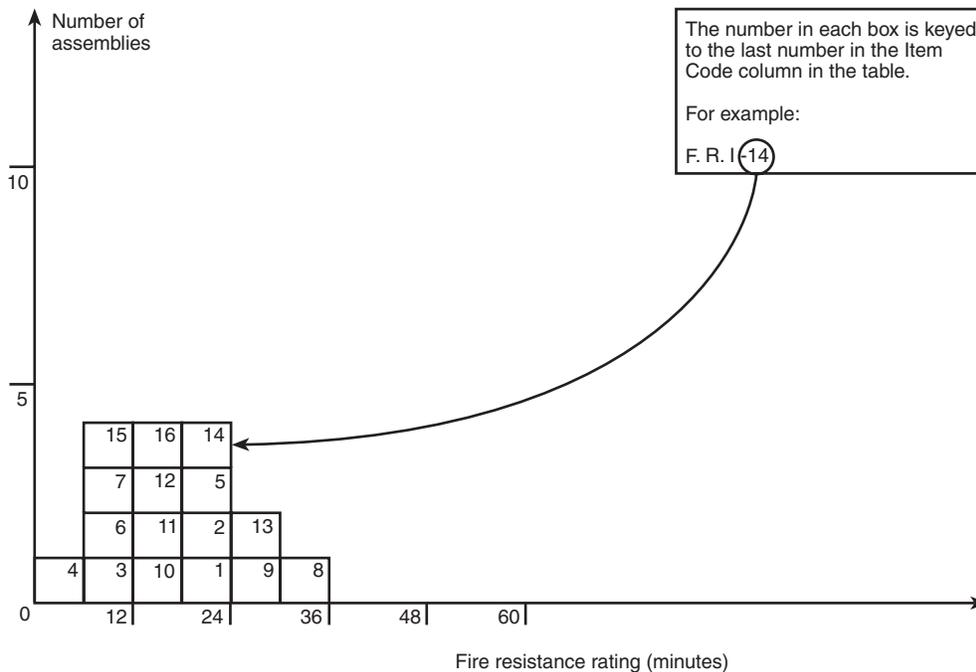
FIGURE O.4.5.17 Finish Ratings — Inorganic Materials.

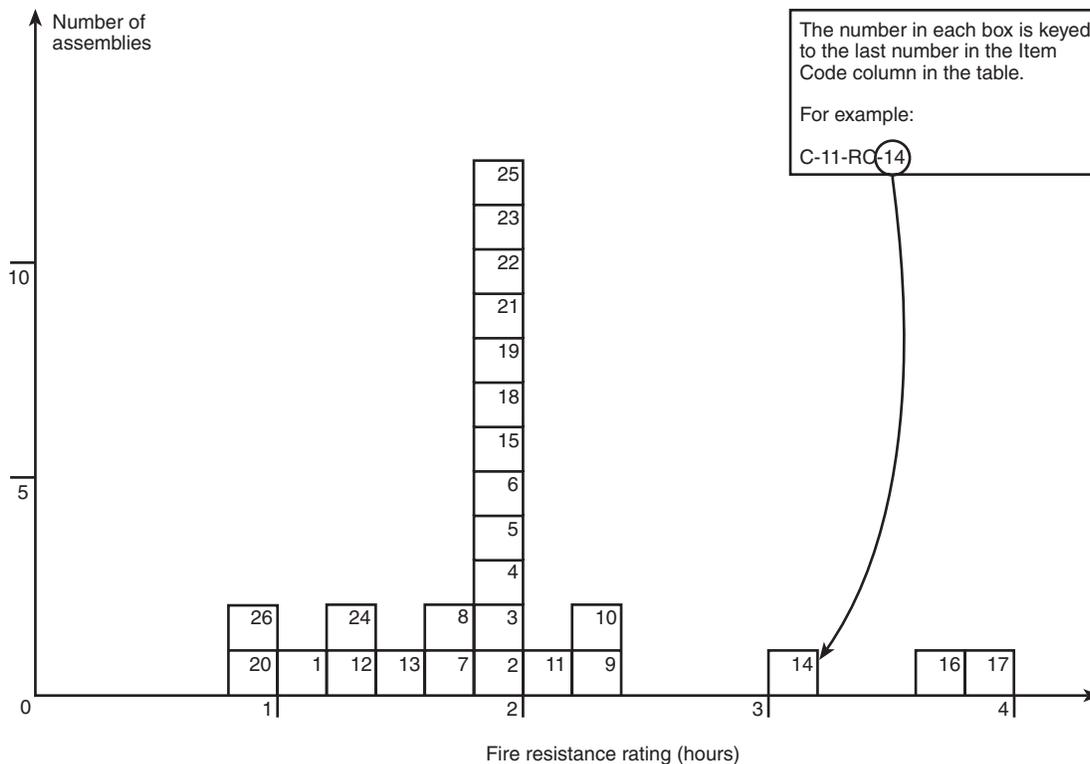
FIGURE O.4.5.20 Reinforced Concrete Columns with Minimum Dimension 10 in. (250 mm) to Less Than 12 in. (300 mm).
